**Phase I Environmental Site Assessment**

Phoenix Inn Suites Hotel  
415 Capitol Way N  
Olympia, Washington  
GeoDesign Project: VIPs-22-01-10

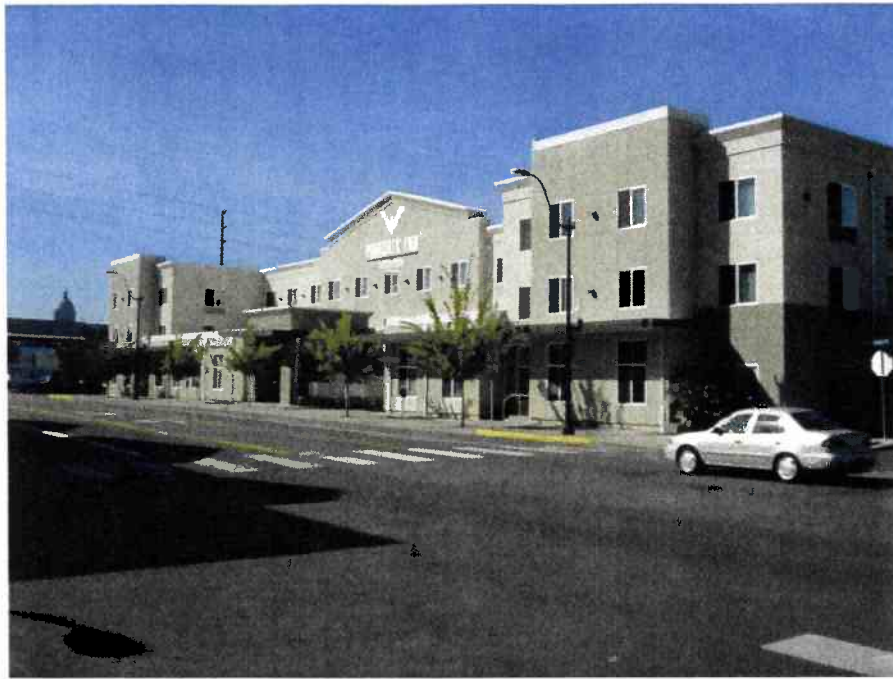
EASTERN PORTION OF PROJECT SITE. PHOTOGRAPH TAKEN FACING SOUTHWEST.

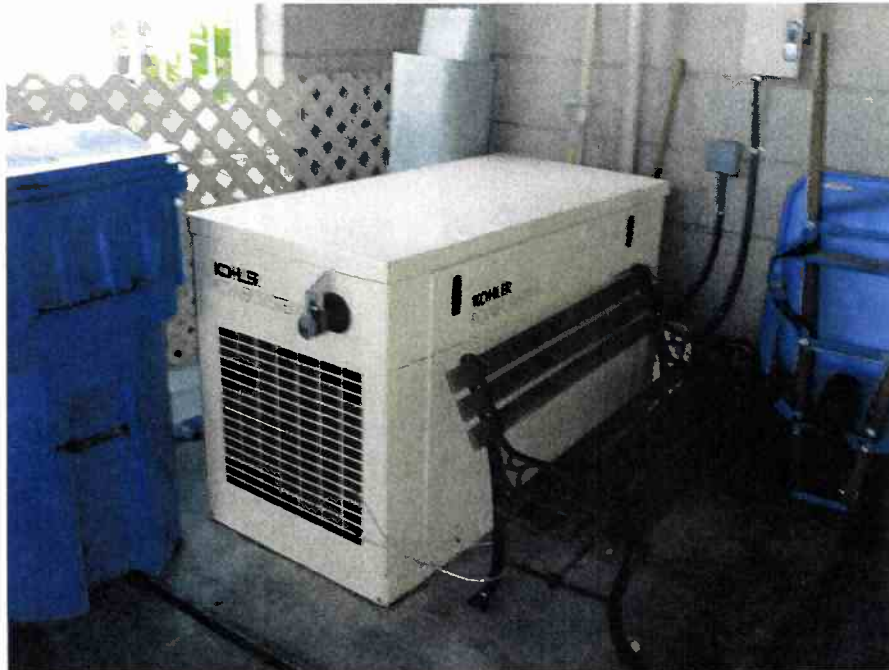
NATURAL GAS-POWERED EMERGENCY GENERATOR LOCATED NEAR THE NORTHWEST CORNER OF THE BUILDING. PHOTOGRAPH TAKEN FACING NORTHEAST.

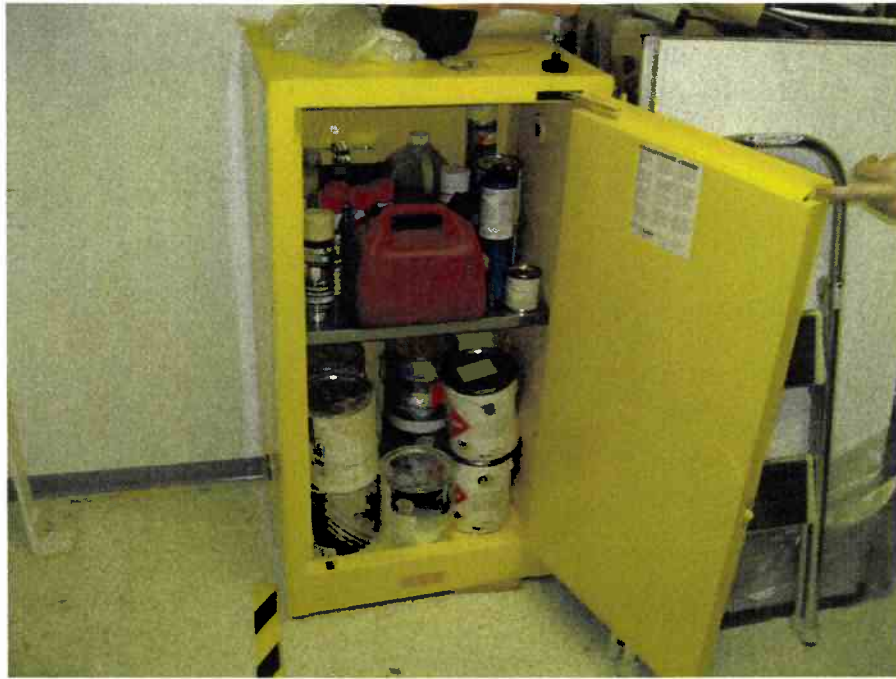
GeoDesign personnel observed numerous small containers of paint, paint thinner, cleaning solutions, and a 1 gallon container of gasoline stored in a fire-safe, metal cabinet in a second floor maintenance room. We did not observe evidence of chemical or hazardous material spills on the project site.

CHEMICAL STORAGE CABINET LOCATED IN THE SECOND-STORY MAINTENANCE ROOM. PHOTOGRAPH TAKEN FACING WEST.

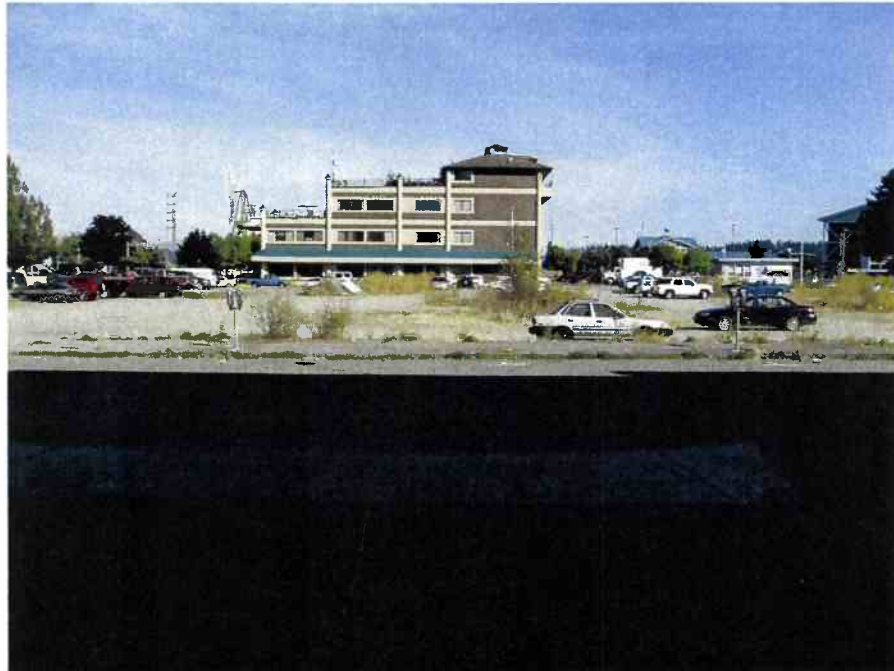
The project site is directly bounded to the north by A Avenue NW, across which is vacant undeveloped property; to the east by Capitol Way N, across which is high-density residential property; to the south by Thurston Avenue NW, across which is commercial property; and to the west by Columbia Street NW, across which is commercial property and a public park. Two groundwater monitoring wells were observed in the A Avenue NW right-of-way north of the project site. No other evidence of adverse environmental conditions was observed on adjacent properties.

VACANT PROPERTY LOCATED NORTH OF THE PROJECT SITE. PHOTOGRAPH TAKEN FACING NORTH.
