PHASE I ENVIRONMENTAL SITE ASSESSMENT
of
Doubletree Olympia
415 North Capitol Way
Olympia, Washington 98501

EMG Project #: 110446.14R - 097.051
Date of Report: September 06, 2014
On Site Date: August 27, 2014

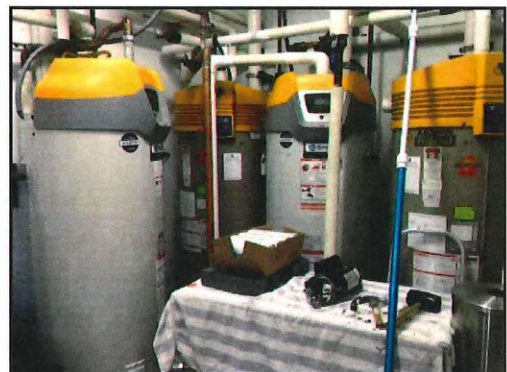
6 : Natural gas-fired water heaters

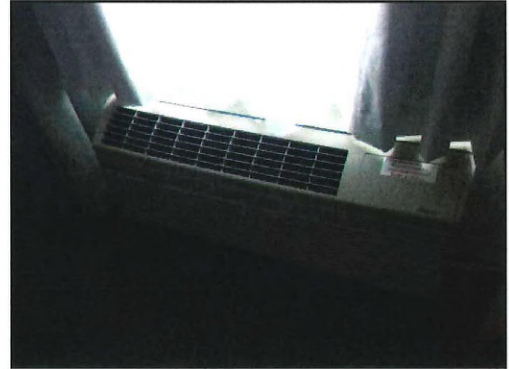
8 : PTAC unit

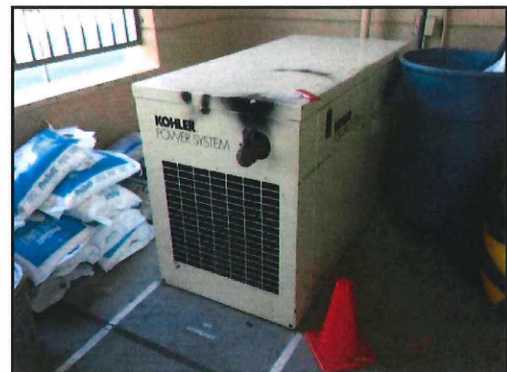
18 : Natural gas-fired emergency generator

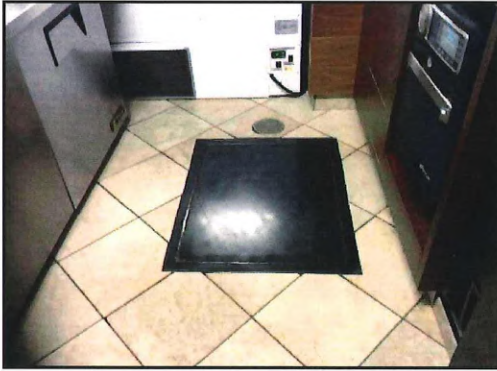
19 : Unused grease trap

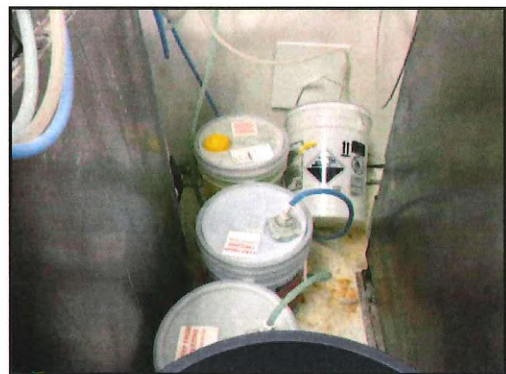
The Project is involved in the use of hazardous materials and petroleum products in the form of laundry detergents, swimming pool chemicals and janitorial/maintenance supplies. The identified materials appear to be properly stored. The materials observed do not appear to pose a hazard to the Project, provided they continue to be used as designed, are properly handled, and all regulations regarding their use are followed. No further action or investigation is recommended regarding the use of these materials.

22 : Laundry detergents

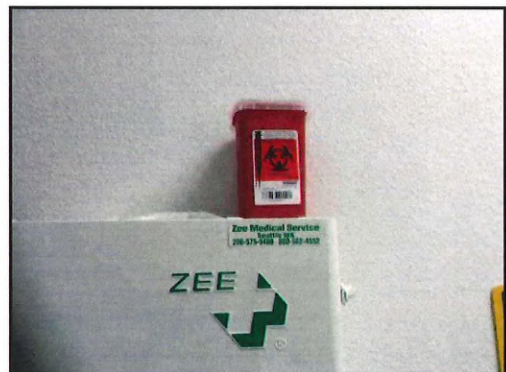
The Project generates medical waste in the form of bio-hazardous materials (i.e. sharps/bandages) as well as non-hazardous solid and liquid wastes. These materials appear to be stored and disposed of properly. No further action or investigation is recommended regarding these materials.

24 : Sharps storage

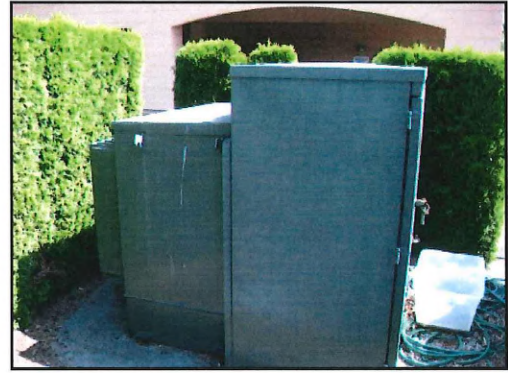
EMG identified utility-owned electrical transformer equipment at the Project. This equipment appeared to be in good condition with no evidence of leaks. The transformer is designated as the property of the public utility and is not classified with regards to its PCB content. The utility is the financially responsible party for maintenance of this equipment. No further action or investigation is recommended regarding the transformer equipment.

26 : Transformer

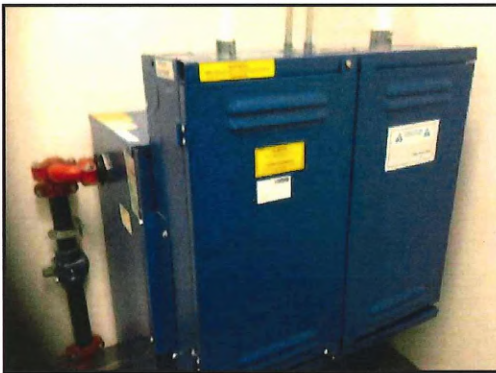
The Project contains hydraulic elevator equipment. No indication of leakage was observed in the area of this equipment. This equipment should be periodically inspected for leakage. If leakage is identified, the unit should be repaired, and any fluid or fluid-soaked waste disposed of in accordance with applicable federal, state, and local regulations. No further action or investigation is recommended regarding this equipment.

27 : Hydraulic elevator equipment

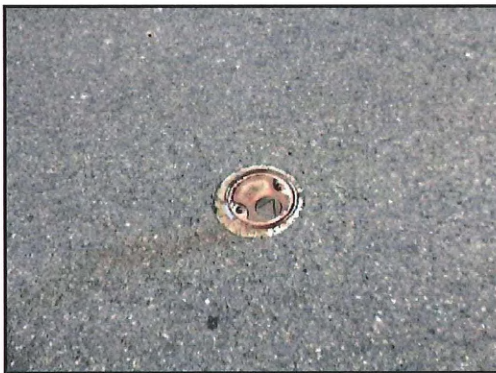
29 : Monitoring well

EMG recommends the continued cooperation with the Washington Department of Ecology regarding the bio-remediation at the Project. If additional information regarding the current status of the remediation at the Project or the off-site contamination sources is required, a file review at the Washington Department of Ecology would be recommended.

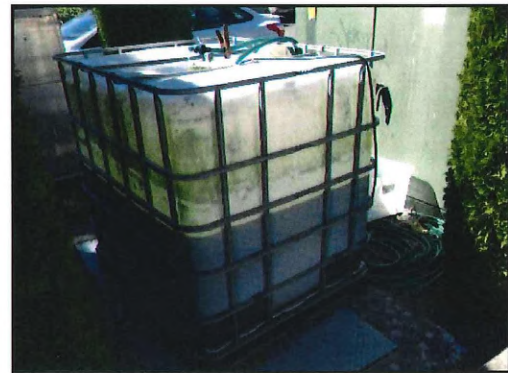
30 : Bioremediation equipment
