Memorandum

To: Adam Harris, Washington State Department of Ecology
Copies: Tom Lovejoy, Puget Sound Truck Lines
From: Brett Beaulieu, LHG
Date: November 30, 2016
Project No: PSTL Longview
**Re: Puget Sound Truck Lines Longview Site—VCP SW1429
2016 Groundwater Monitoring Results and Summary of Soil Compliance**

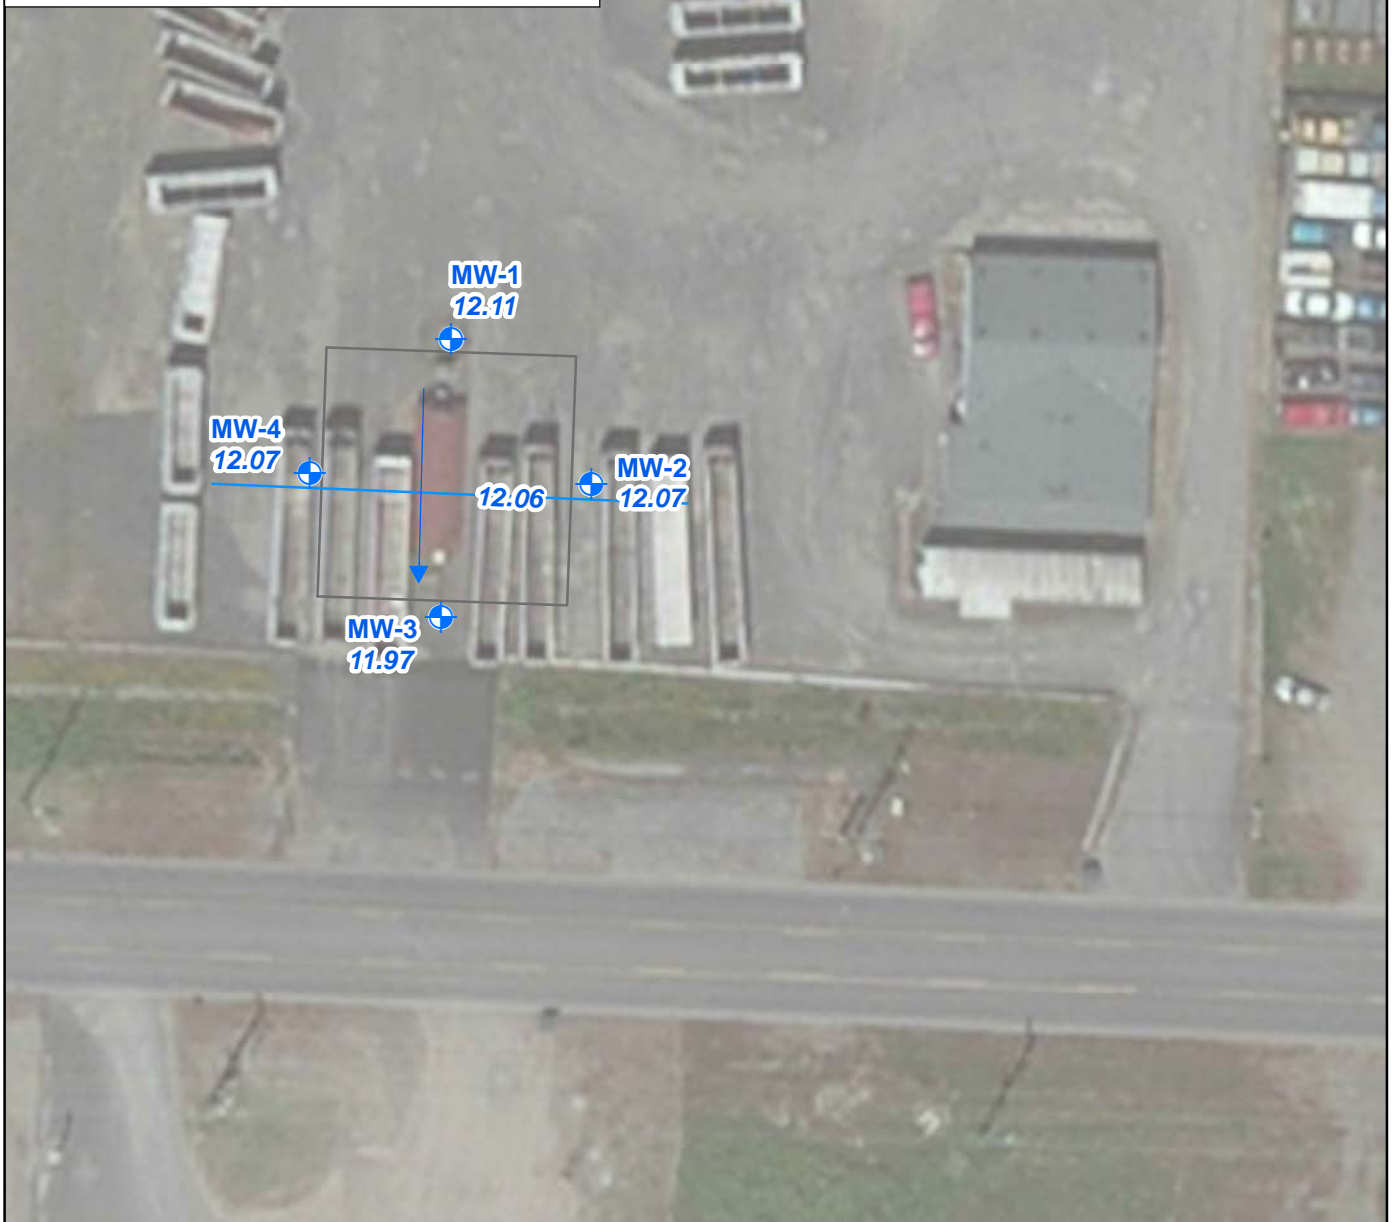
**Figure 2
Potentiometric Surface and
Groundwater Elevations
March 30, 2016**

Water level measurements, elevations, and horizontal hydraulic gradients are reported in Table 1. Groundwater elevations and potentiometric surface contours for each event are illustrated in Figures 2, 3, and 4. Average water levels for each event are plotted on Figures 5, 6, 7, and 8. Water level elevations fluctuated by approximately 4 feet over the three monitoring events, from a high of greater than 12 feet relative to the North American Vertical Datum of 1988 (NAVD 88) in March to a low of approximately 8 feet NAVD 88 in September.

Potentiometric contours indicate an overall southerly groundwater flow direction that varied from southerly during the March and June events to southeasterly during the September event.

Water level data indicate low horizontal gradients ranging from approximately 0.001 to 0.003 feet per foot (ft/ft), which is consistent with the flat topography in the vicinity.

Available potentiometric contours from 2014 to 2016 indicate a general southerly direction of groundwater flow. The greatest variations in the apparent flow direction are seen during September monitoring events, when water levels are generally near their lowest levels of the year, suggesting a temporary and local condition that likely does not reflect the overall southerly
