Phase II Environmental Site Assessment

Plum Street Chevron

1018 Plum Street SE

AEG Project #: 16-121
Date of Report: May 24, 2016

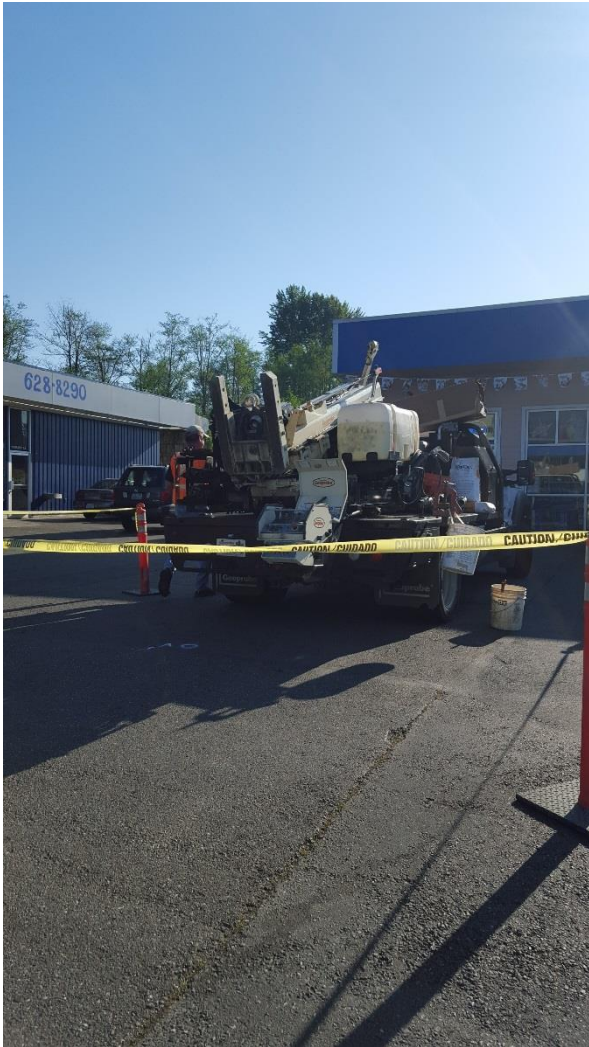
<p>Photo #1:</p>	<p>Location of B-1, situated east of the used oil tank.</p>	<p>Photo #2:</p>	<p>Soil cuttings from B-1. No visible contamination was observed.</p>
------------------	---	------------------	---

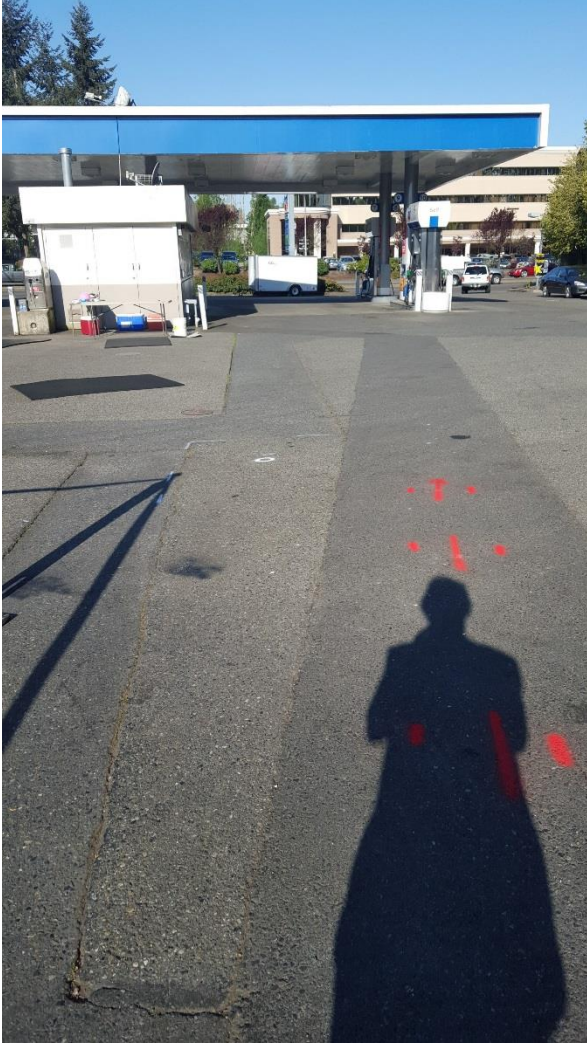
<p>Photo #2:</p>	<p>Location of B-2, situated due north of the used oil tank.</p>	<p>Photo #4:</p>	<p>Soil cuttings from B-2. Visible contamination was observed.</p>
------------------	--	------------------	--

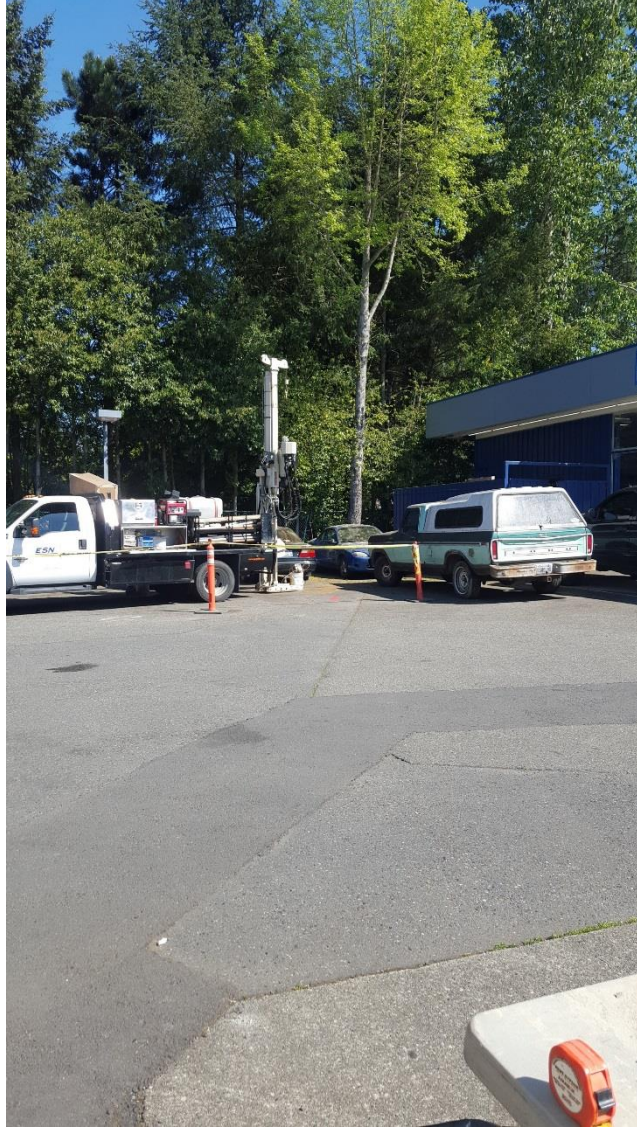
<p>Photo #7:</p>	<p>Location of B-4, situated west of MW-4.</p>	<p>Photo #8:</p>	<p>Soil cuttings from B-4. No visible contamination was observed.</p>
------------------	--	------------------	---
