Supplemental Remedial Investigation

Former USG Taylor Way Plant Site
2301 Taylor Way
Tacoma, Washington
Cleanup Site ID 5003

September 30, 2016

**AGENCY-REVIEW FINAL DRAFT
SUPPLEMENTAL REMEDIAL INVESTIGATION
2301 TAYLOR WAY
TACOMA, WASHINGTON**

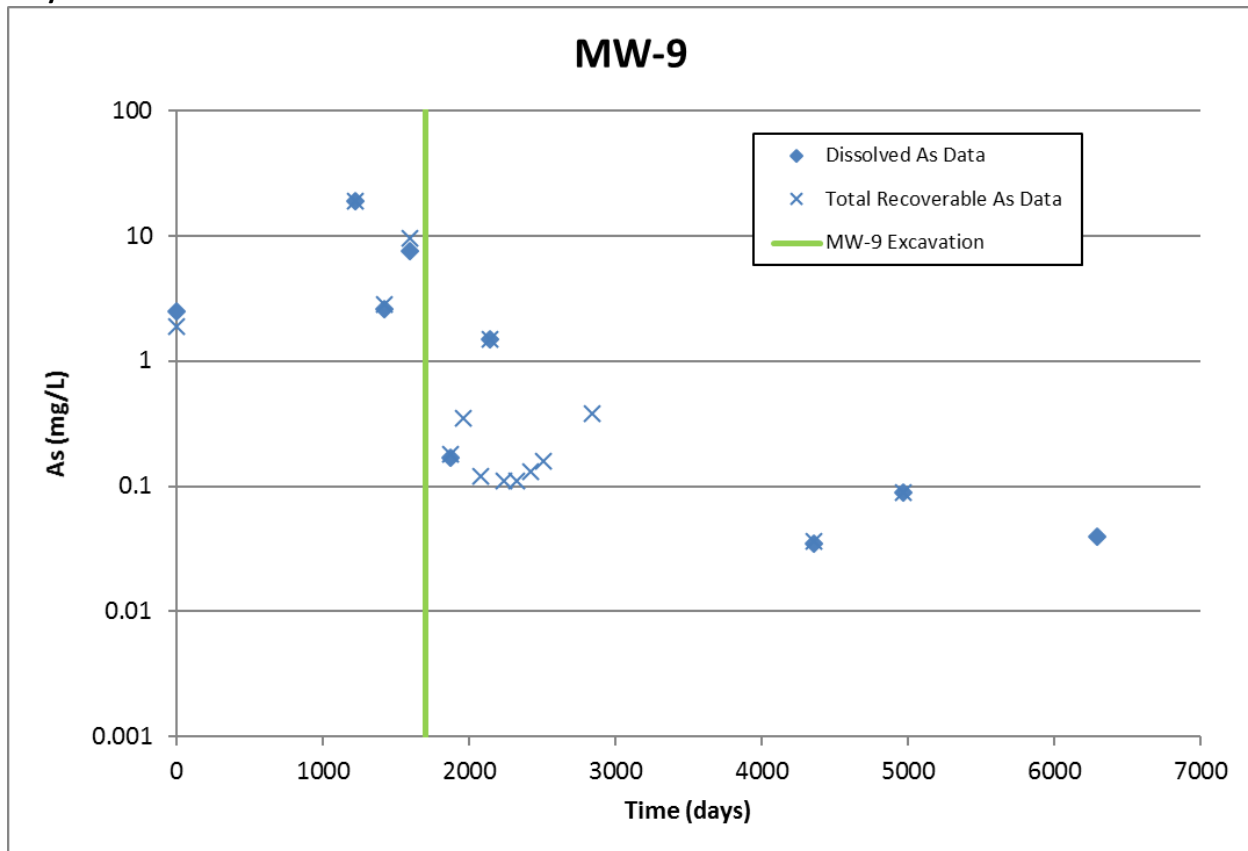
Figure 8-2 – Trend in Groundwater Arsenic Concentrations in Well MW9 from November 1994 through May 2012.

Well MW9 historically had by far the highest arsenic concentrations on the Site. **Figure 8-2** shows the dramatic decrease in arsenic concentrations following the MW9 area soil excavation in the summer of 1999. Arsenic concentrations have declined three orders of magnitude subsequent to the IA. In November 1998, dissolved arsenic concentrations reached a high of 19,000 $\mu\text{g/L}$. The well was removed during the excavation and replaced following backfilling with clean soil. Following the excavation, the groundwater concentrations significantly declined. Since 2006, dissolved arsenic concentrations at MW9 have ranged between 35 and 90 $\mu\text{g/L}$.

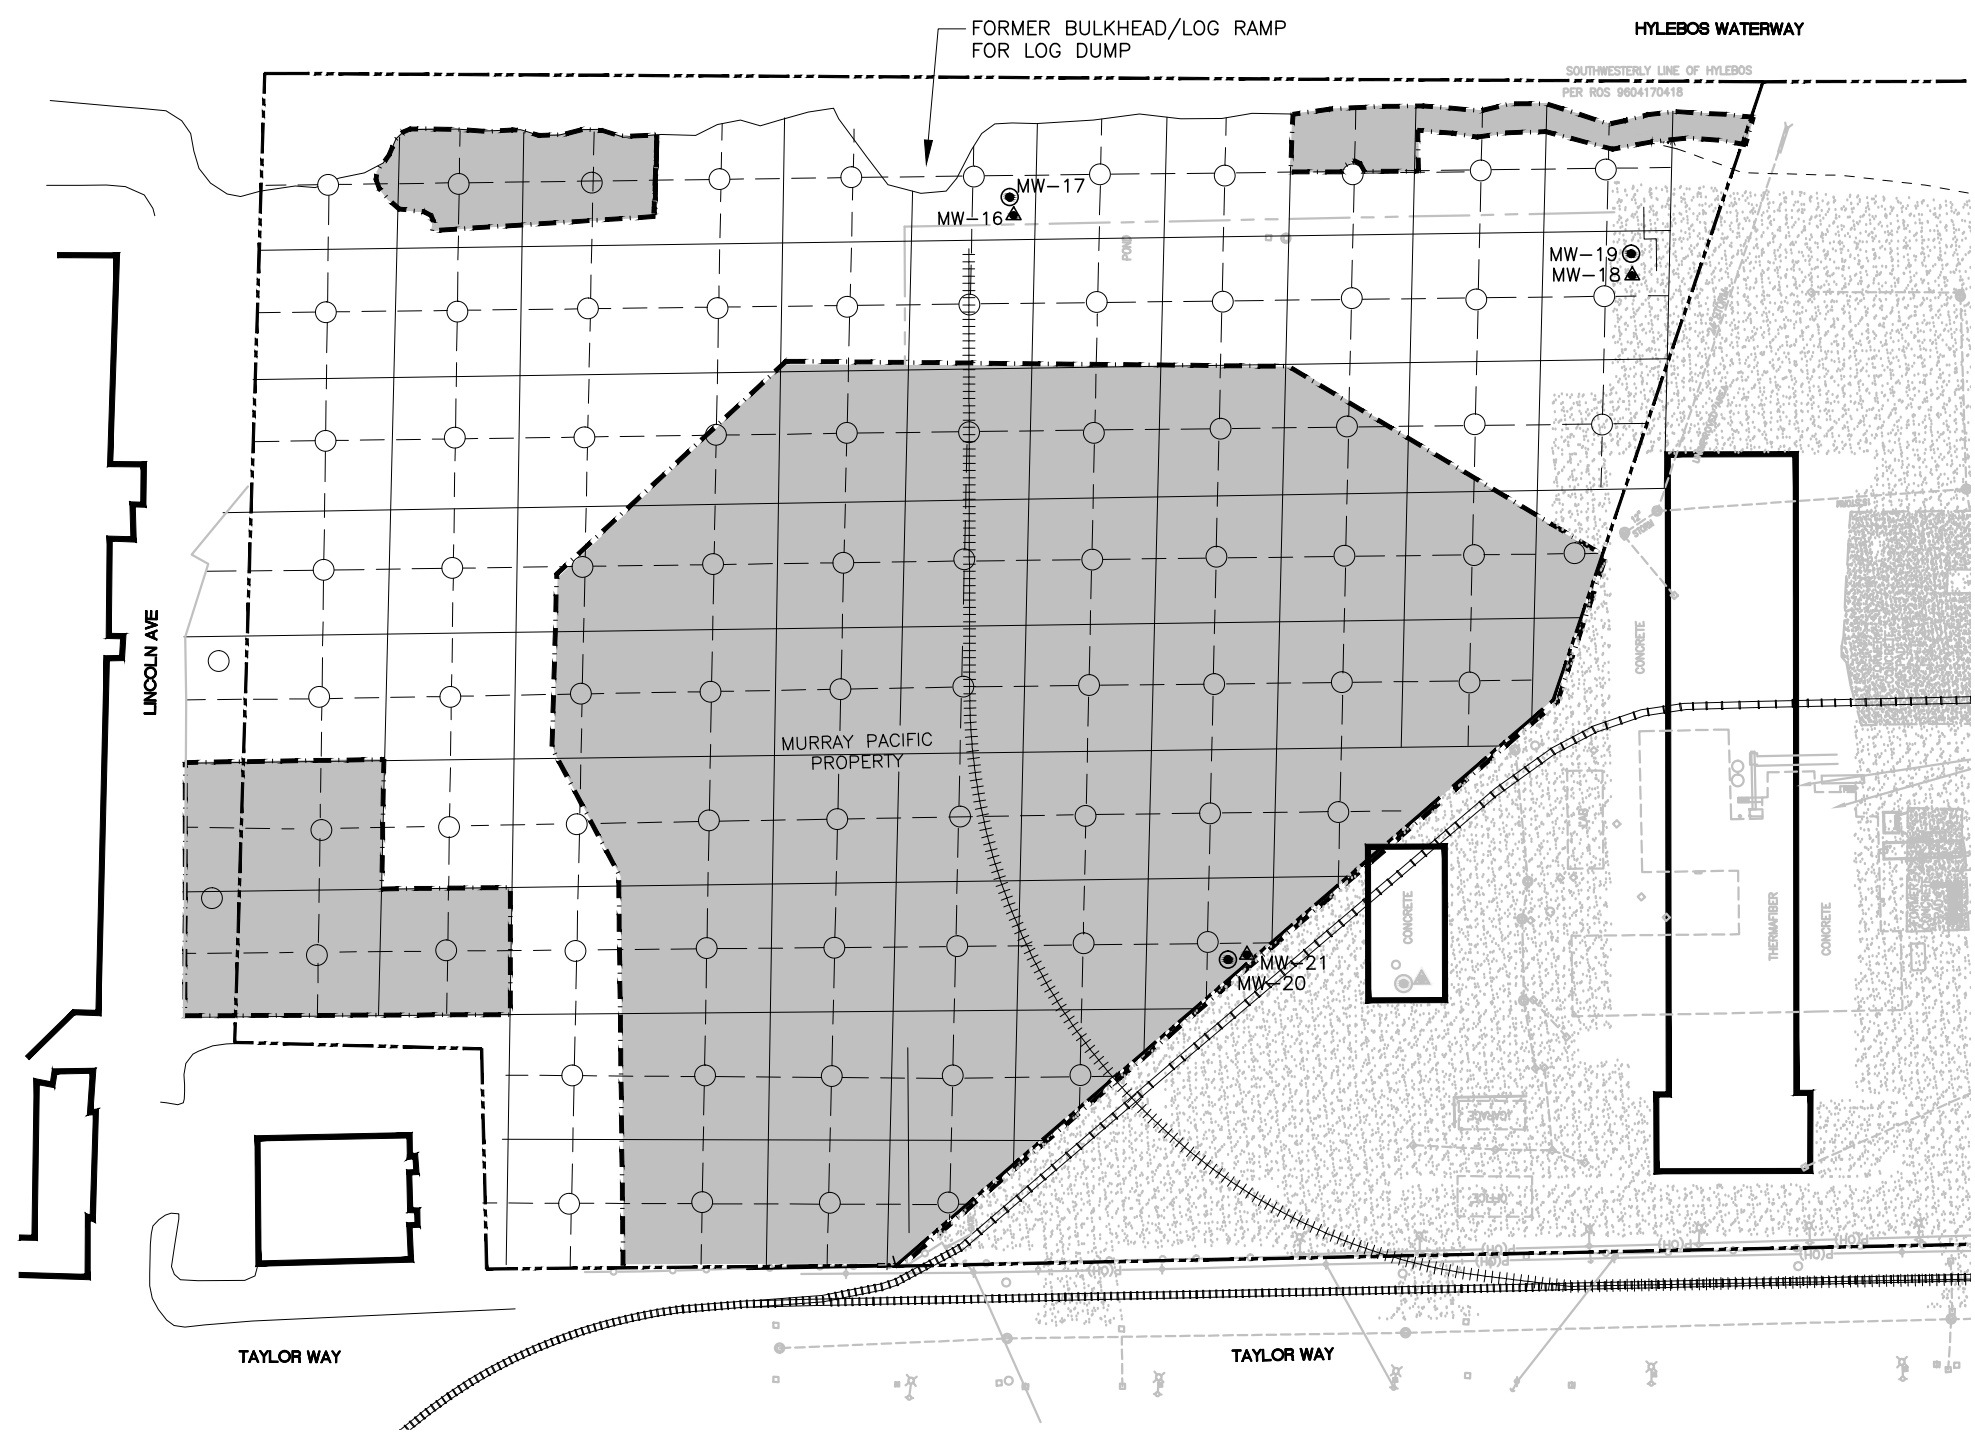
Figure No. 5
 Murray Pacific
 Grid Sampling Plan Post Remediation

REFERENCE: HYDROMETRICS INC. 1996.
 FINAL ENGINEERING REPORT MURRAY
 PACIFIC LOG SORT YARD NO 1 REMEDIATION

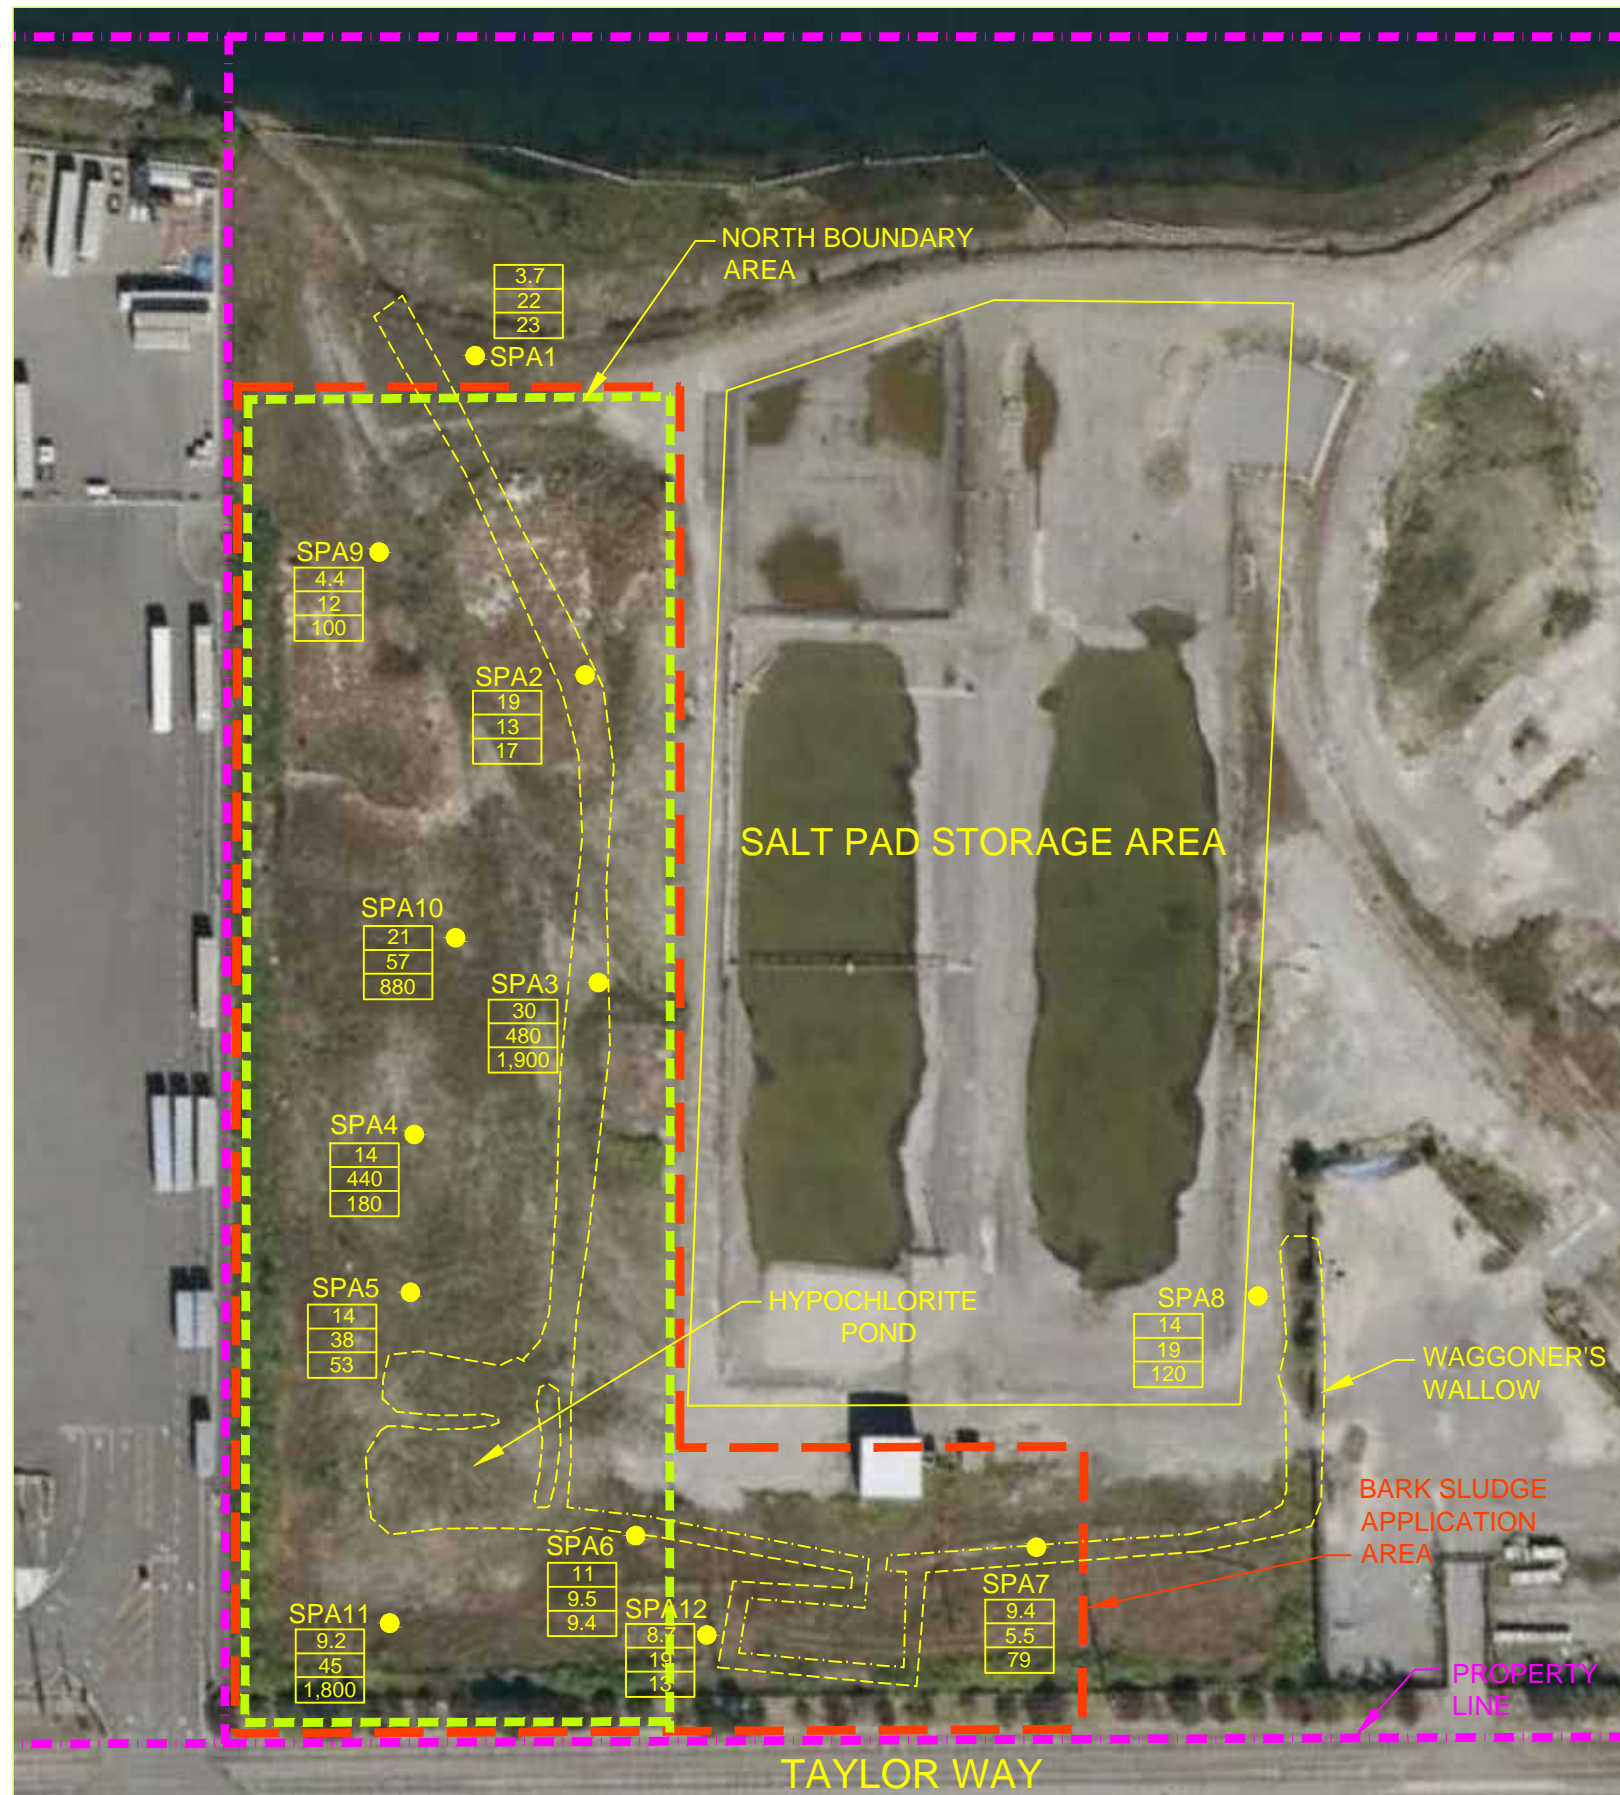
Figure No. 6
 Arkema Property North Boundary Area
 and Salt Pad Layout

MALCOM PIRNIE 2006 INVESTIGATION RESULTS

Malcolm Pirnie analyzed soil and groundwater samples for metals, including arsenic, and these data are summarized on **Figure 6**. Surficial soil arsenic concentrations ranged between 3.7 mg/kg and 30 mg/kg. Arsenic concentrations in two of the samples were greater than the MTCA Method A unrestricted land use cleanup level of 20 mg/kg. Lead concentrations ranged between <5.6 and 44 mg/kg.

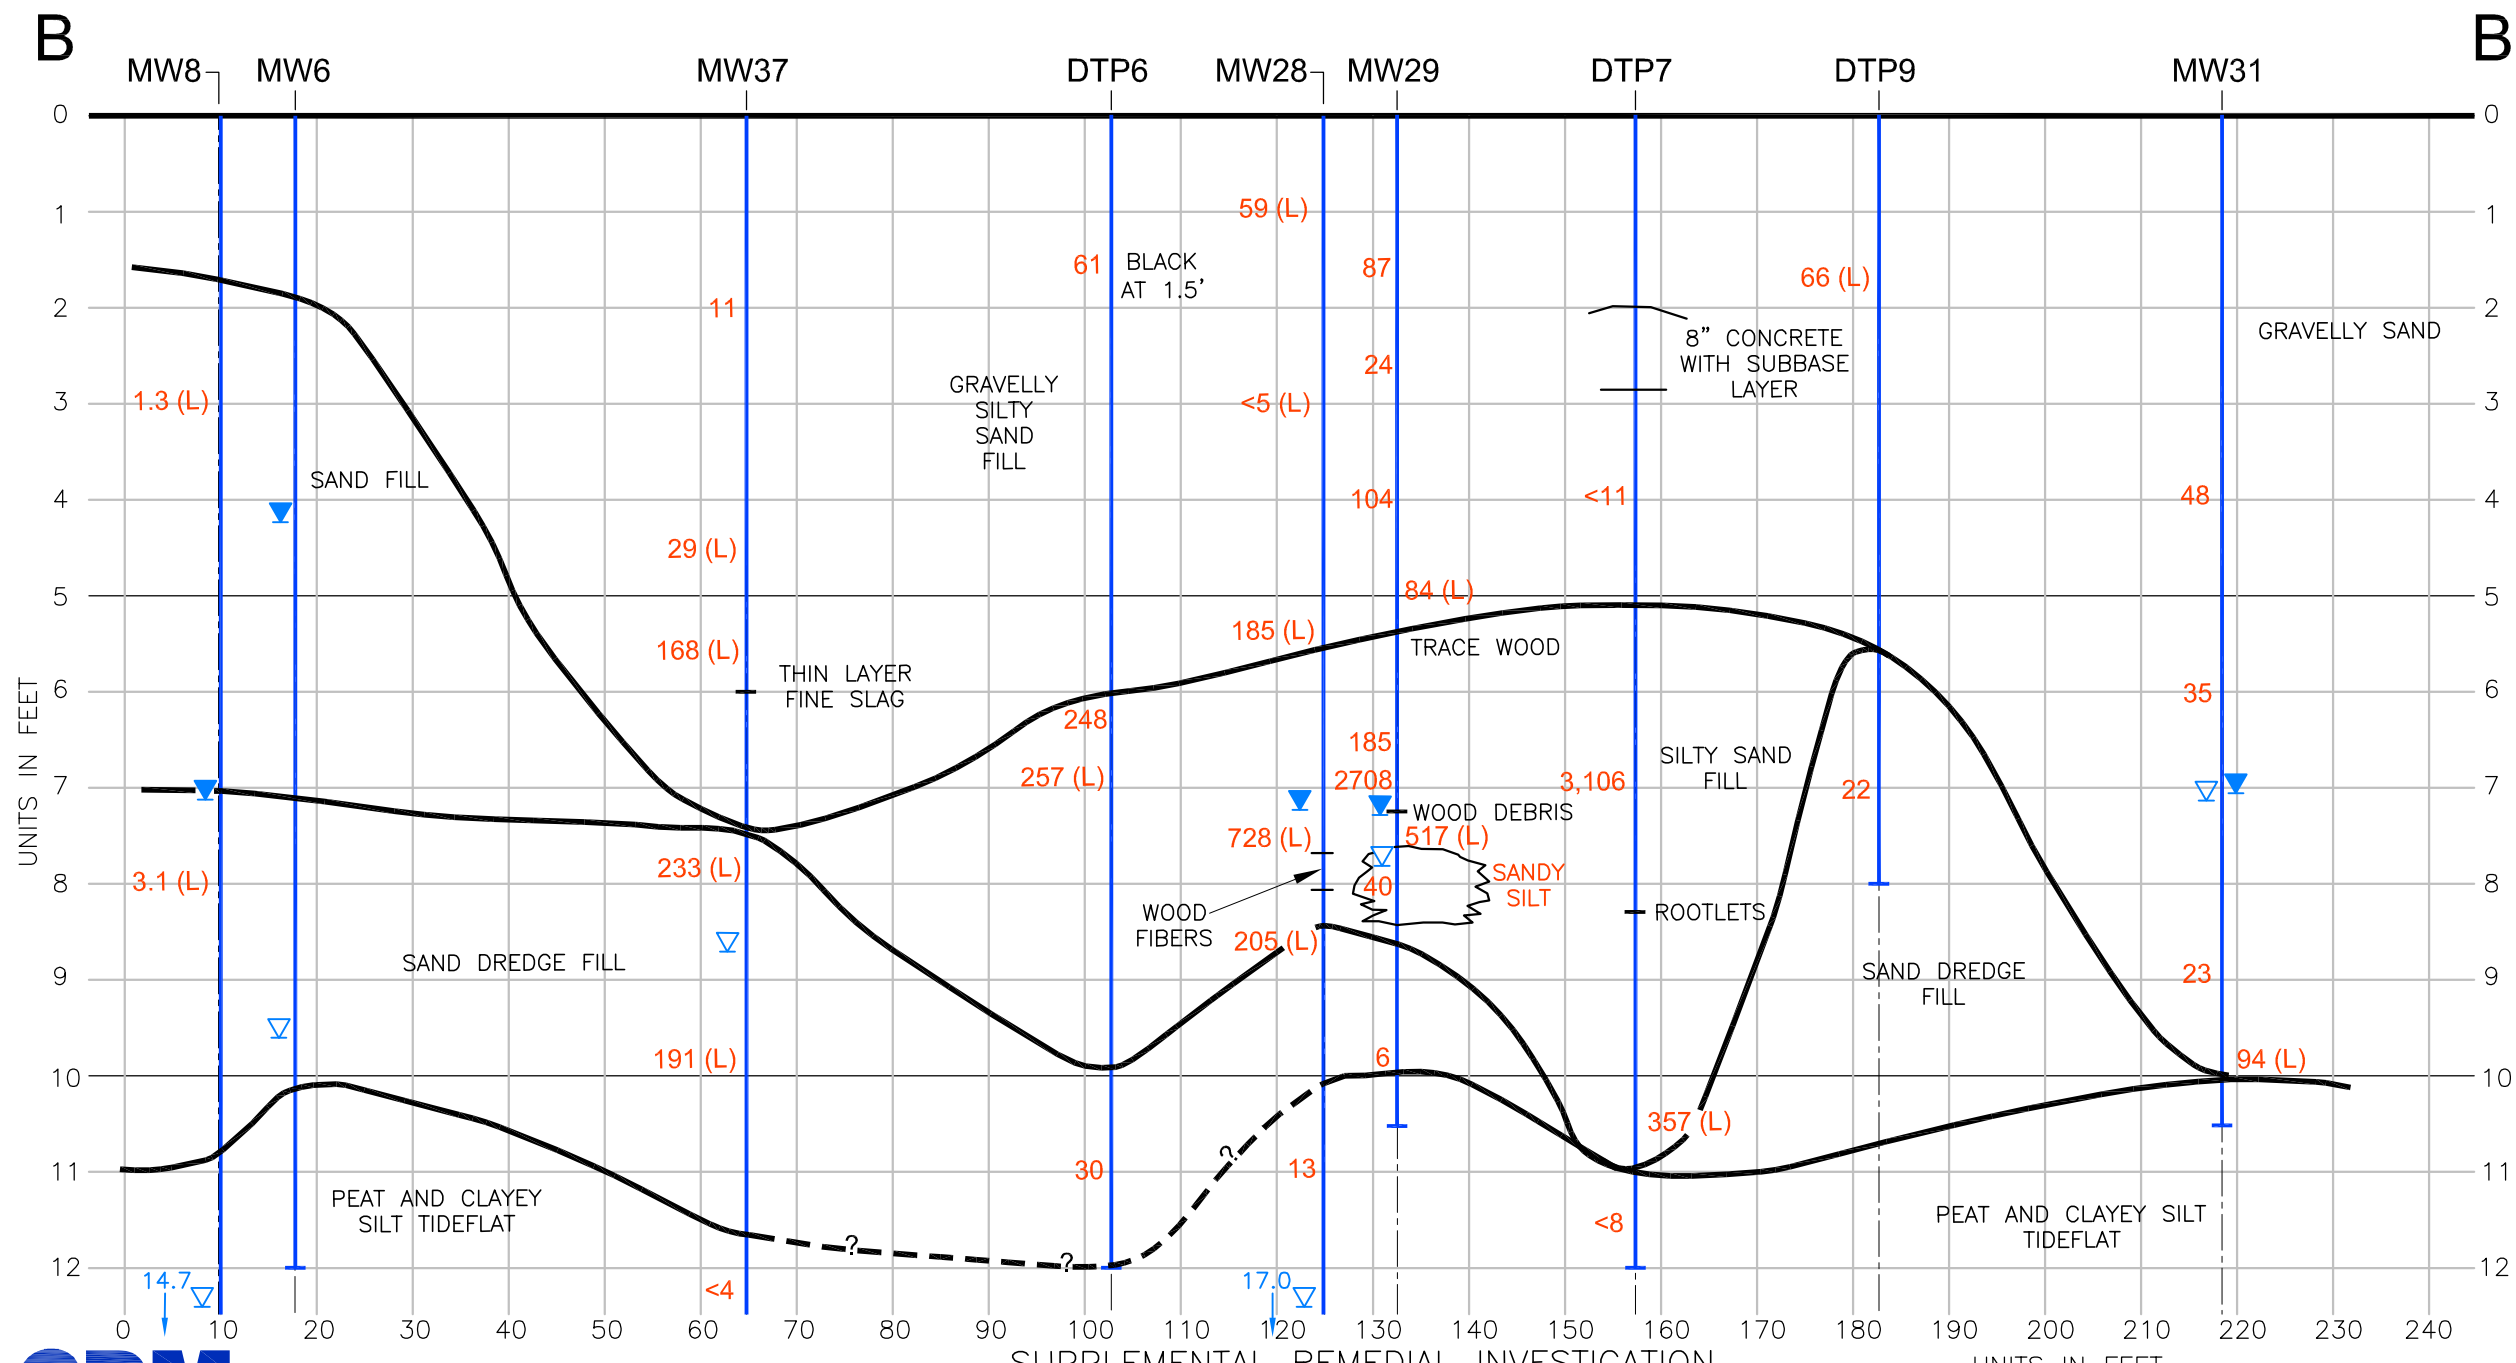
Figure No. 20
 Cross Section B-B'
 Taylor Way/Murray Pacific Property Line at
 Hylebos Waterway

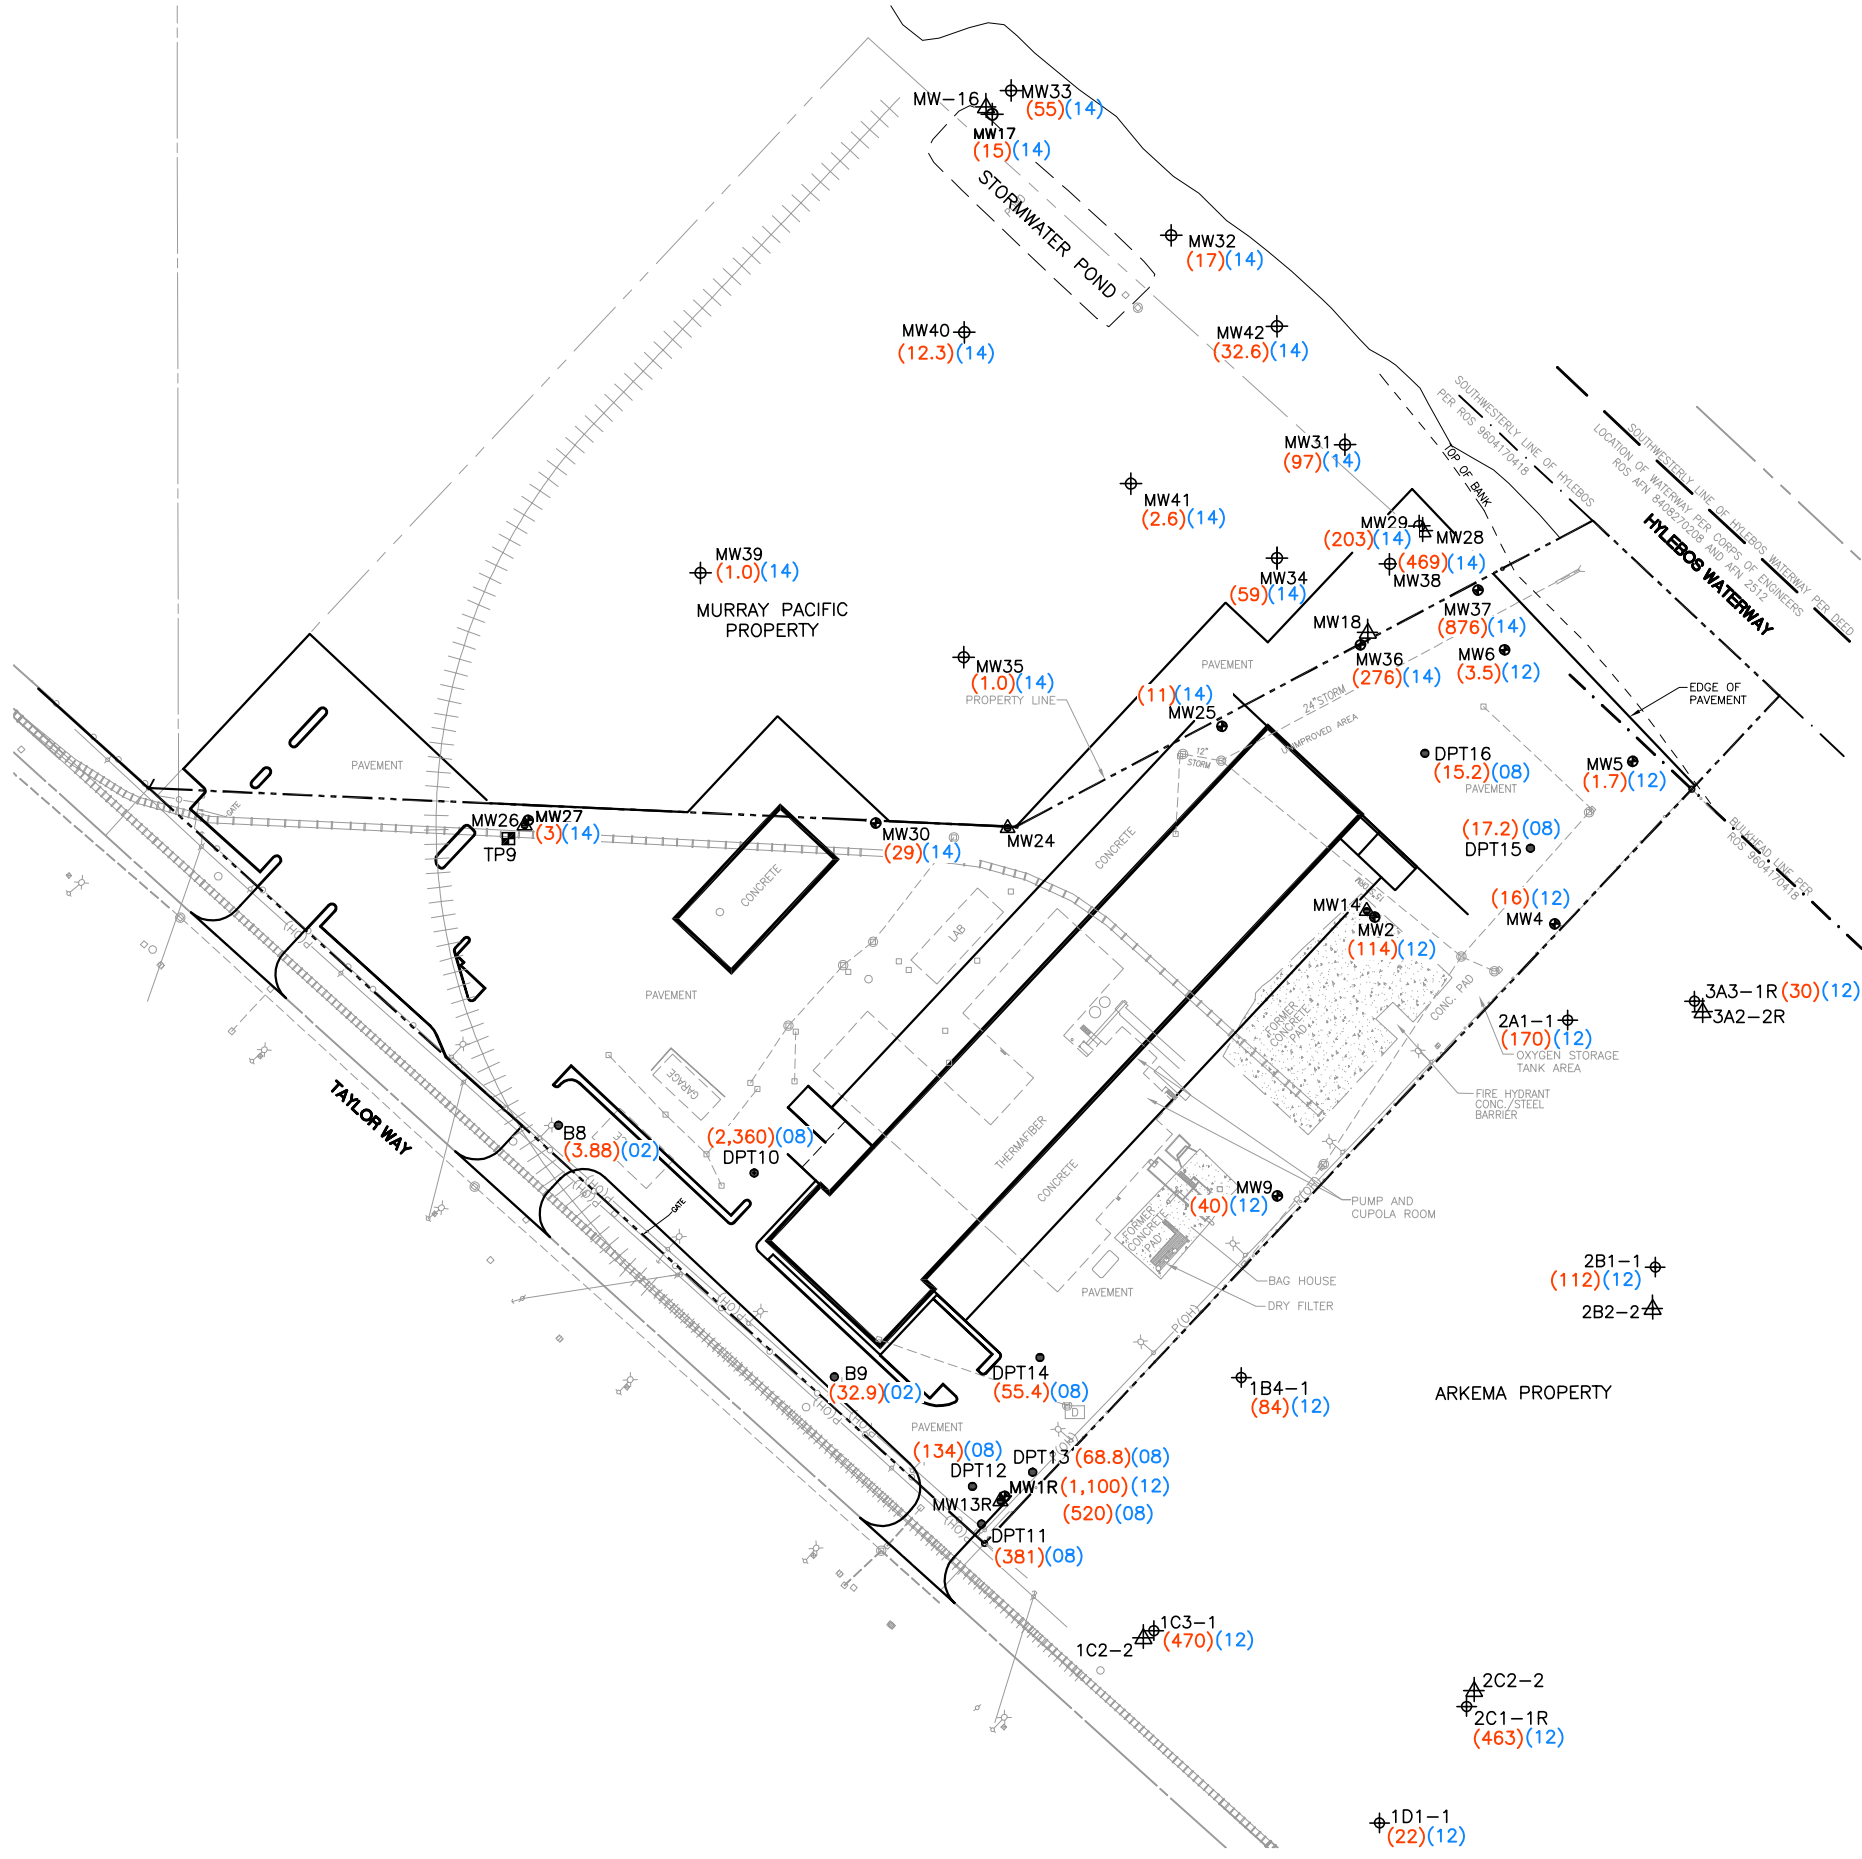
Figure No. 22
 Surface Aquifer Dissolved
 Arsenic Concentrations

- DPT16 ● DPT BORING WITH GRAB GROUNDWATER SAMPLE
- MW6 ● SURFACE AQUIFER WELL AND DESIGNATION
- MW26 ▲ SECOND AQUIFER WELL AND DESIGNATION
- 1C3-1 ⊕ OFF-SITE SURFACE AQUIFER WELL AND DESIGNATION
- 2B2-2 ⊕ OFF-SITE SECOND AQUIFER WELL AND DESIGNATION
- TAYLOR WAY PROPERTY BOUNDARY
- EXISTING BUILDING
- NEW ASPHALT PAVED AREA
- ▨ FORMER CONCRETE PAD
- FORMER BUILDING LOCATION
- ⊕ STORM DRAIN SYSTEM
- (2.6)(14) DISSOLVED ARSENIC CONCENTRATION IN MICROGRAMS PER LITER (RED) AND YEAR SAMPLED (BLUE)

Figure 22 shows the most recent (2012/2014) arsenic concentrations in the surface aquifer at the individual monitoring wells. Some of the earlier groundwater data (2002/ 2008) from temporary (DPT) wells is also presented for discussion purposes. Arsenic concentrations throughout the Site are not suitable for contouring due to the various source control actions taken throughout the Site and interspersed nature of remaining arsenic in soils; thus no arsenic isoconcentration maps have been prepared. The following sections discuss arsenic data for groundwater by area, similarly as for the soils in Section 7.

Groundwater samples collected from temporary well points in the area immediately surrounding MW1 in August 2008 indicate attenuation of arsenic with distance from MW1/MW1R occurs over a fairly short distance (**Figure 22**). At that time, the arsenic concentration was highest at MW1R (510 µg/L) and lower at all of the surrounding well points. The arsenic concentration was an order of magnitude less at both downgradient sample locations: DPT13 (68.8 µg/L) 30 feet away, and DPT14 (55 µg/L) 110 feet away. Upgradient of MW1, the arsenic concentration at DPT11 was similar, but also slightly lower (381 µg/L).

DPT15 and DPT16 were located within the former material stockpile area (**Figure 22**). Arsenic concentrations at these two locations were relatively low at less than 20 µg/L. The arsenic concentration drops by an order of magnitude between upgradient well MW2 (**Figure 22**) and DPT15/DPT16 (approx. 100 ft distance), and another one to two orders of magnitude between DPT15/DPT16 and MW5/MW6 (approx. 100 ft distance) located by the Hylebos Waterway. At MW5 and MW6, which are adjacent to the Hylebos Waterway, arsenic concentrations have been less than the Method A cleanup level since 2008 and 2006, respectively. In 2012, the arsenic concentration was less than the detection limit of 1 µg/L in both wells.

Based on the groundwater arsenic distribution at the site (**Figure 22**) and the arsenic distribution in soil (**Figure 15**) it is clear that groundwater arsenic concentrations decrease rapidly from the residual source areas at the Site. Such behavior is strong evidence that arsenic is being effectively attenuated within the aquifer at the Site. Exceptions to this rule occur where wood waste and/or residual hydrocarbons are present, such as down-gradient of the Bunker C release area (wood waste and residual hydrocarbons). The geochemical evaluation presented in **Appendix J** provides an evaluation of the most likely attenuation mechanisms which are responsible for the rapid removal of arsenic from solution over much of the Site. The most important mechanism is likely coprecipitation of arsenic with iron oxyhydroxides at the interface where the groundwater and infiltration water mix. The mixing zone is the location of a redox gradient where several chemical reactions occur, such as oxidation of arsenic from arsenite to arsenate and oxidation of iron from ferrous to ferric. The removal of arsenic from solution under such conditions as a coprecipitate is well documented in the literature both for arsenate and arsenite, although the process is enhanced for the more oxidized arsenate form.

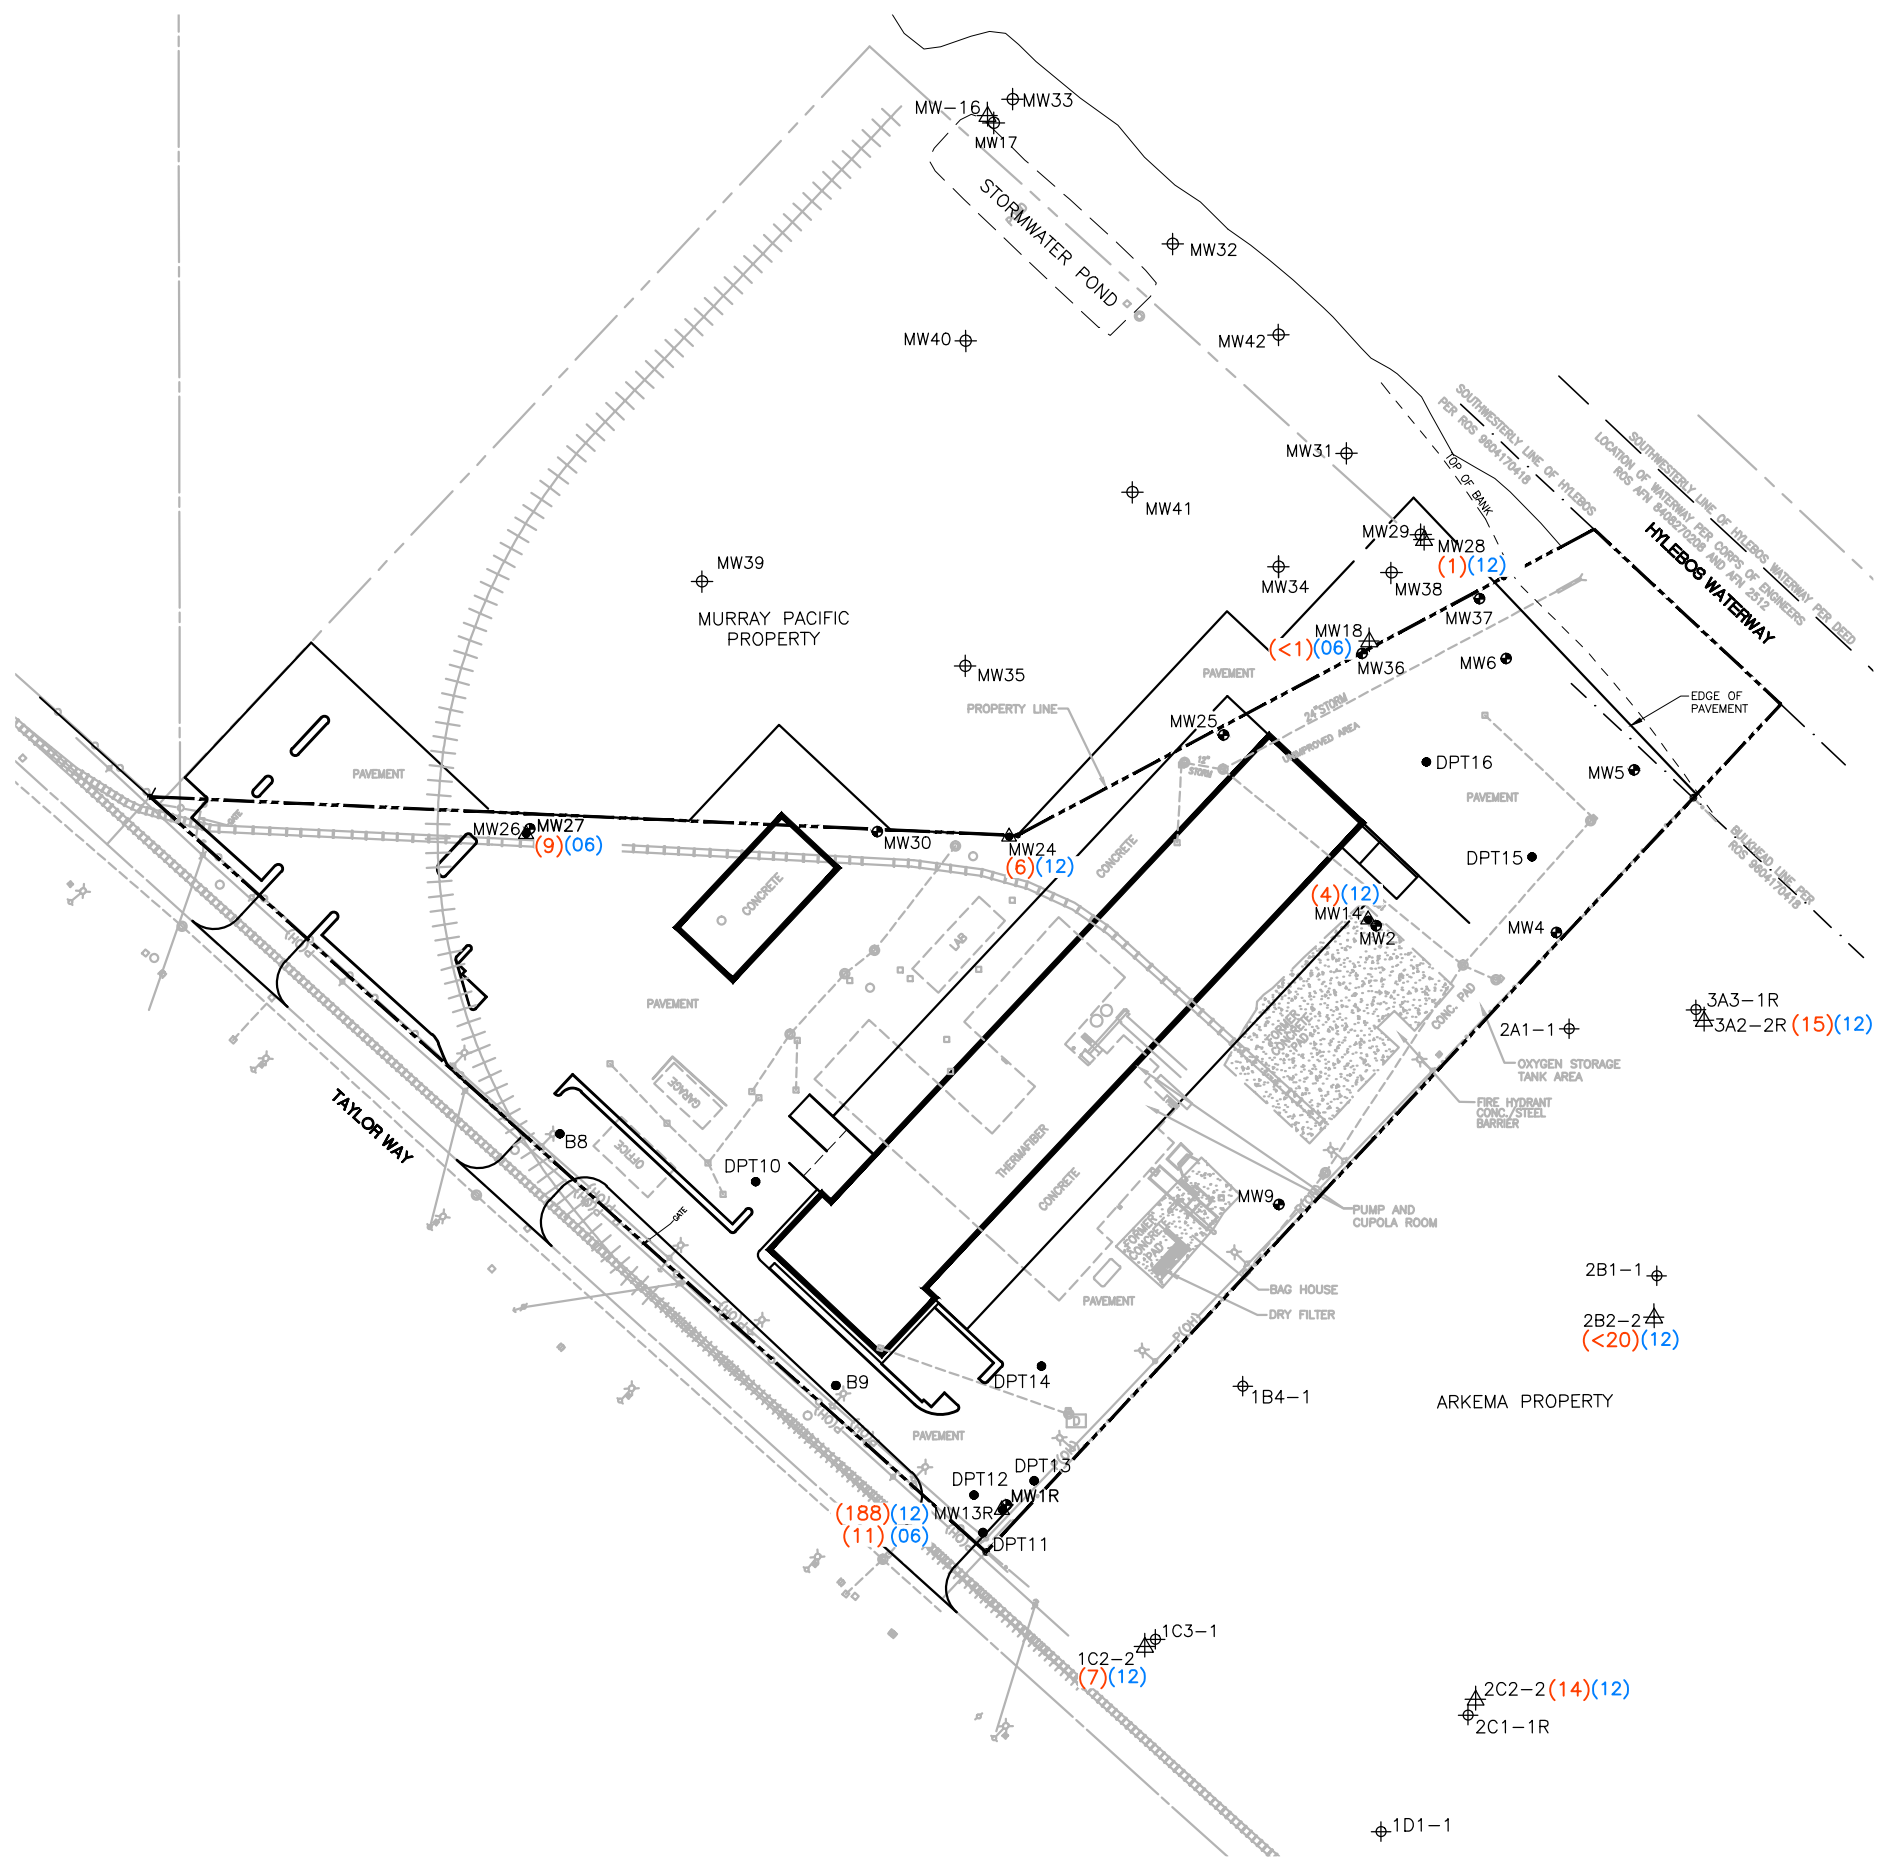
Figure No. 23
 Second Aquifer Dissolved
 Arsenic Concentrations

- MW6 ● SURFACE AQUIFER WELL AND DESIGNATION
- MW26 ▲ SECOND AQUIFER WELL AND DESIGNATION
- 1C3-1 ⊕ OFF-SITE SURFACE AQUIFER WELL AND DESIGNATION
- 2B2-2 ⊕ OFF-SITE SECOND AQUIFER WELL AND DESIGNATION
- TAYLOR WAY PROPERTY BOUNDARY
- ===== EXISTING BUILDING
- NEW ASPHALT PAVED AREA
- [Stippled Area] FORMER CONCRETE PAD
- FORMER BUILDING LOCATION
- ⊕ STORM DRAIN SYSTEM
- (15) (12) DISSOLVED ARSENIC CONCENTRATION IN MICROGRAMS PER LITER (RED) AND YEAR SAMPLED (BLUE)

Second aquifer arsenic concentrations are summarized on **Table 8** and **Figure 23** shows the most recent arsenic concentrations in the second aquifer at each well location. Historically (between 1994 and 2001) dissolved arsenic concentrations in MW14 ranged between 8 and 41 µg/L and in MW13, between <1 and 69 µg/L. In 2006 dissolved arsenic concentrations in all Taylor Way and Murray Pacific Property second aquifer wells ranged between <1 µg/L (MW24 and MW18) and 11 µg/L (MW13R). December 2006 data indicate nearly an order of magnitude decrease at MW13 and MW14. DOF sampled MW13R, MW14, MW24, and MW28 in 2012. The data for MW14, MW24, and MW28 were reasonably consistent with the 2006 data (≤6 µg/L arsenic); however, a dissolved arsenic concentration of 188 µg/L was reported at MW13R. This is anomalous as it is about 3 times higher than the highest totals concentration (69 µg/L/July 2001) ever reported and six times higher than any dissolved concentration ever reported at MW13. In reviewing the field monitoring data for MW13R, we note that the turbidity was at the time of sampling was 727 NTU. We do not know if this has any bearing on the arsenic data, but there is enough to warrant questioning the validity of the data.
