### Carlile Storm Drain Drawings and Storm Drain System Camera Survey

*Subject: Storm Drain System Camera Survey  
Carlile Facility  
2301 Taylor Way  
Tacoma, Washington*

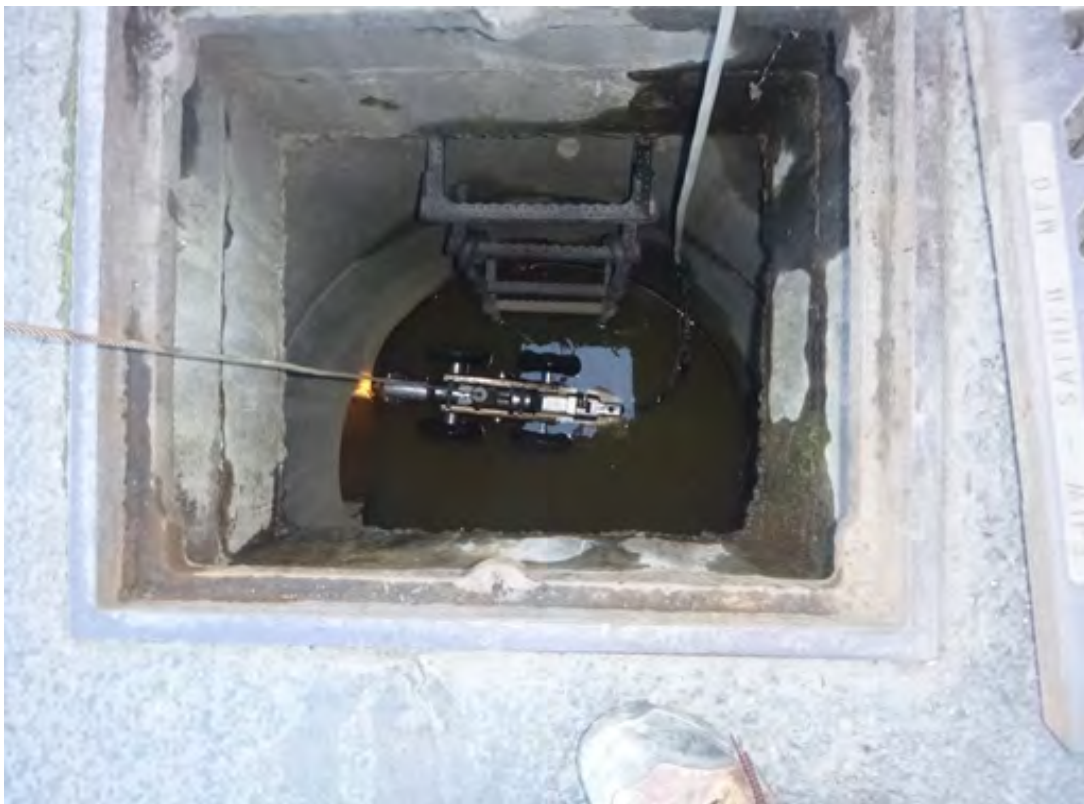
MH1, MH2, and manholes in-between have been converted to a dual use of being catch basins. In doing so, risers were added to the manholes. Seepage between the risers is quite evident at MH1 and the next downstream manhole, MH6, as shown on the following Photos #1 and #2.

Photo #1: MH1 Showing Seepage

- 1) Ground water seepage between catch basin grade risers. The mortar between the risers may be failing or improperly placed.
- 2) Improperly set gaskets at two joints between MH1 and MH6
- 3) Improperly sealed or failing mortar connection at MH6.
- 4) Storm drain line between MH1 and MH6 installed with a slope in the wrong direction.
- 5) Accumulation of water and sediments behind the bag of oyster shells between MH2 and MH3.
- 6) Not having abandoned and sealed an older line that may no longer be of use.

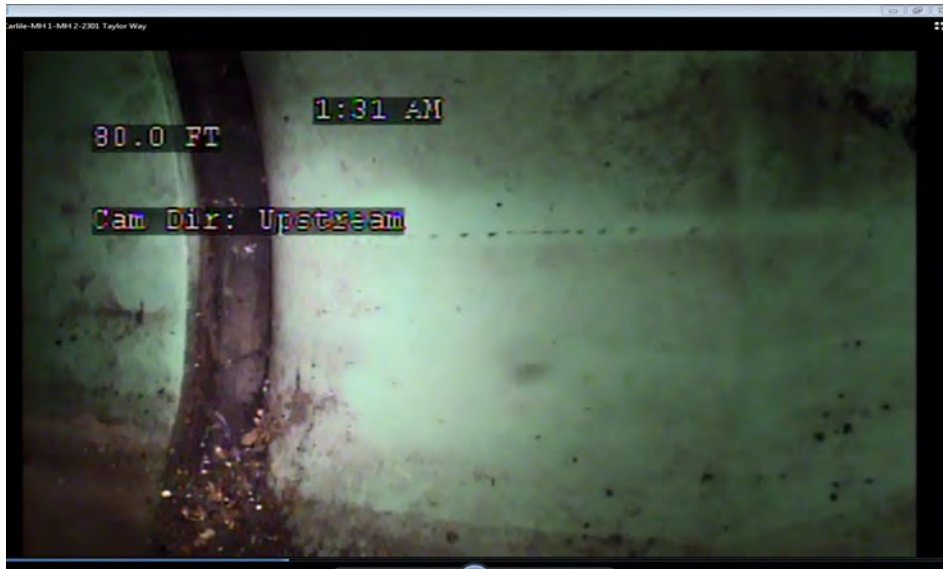
The camera survey between MH1 and MH2 proceeded upstream beginning at MH2. The pipe lengths are 20 foot (ft) sections. However, between 80 ft and 84 ft, there is a four foot section. As shown in photographs #3 and #4 below, the gaskets at both connections appear to be not set correctly and pushed into the pipeline. The gasket at 80 ft may not have been set all the way. Groundwater may be seeping into these joints and around the gasket. These joints are a possible source of infiltration.

Photo #3 - 80 Feet Upstream of MH2 Showing Section of Pipe with an Incorrectly Set Gasket

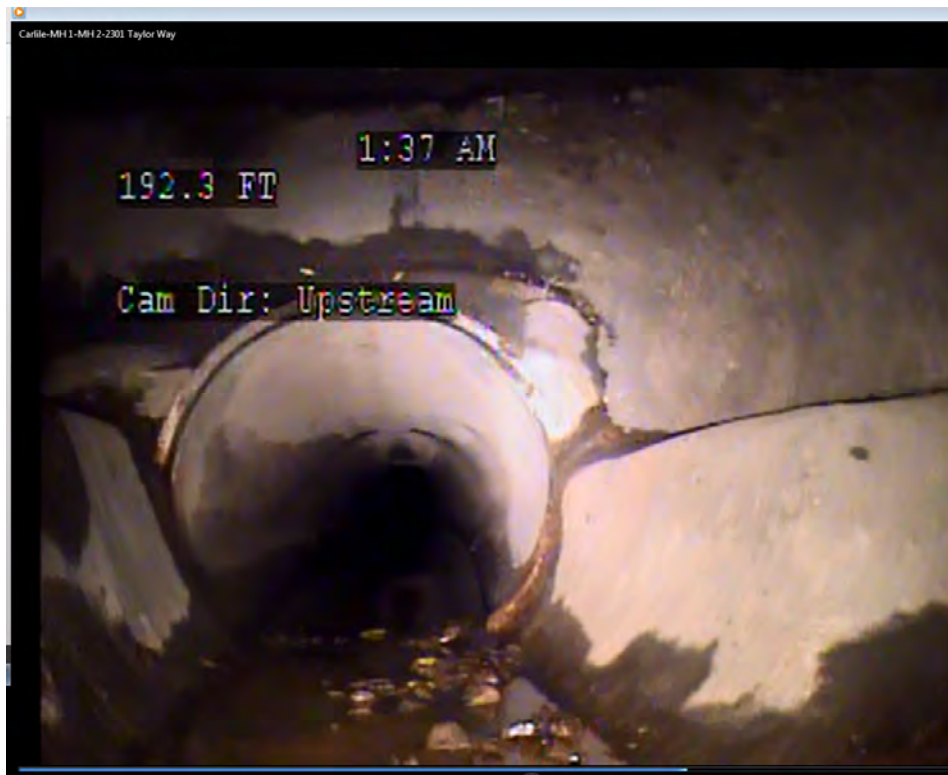
Beginning at 192 feet from MH2, at MH6, the pipe becomes increasingly full of water. MH6 also appears to have water seepage around the mortared pipe connection (Photo #5). By 225 feet the pipe is greater than 25 percent full of water. The pipe run from MH2 to MH1 is 302 feet long. It appears that the pipe was installed sloping to the southwest from MH6 towards MH1 instead of to the northeast from MH1 towards MH6. This may be causing water to collect in MH1, instead of draining from MH1 to MH6.

Photo #5 - MH6 with Seepage around the Mortared Pipe Connection

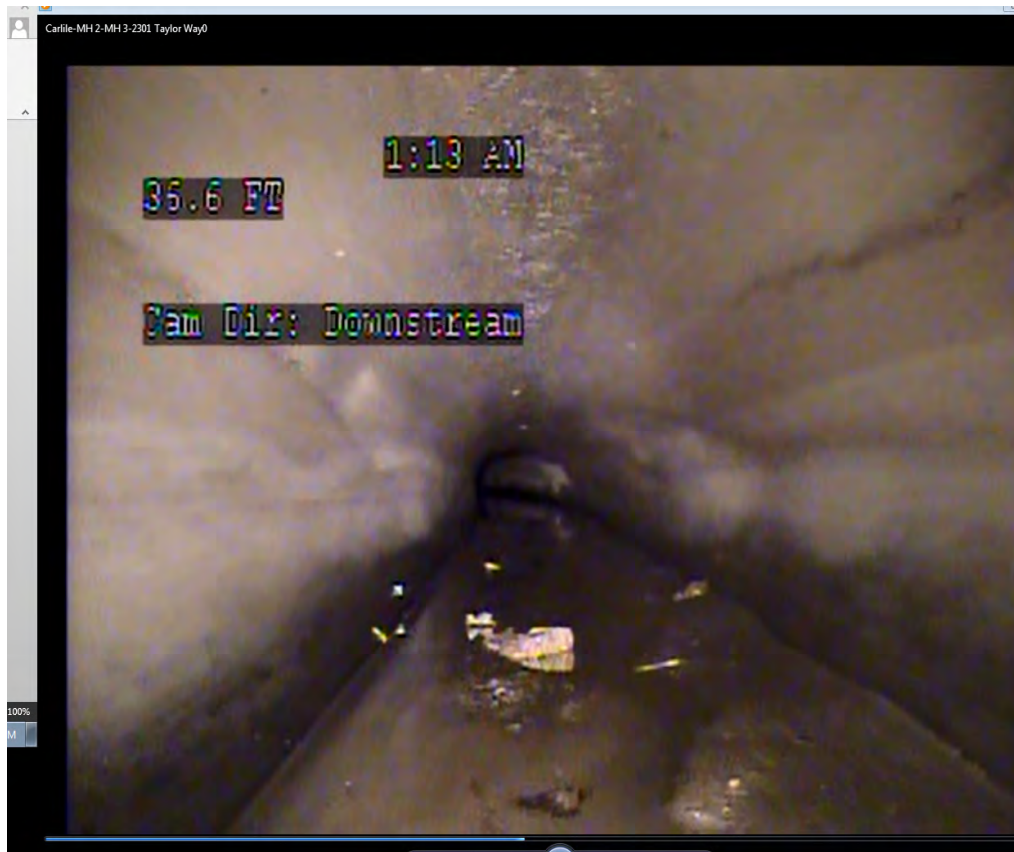
Photo #6 – Accumulation of Sediment at 37 Feet Downstream of MH2

Beginning at 32 feet, accumulations of sediment are observed and the water level in the pipe begins to rise (Photos #6 and #7). Where the pipe section ends at the catch basin it is nearly 25 percent full of water. There are two possible reasons why water and sediments have accumulated in this pipe:

1. It is possible that the oyster shell filter has been plugged with sediment and is causing sediments and water to accumulate in the pipe
2. A sag in the pipe may be present near the location of the bag of oysters. The bag of oyster shells would need to be removed and the pipe cleaned in order to verify this condition.

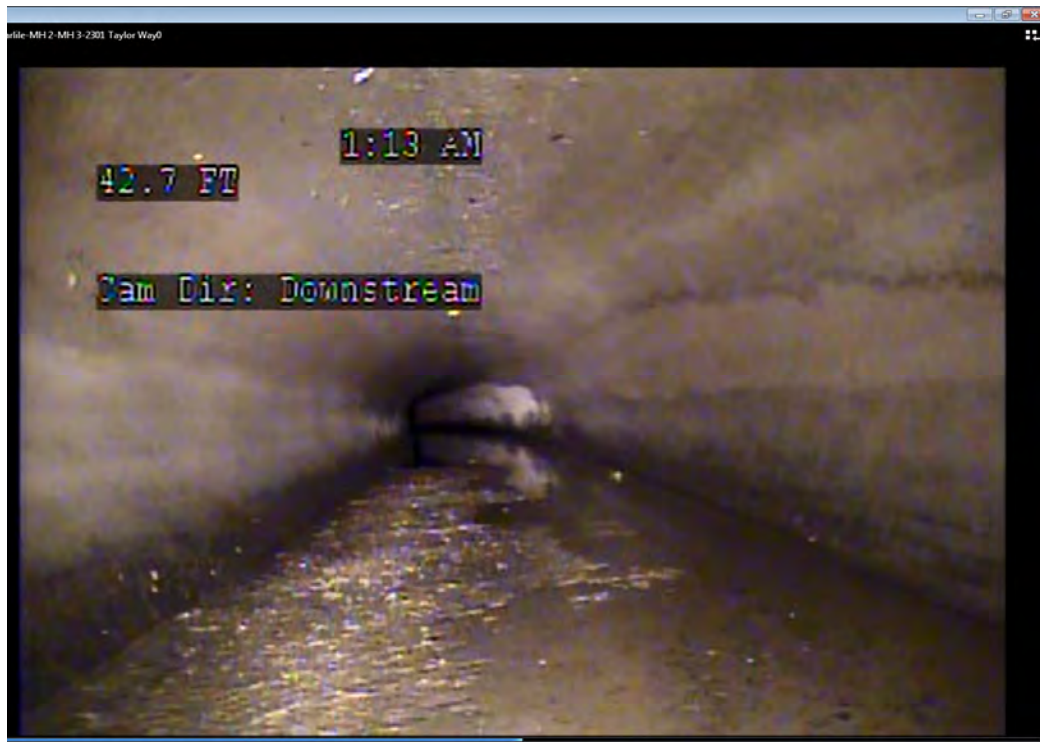
Photo #7 - Accumulation of Sediment at 43 Feet Downstream of MH2

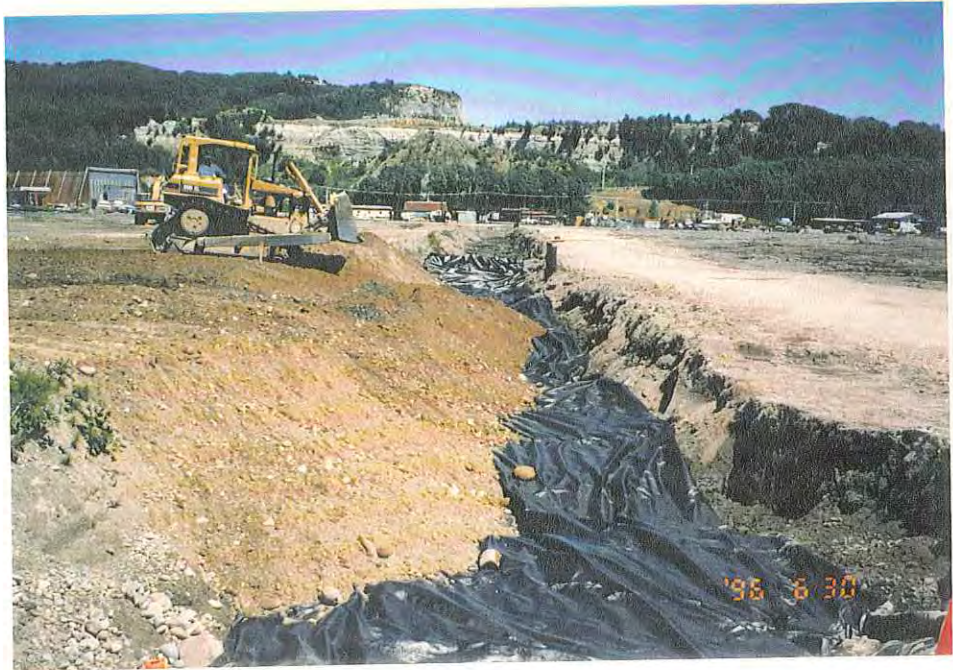
Photograph 19

Backfilling Central Ditch

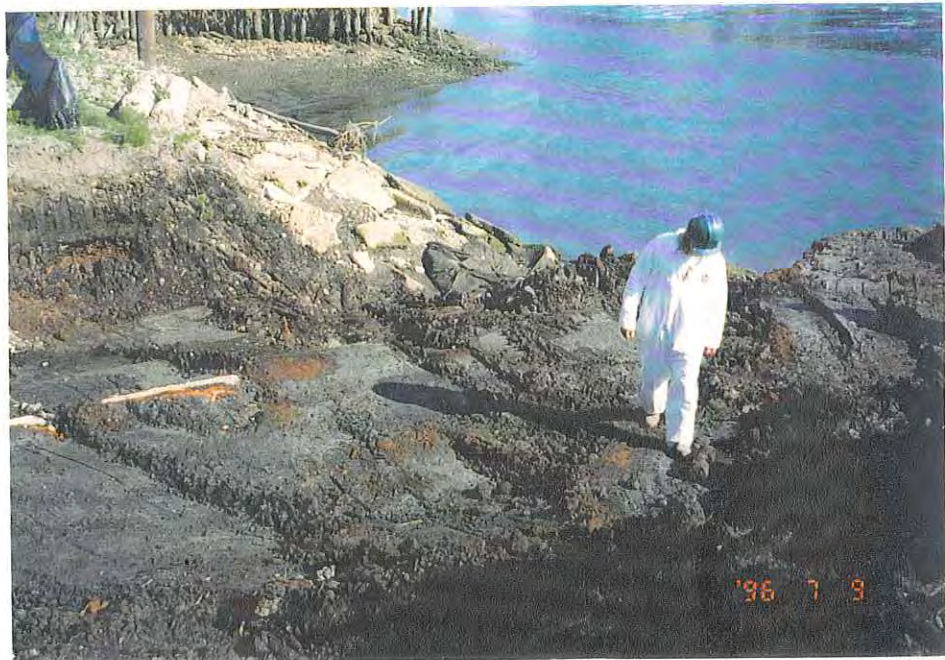
Photograph 20

Excavation Below High Water Line  
Along Waterway

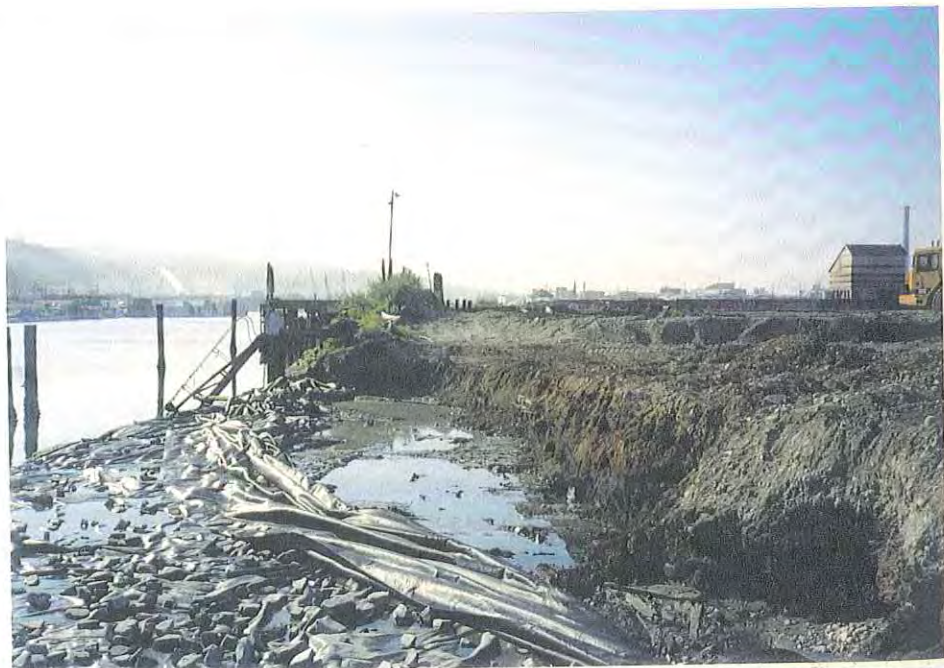
Photograph 21

Looking up the Waterway at the  
Shoreline Excavation, Dark Material in  
Cut is Sawdust
