**2016 ANNUAL REPORT**  
Remedy Implementation,  
Crownhill Elementary School Site  
Prepared for: Bremerton School District

Project No. 100094-004-01 • January 9, 2017

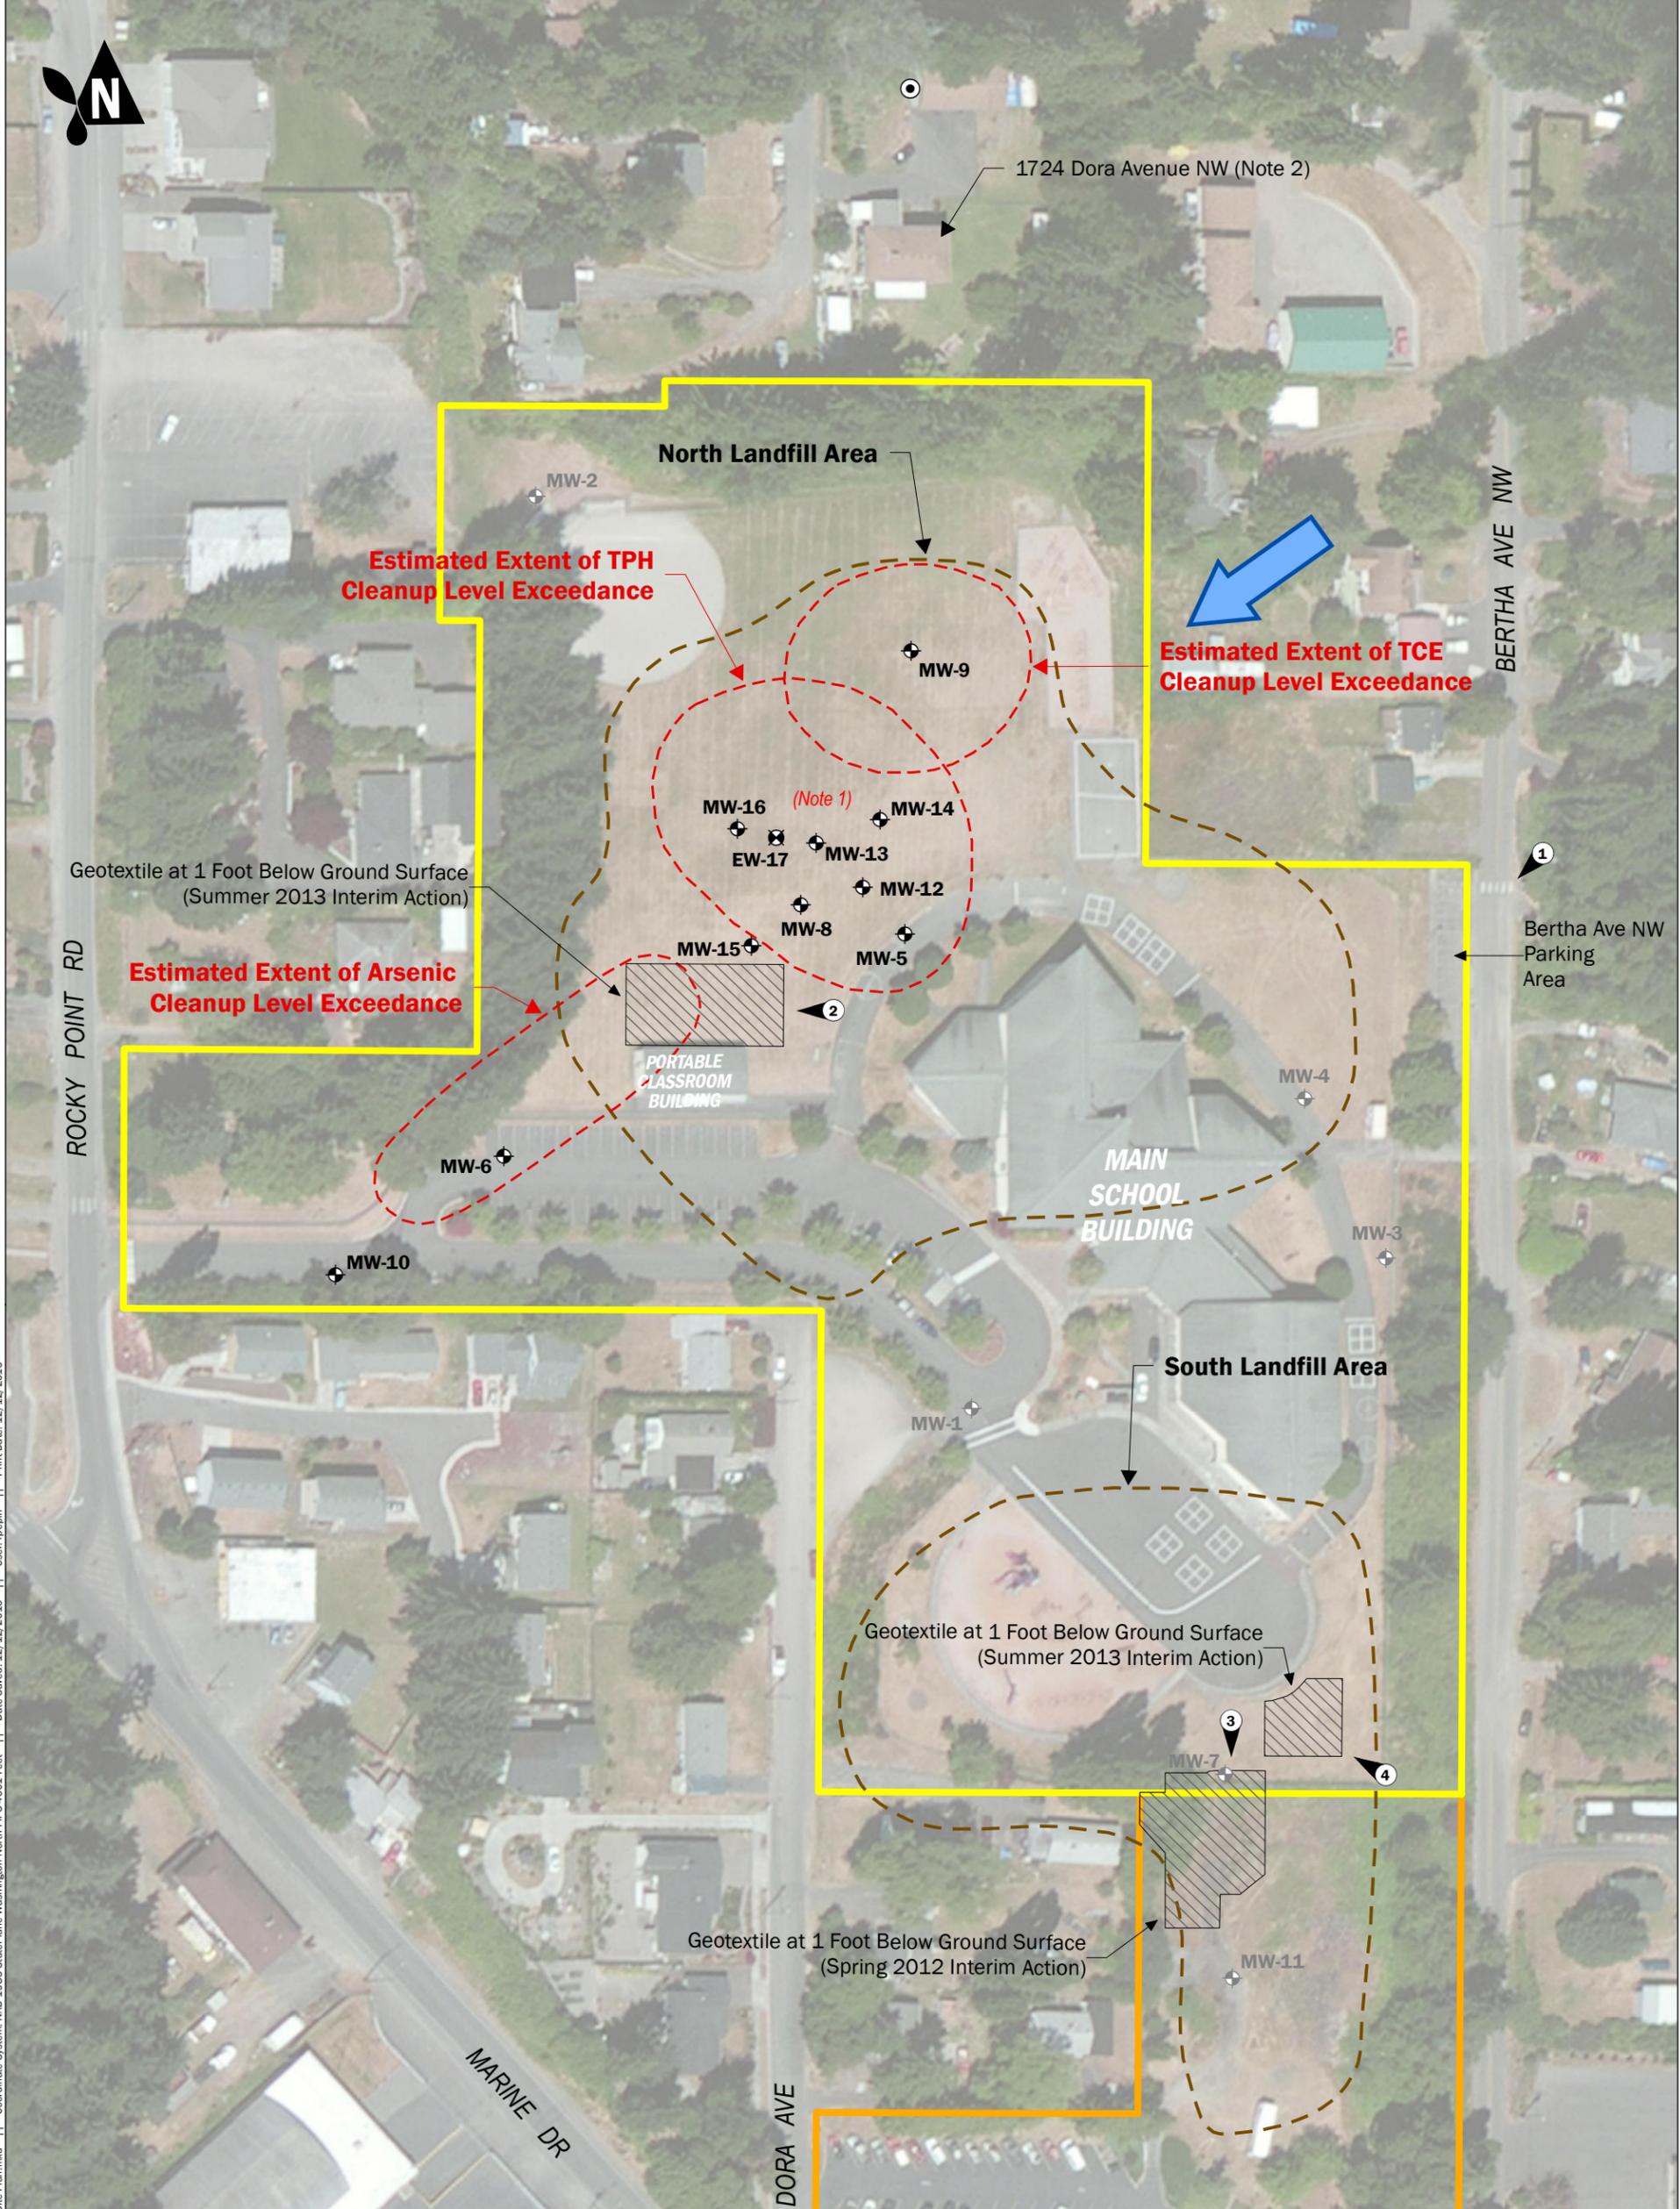
**Site Plan**  
2016 Annual Report  
Crownhill Elementary, Bremerton, Washington

- Extraction Well Included in Monitoring Program
- Monitoring Well Included in Monitoring Program
- Monitoring Well Not Included in Monitoring Program
- McKinney Domestic Well (Note 2)
- Approximate photo location & orientation for semiannual cover system inspections

(1) LNAPL has been observed in Wells EW-17, MW-8, MW-13, MW-14, and MW-16.  
 (2) The McKinney well water sample is collected from the outdoor faucet on the north side of the residence at 1724 Dora Avenue NW.

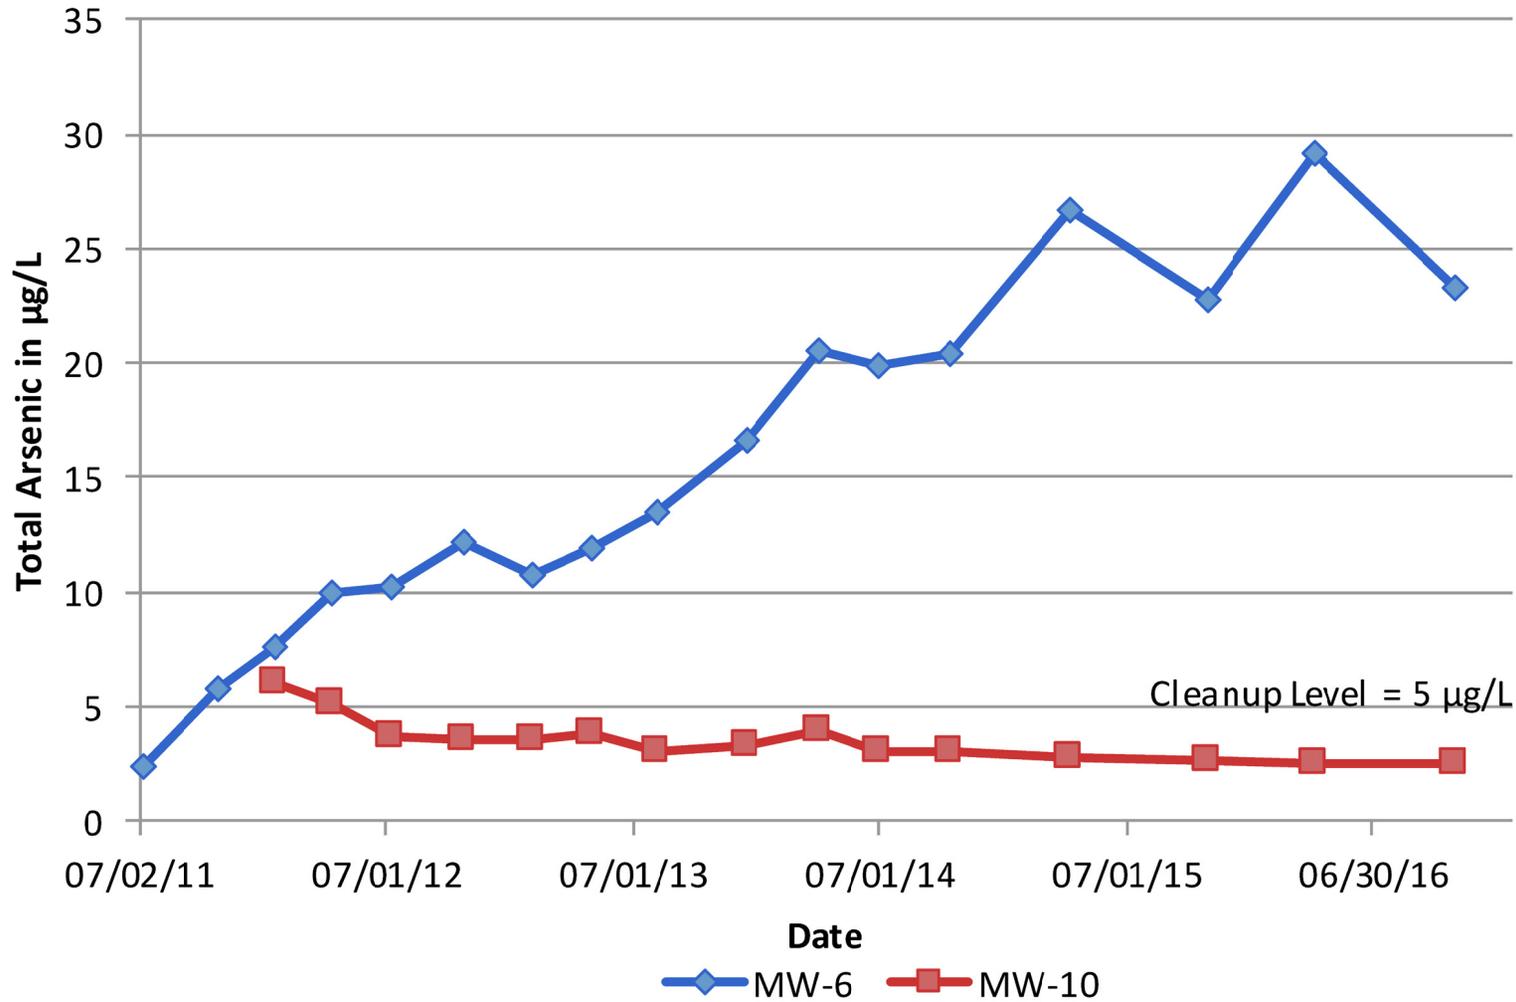
**Arsenic Concentration Trends  
 in Wells MW-6 and MW-10**

<sup>2</sup> As shown on Figure 3, the arsenic cleanup level was also exceeded at MW-10 the first two times it was sampled following its installation in December 2011. Arsenic at MW-10 has been consistently below its cleanup level in the last 13 monitoring rounds.

1. Well MW-6 provides early warning of potential arsenic migration.
2. Well MW-10 is the conditional point of compliance for achieving groundwater cleanup levels.

Groundwater cleanup levels are 500 micrograms per liter ( $\mu\text{g/L}$ ) for diesel- and motor-oil-range TPH, and 5  $\mu\text{g/L}$  for TCE and total arsenic. Well MW-10 is the conditional point of compliance for achieving these cleanup levels. This well has been sampled on 15 occasions through October 2016, and arsenic is the only COC detected in any of those sampling rounds. Well MW-6, the only well with arsenic cleanup level exceedances since early 2012<sup>2</sup>, is located approximately 130 feet upgradient of MW-10 and serves as a sentinel well for dissolved contaminant plume migration. The *Groundwater/LNAPL Monitoring and Contingency Plan* (Aspect, 2015a) specifies contingency actions that will be taken if arsenic is detected above 40  $\mu\text{g/L}$  at MW-6 or above 4.5  $\mu\text{g/L}$  at MW-10. Figure 3 shows arsenic concentration trends in these two wells since they were installed. Neither of the above concentration limits was exceeded in 2016.

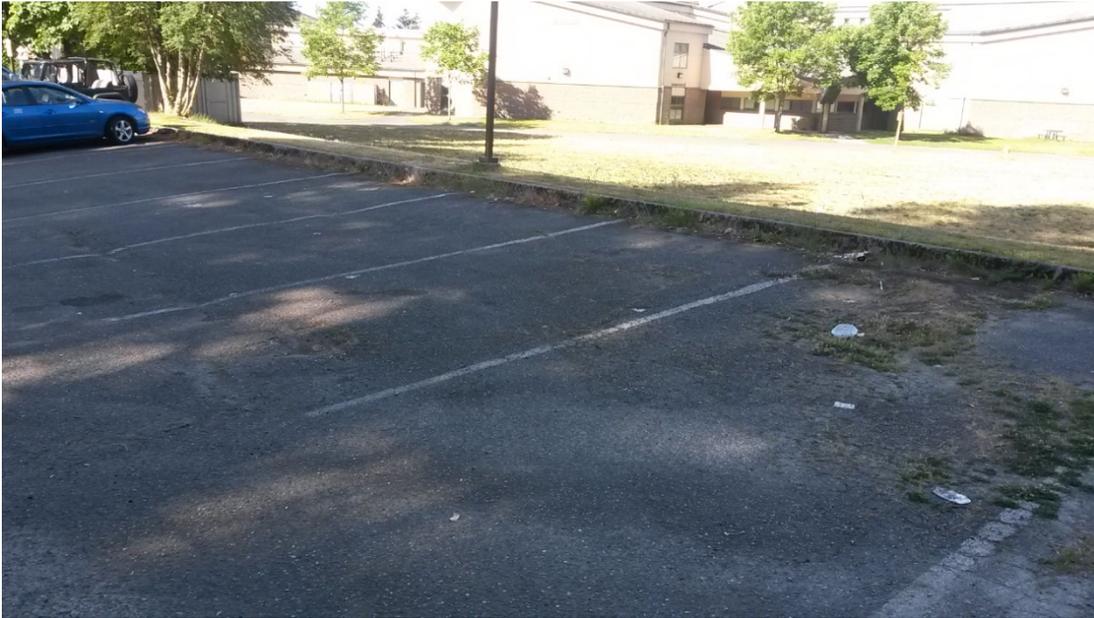
- Photo Location 1 – Pavement in the parking area along Bertha Avenue NW, where an RI soil sample collected from beneath the pavement (composite sample to 3-foot depth) contained lead at a concentration exceeding the cleanup level.
- Photo Locations 2 and 4 – Soil/sod covers next to the portable classroom building and in the southeast corner of the school property, where lead cleanup level exceedances were identified in soil samples collected from the 1- to 3-foot depth range. In summer 2013, these two areas were covered with a geotextile fabric (placed directly on the undisturbed ground surface) and an additional 1-foot thickness of fill soil was imported and hydroseeded to supplement the pre-existing clean soil cover layer.

Photo Location 1, 6/7/16 site inspection

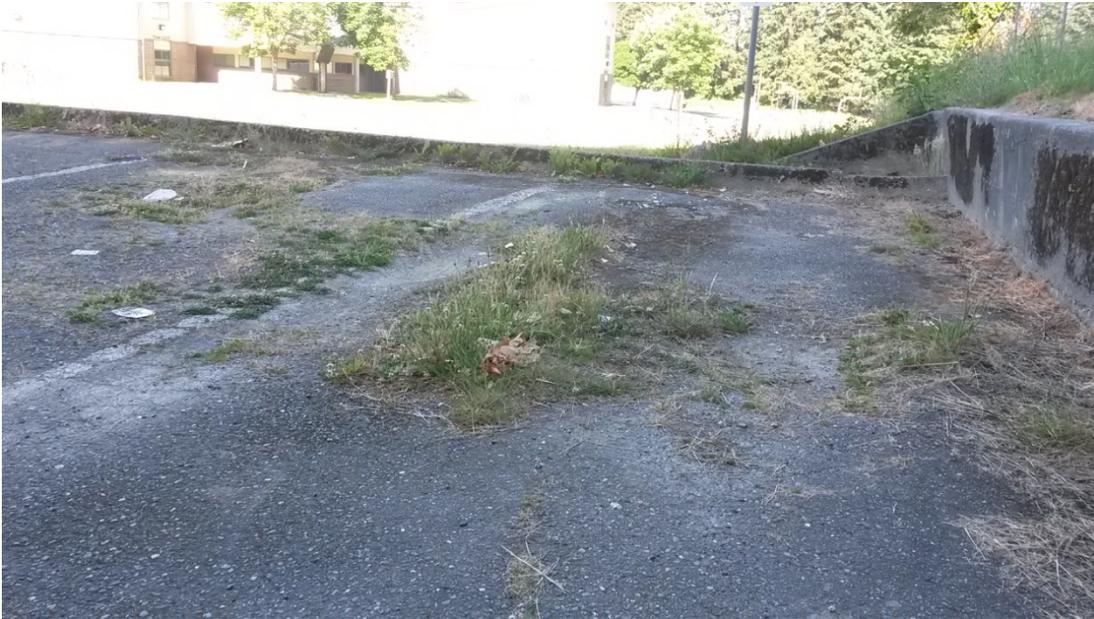
Potholes and extensive cracks were observed in the pavement in the northern portion of the Bertha Avenue NW parking area. (See close-up photos in Appendices A and B.) However, the pavement continues to provide an effective barrier to direct-contact exposure to the underlying soils (i.e., the paved surface remains intact, with no exposed soil areas).

INSPECTION ITEM	YES	NO	COMMENTS/NOTES
<b>1. North Environmental Covenant Area</b>			
a. Building or pavement modifications since last inspection?		X	None are planned before next inspection either some depressions in pavement (~2-3" deep) cracked & broken inside

Photo Location 1 showing pavement deterioration, 6/7/16 site inspection

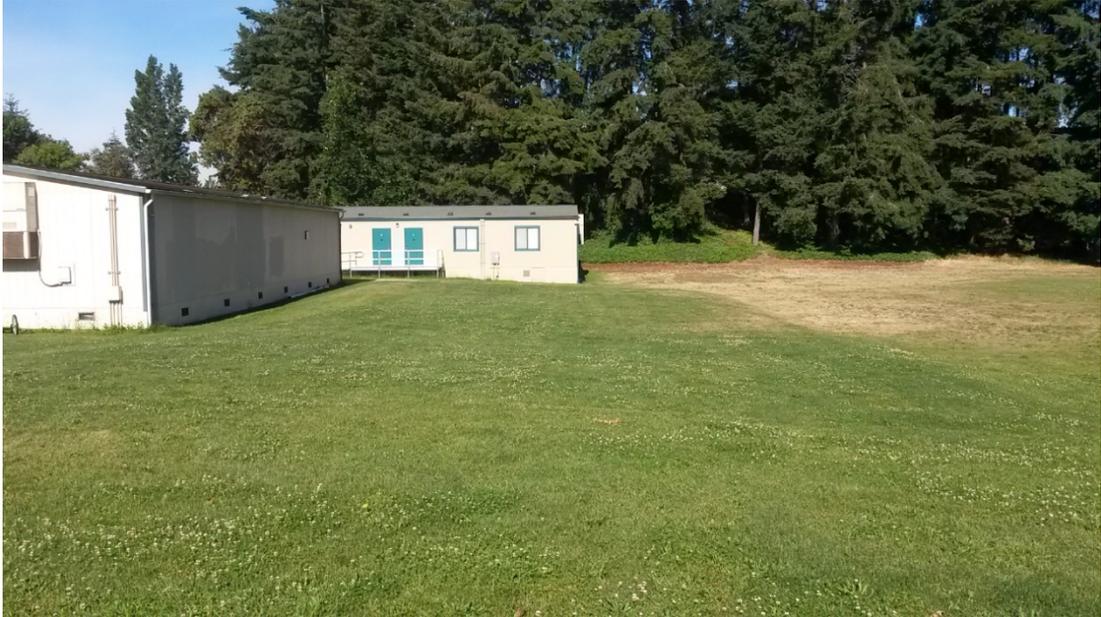
The soil/sod covers at Photo Locations 2 through 4 appeared to be in good condition, and the 2016 inspections did not identify any cover system deficiencies in other areas of the Site or other action items.

Photo Location 2, 6/7/16 site inspection

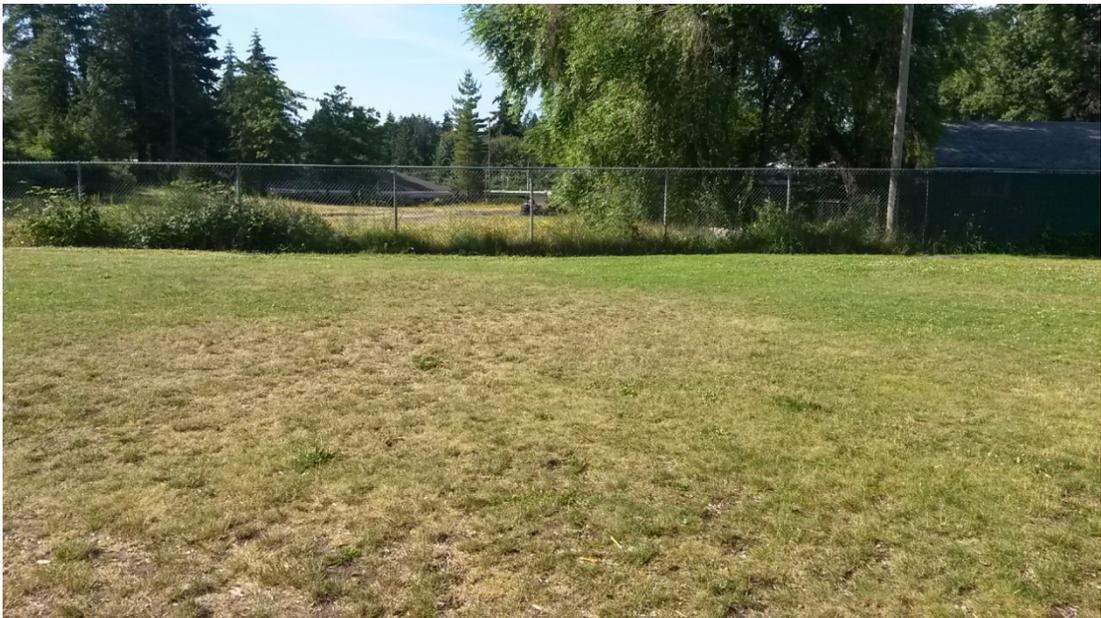
- Photo Location 3 – A soil/sod cover in the northwest corner of the church property (and extending approximately 10 feet onto the school property), where an interim action was completed in spring 2012 in which contaminated surface soils were removed to a 1-foot depth, a geotextile fabric was placed on remaining contaminated soils, and a 1-foot thickness of fill soil was imported and hydroseeded.

Photo Location 3, 6/7/16 site inspection

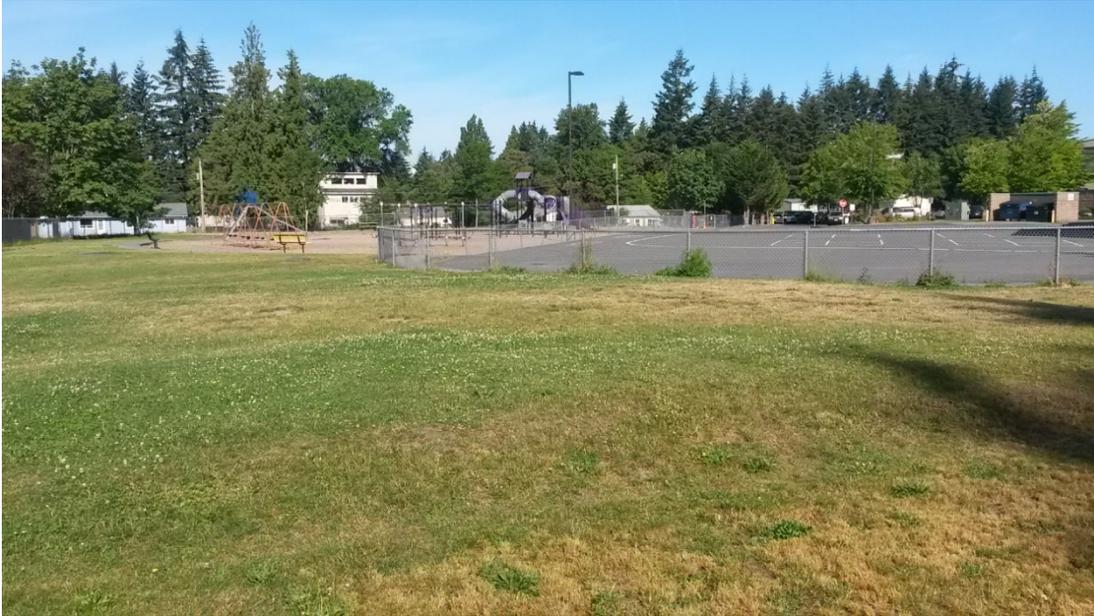
Photo Location 4, 6/7/16 site inspection

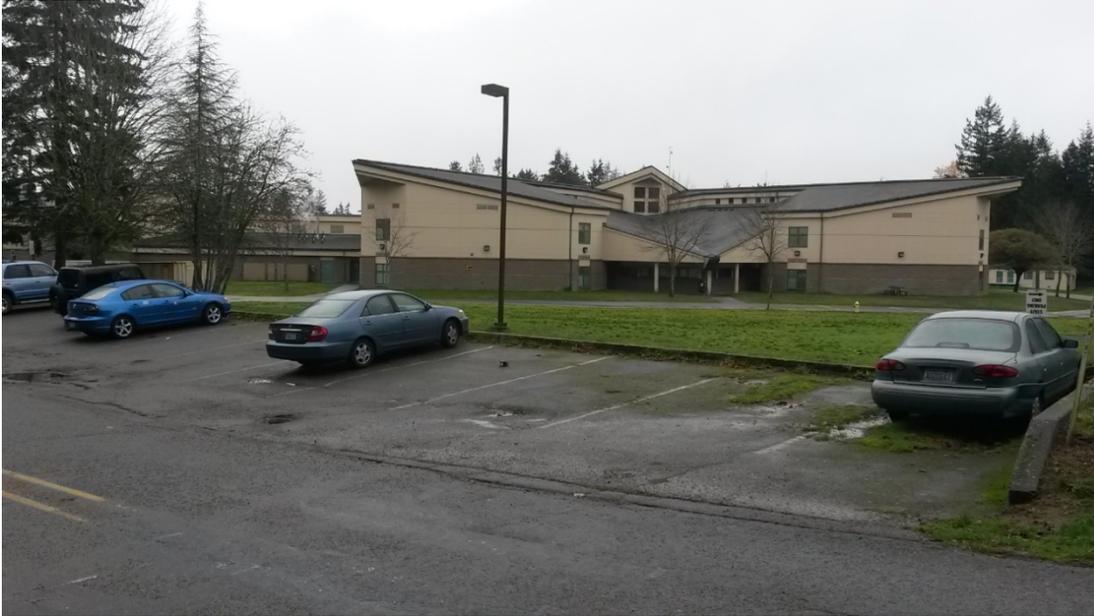
Photo Location 1, 12/5/16 site inspection

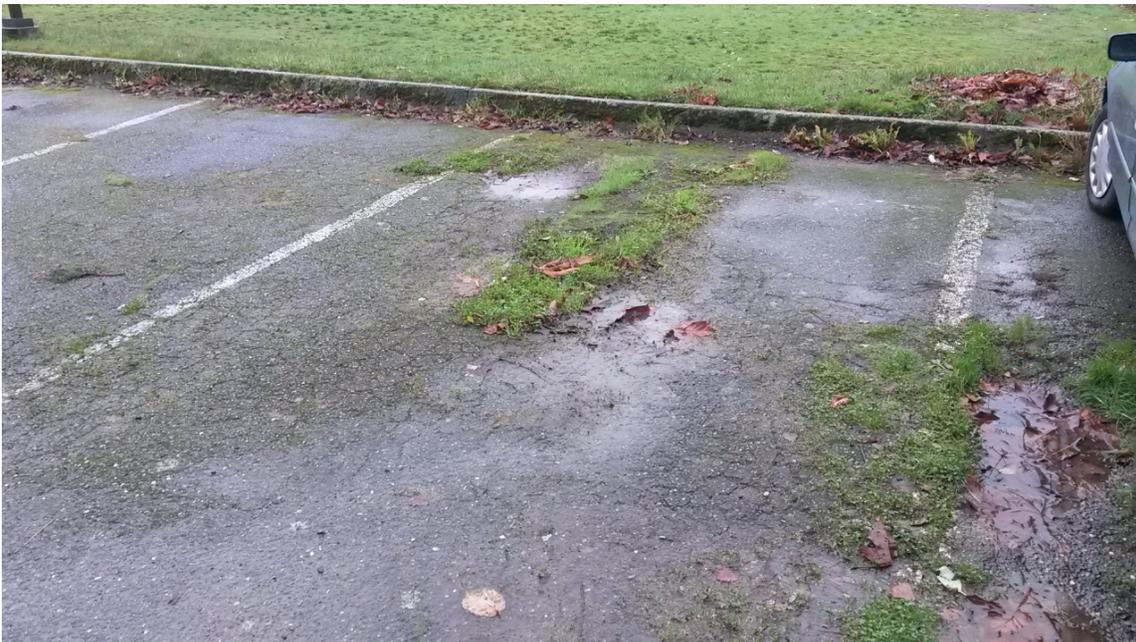
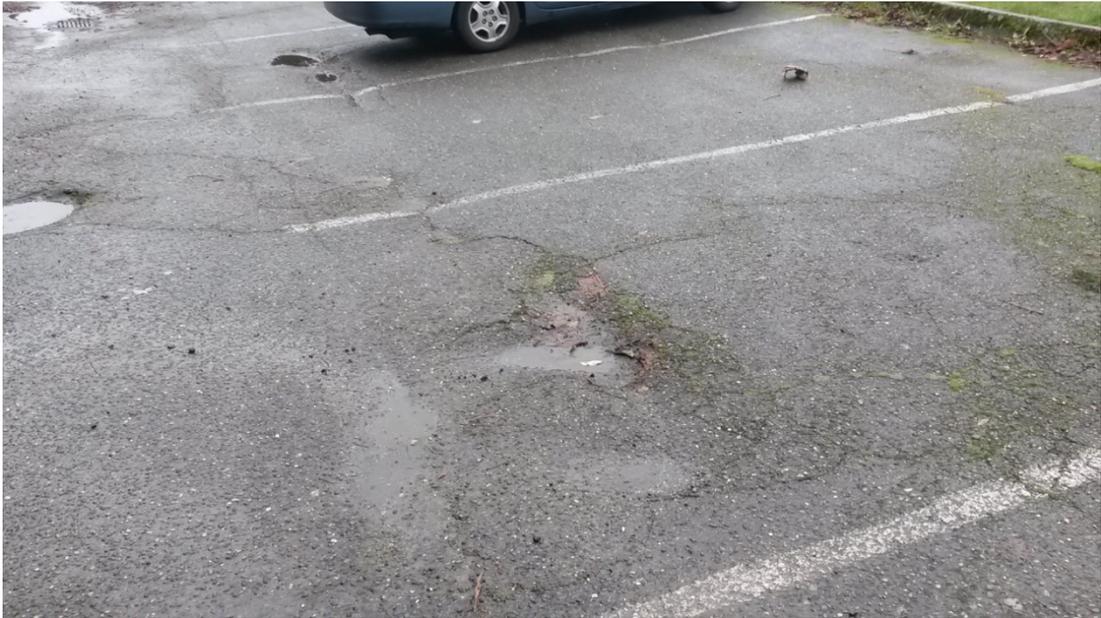
INSPECTION ITEM	YES	NO	COMMENTS/NOTES
<b>1. North Environmental Covenant Area</b>			
a. Building or pavement modifications since last inspection?		X	
b. Pavement deterioration/damage along Bertha Ave NW? <sup>1</sup>	X		Same as last inspection. No new deterioration.

Photo Location 1 showing pavement deterioration (1<sup>st</sup> view), 12/5/16 site inspection

Photo Location 1 showing pavement deterioration (2nd view), 12/5/16 site inspection

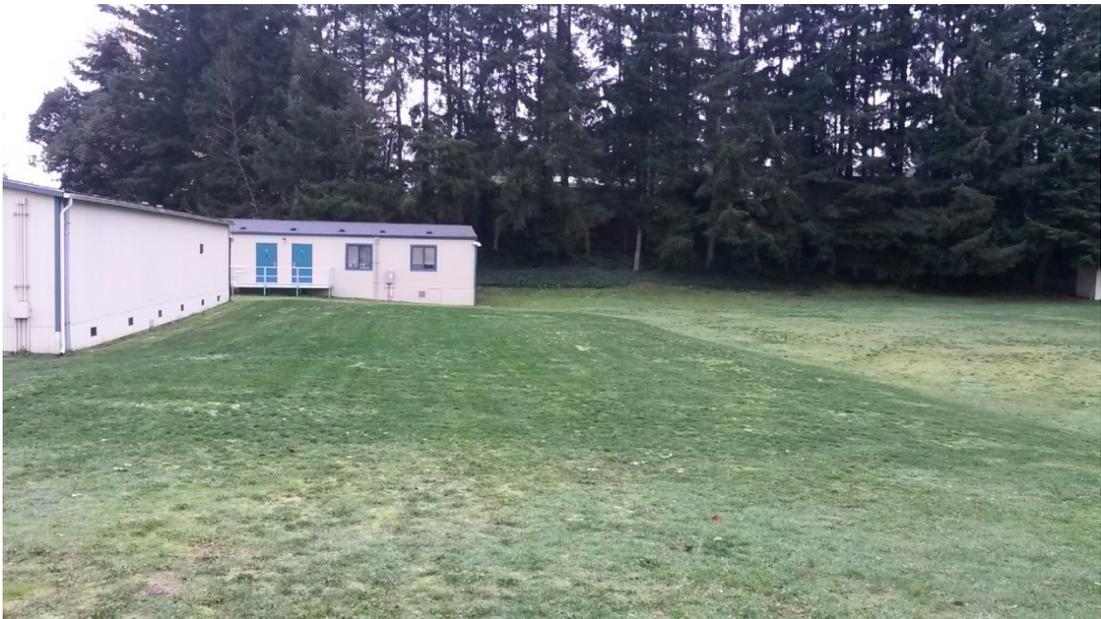
Photo Location 2, 12/5/16 site inspection

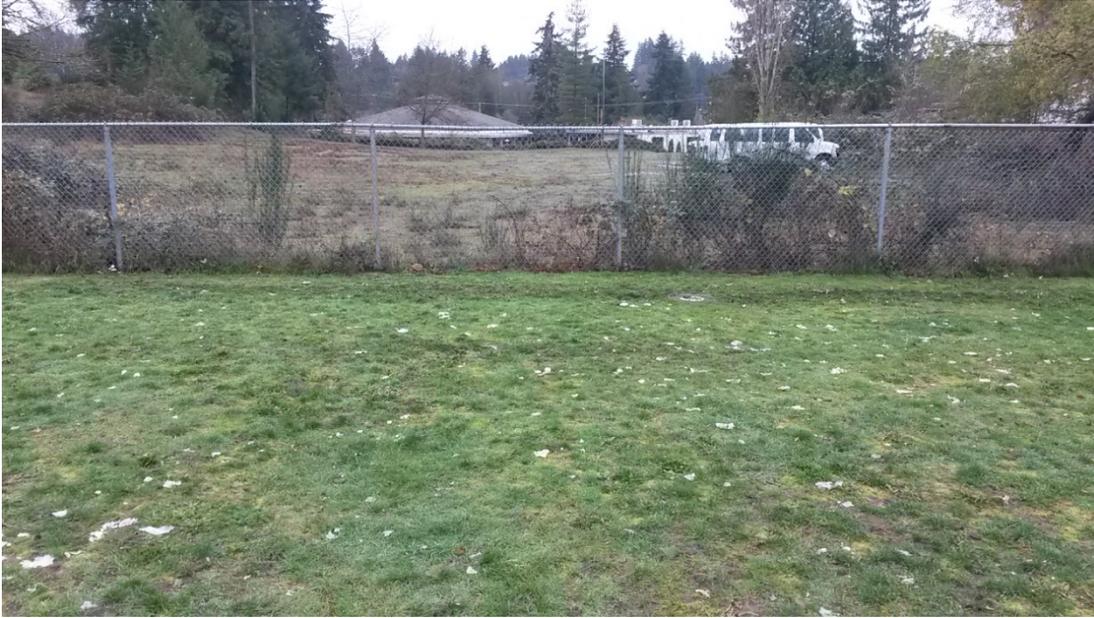
Photo Location 3, 12/5/16 site inspection

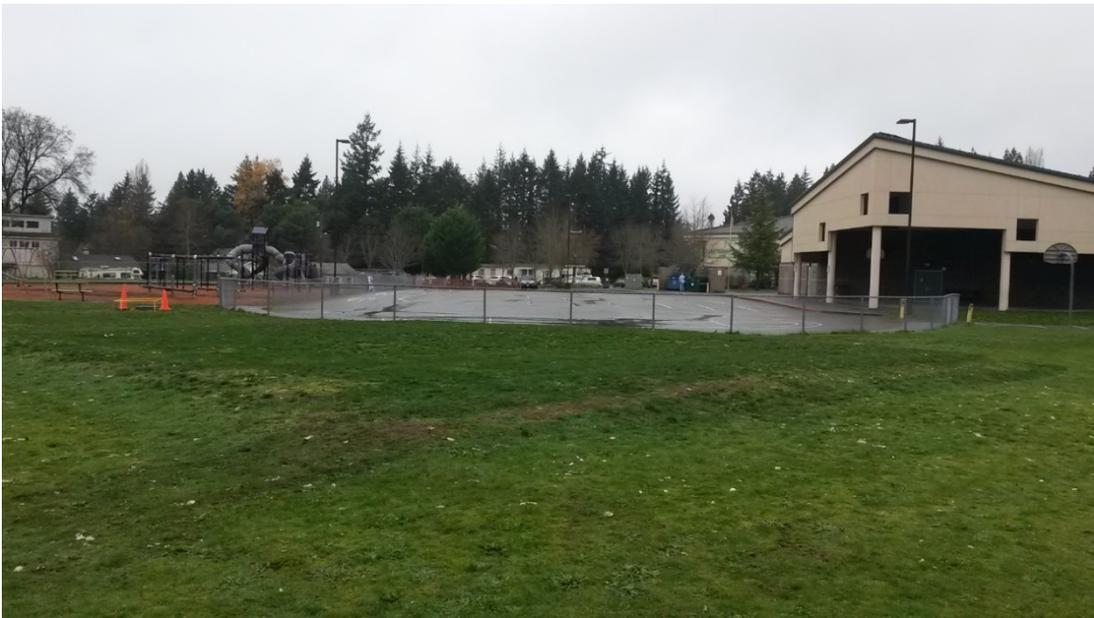
Photo Location 4, 12/5/16 site inspection
