REMEDIAL INVESTIGATION AND FEASIBILITY STUDY

Former Walker Chevrolet Site

633 Division Avenue, Tacoma, Washington

Project No. 080190-004-15 • July 25, 2016 Final

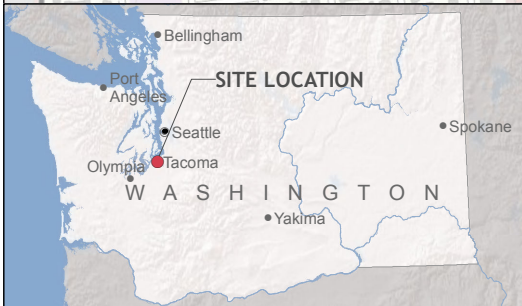
JUN-2016	BY: AN/SCC	FIGURE NO. 1
	PROJECT NO. 080190	REV BY: -

Site Location Map
 Remedial Investigation/Feasibility Study
 Former Walker Chevrolet (VCP No. SW1040)
 633 Division Avenue, Tacoma, Washington

The Former Walker Chevrolet site (Site), located at 633 Division Avenue in Tacoma, Washington (Property), is enrolled in the Washington State Department of Ecology (Ecology) Voluntary Cleanup Program (VCP) and assigned VCP No. SW1040. The Site location is shown on Figure 1. Figure 2 shows the relationship between the Site and the adjacent parcel to the north (VCP No. SW1039).

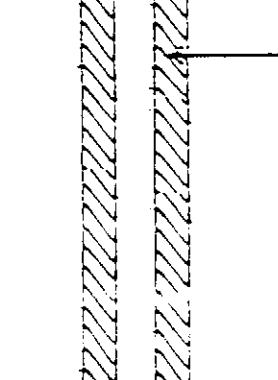
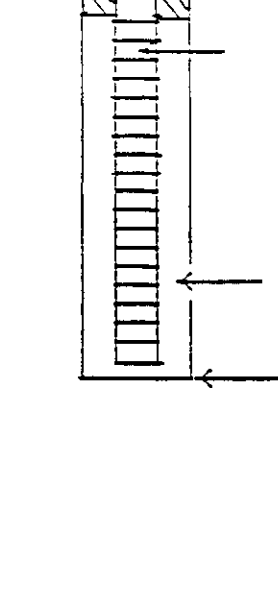
BACKFILL: <u>48 FT</u> TYPE: <u>3/4" CHIPS</u>	<u>3-54 FT</u> GREY TO BROWN SILTY FINE SAND VERY DENSE DRY OCCASION 20-30% FINES (TILL) <u>FT</u>

SCREEN: <u>2" x 15'</u> TYPE: <u>FACTORY FLOW</u> SLOT SIZE: <u>.020</u>	<u>54-65 FT</u> BROWN MOIST BROWN SAND MEDIUM DENSE 10-15% FINES <u>FT</u>

SAND PACK: <u>17'</u> MATERIAL: <u>10x20 SILICA</u> WELL DEPTH: <u>67'</u>	<u>65-67' FT</u> GREY VERY DENSE GREY SILTY FINE SAND WITH GRAVELS (TILL) <u>FT</u> REMARKS <hr/> <hr/> <hr/>

Stemen constructed MW-3 on the northeast corner of the north gas station on February 1, 2007. The boring encountered dense, dry glacial till from 3 to 54 feet bgs, moist dense sand from 54 to 65 feet bgs, and very dense glacial till from 65 to 67 feet bgs. The well screen was set from 52 to 67 feet bgs. MW-3 did not produce water and was reported as dry in February 2008, October 2008, and May 2009. MW-3 was decommissioned in accordance with WAC 173-160 on December 25, 2010.
