# REVISED SUPPLEMENTAL REMEDIAL INVESTIGATION REPORT

**RGI PROJECT No. 2012-107L**

**REVISED SUPPLEMENTAL REMEDIAL INVESTIGATION REPORT**

**MAIN STREET APARTMENTS DEVELOPMENT  
10505 MAIN STREET  
BELLEVUE, WASHINGTON 98004**

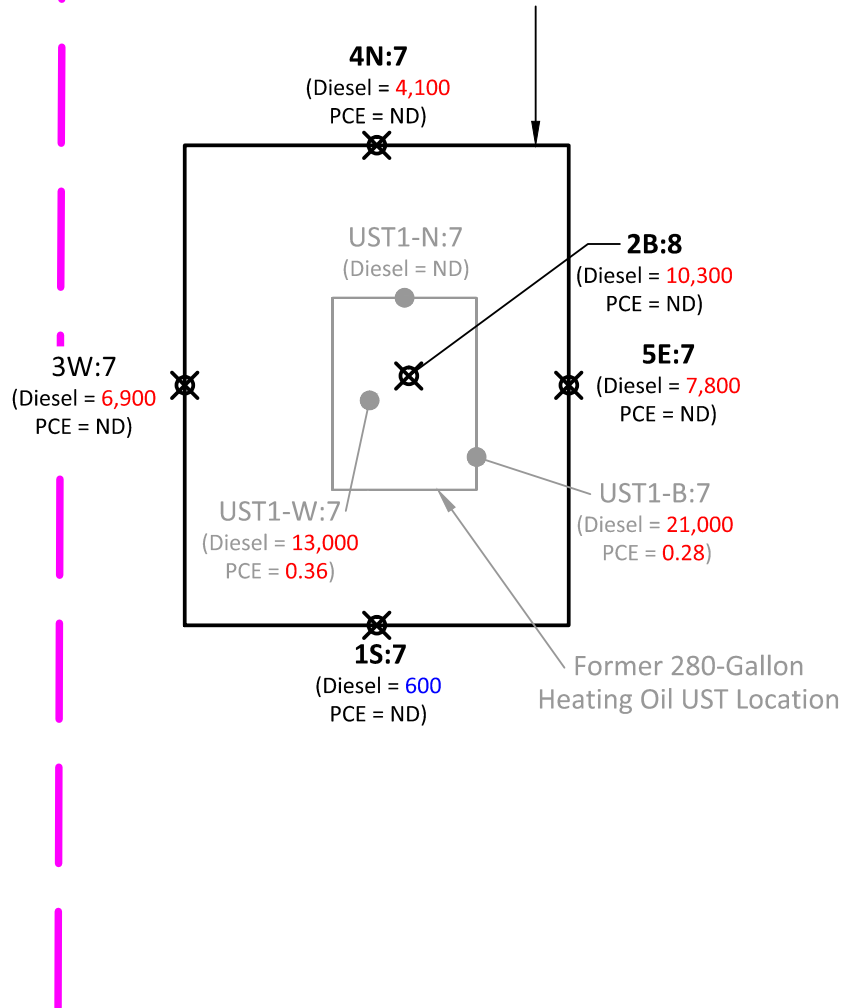
**Limits of Area 3 Phase I - Remedial Excavation** - Area where PCE and diesel-range TPH were detected in soil at concentrations exceeding the MTCA Method A Soil Cleanup Levels beneath a 280-gallon heating oil UST. Phase I of the remedial excavation focused on removal of all PCE impacted soil. Diesel-range TPH impacts extended beyond the limits of the PCE soil impacts and was addressed in Phases II through V (see Figure 6). Soil concentrations of PCE and diesel-range TPH are given in mg/kg. Sample prefix (A3) not included in sample ID.

- bgs = Below ground surface, which was the grade of the Property prior to redevelopment.
- (0.28) = Red indicates soil concentration exceeds MTCA Method A Cleanup Level.
- (600) = Blue indicates soil concentration was below the MTCA Method A Cleanup Level.
- ND = No contaminants of concern (COCs) detected at concentrations above laboratory detection limits.
- = Soil Characterization sample. Soil was removed under a Contained-In determination from Ecology.
- ⊗ = Final performance sample. Indicates extent of PCE impacts, not diesel-range TPH impacts.

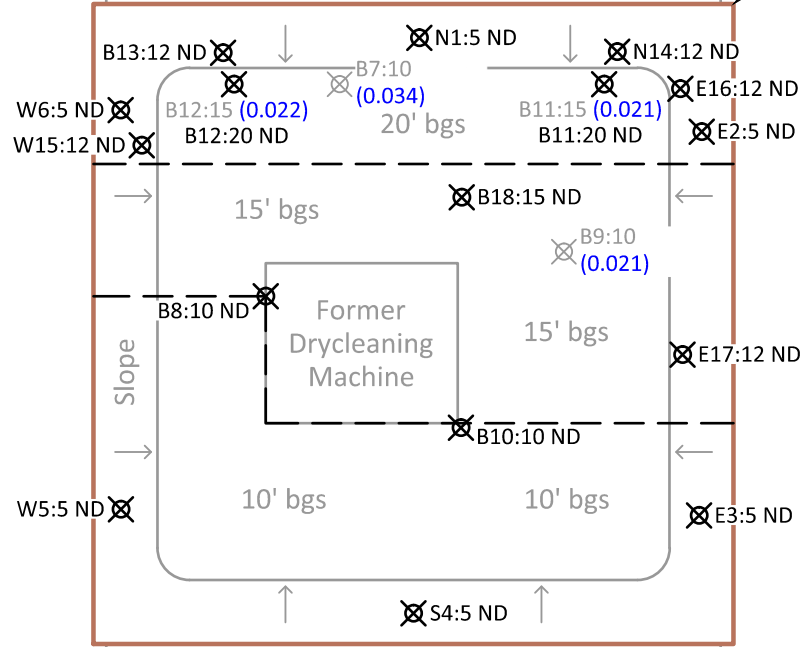
**Limits of Area 1 - Redevelopment Excavation -** Area where PCE was detected in soil at concentrations below MTCA Method A Soil Cleanup Levels. Approximately 265 tons of Class 2 soils were removed from this area in support of redevelopment activities. (xxx) = Soil concentration of PCE in mg/kg. Sample prefix (A1) not included in sample ID.

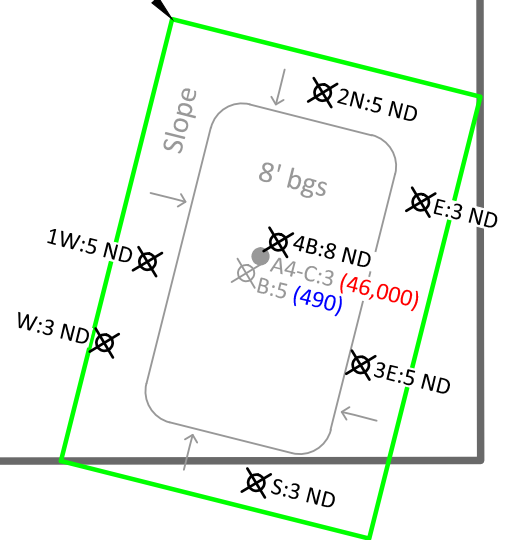
**Limits of Area 4 - Remedial Excavation -** Area where oil-range TPH was encountered in soil at concentrations exceeding MTCA Method A Soil Cleanup Levels. Approximately 41 tons of oil-range TPH impacted soil was removed from this location for MTCA compliance. Excavation starting depth was 2 feet bgs. (xxx) = Soil concentration of oil-range TPH in mg/kg. Sample prefix (A4) not included in sample ID.

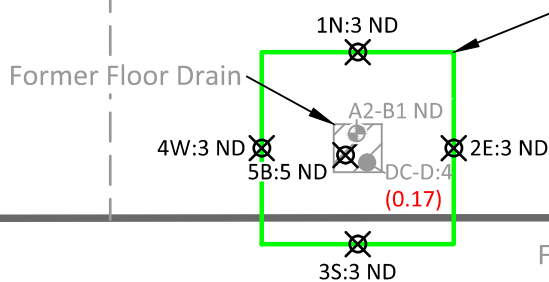
**Limits of Area 2 - Remedial Excavation -** Area where PCE was detected in soil at concentrations above MTCA Method A Soil Cleanup Levels beneath the location of a former floor drain. Approximately 7 tons of PCE impacted soils were removed from this location for MTCA compliance. (xxx) = Soil concentration of PCE in mg/kg. Sample prefix (A2) not included in sample ID.

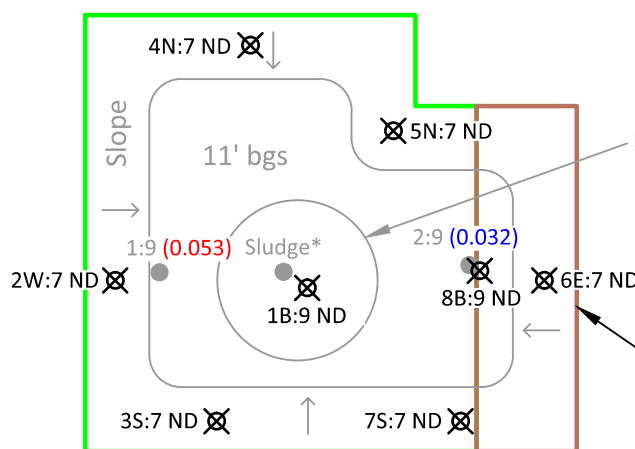
**Limits of Area 6 - Remedial Excavation -** Former 750-gallon septic tank location where PCE was detected in soil at concentrations above MTCA Method A Soil Cleanup Levels. Approximately 49 tons of PCE impacted soils and the septic tank and contents were removed from the eastern portion of the excavation for MTCA compliance. An additional 13 tons of Category 2 soils were removed in support of redevelopment activities. Sample depths were referenced from top of septic tank which was situated at approximately 2 feet bgs. Excavation starting depth was approximately 4 feet bgs. (xxx) = Soil concentration of PCE in mg/kg. Sample prefix (A6-EX) not included in sample ID.

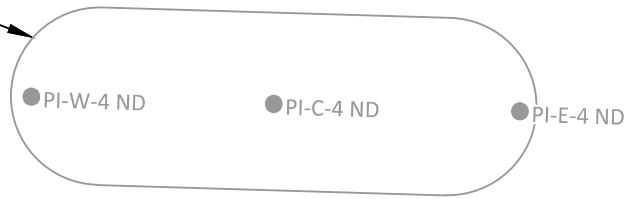
Former Pump Island Location.  
No gasoline-, diesel-, or oil-range TPH or BTEX was detected in soil at concentrations above the laboratory detection limit.

**Limits of Area 7 - Remedial Excavation** - Area where gasoline-range TPH was detected in soil at concentrations above MTCA Method A Soil Cleanup Levels in the vicinity of the former gasoline station. Approximately 73 tons of impacted soil was removed from the excavation for MTCA compliance. Sample depths were referenced from the surface grade on the eastern portion of the Property. The grade at the northern portion of the excavation was approximately 2' bgs and 9' bgs at the southern portion of the excavation (xxx) = Soil concentration of gasoline-range TPH in mg/kg. Sample prefix (A7) not included in sample ID.

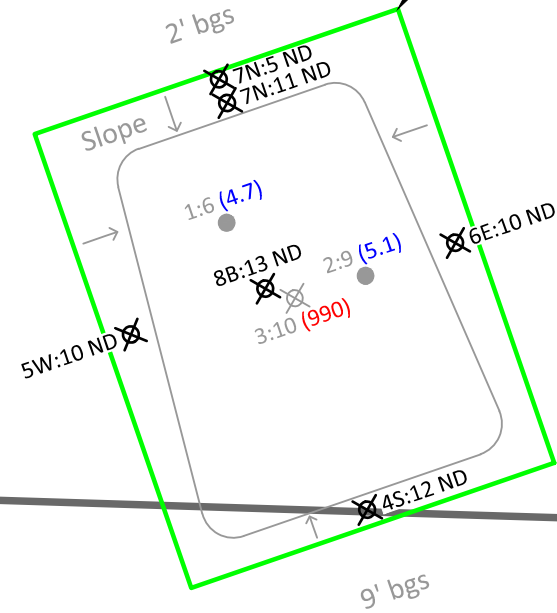
**Limits of Area 5 (UST3) - Remedial Excavation** - Area where oil-range TPH was detected in soil at concentrations above MTCA Method A Soil Cleanup Levels beneath a 500-gallon UST that was decommissioned on August 27, 2013. Approximately 103 tons of oil-range TPH impacted soil was removed from the excavation for MTCA compliance. Excavation depths were referenced from the surface grade on the northern portion of the Property. (xxx) = Soil concentration of oil-range TPH in mg/kg. Sample prefix (A5) not included in sample ID.

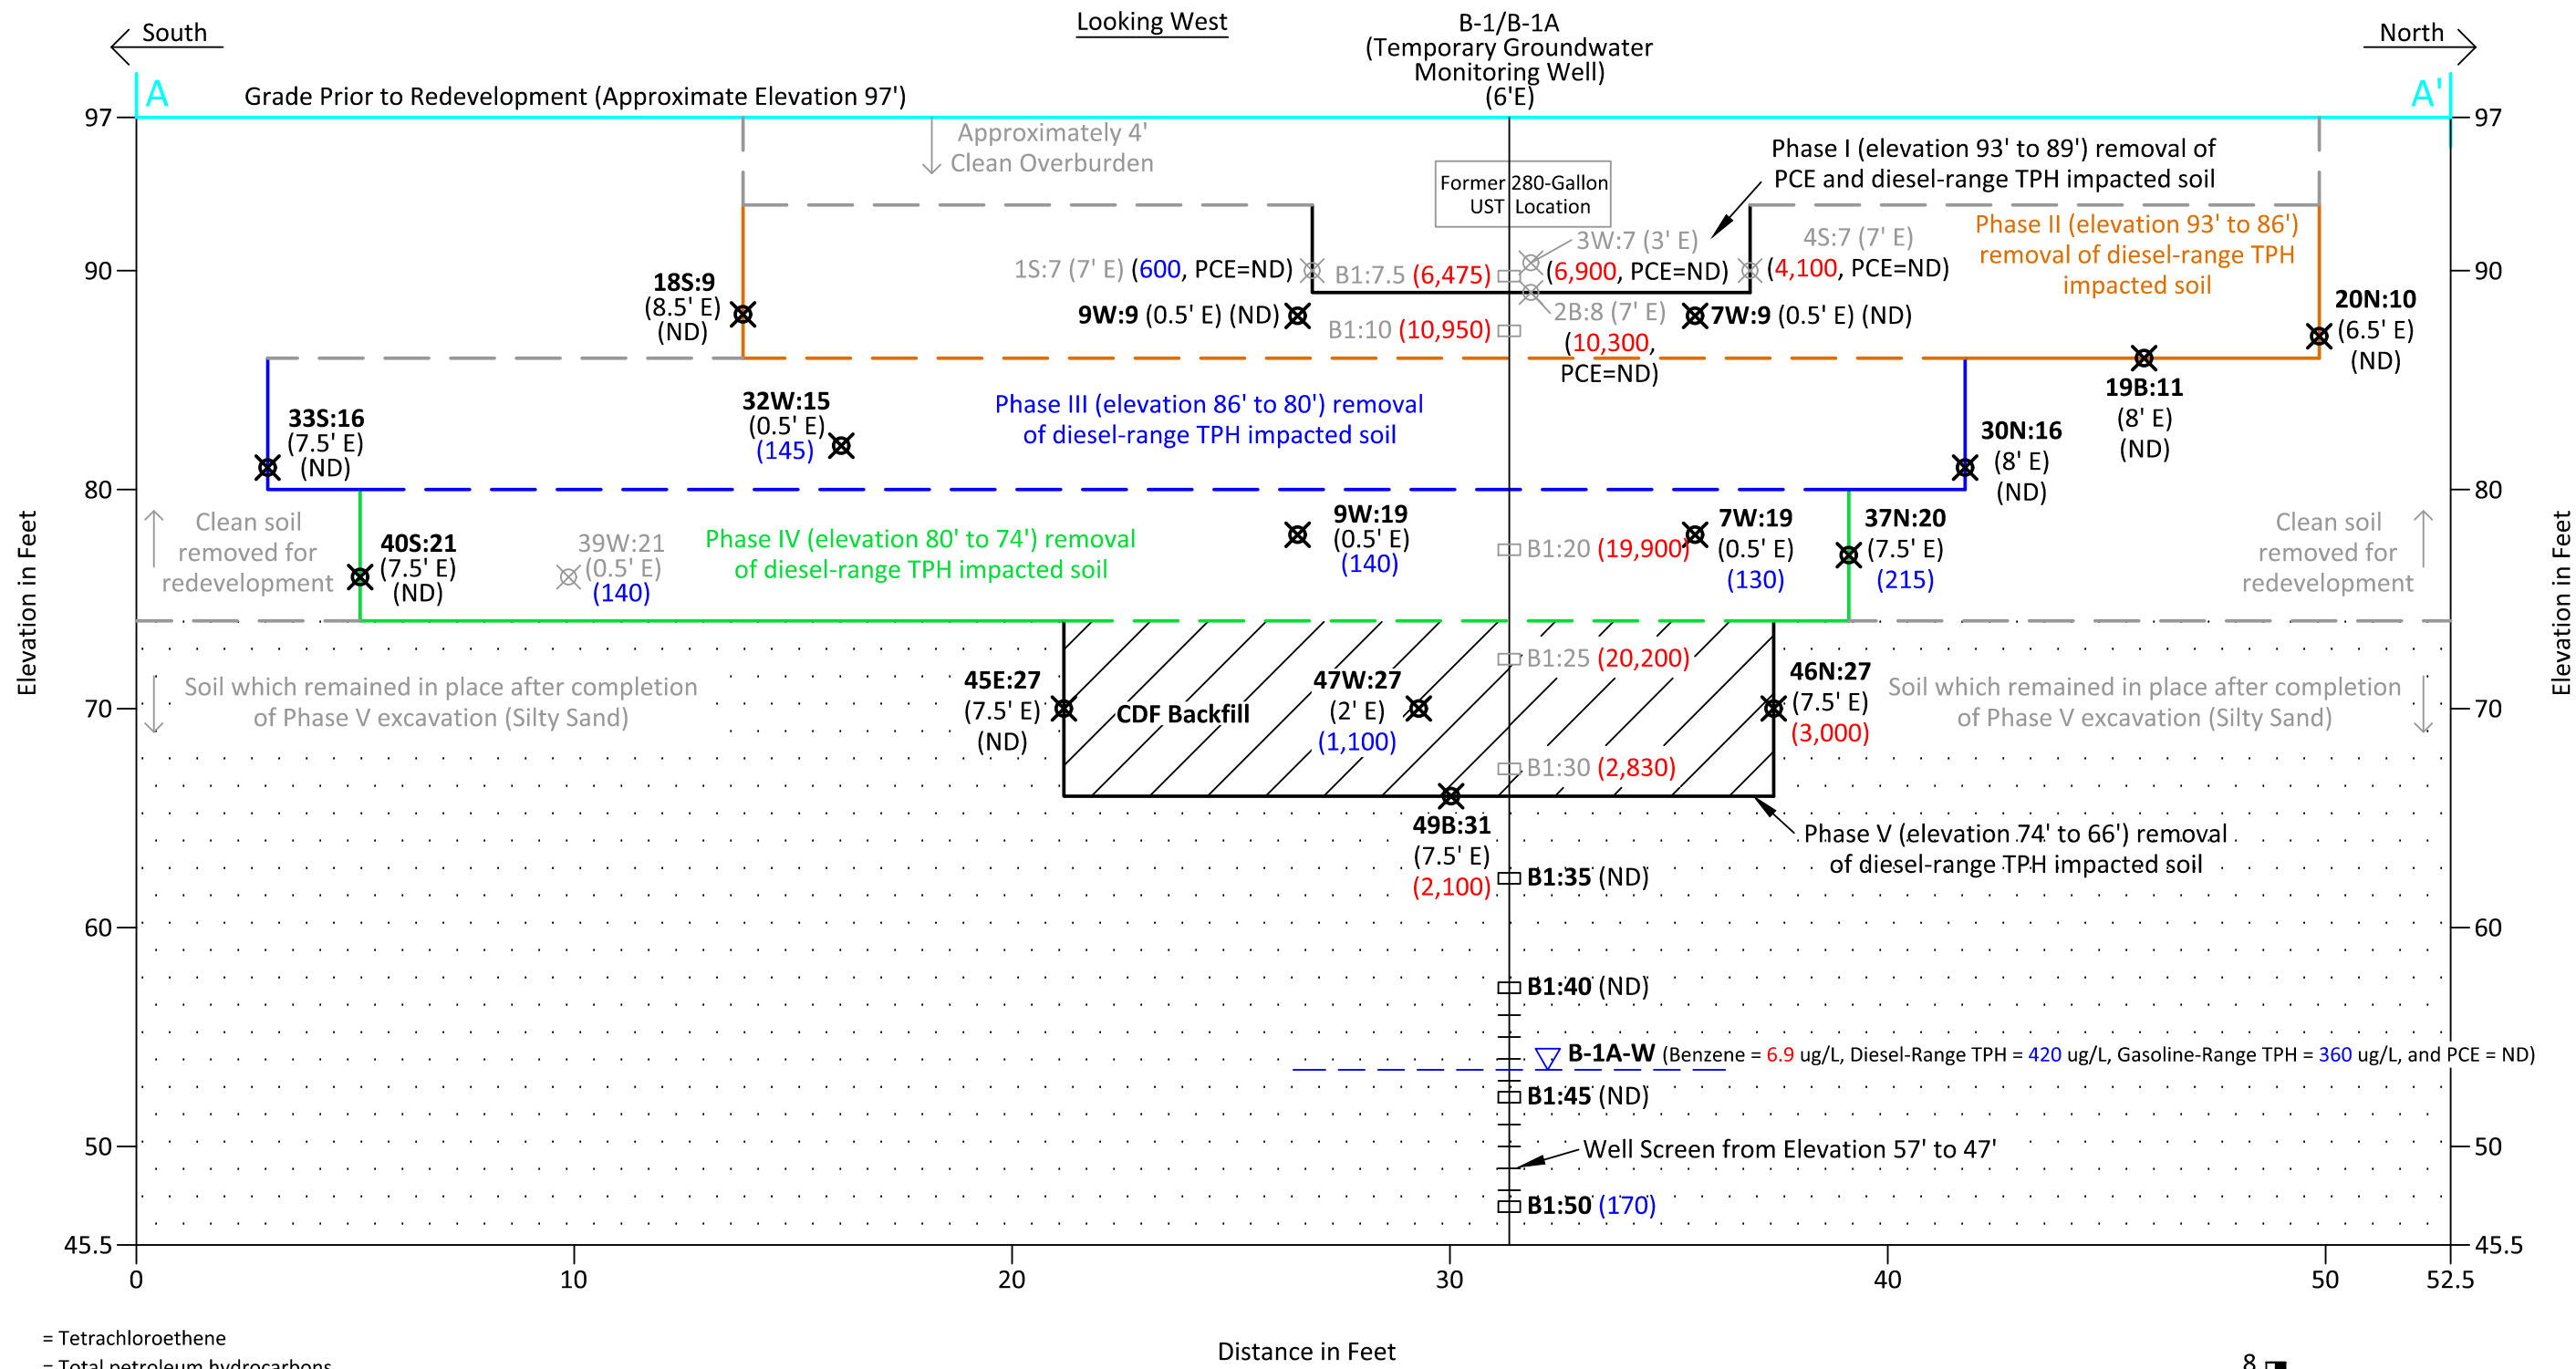
Corporate Office		Main Street Apartments Development		Figure 10
	17522 Bothell Way Northeast		RGI Project Number	Area 3 Cross Section A-A'	
	Bothell, Washington 98011		2012-107J	Date Drawn: 06/2014	
Phone: 425.415.0551		Address: 10505 Main Street, Bellevue, Washington 98004			
Fax: 425.415.0311

PCE = Tetrachloroethene  
 TPH = Total petroleum hydrocarbons  
 (8.5' E) = Indicates distance (in feet) and direction sample was offset from cross section.  
 (2,100) = Unless otherwise indicated, diesel-range TPH concentration in milligrams per kilogram (mg/kg). For groundwater, concentrations of contaminants of concern (COCs) are displayed in micrograms per liter (ug/L)  
 Red indicates soil or groundwater concentration exceeds MTCA Method A Cleanup Level.  
 Blue indicates soil or groundwater concentration was below the MTCA Method A Cleanup Level.  
 ND = No contaminants of concern (COCs) detected at concentrations above laboratory detection limits.  
 ⊗ (in gray) = Indicates performance soil sample location where soil was removed as Category 2, 3, or 4 PCS during the course of remedial excavations and excavations in support of redevelopment.  
 ⊗ (bold sample ID) = Indicates final performance sample collected from the final limits of the excavation.

□ = Soil boring sample location. Gray indicates soil was removed during Area 3 excavation.  
 ▽ (in blue) = Depth to groundwater observed in temporary groundwater monitoring well B-1A on 09/03/13
