Former Pace National Site
500 7TH Avenue South
Kirkland, Washington
Site Cleanup ID# 5063
Facility Site ID# 2159

Cleanup Action Plan

Toxics Cleanup Program
Northwest Regional Office
Washington State Department of Ecology
Bellevue, Washington

January 2012

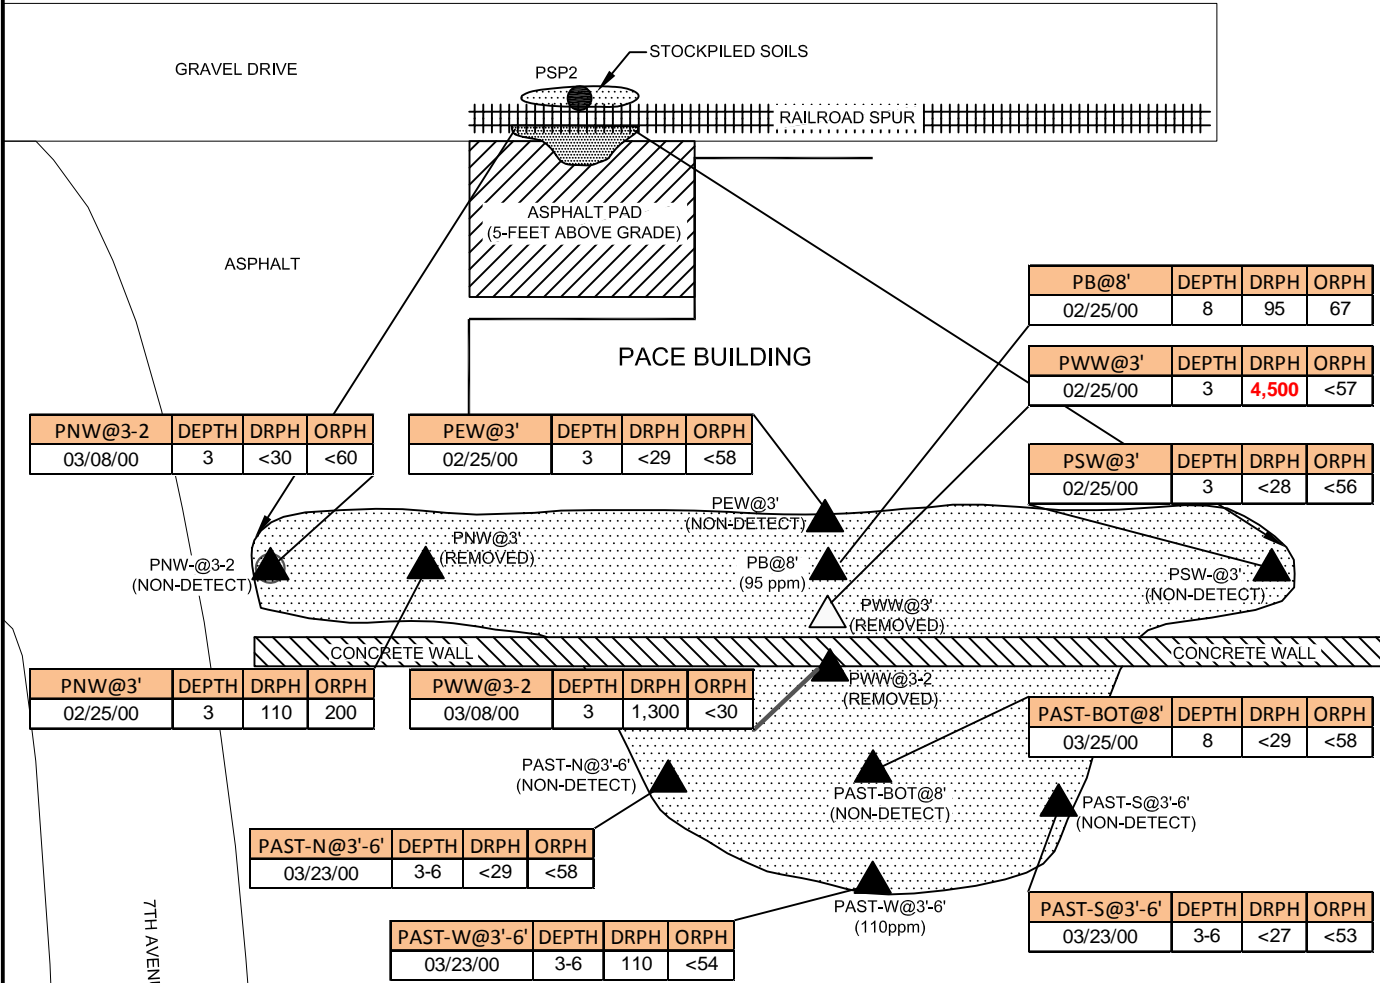
FIGURE 5
 MAP SHOWING RUA SOIL
 SAMPLING LOCATIONS 2000

ENLARGEMENT OF EXCAVATION
