November 4, 2016  
G-Logics File 01-0739-F

**Subject: 2016 4<sup>th</sup> Quarter System Operation and Monitoring Report  
Former Drycleaner Location  
10610 NE 8th Street  
Bellevue, WA**

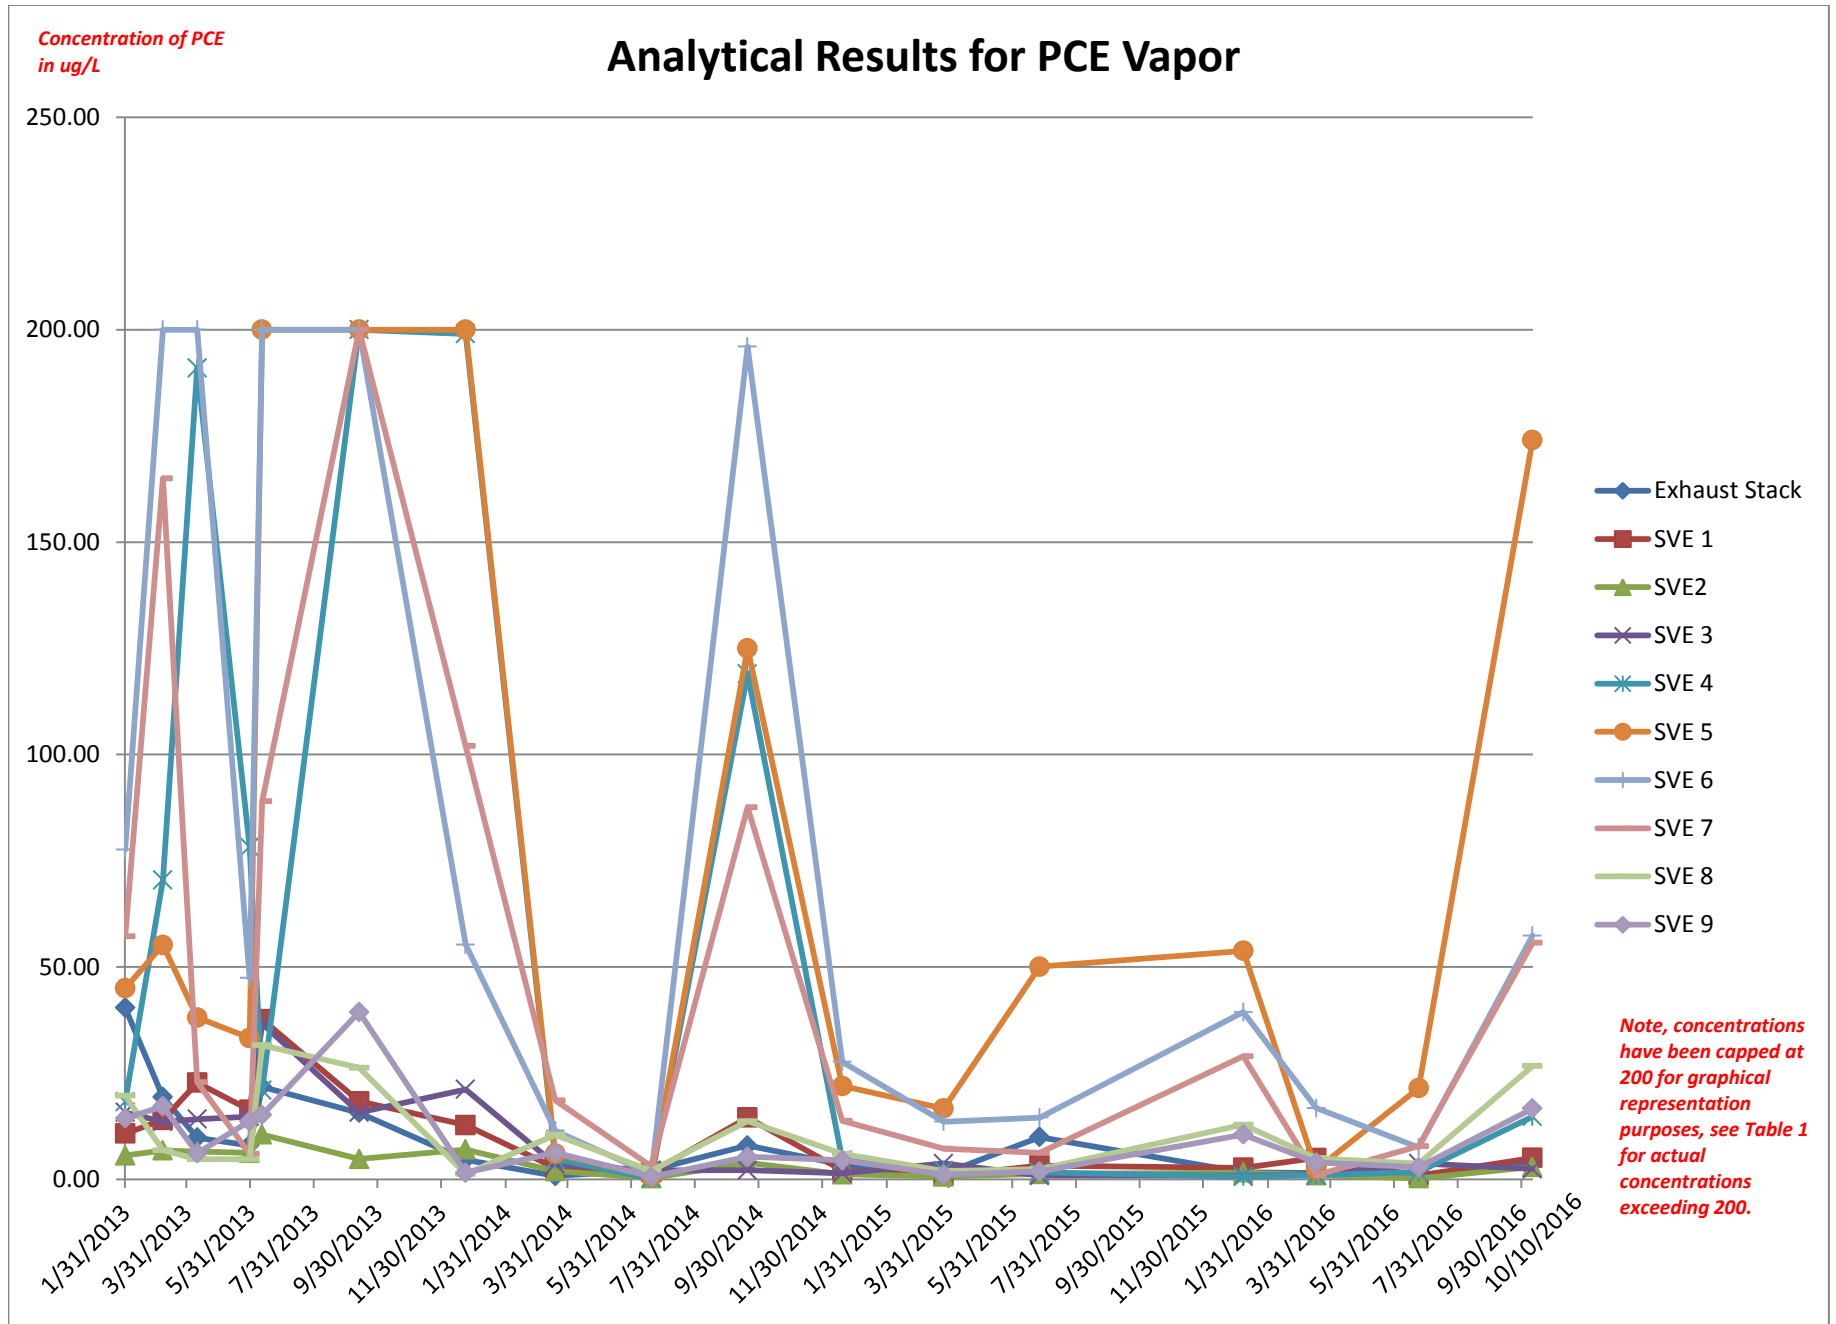
**Graph 1**  
**Former Thinker Toys**

On October 10, 2016, vapor samples were collected from the exhaust-stack and SVE Wells. Collected vapor samples were analyzed for PCE and its breakdown components by EPA Method 8260. Analytical results demonstrate that PCE continues to be removed from the soil on the property (Table 1, Graph 1). The highest concentration of PCE removal

continues to be observed in SVE Wells 5, 6, and 7. These wells are located in the area that was mapped as having elevated concentrations of Tetrachloroethene (PCE) in the soil (Figure 3). From June 23, 2016 to October 10, 2016, an additional 0.56 pounds of PCE have been removed from the subsurface (see Table 2).

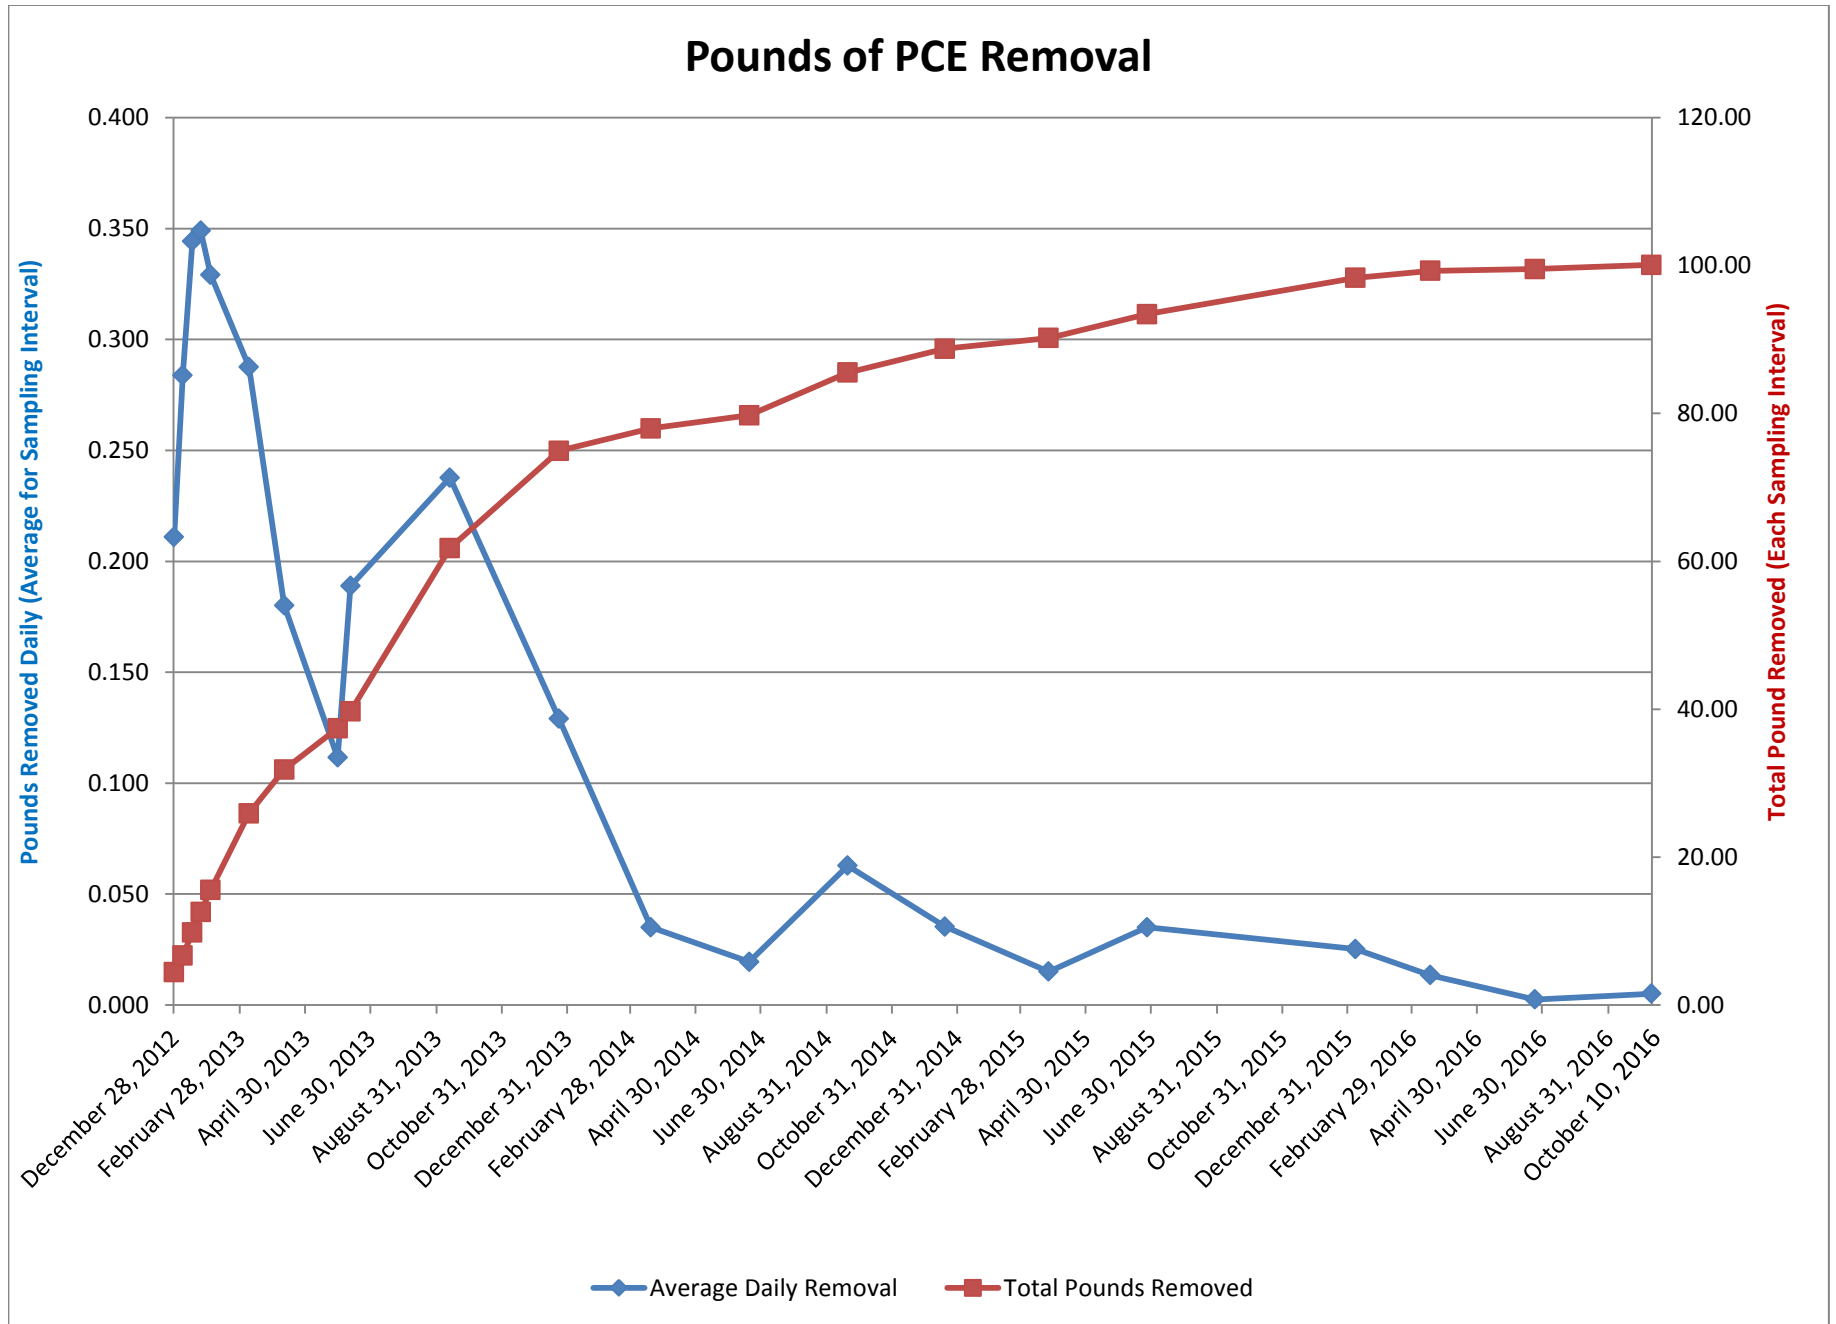
**Graph 2**  
**Former Thinker Toys**

The system has removed over 100 pounds of PCE since the system was started (December 7, 2012 to October 10, 2016), with the largest volume removed during the first year of system operation. This also is illustrated on Graph 2, which plots the effluent concentrations of PCE over time removed by the system. Both the cumulative total and daily average of PCE removal are shown on Graph 2.

The most recent analytical results indicate that the system continues to remove PCE contaminants from the subsurface. Based on the continued removal of PCE, the understood objective to reduce PCE concentrations in the soil (for ultimate soil disposal), and the agreement with SRO (to reduce potential off-site migration), it is recommended the SVE system continue to be operated on a pulsed-operating schedule. A pulsed-operating schedule reduces the time of system operation to a few hours per day. This allows for the diffusion of contaminant into the soil pores during resting phases, which can then be removed by the SVE during the operational phase. Additionally, pulsed operation allows for decreased electricity use while still removing residual contamination.
