K Ply Site

Construction Completion Report

Prepared for

December 2016

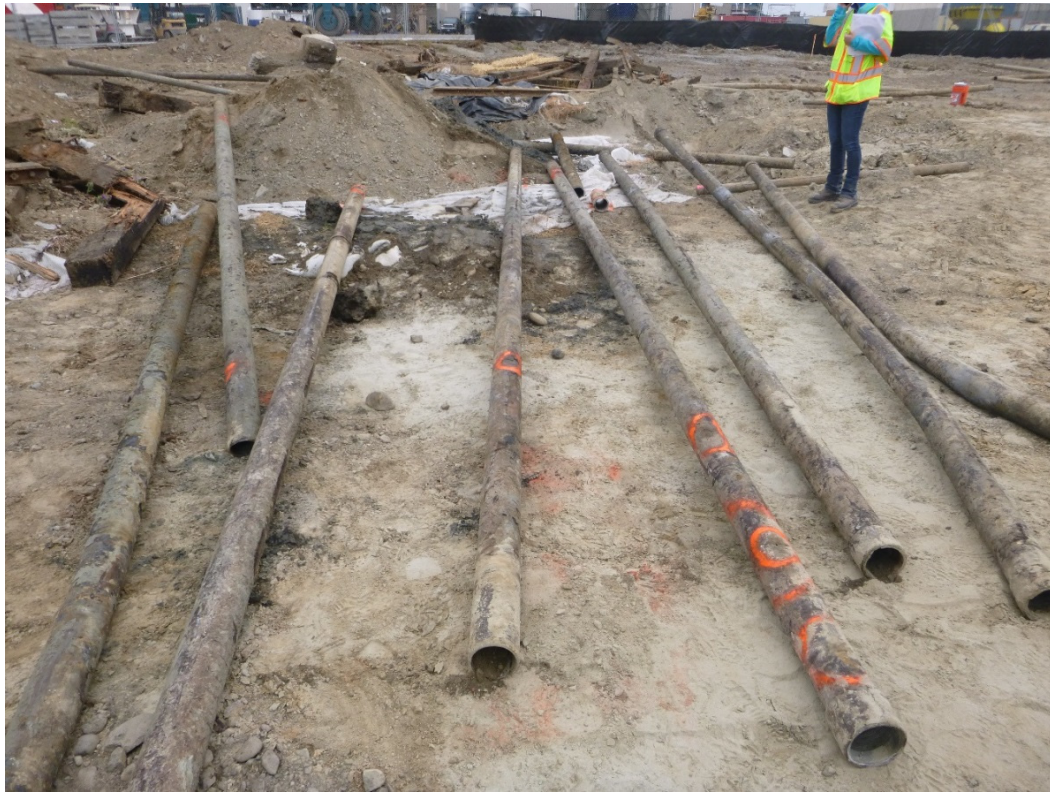
Photograph 3. Holes and corrosion in Pipeline 8 outlined by orange paint.

During RI/FS field work, gasoline-contaminated water was found in the two 4-inch-diameter steel pipes that comprise Pipeline 8. The water in these pipes was pumped out and disposed of prior to the pipes being removed from the ground. Prior to being removed, the pipes were exposed along their length by trenching. The pipes were inerted and cut at the location where the pipes extended under the alley toward the Peninsula Fuels property. The trenched sections of pipe were then removed by lifting out sections with the excavator. The section of Pipeline 8 (both 4-inch-diameter pipes) that passed under the concrete pad was found to have a number of corrosion holes along its length. These holes were the likely release points for gasoline contamination to the surrounding soils (refer to Appendix D, Attachment D.2). With the exception of the section of pipe that remains underneath the alley, all of Pipeline 8 has been removed from the Site.

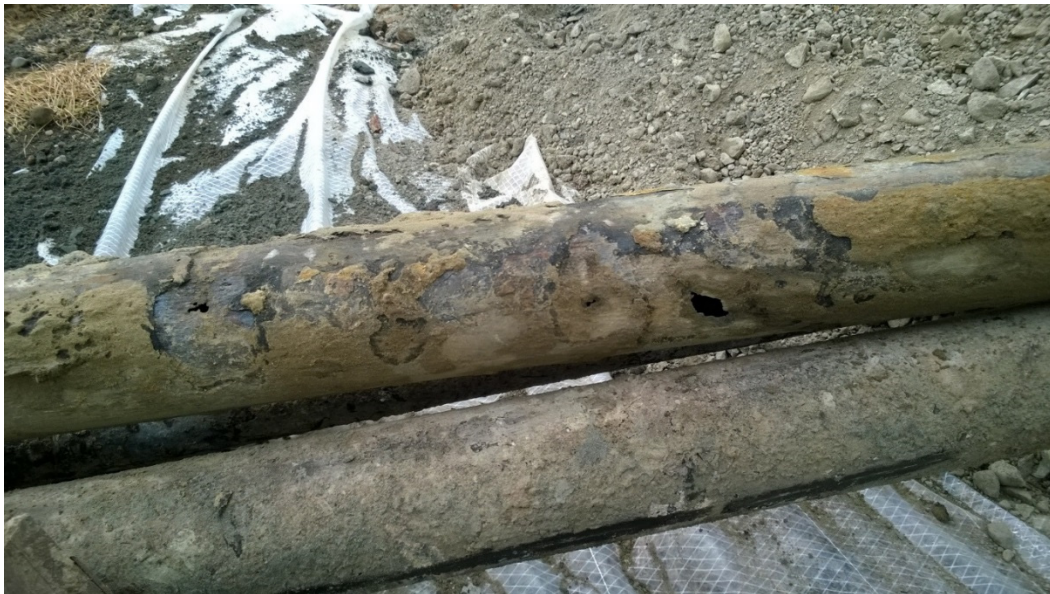
Photograph. Close up of corrosion and holes in Pipeline 8.

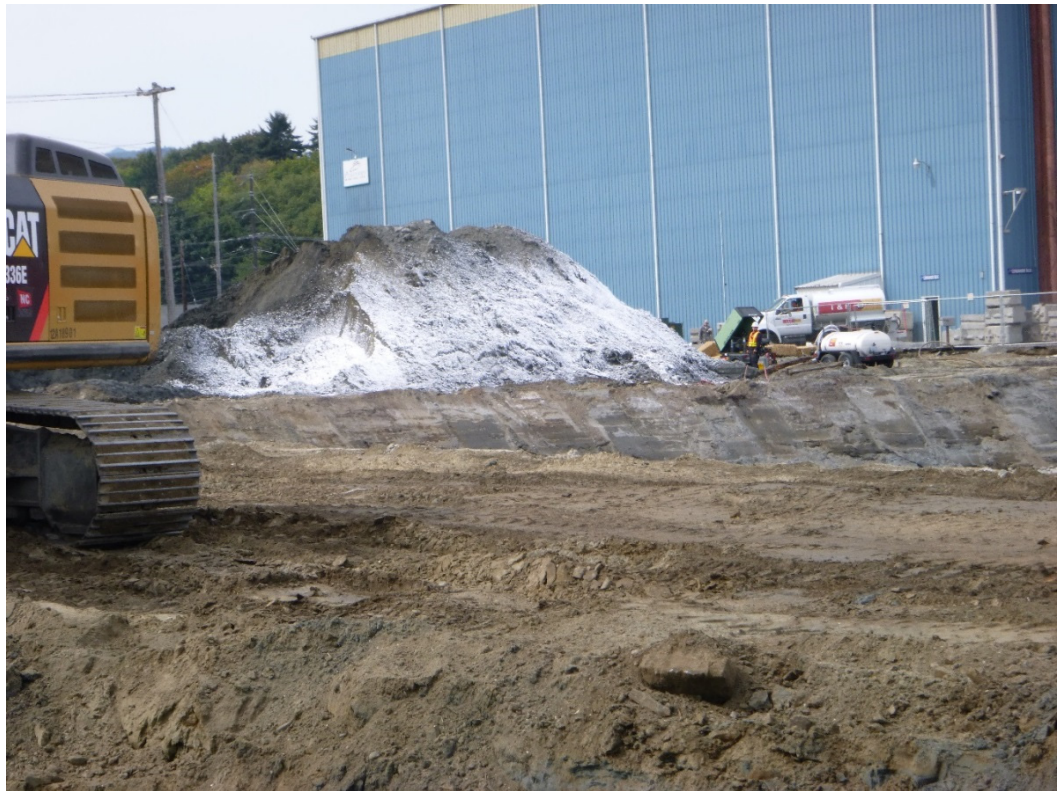
Photograph 8. Foam applied to stockpiles to address odor complaint.

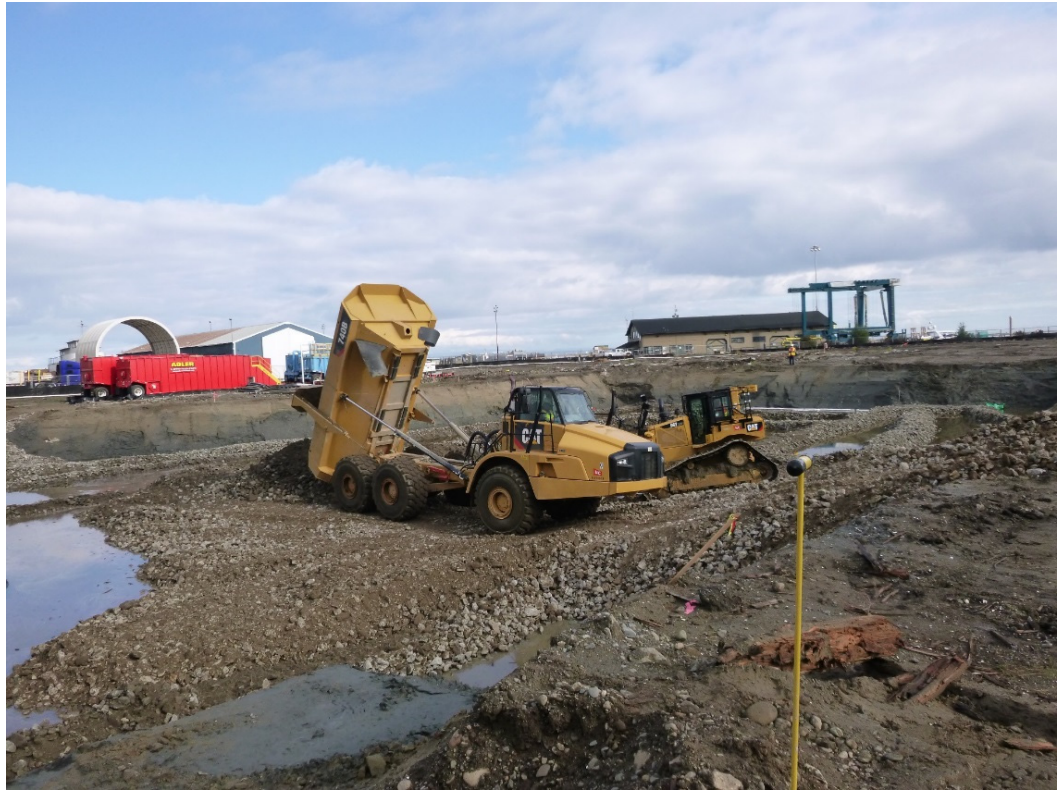
Photograph 9. Example of base fill in Excavation Area 5.

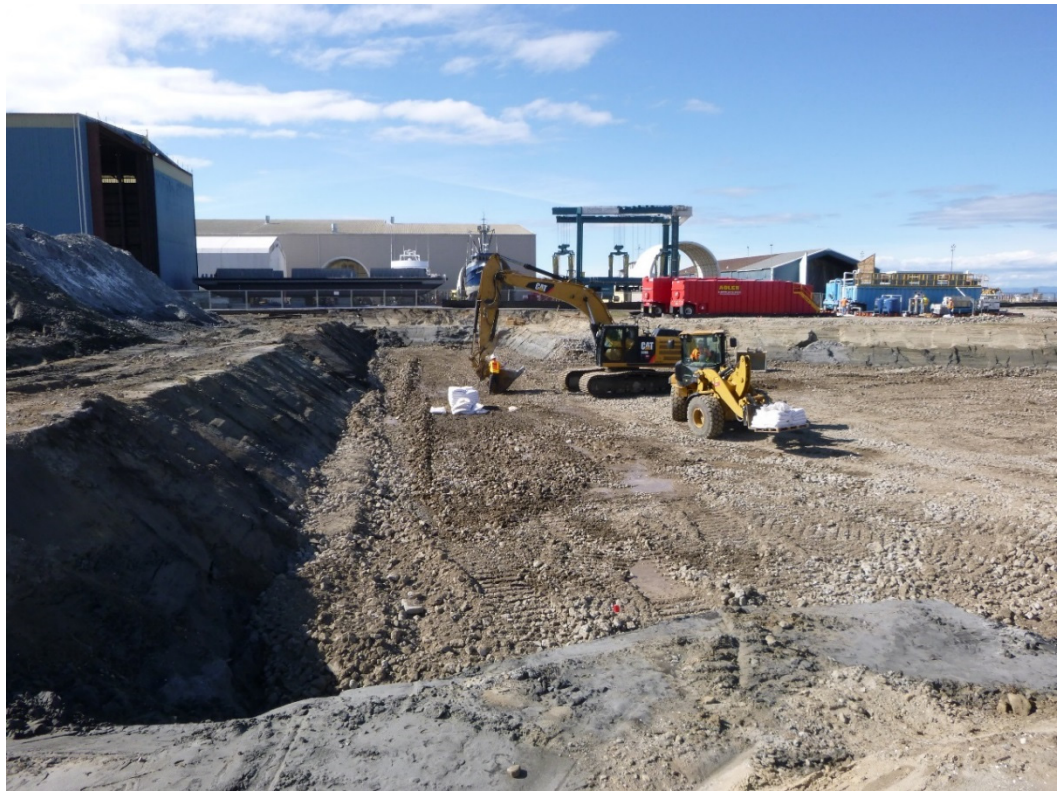
Photograph 10. Application of bioamendment in Excavation Area 5.

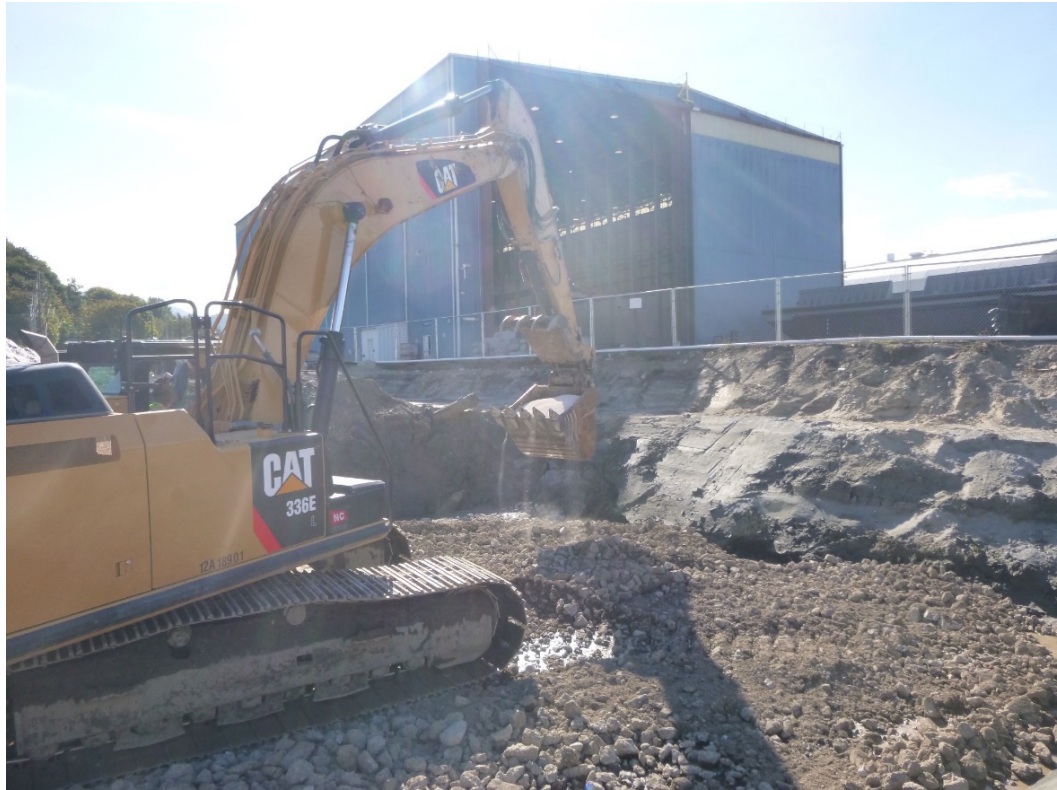
Photograph 11. Spreading of bioamendment in Excavation Area 5.

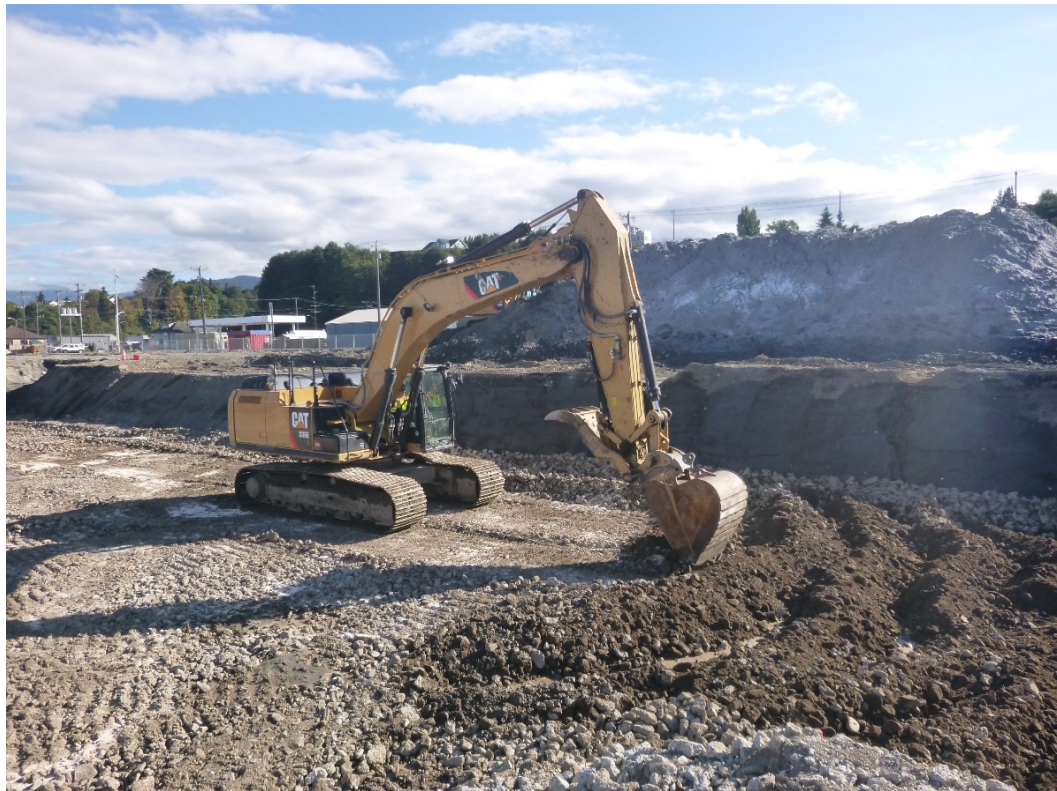
Photograph 12. Tilling of bioamendment in Excavation Area 5.

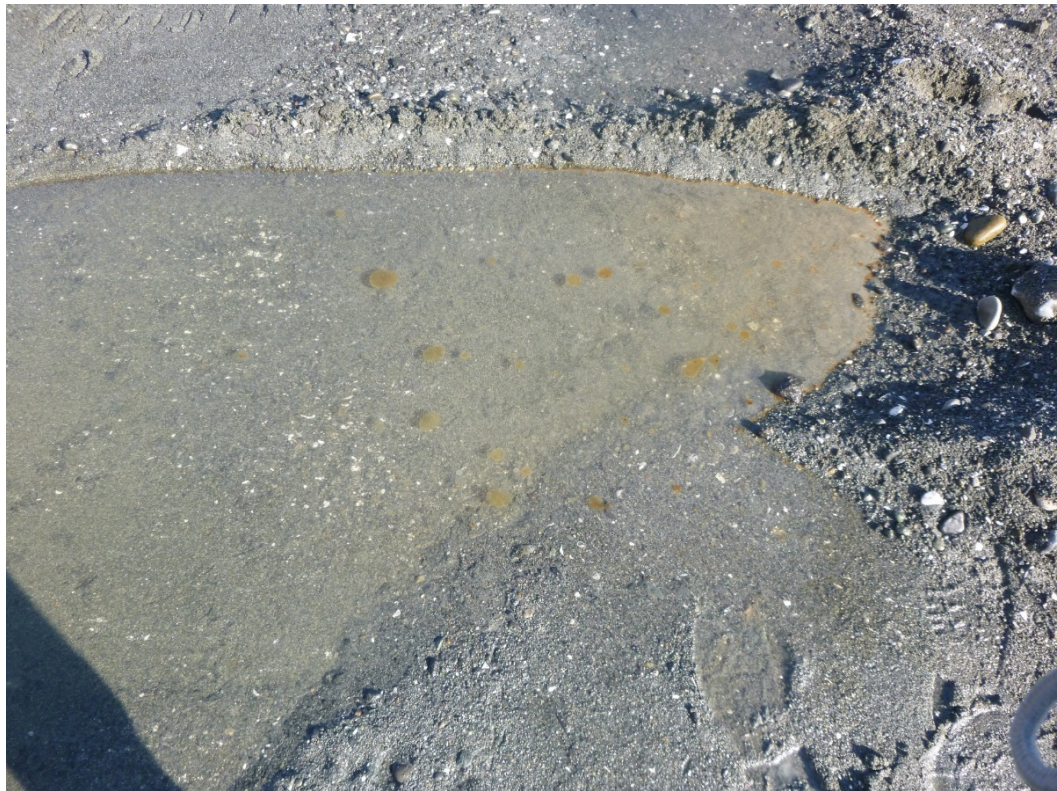
Photograph 14. LNAPL within Excavation Area 6.

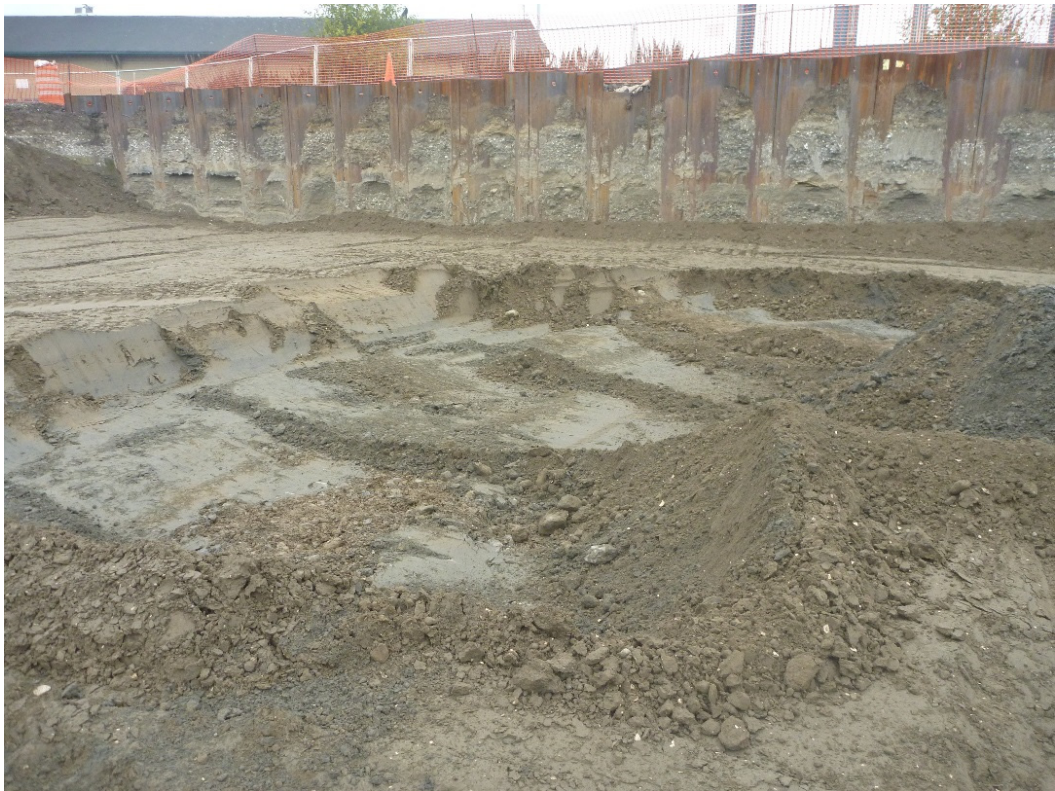
Photograph 16. Backfilling soft spot in Excavation Area 6 near sheetpile.

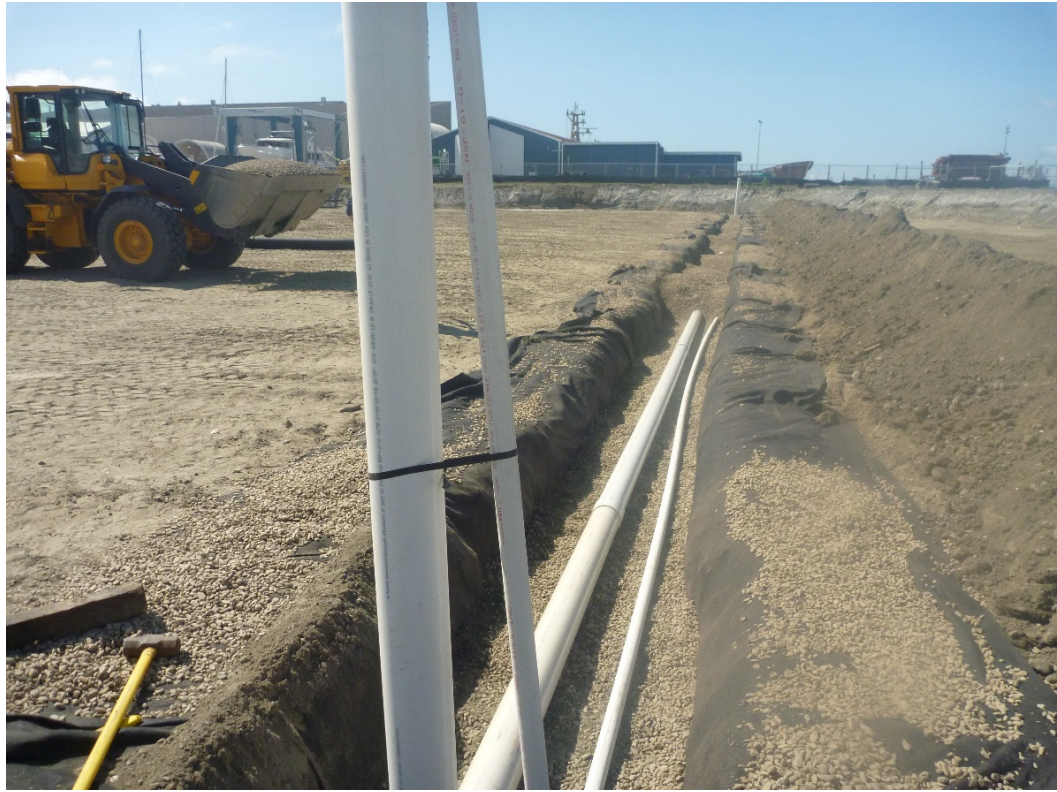
Photograph 19. Installation of infiltration gallery.

Five parallel infiltration galleries were placed at a depth of approximately 1 foot above the water table. The infiltration galleries were installed at locations approximately 100 to 200 feet apart in the excavation area (refer to Figure 4.2) in order to provide a distribution network for additional bio-amendments throughout the contaminated groundwater area should that be necessary. The infiltration galleries are constructed of 2-inch-diameter perforated polyvinyl chloride (PVC) piping (refer to Appendix D, Attachment D.2). A second 6-inch-diameter perforated PVC pipe was installed next to the 2-inch-diameter pipe to allow for larger/faster addition of amendments as well as potential future use for stormwater infiltration (following groundwater cleanup). The pipes are wrapped in a filter fabric to prevent soil clogging and are embedded in pea gravel placed atop the crushed concrete base fill. Generally, the pipes are gently sloped (0.5 percent) from each end to a low central point to ensure that the bioremediation amendment that is injected reaches the entire length of the gallery (refer to Figure 4.2). There are vertical PVC risers set on either side of the infiltration gallery that will be used to inject the bioremediation amendment. The

pipes are capped and surrounded by Ecology blocks. In the future, when the grade at the Site is finished, the infiltration gallery risers will be cut down and set in protective vaults at grade.
