CARTY LAKE CONSTRUCTION COMPLETION REPORT

CARTY LAKE REMEDIAL ACTION
111 W DIVISION STREET
RIDGEFIELD, WASHINGTON

Prepared for
PORT OF RIDGEFIELD
RIDGEFIELD, WA
November 17, 2015
Project No. 9003.01.40

Prepared by
Maul Foster & Alongi, Inc.
400 East Mill Plain Blvd., Suite 400
Vancouver, WA 98660

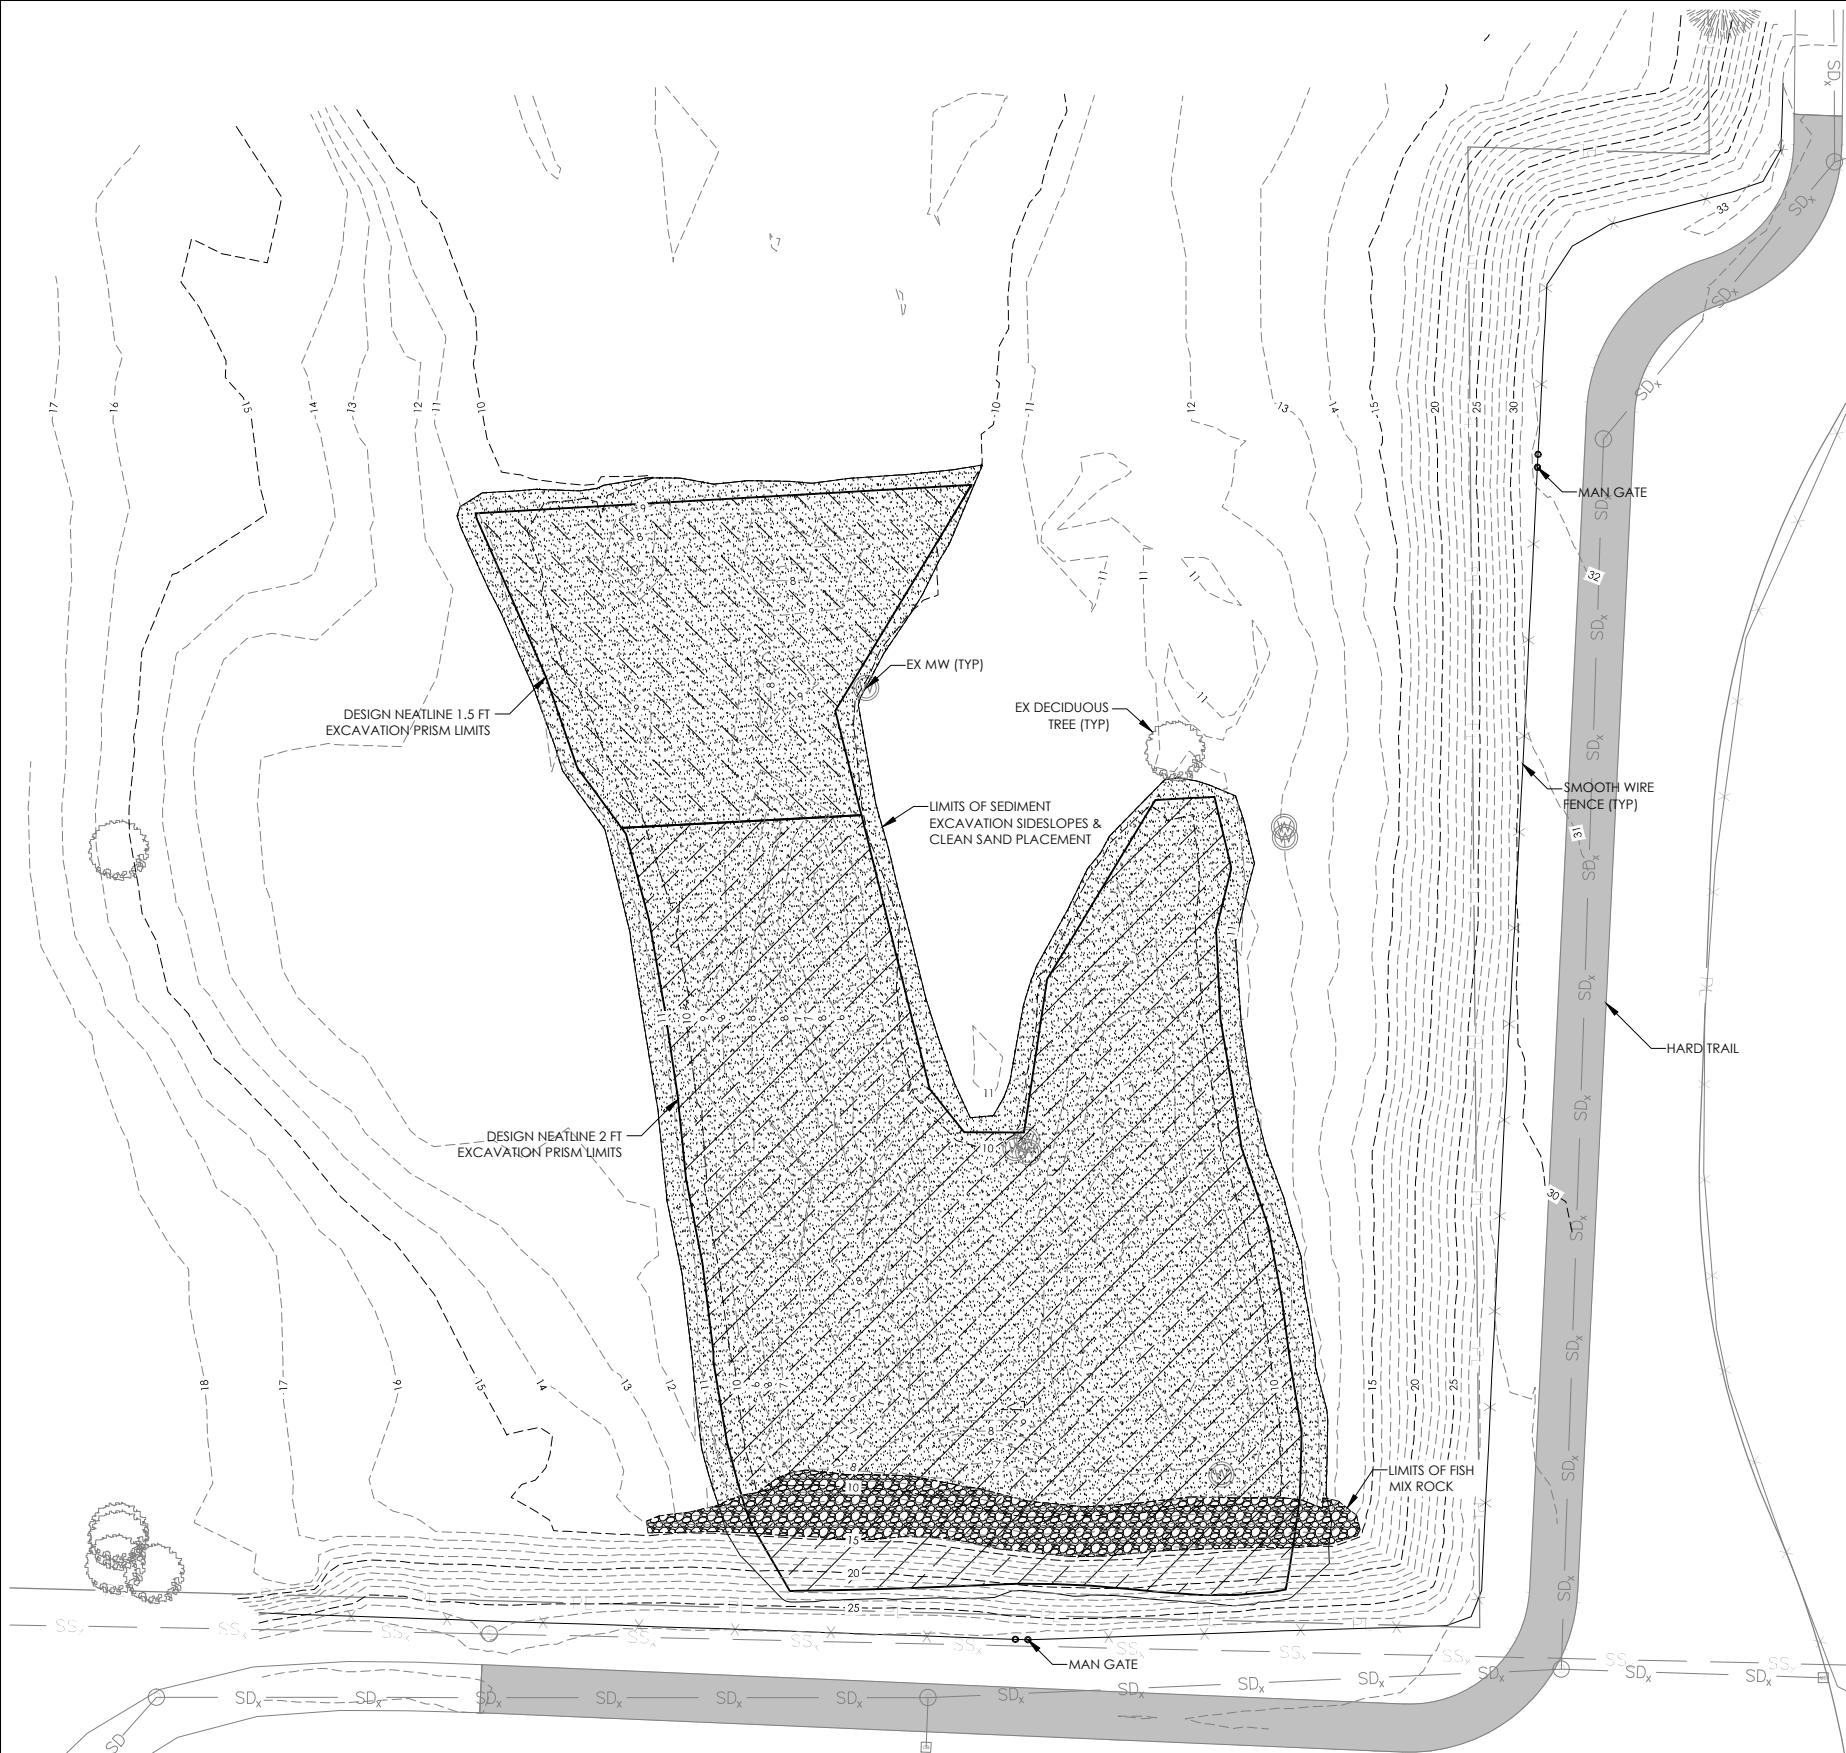
SHEET TITLE
POST-REMEDIAL ACTION CONDITIONS PLAN

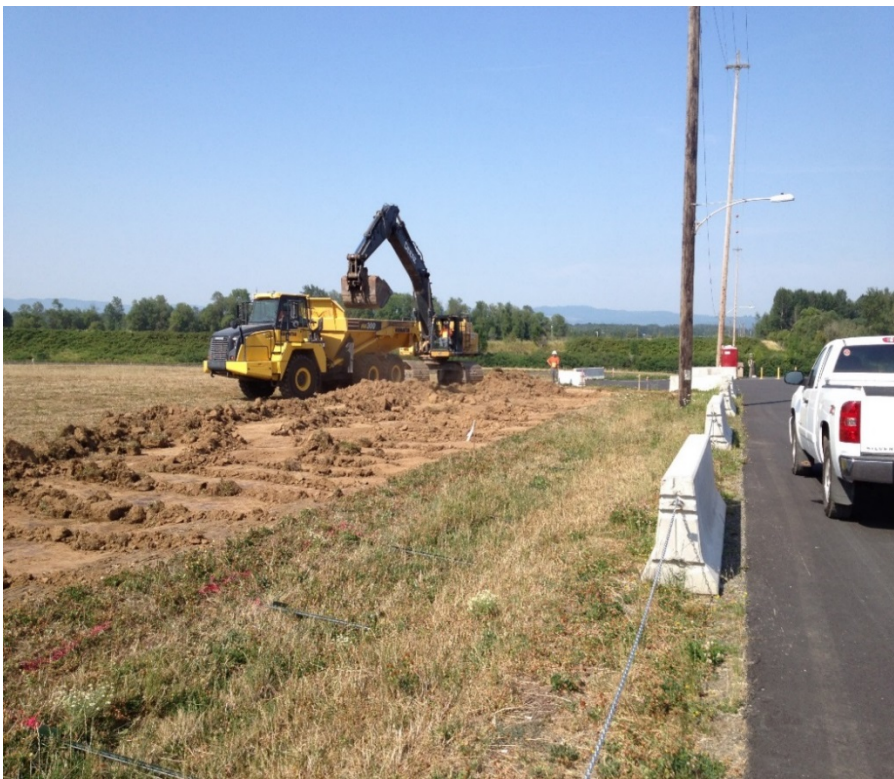
Clean soil cap removal.

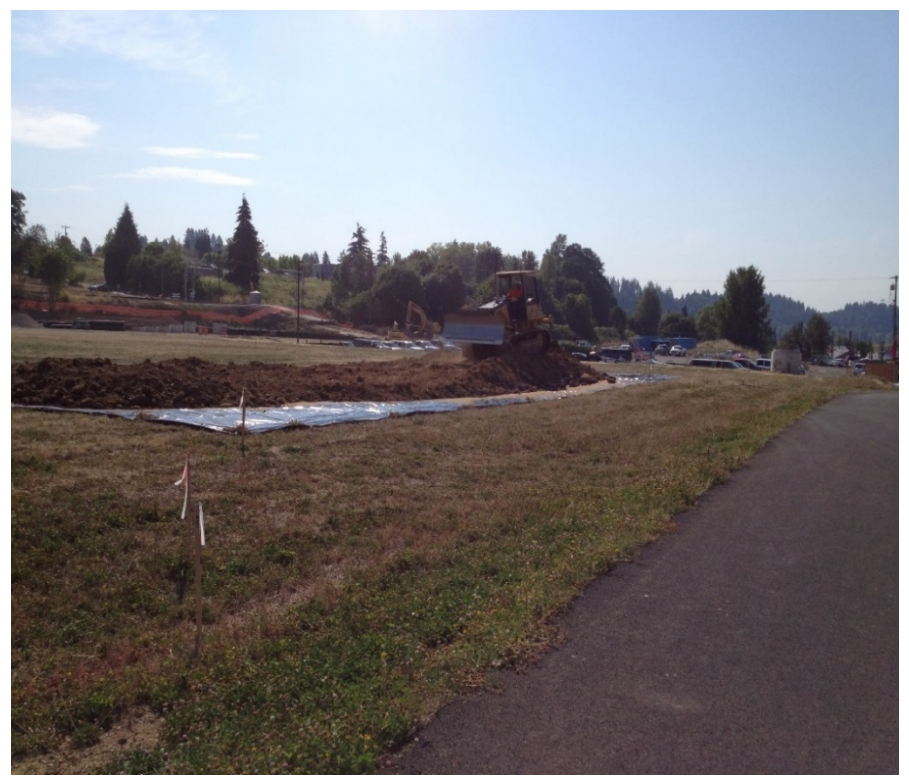
Clean soil cap stockpiled on liner

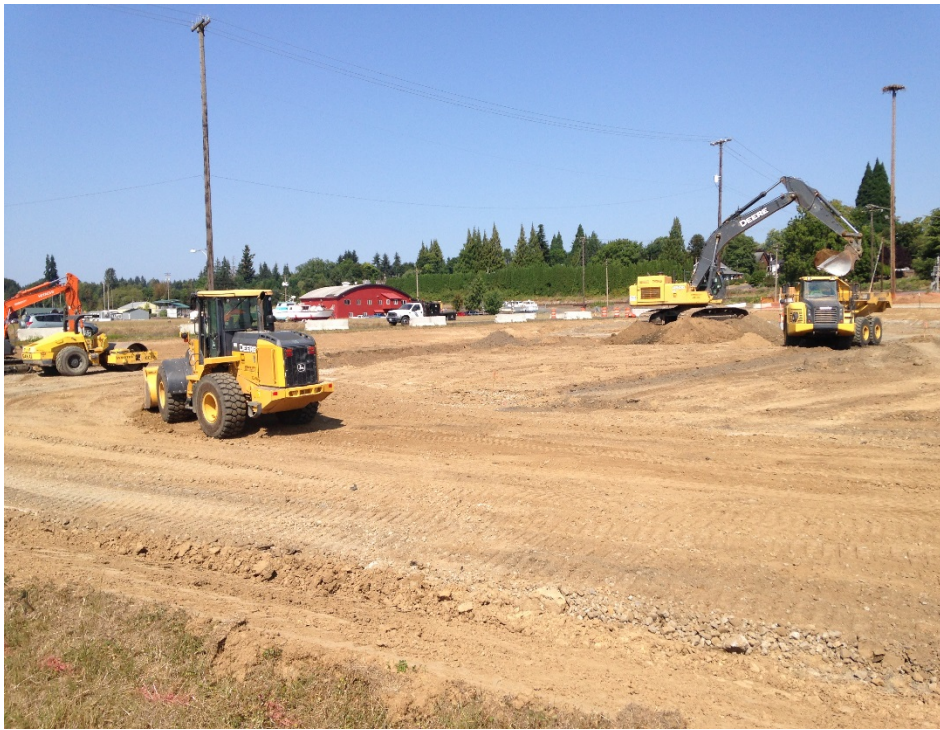
Looking northeast at grading of the sediment handling area.

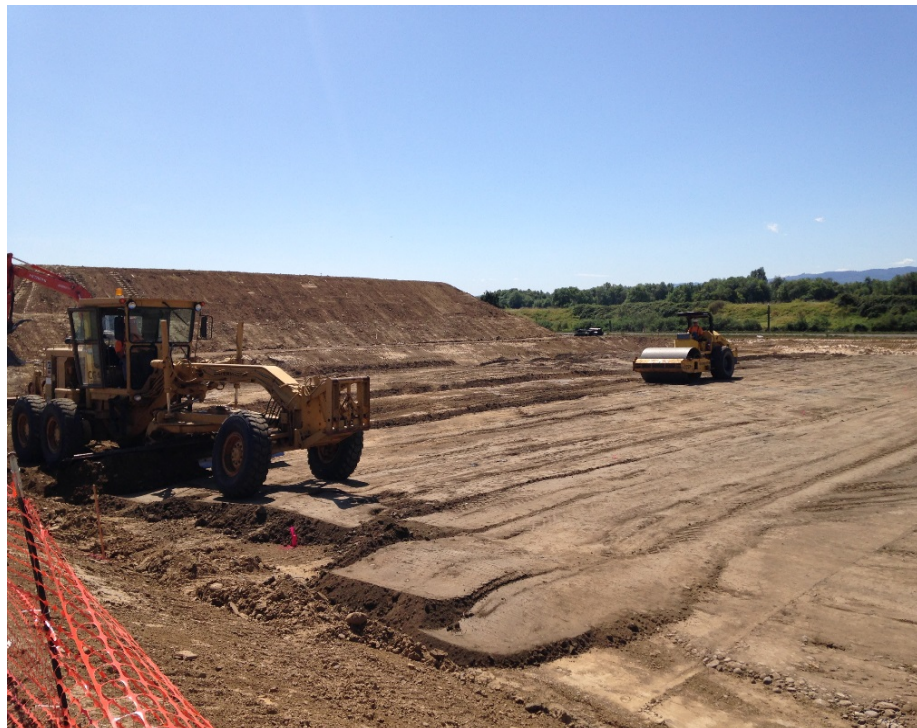
Looking southwest at grader and roller grading out the subgrade.

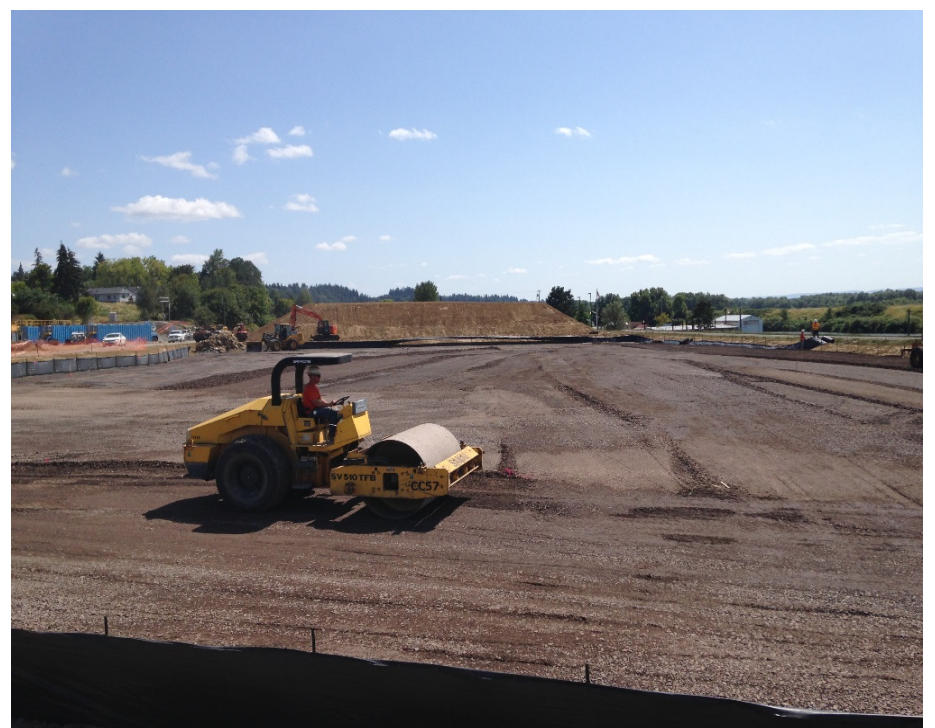
Looking south at roller compacting recently placed ballast.

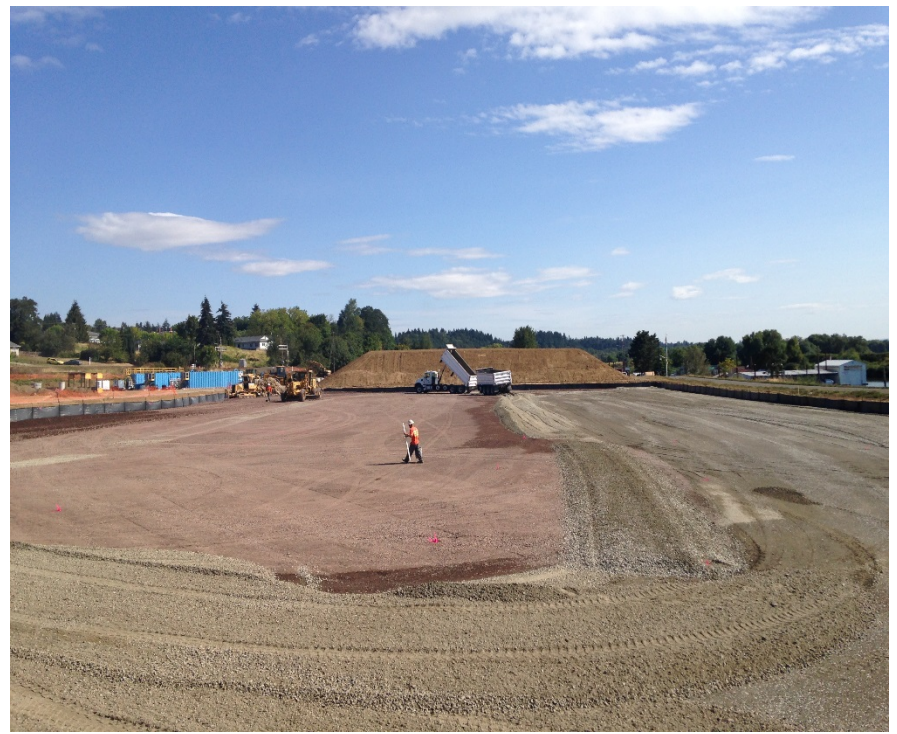
Looking south at grader grading ballast and truck delivering crushed surfacing

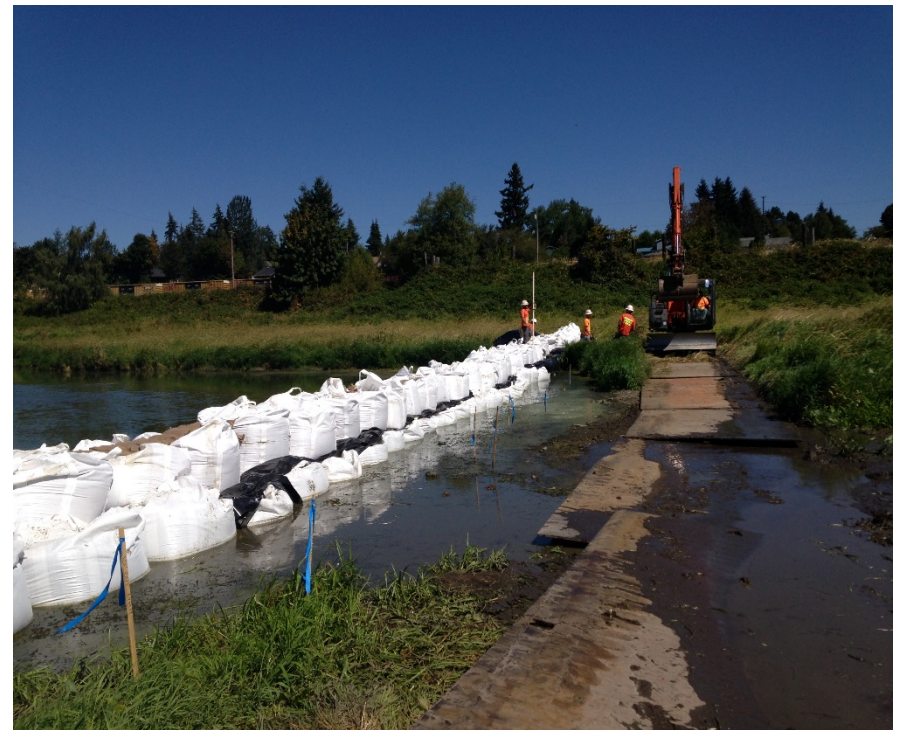
Looking east at the temporary isolation barrier, before the final wrap with visqueen.

Strider constructed the temporary isolation barrier in accordance with the plans, and prior to excavation within the wetland, using bulk bags instead of smaller sand bags. A low-density polyethylene sheeting was incorporated in the cross section of the temporary isolation barrier to reduce infiltration through the barrier. The water elevation in Carty Lake was approximately 9 feet NGVD at the time of the temporary isolation barrier installation. The sediment within the delineated area of excavation was saturated; however, standing water was not present at significant depths.

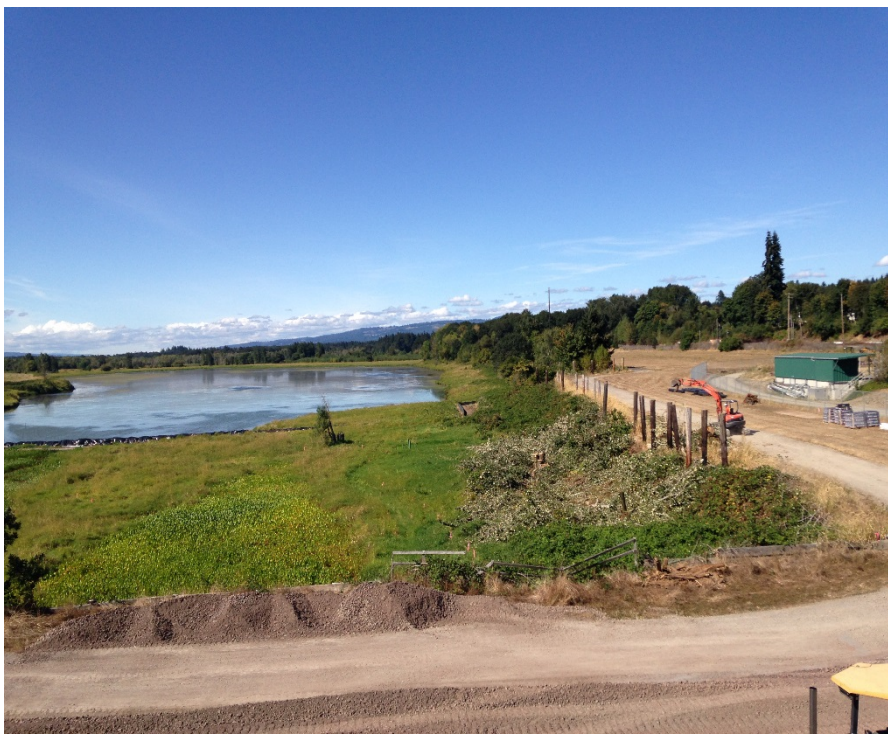
Looking northeast at Carty Lake, before sediment excavation begins. Note the demolished trees on the east embankment.

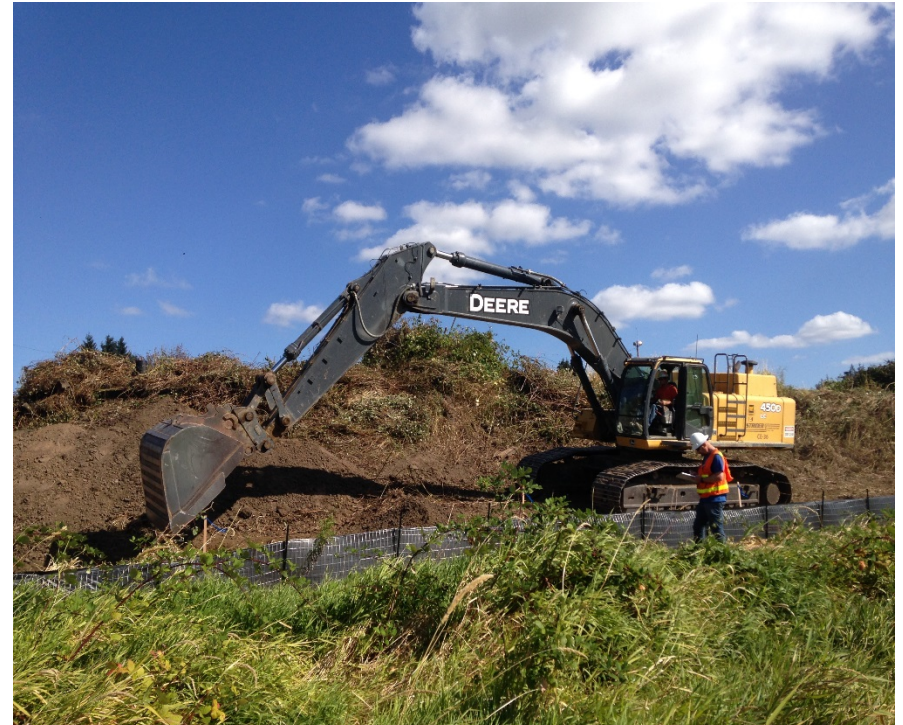
Looking east at the 450 excavating the keyway on the east embankment.

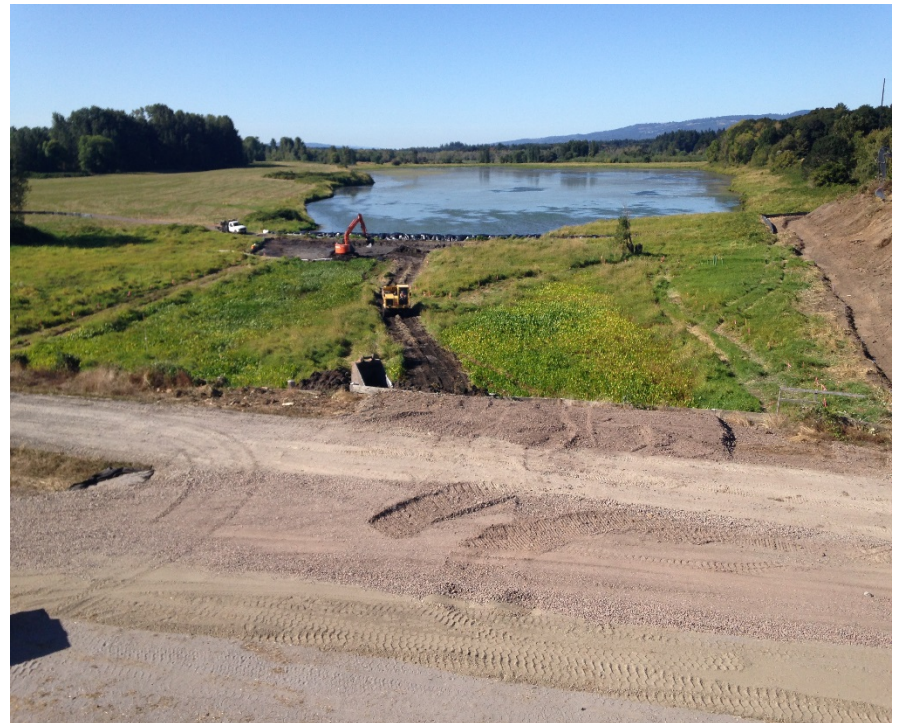
Looking north at sediment excavation activities.

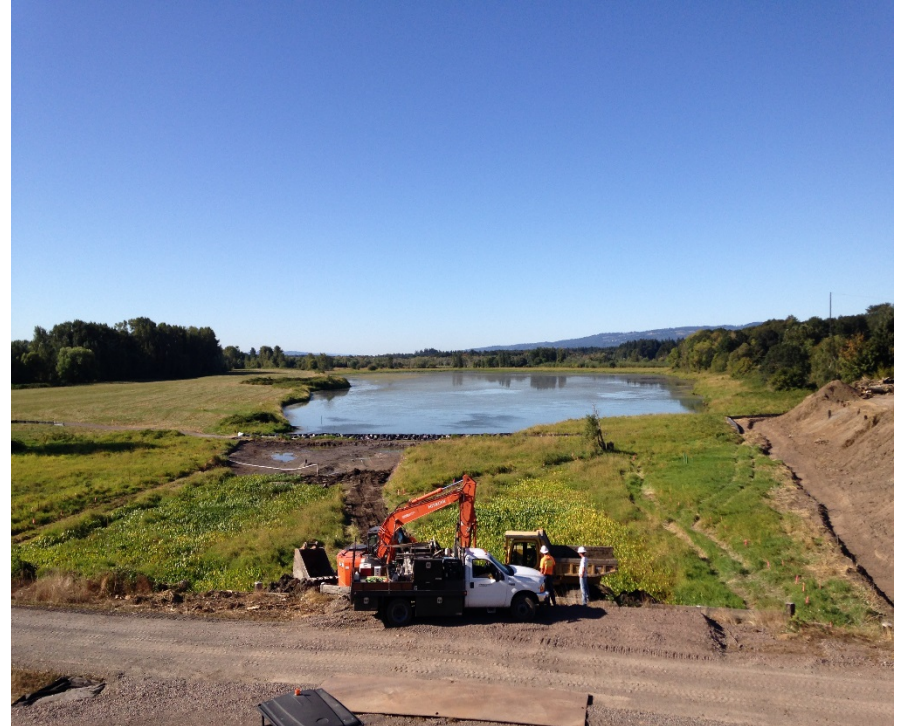
Looking north at extent of completed sediment excavation. Note equipment fueling up from bulkhead.

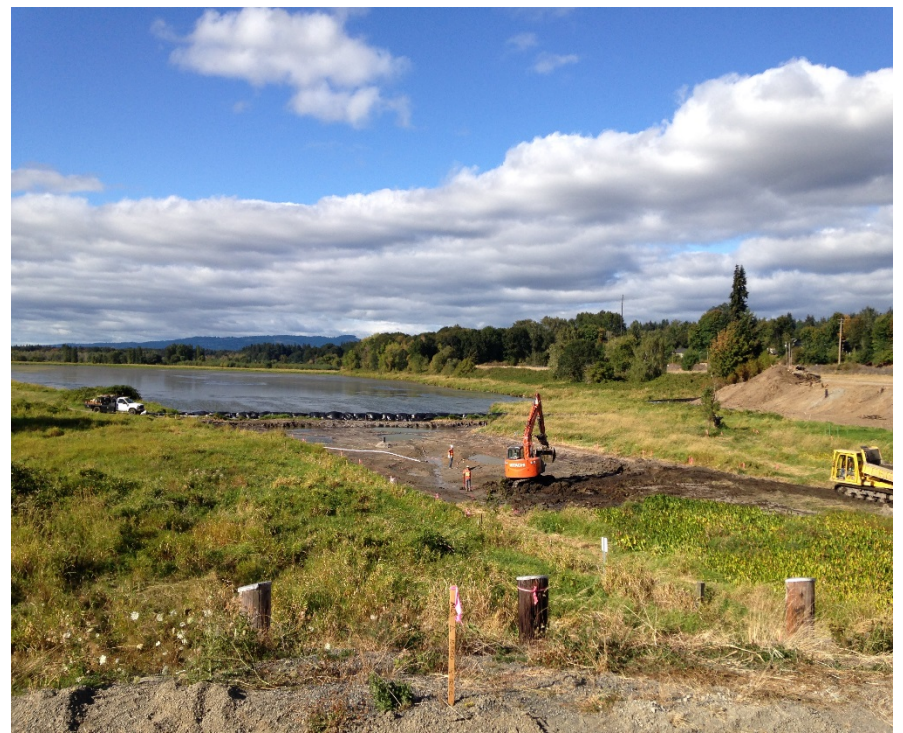
Looking north at sediment excavation operations.

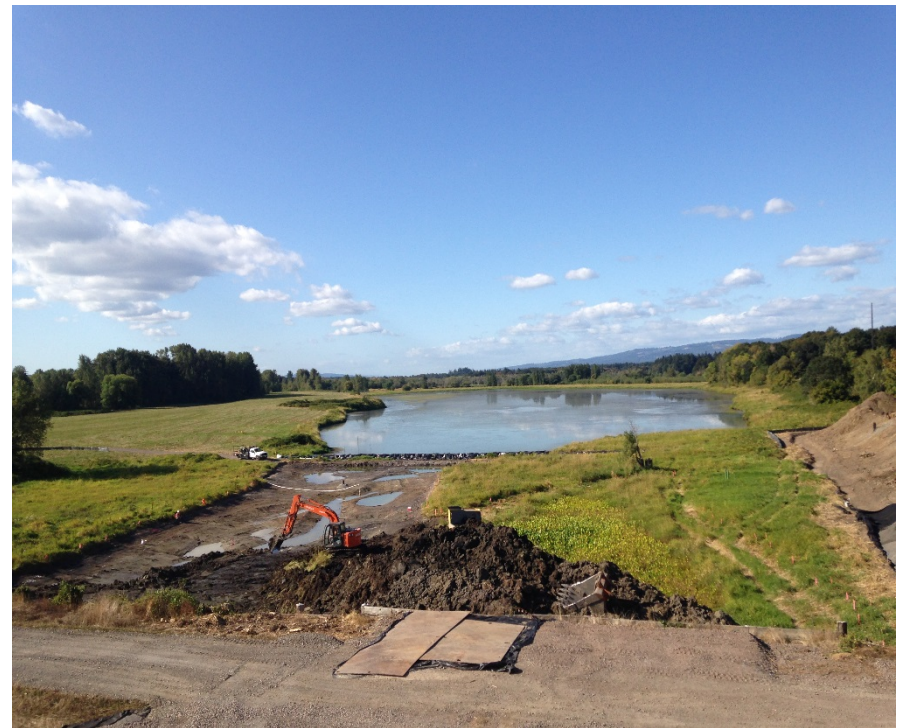
Looking north at sediment excavation operations from the sand stockpile.

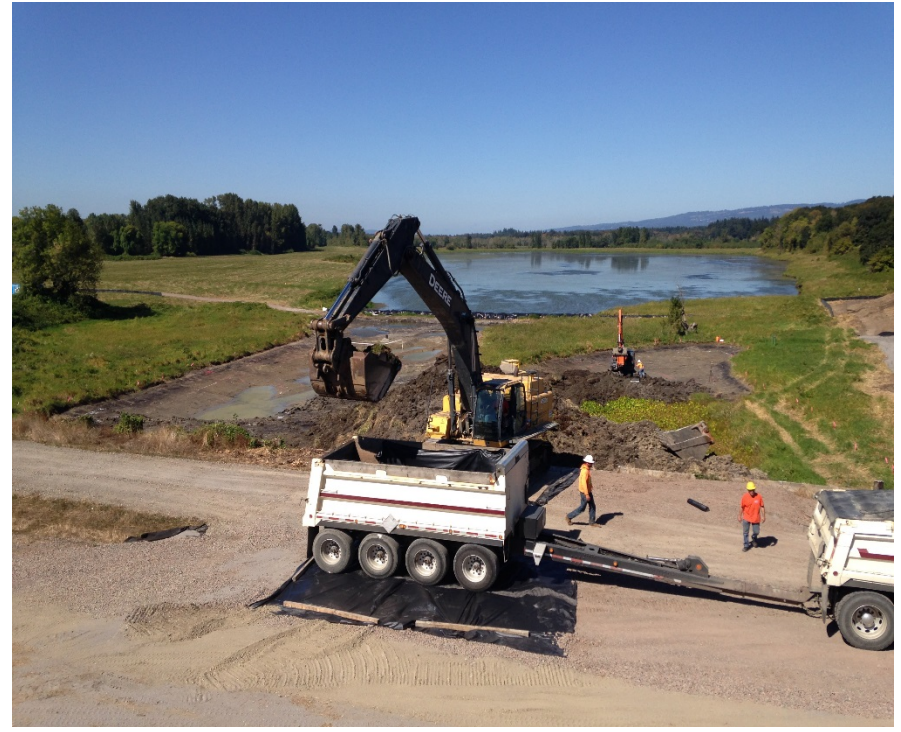
Looking north at the first truck getting loaded with sediment for disposal.

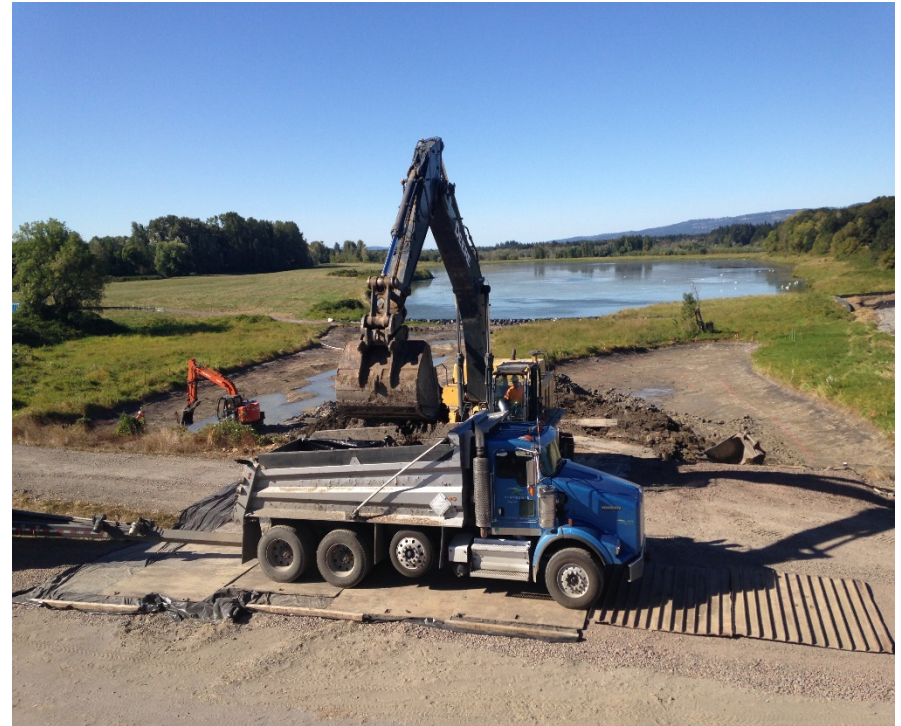
Looking north at a truck getting loaded with sediment for disposal. Note the steel plates, visqueen, and rumble strip.

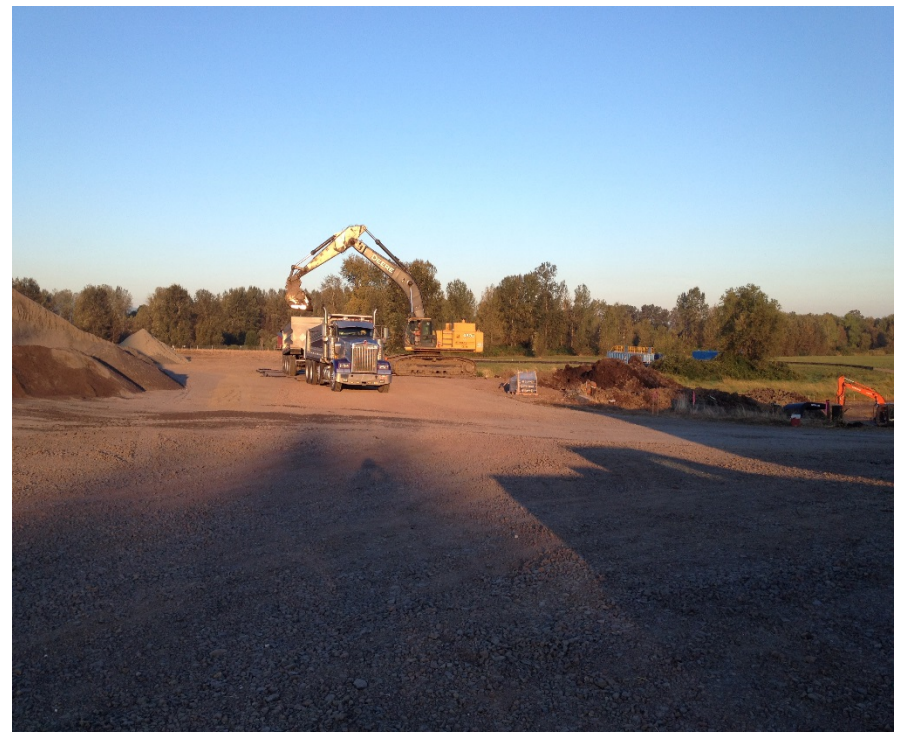
Looking west at a truck getting loaded with sediment for disposal.

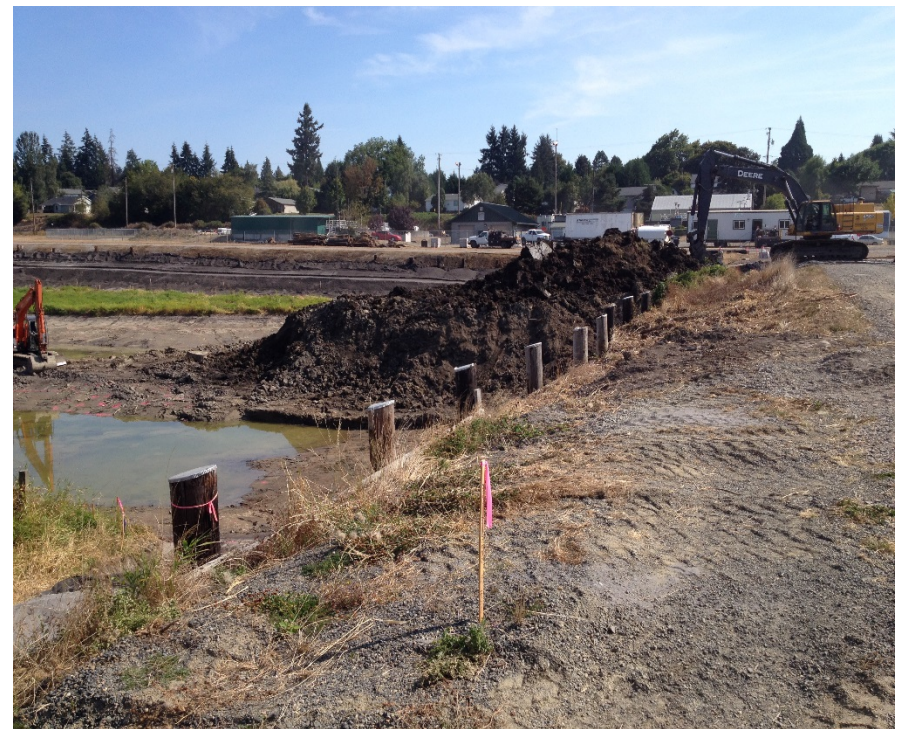
Looking east at the sediment stockpile with the southern portion of the east embankment in the background.

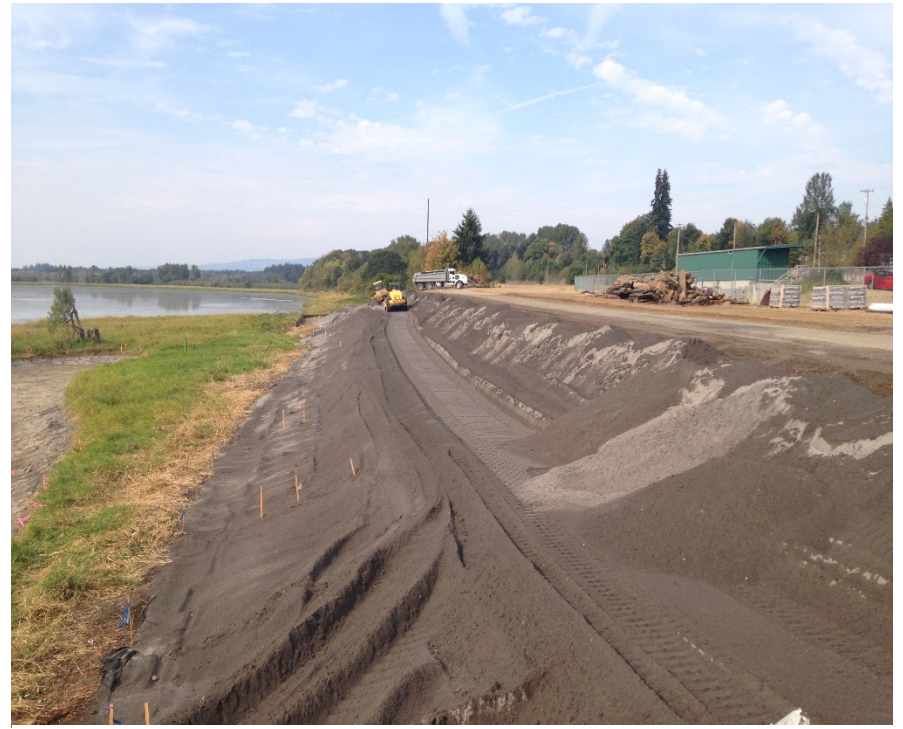
Looking north at compactive efforts on the east embankment.

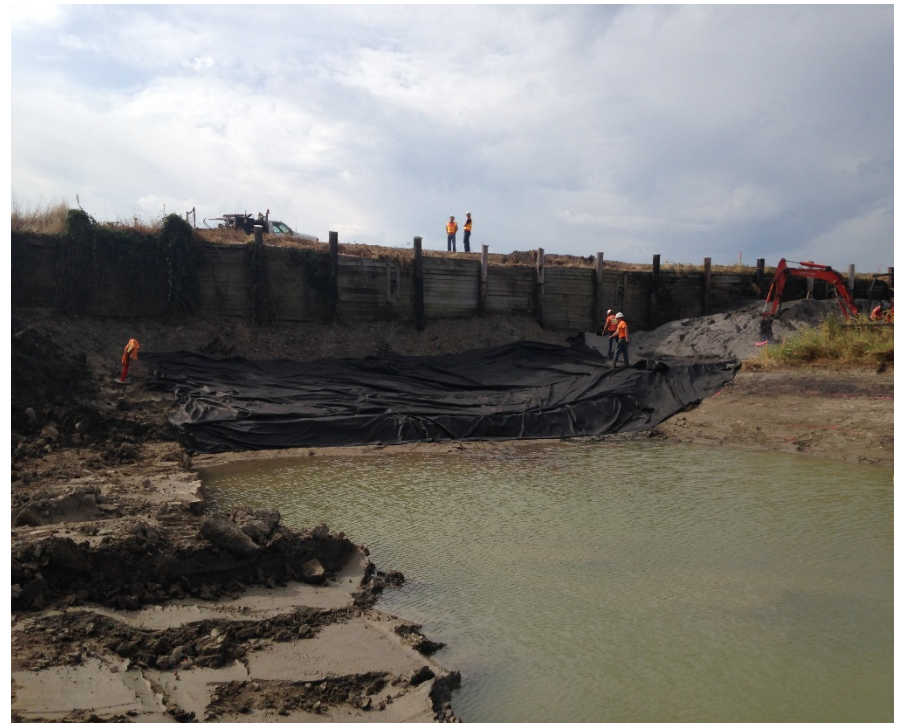
Looking south at the placement of filter fabric on the embankment and keyway subgrade on the south embankment.

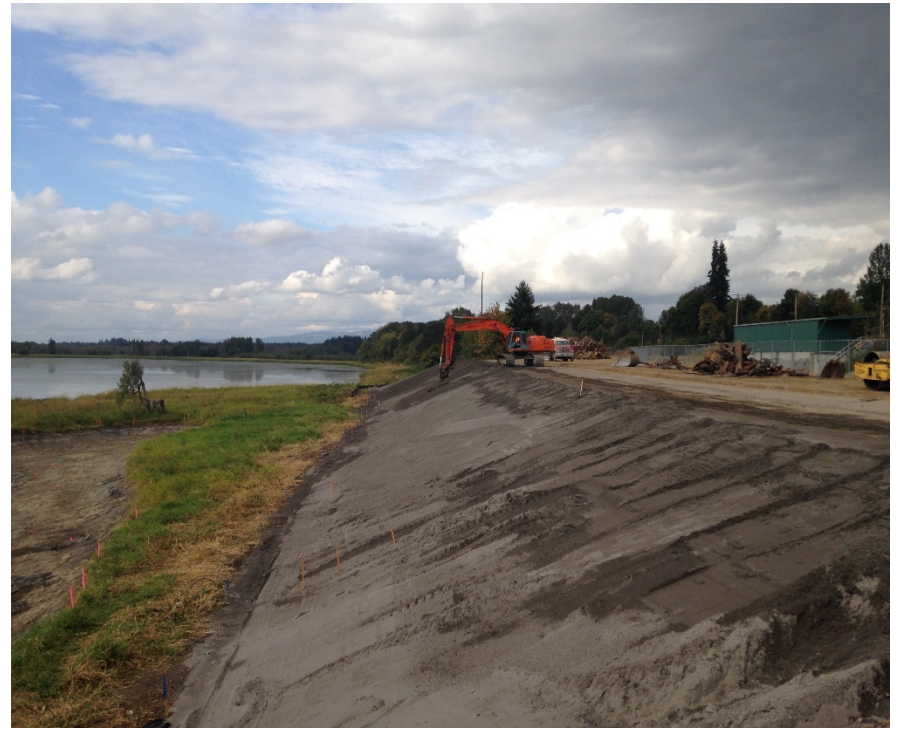
Looking north at the excavator dressing the slope of the east embankment. Note the tracks from the roller passes on the top lift.

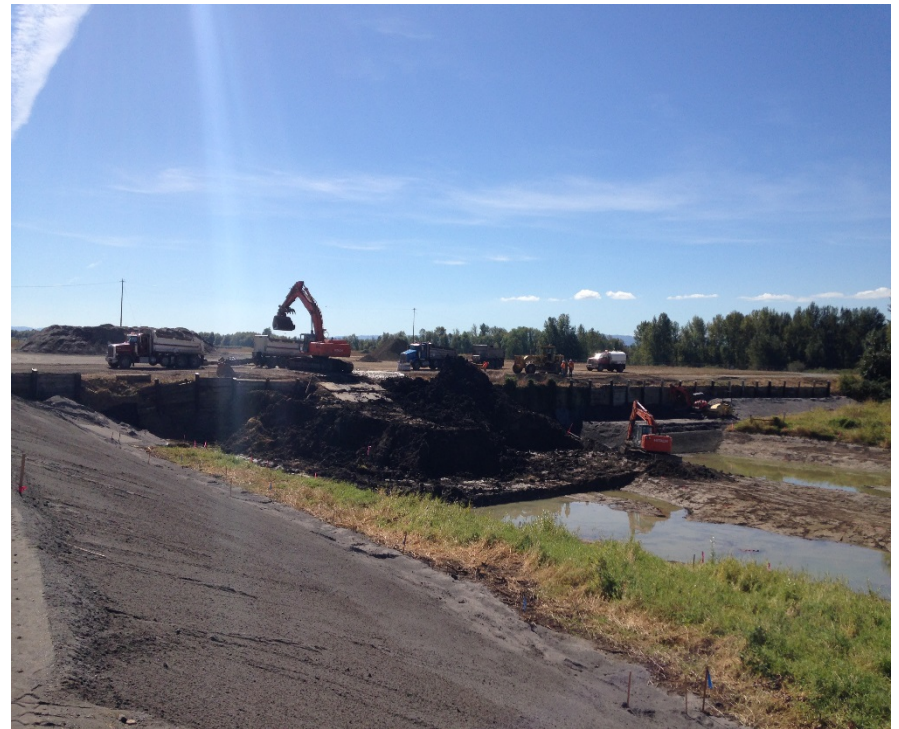
Looking southwest at sediment load-out operations and fill placement for the south embankment. Note the transition from crushed rock to sand at Elev. 12'.

As Strider had selected Cowlitz River dredge sand to satisfy the specification requirements for structural fill, GeoDesign recommended that CSBC be used as structural fill below elevation 12 National Geodetic Vertical Datum of 1929/1947 (NGVD) (the ordinary high-water mark [OHWM]) and that sand could be used above elevation 12 NGVD. Additional detail regarding this change is provided in Section 5.1. CSBC or sand (as applicable) was placed and compacted on the east embankment each day until the slope was at grade and ready for topsoil placement. Following excavation of the keyway for the southern embankment and the hauling of all contaminated sediment from the site, filter fabric was placed on the cleared subgrade and the south embankment was brought up to grade with structural fill. Fish mix rock, imported from the Storedahl Daybreak Quarry in Battleground, Washington, was placed at the toe of the slope as shown on the plans. The fish mix placement was completed and the slope was ready for topsoil placement on October 8, 2014. Topsoil was placed on both embankments from September 30, 2014, until October 10, 2014; topsoil material was supplied by City Bark & Recycling of Vancouver, Washington. The final topsoil

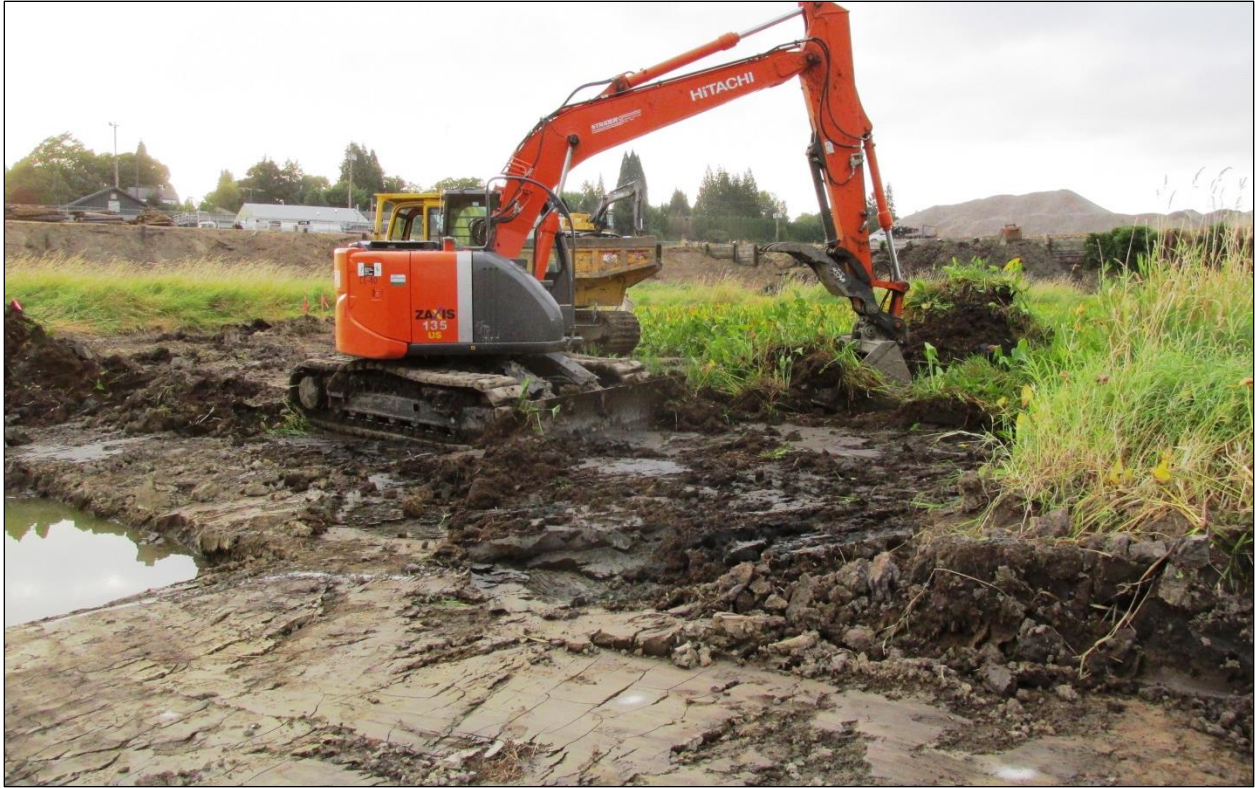
Figure 4. View of sediment removal excavation in the central portion of the remedy area on September 8, 2014, facing southeast.

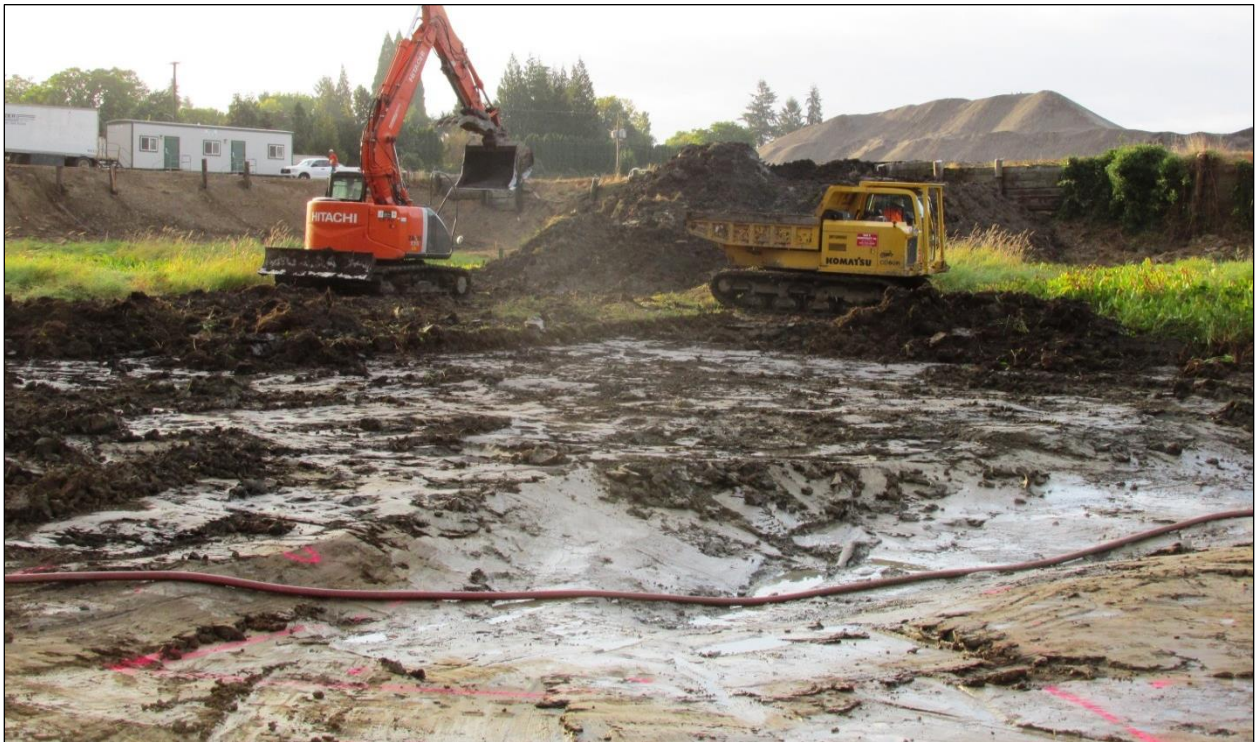
Figure 5. View facing south of an excavator stockpiling sediment for removal from the site on September 12, 2014.
