# City of Poulsbo

Subject: Independent Remedial Action Report and Request for No Further Action  
Determination; Former City Hall Property, Poulsbo, WA

INDEPENDENT REMEDIAL ACTION REPORT and  
UST SITE ASSESSMENT REPORT  
FORMER CITY HALL  
UNDERGROUND HEATING OIL STORAGE TANK  
19050 JENSEN WAY  
POULSBO, WA

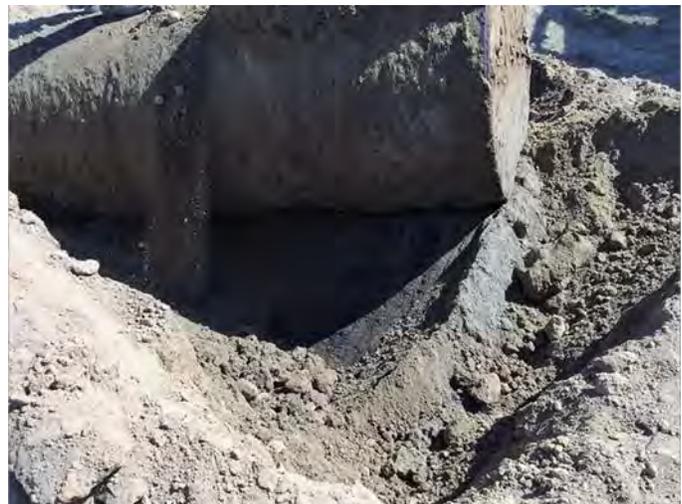
**Photograph 4 - Tank B Impacted Soils**

During excavation of Tank B, contaminated soil was not encountered until five and one-half feet below the surface. Shallower soil was not impacted by the release because the leak occurred through small holes in the bottom of the tank. Gray-stained soil between five and one-half feet and eight feet below the surface were excavated and placed on plastic. The excavation was also expanded to the west by approximately three feet. At the end of the day, the excavation was approximately 21 feet long by eight feet wide by eight feet deep. Stained soil was observed on the west, south, and north end of the Tank B excavation. The east and bottom samples were not stained. No groundwater was observed in the excavation.

Laboratory testing of the Tank B soil samples confirmed diesel range hydrocarbons were present in samples collected from gray-stained soil. Unstained soil samples showed no evidence of petroleum contamination. The analysis of the samples collected from the Tank B excavation are summarized in Table 1 and presented in the Environmental Specialists Site Assessment report presented in Appendix B.

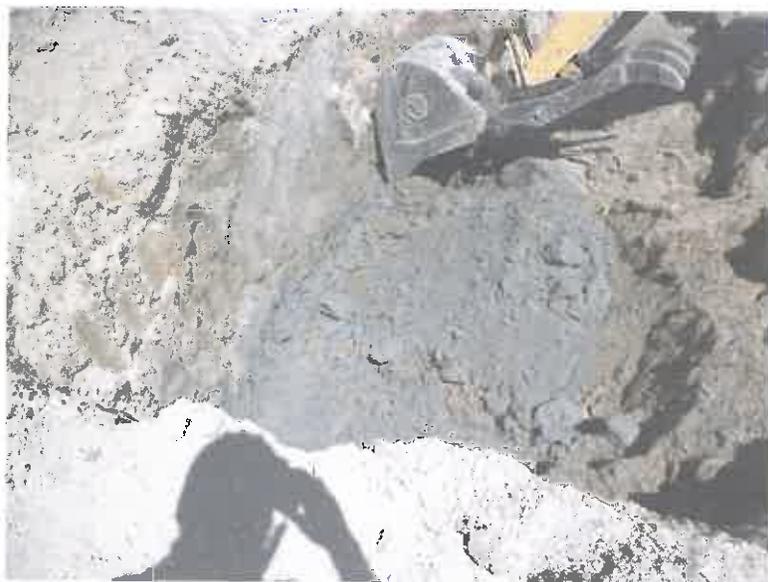
**title** LT contamination  
**date** August 12, 2016 at 11:07:16 AM

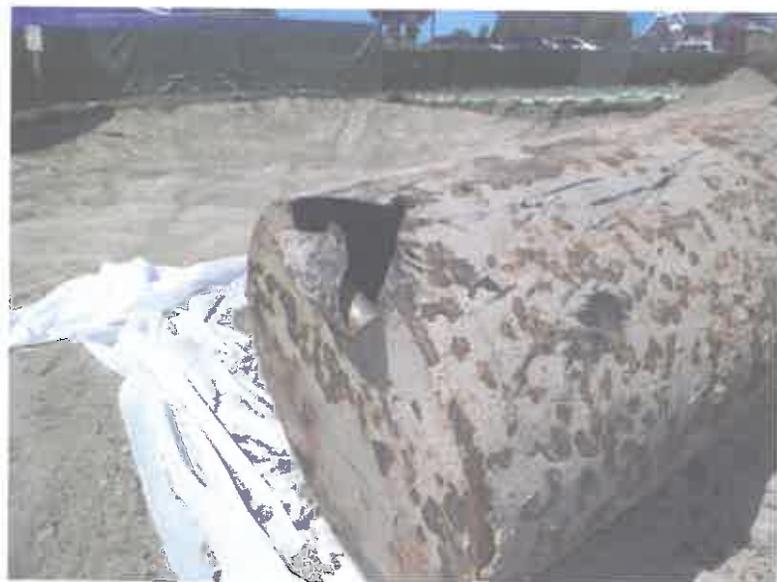
**title** LT out  
**date** August 12, 2016 at 11:51:29 AM

contamination was observed until the tank was lifted from the ground. At this point, several small (less than one-half inch) holes were observed in the bottom of the tank. Stained soil and strong diesel odors occurred in the soil immediately beneath the tank. Approximately 20 yards of petroleum contaminated soil was removed from beneath the former tank location and stockpiled on plastic on the property. Environmental Specialists collected six soil samples from the sidewalls and bottom of the excavation and four samples from the Tank B soil stockpile. The results of laboratory testing showed that four of the six excavation samples contained diesel range hydrocarbons at concentrations exceeding MTCA Method A cleanup levels. The results of the Environmental Specialists UST Site Assessment are presented in Appendix B.

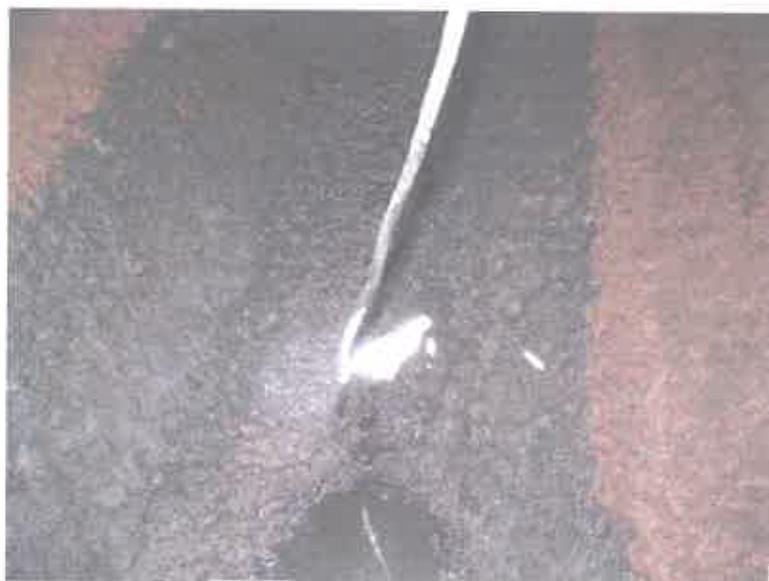
**title** LT Inside  
**date** August 12, 2016 at 11:51:43 AM
