**Summary of Previous Environmental Investigations
and Documents, Brief Descriptions of Previous
Investigations, and Data Tables Summarizing
Previous Investigation Results**

SUMMARY OF PREVIOUS INVESTIGATIONS

This Appendix provides brief descriptions of the previous environmental investigations conducted at the North Marina Area, which includes the Ameron/Hulbert Site and areas west and south of the Site. Information included in this appendix was also presented in the Interim Action Report (Landau Associates 2010). Figures A-1 through A-13 showing the site characterization sampling locations by parameter and tables A-1 through A-18 summarizing the site characterization analytical data are also included in this appendix.

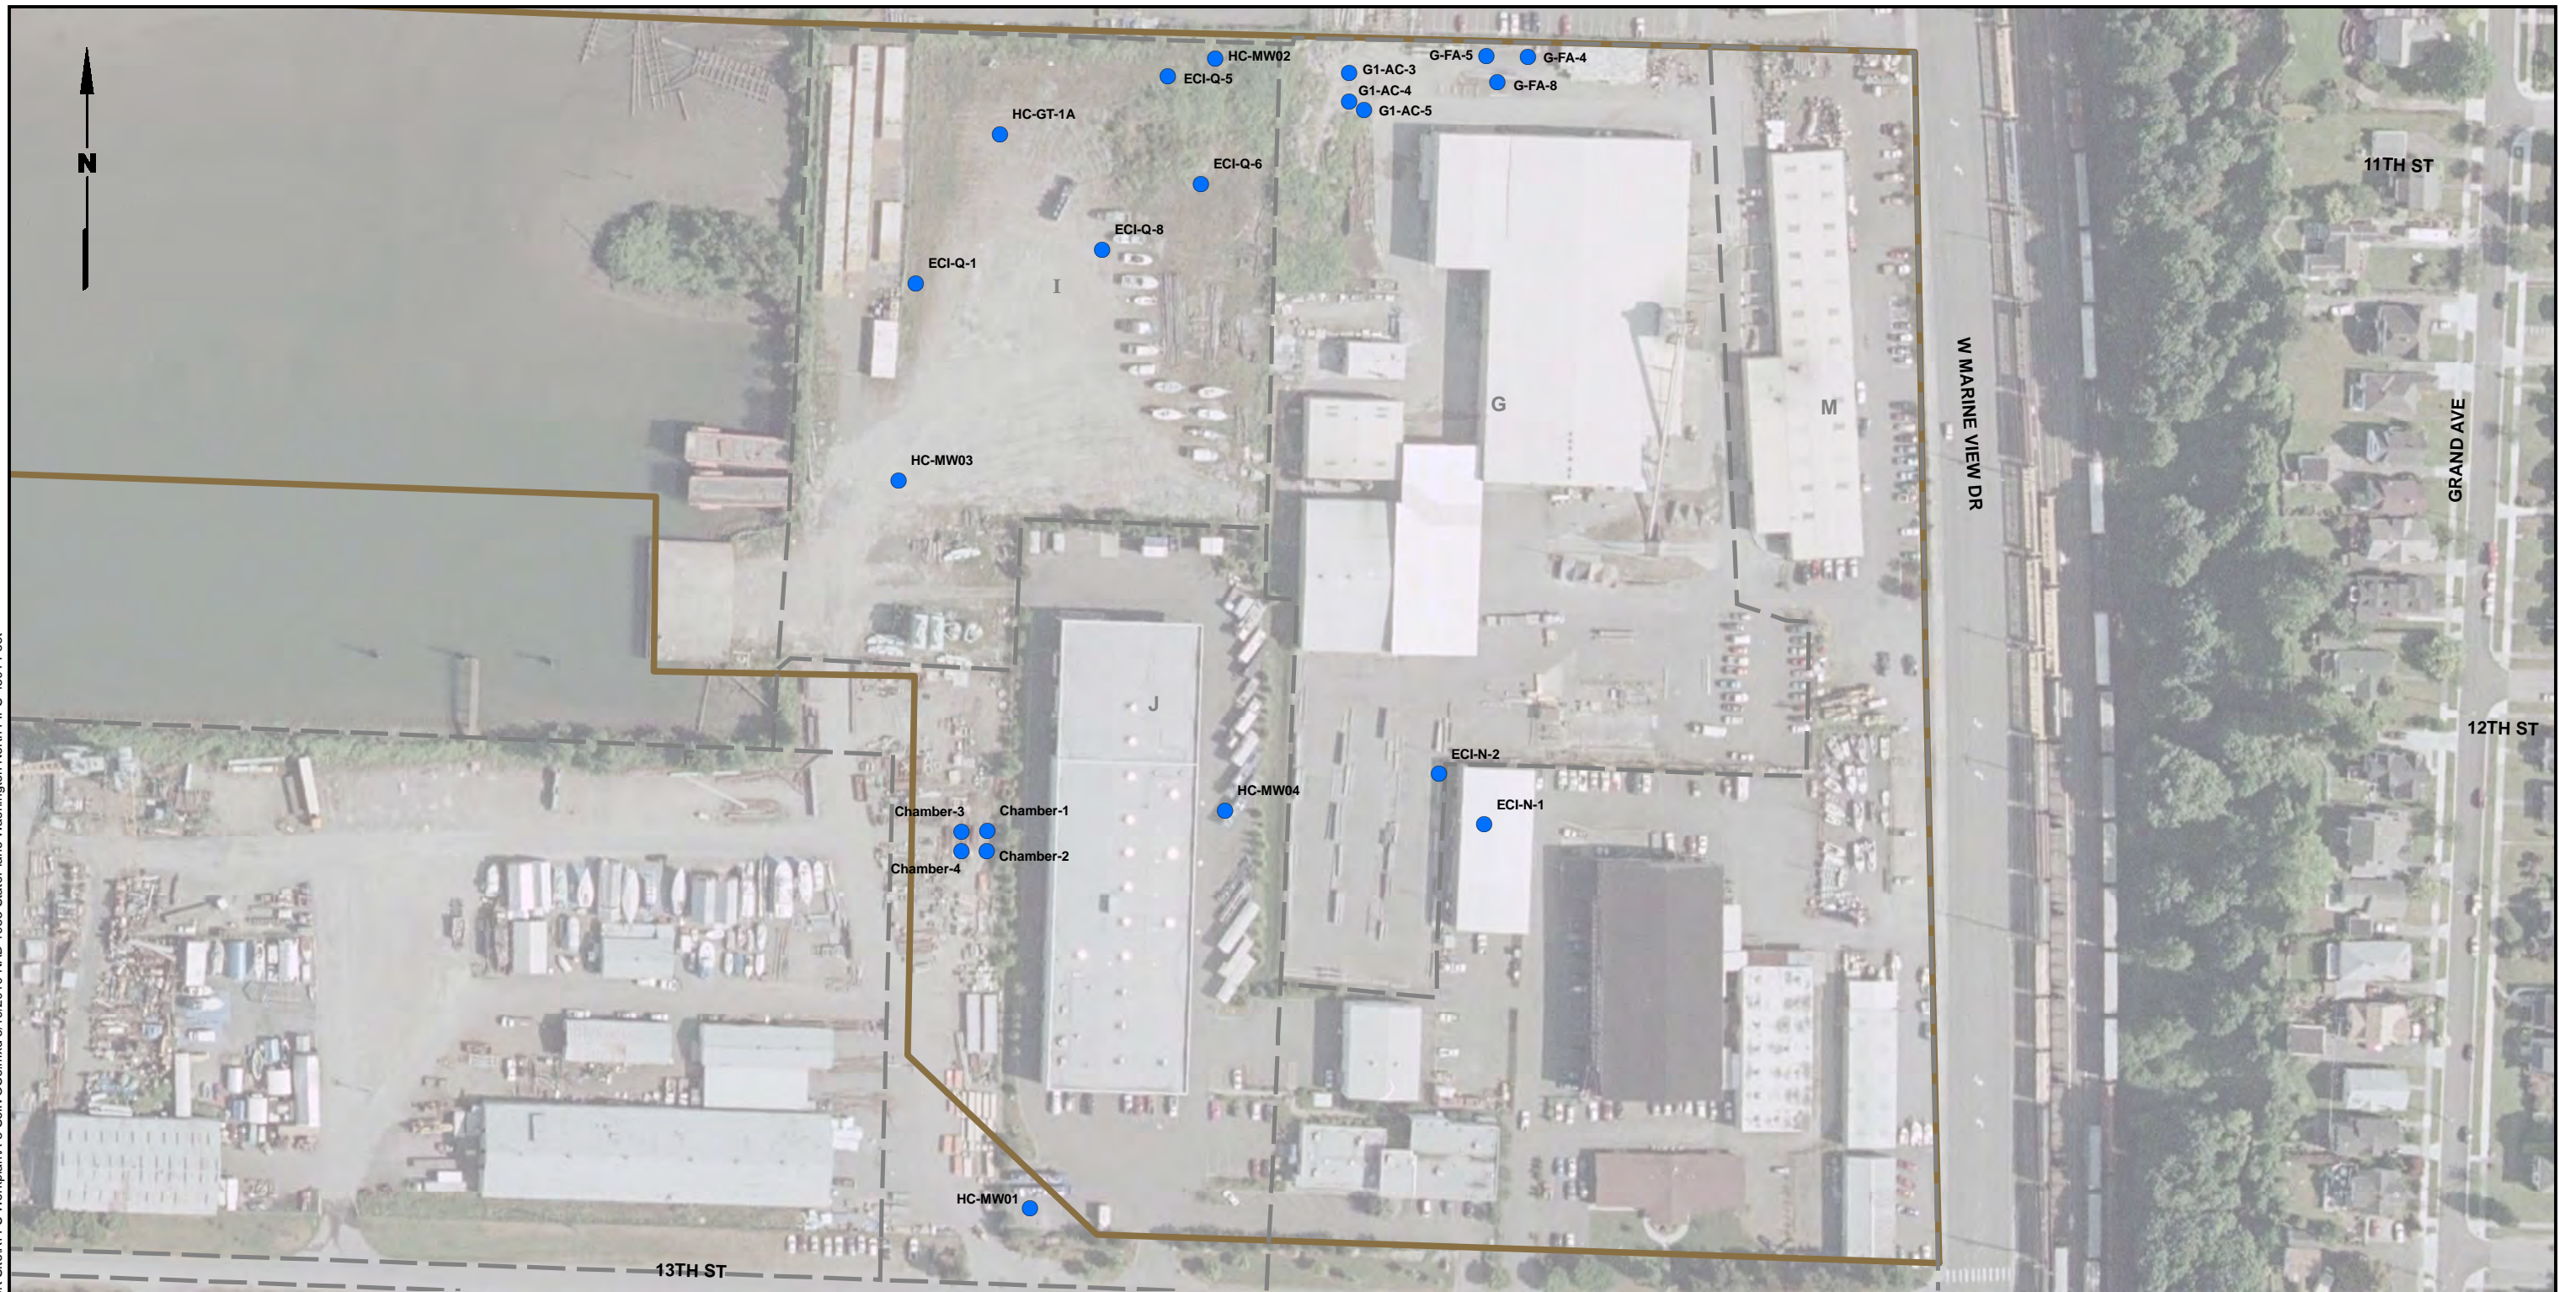
Figure
A-2

- Soil Sample Locations Analyzed for VOCs
- G - Area Designation
- Approximate North Marina Ameron/Hulbert Site Boundary

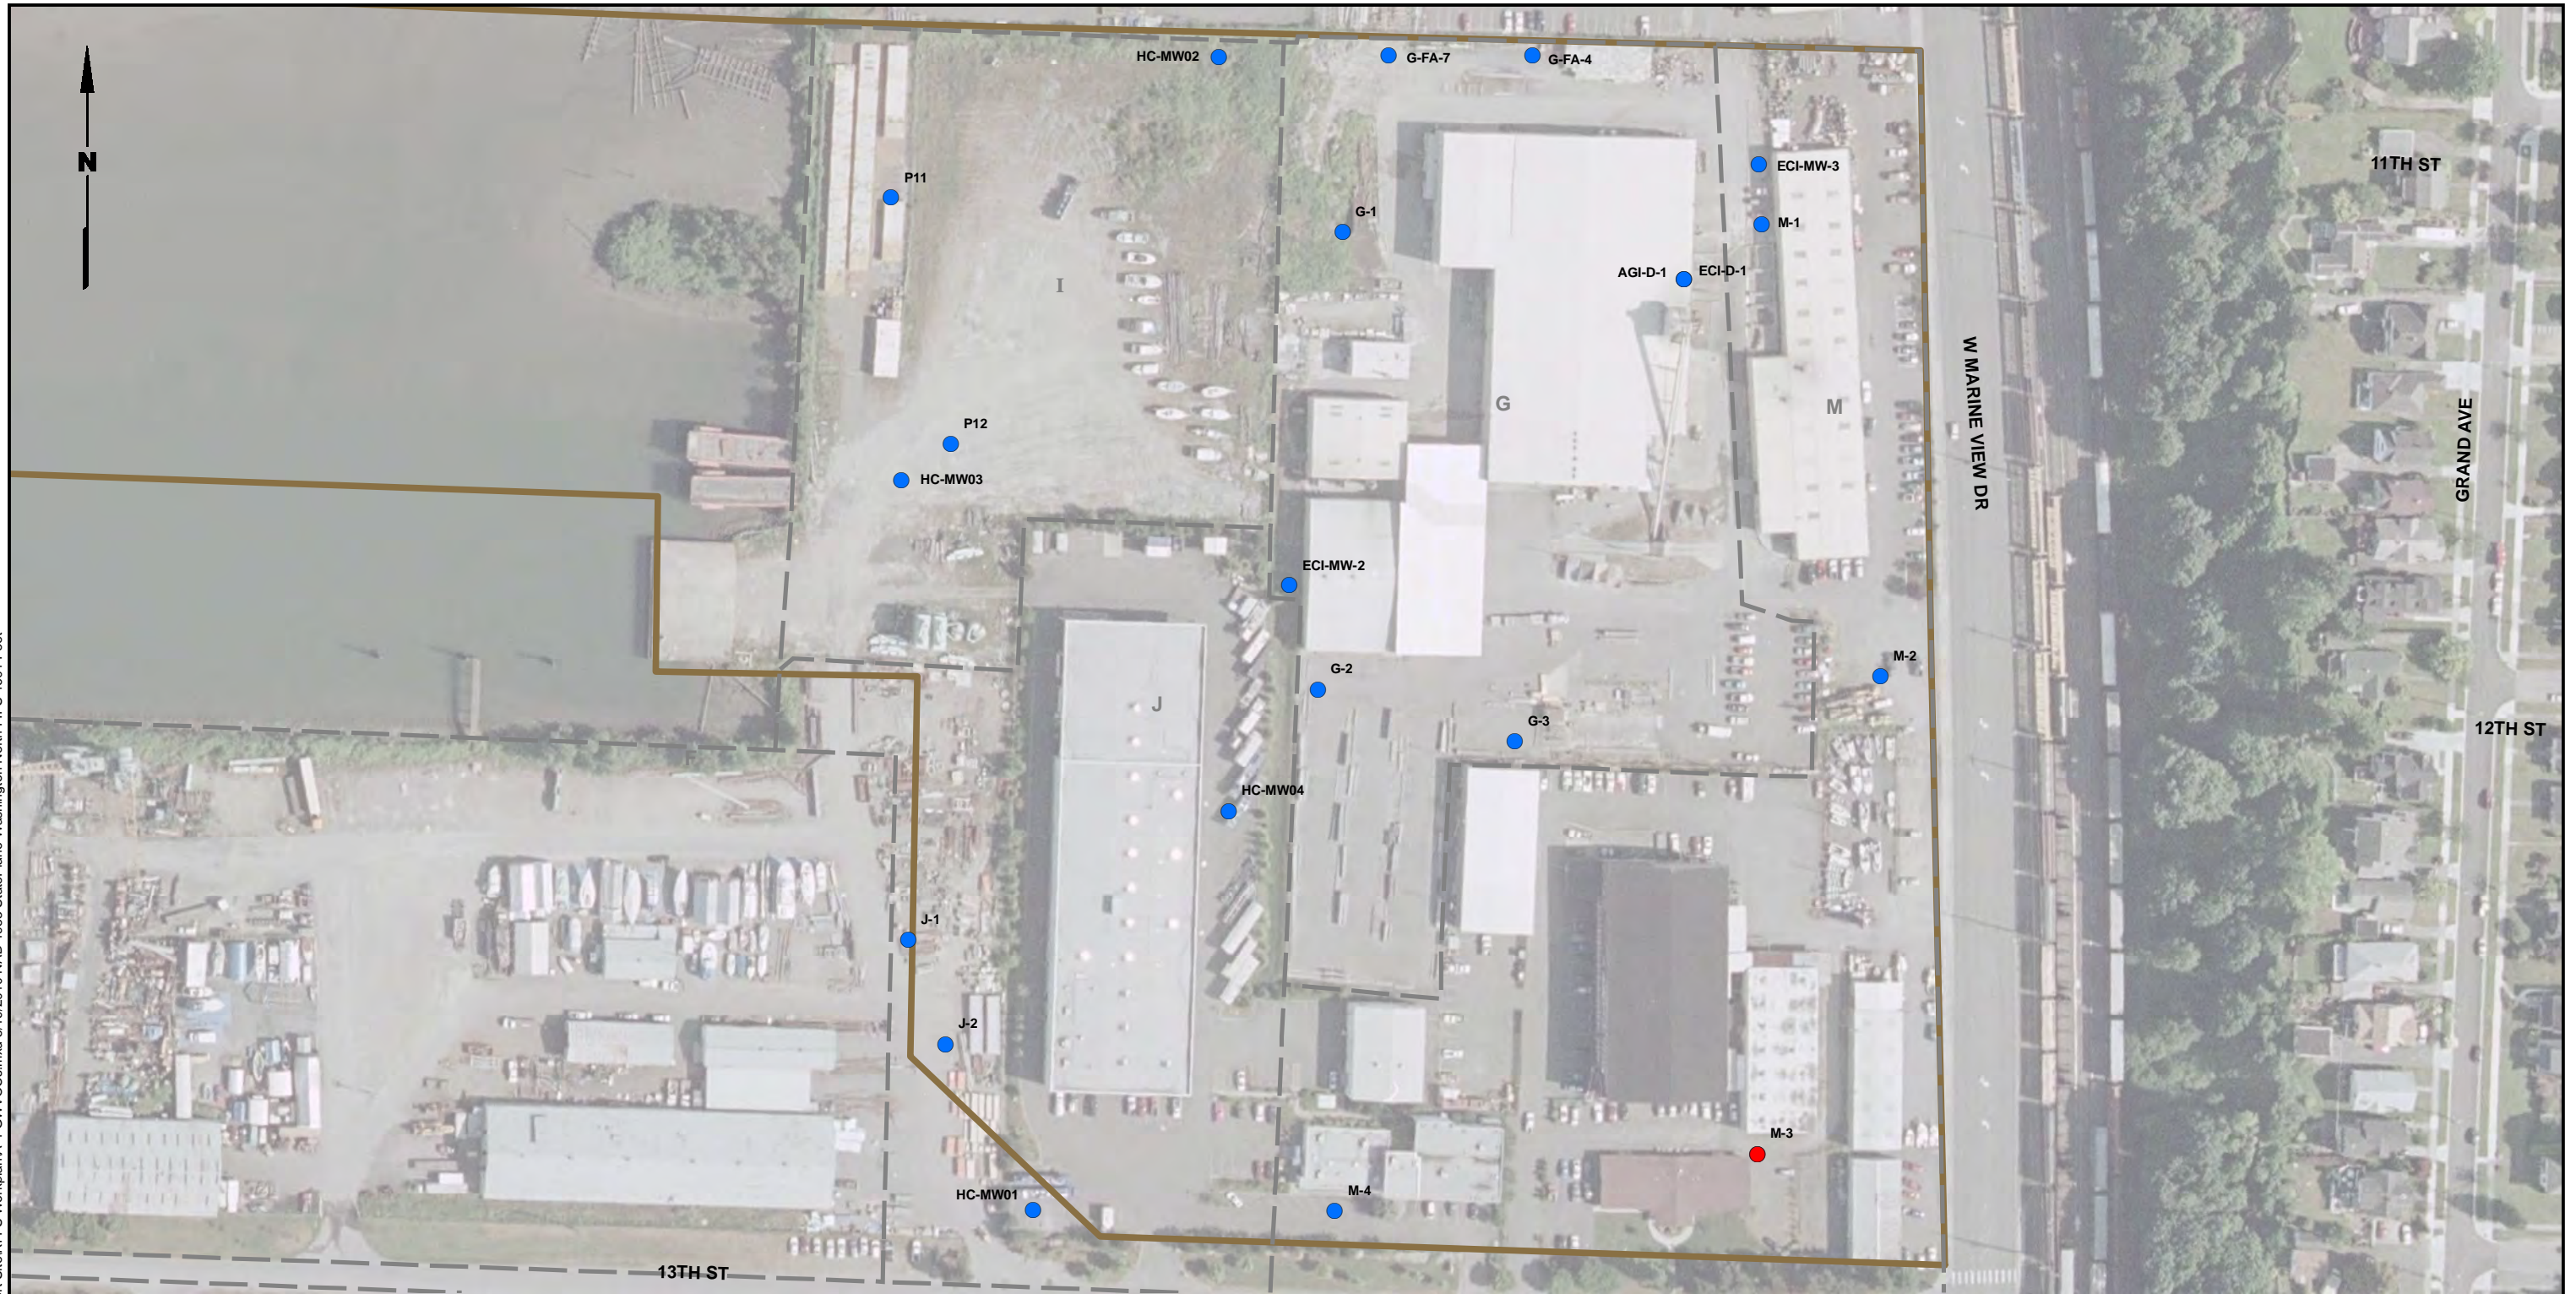
- Groundwater Sample Exceeds Cleanup Screening Level for VOCs
- Groundwater Sample Locations Analyzed for VOCs
- G G - Area Designation
- Approximate North Marina Ameron/Hulbert Site Boundary

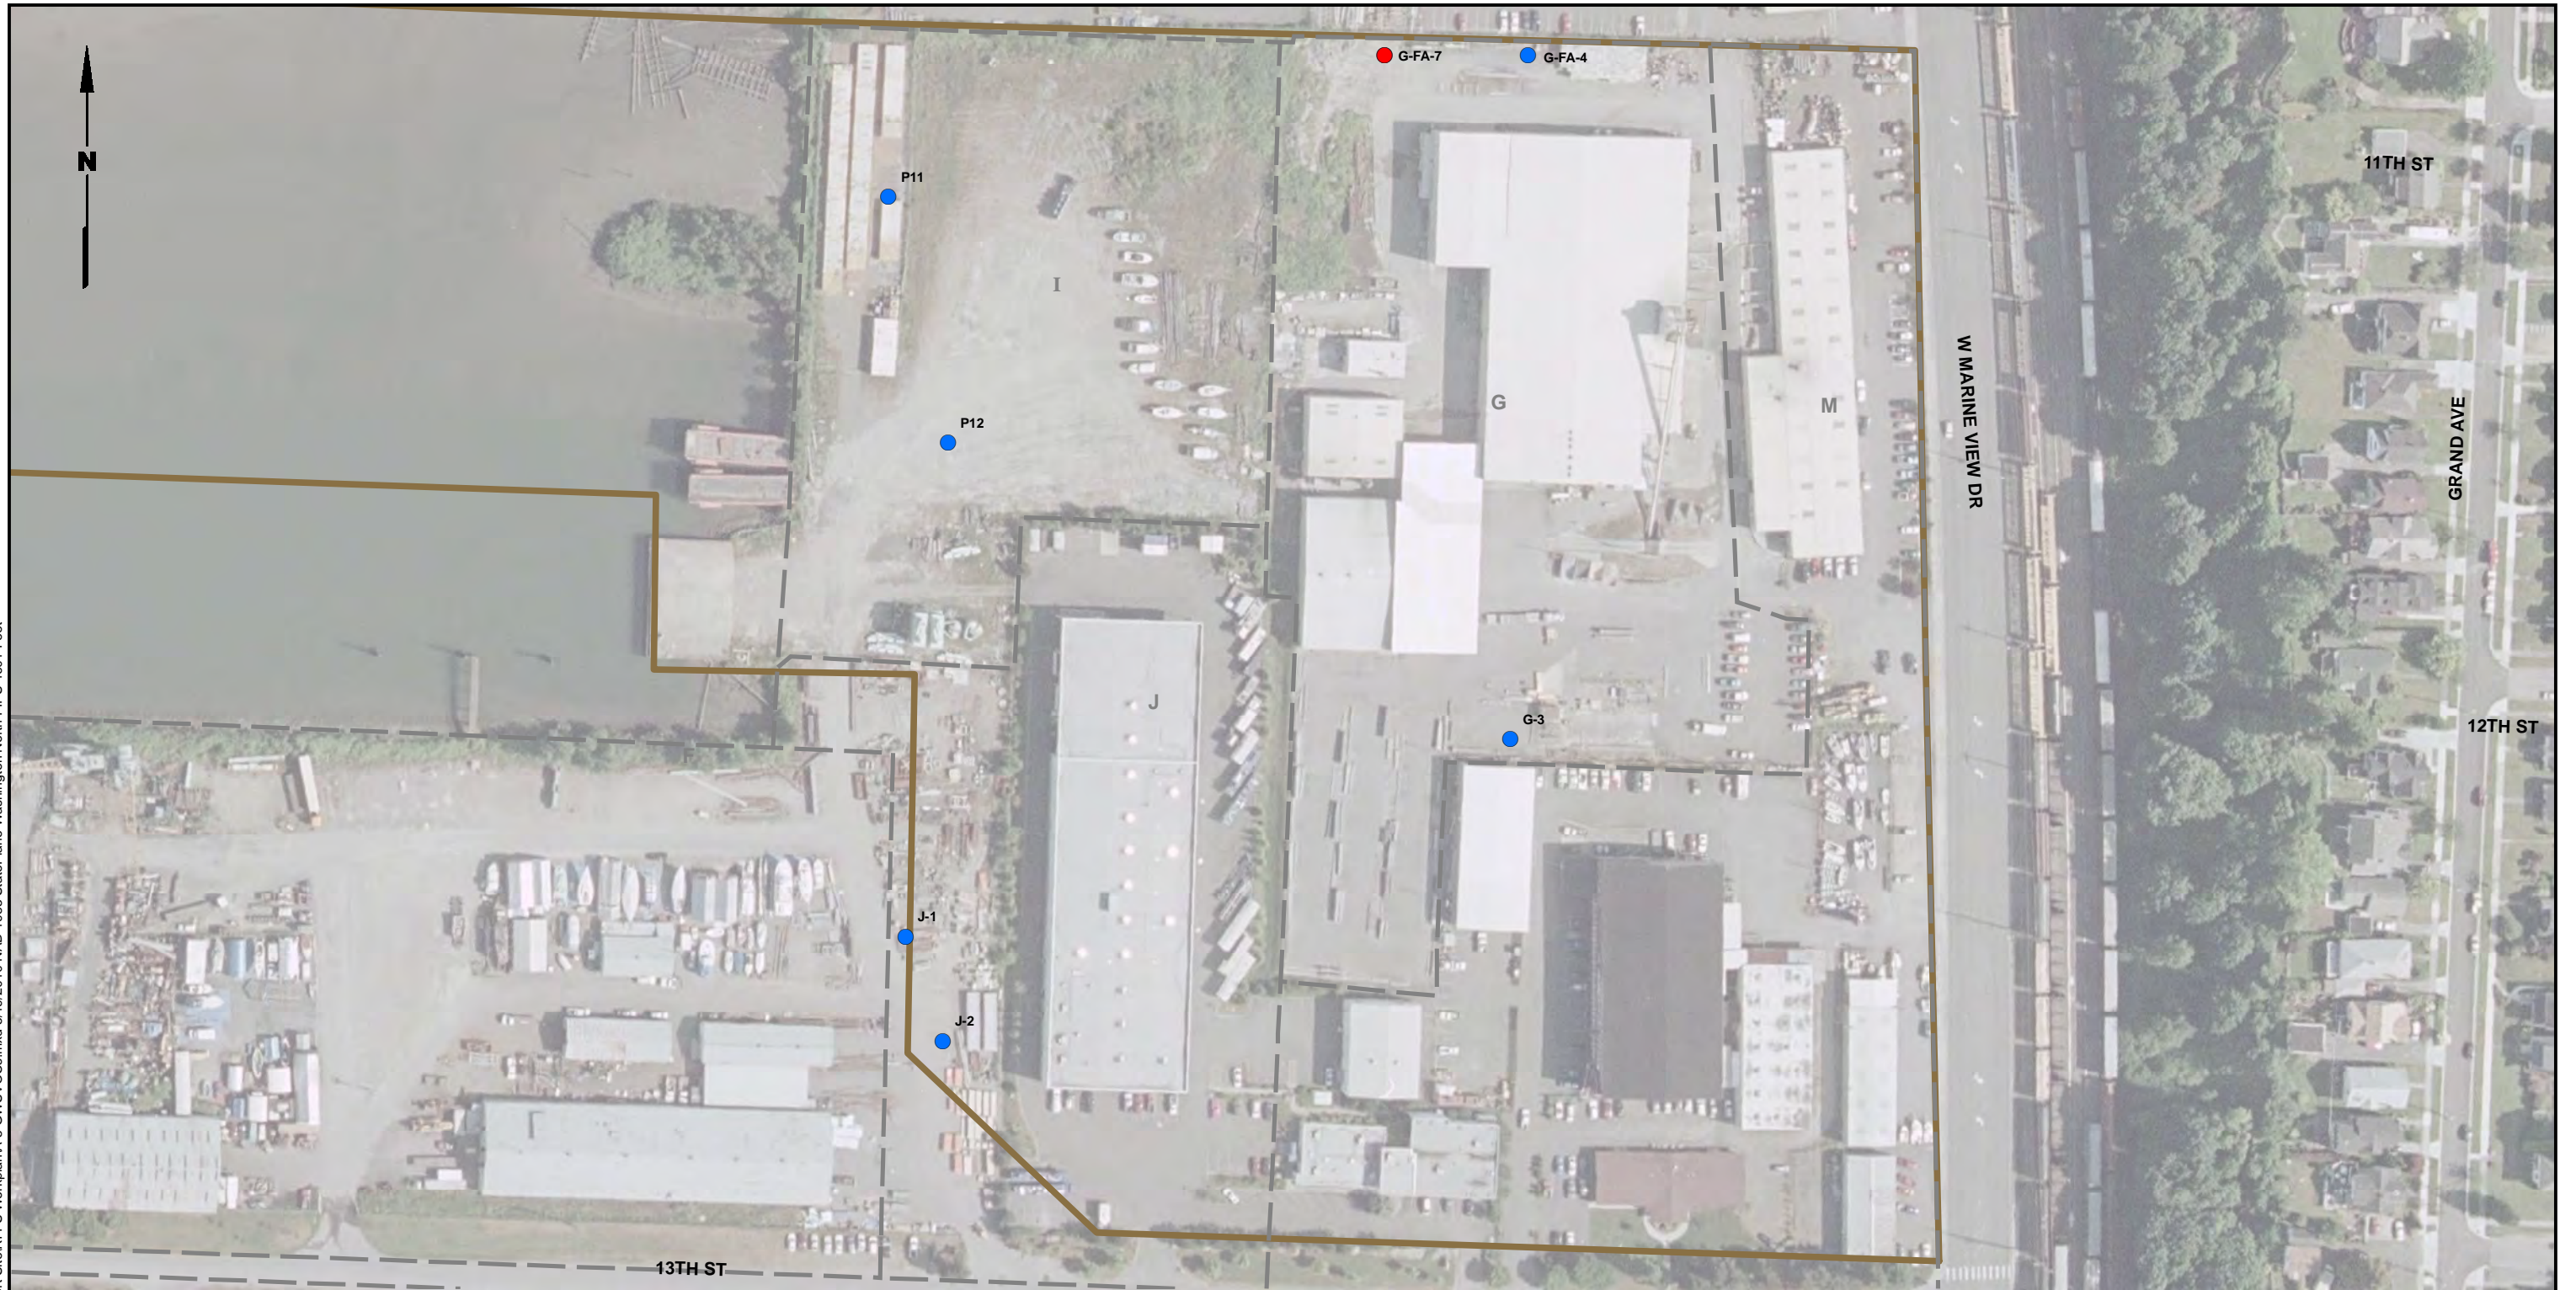
- Groundwater Sample Exceeds Cleanup Screening Level for SVOCs
- Groundwater Sample Locations Analyzed for SVOCs
- G - Area Designation
- Approximate North Marina Ameron/Hulbert Site Boundary

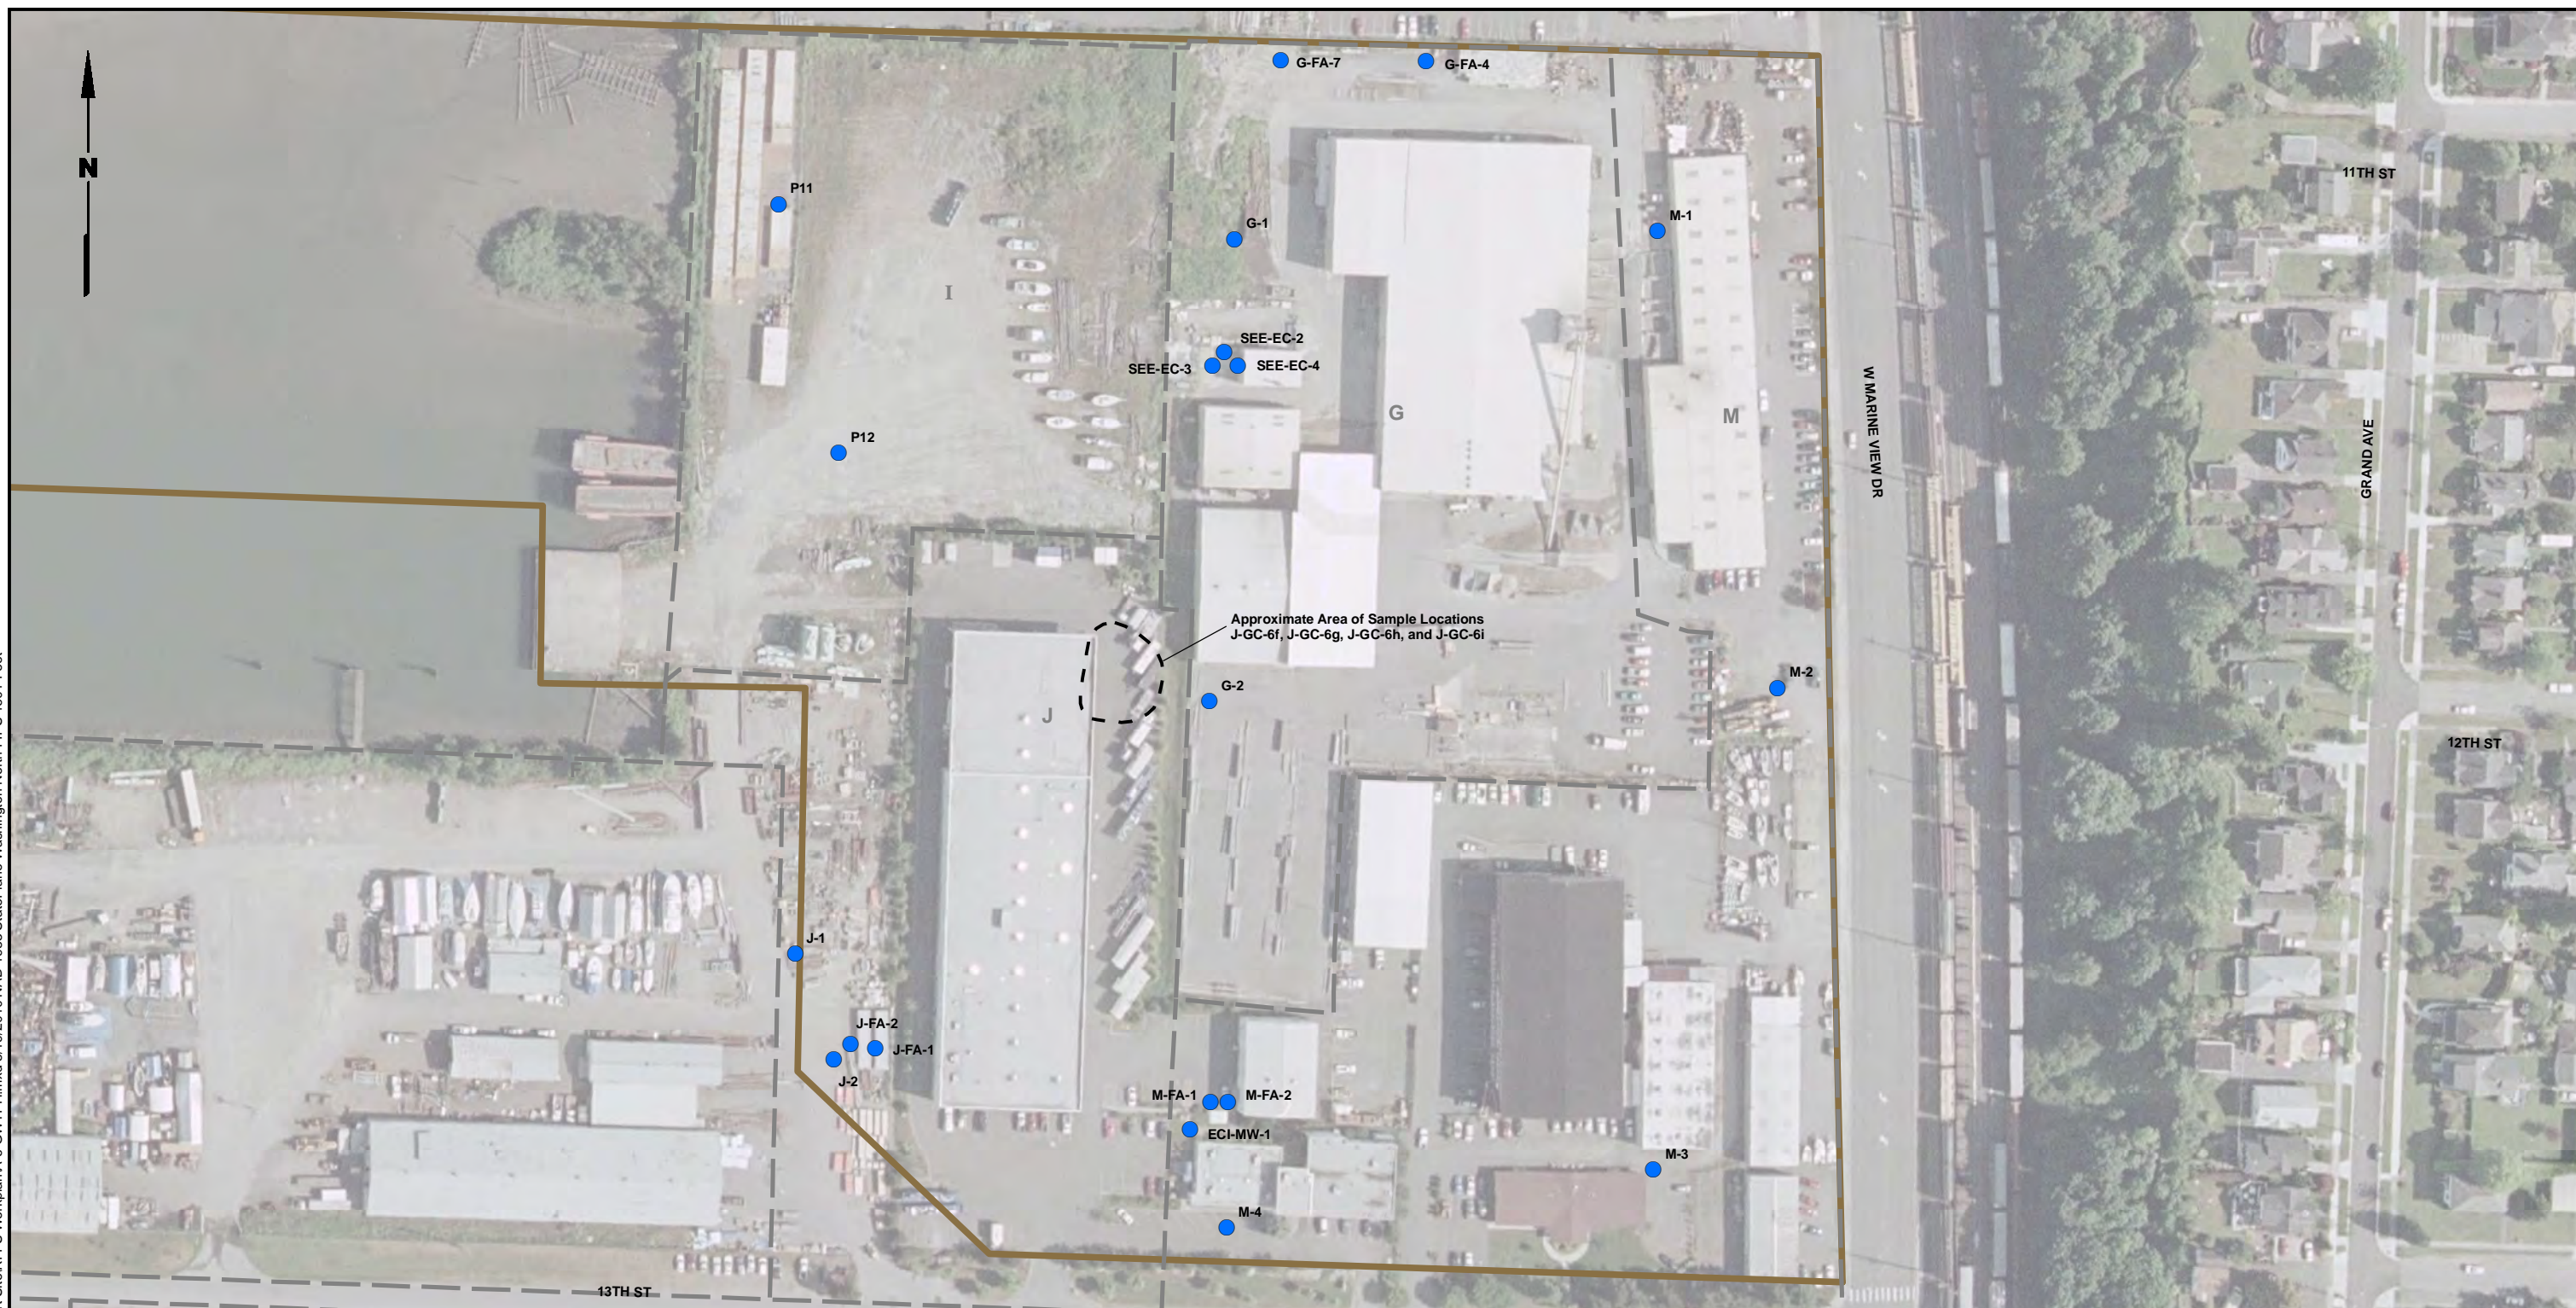
Figure
A-5

- Groundwater Sample Locations Analyzed for TPH
- G - Area Designation
- Approximate North Marina Ameron/Hulbert Site Boundary

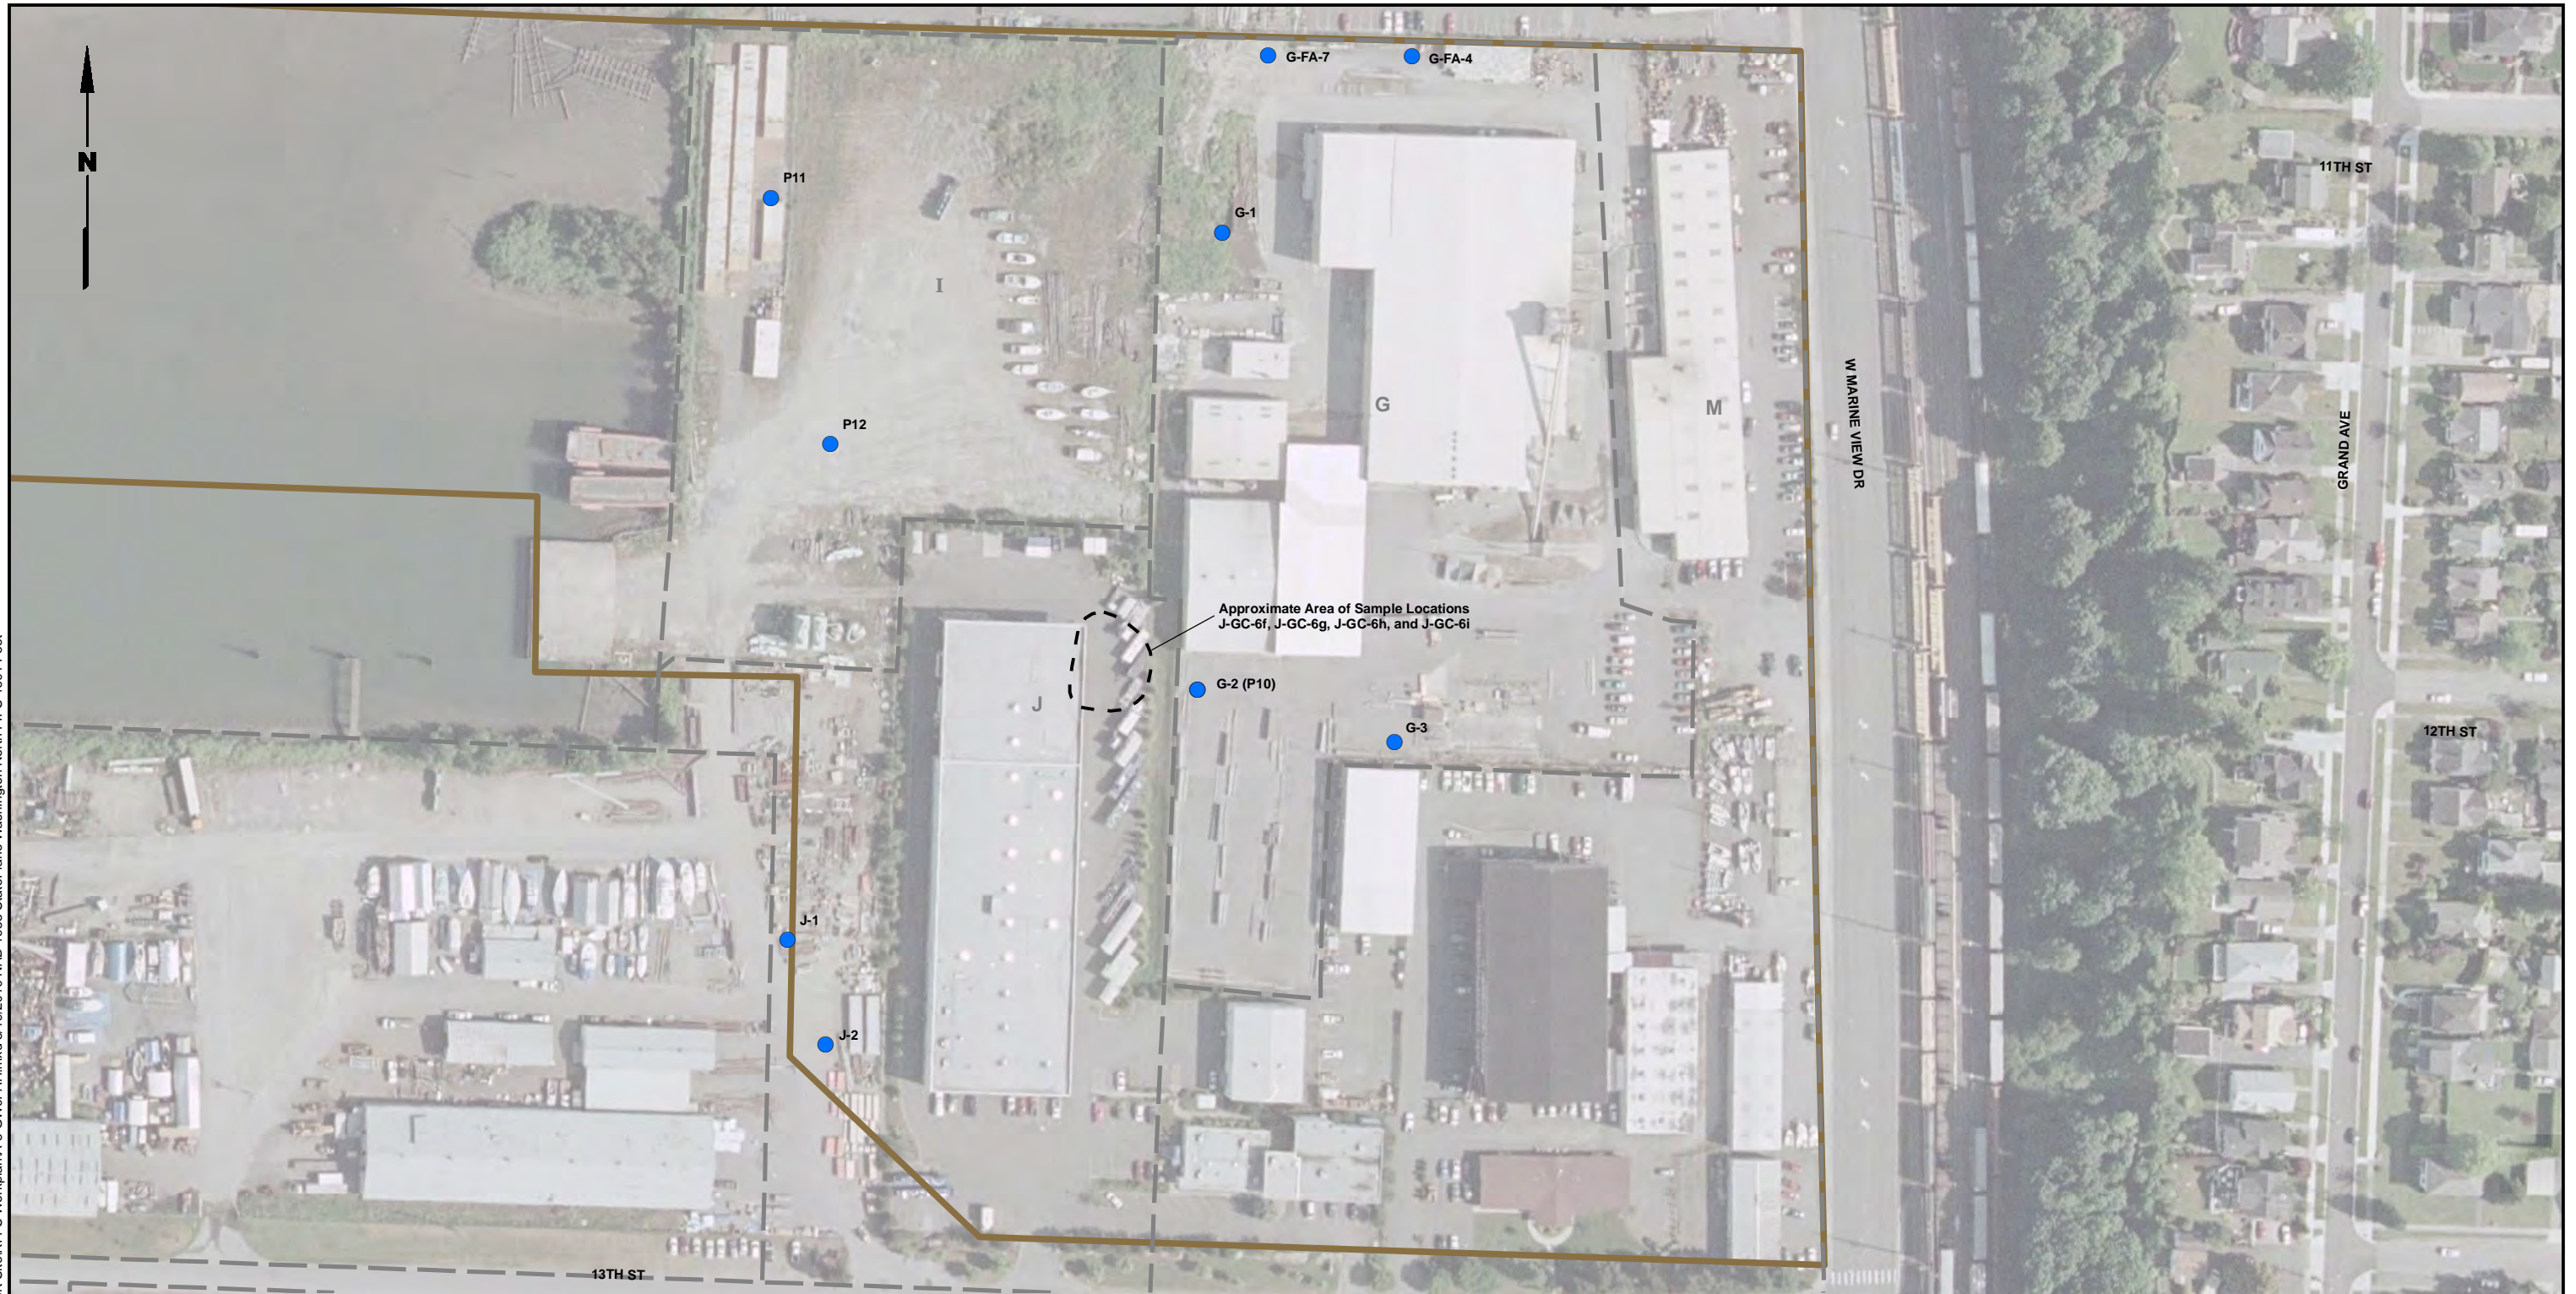
- Groundwater Sample Locations Analyzed for cPAH's
- G - Area Designation
- Approximate North Marina Ameron/Hulbert Site Boundary

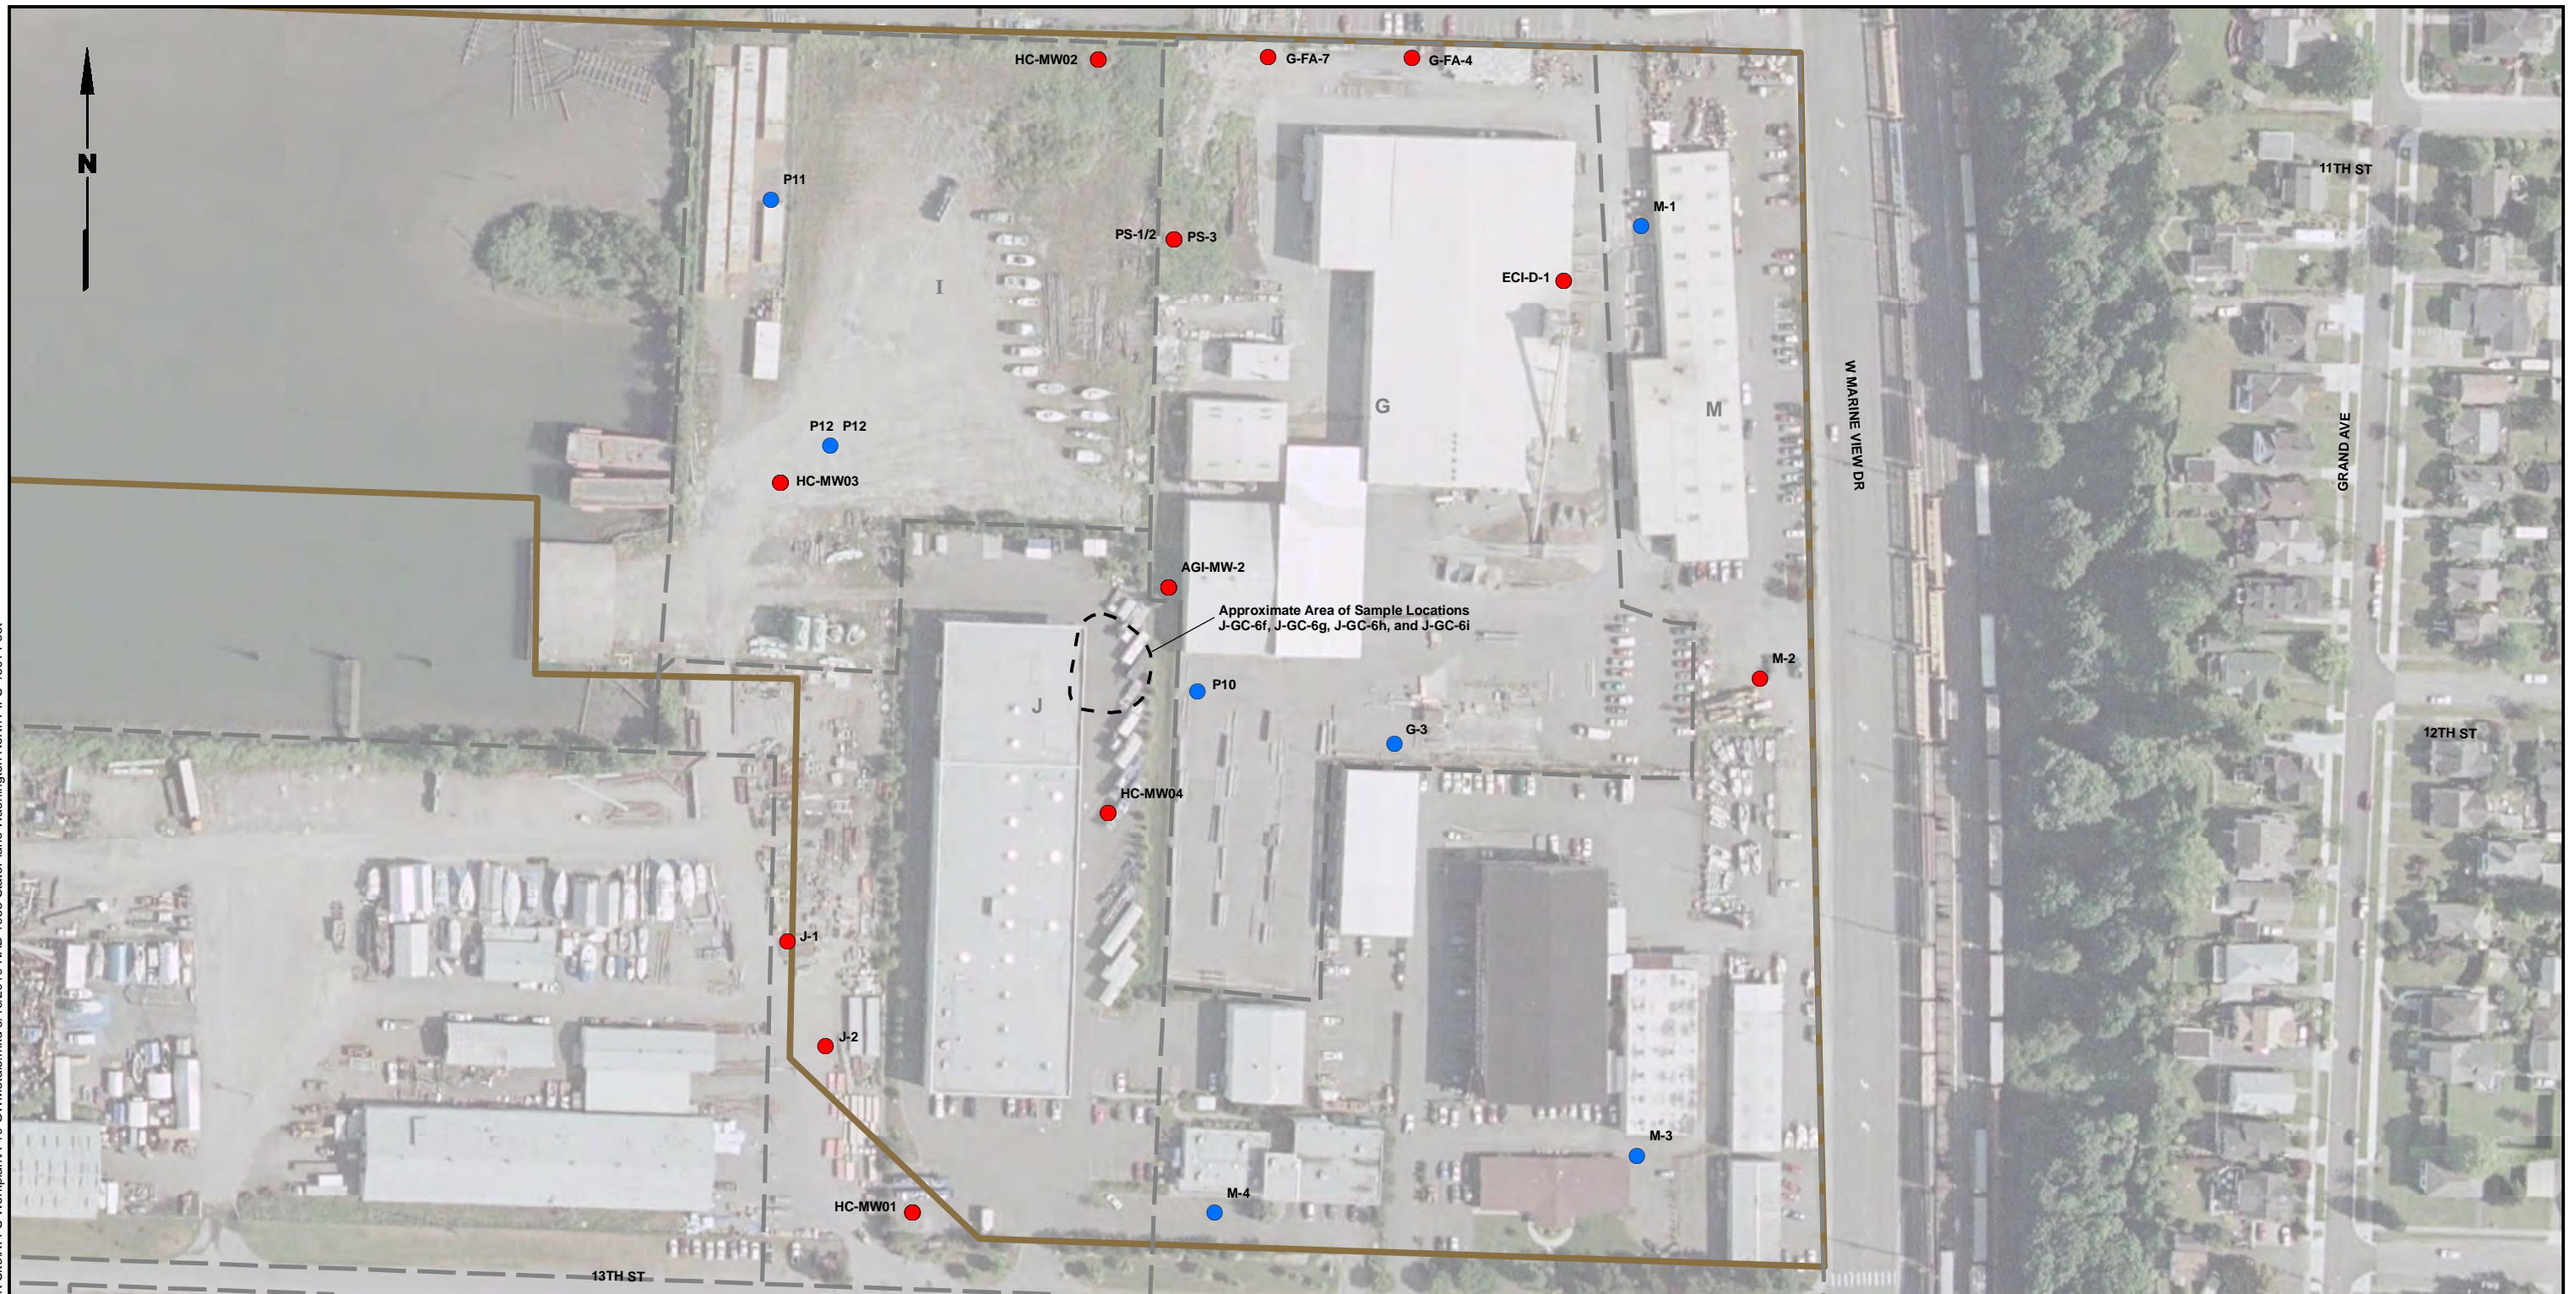
Figure
A-9

**Soil Characterization Sample
Locations Analyzed for Metals**

- Groundwater Sample Exceeds Cleanup Screening Level for Metals
- Groundwater Sample Locations Analyzed for Metals
- G - Area Designation
- Approximate North Marina Ameron/Hulbert Site Boundary
