**Summary of Previous Environmental Investigations
and Documents, Brief Descriptions of Previous
Investigations, and Data Tables Summarizing
Previous Investigation Results**

SUMMARY OF PREVIOUS INVESTIGATIONS

This Appendix provides brief descriptions of the previous environmental investigations conducted at the North Marina Area, which includes the Ameron/Hulbert Site and areas west and south of the Site. Information included in this appendix was also presented in the Interim Action Report (Landau Associates 2010). Figures A-1 through A-13 showing the site characterization sampling locations by parameter and tables A-1 through A-18 summarizing the site characterization analytical data are also included in this appendix.

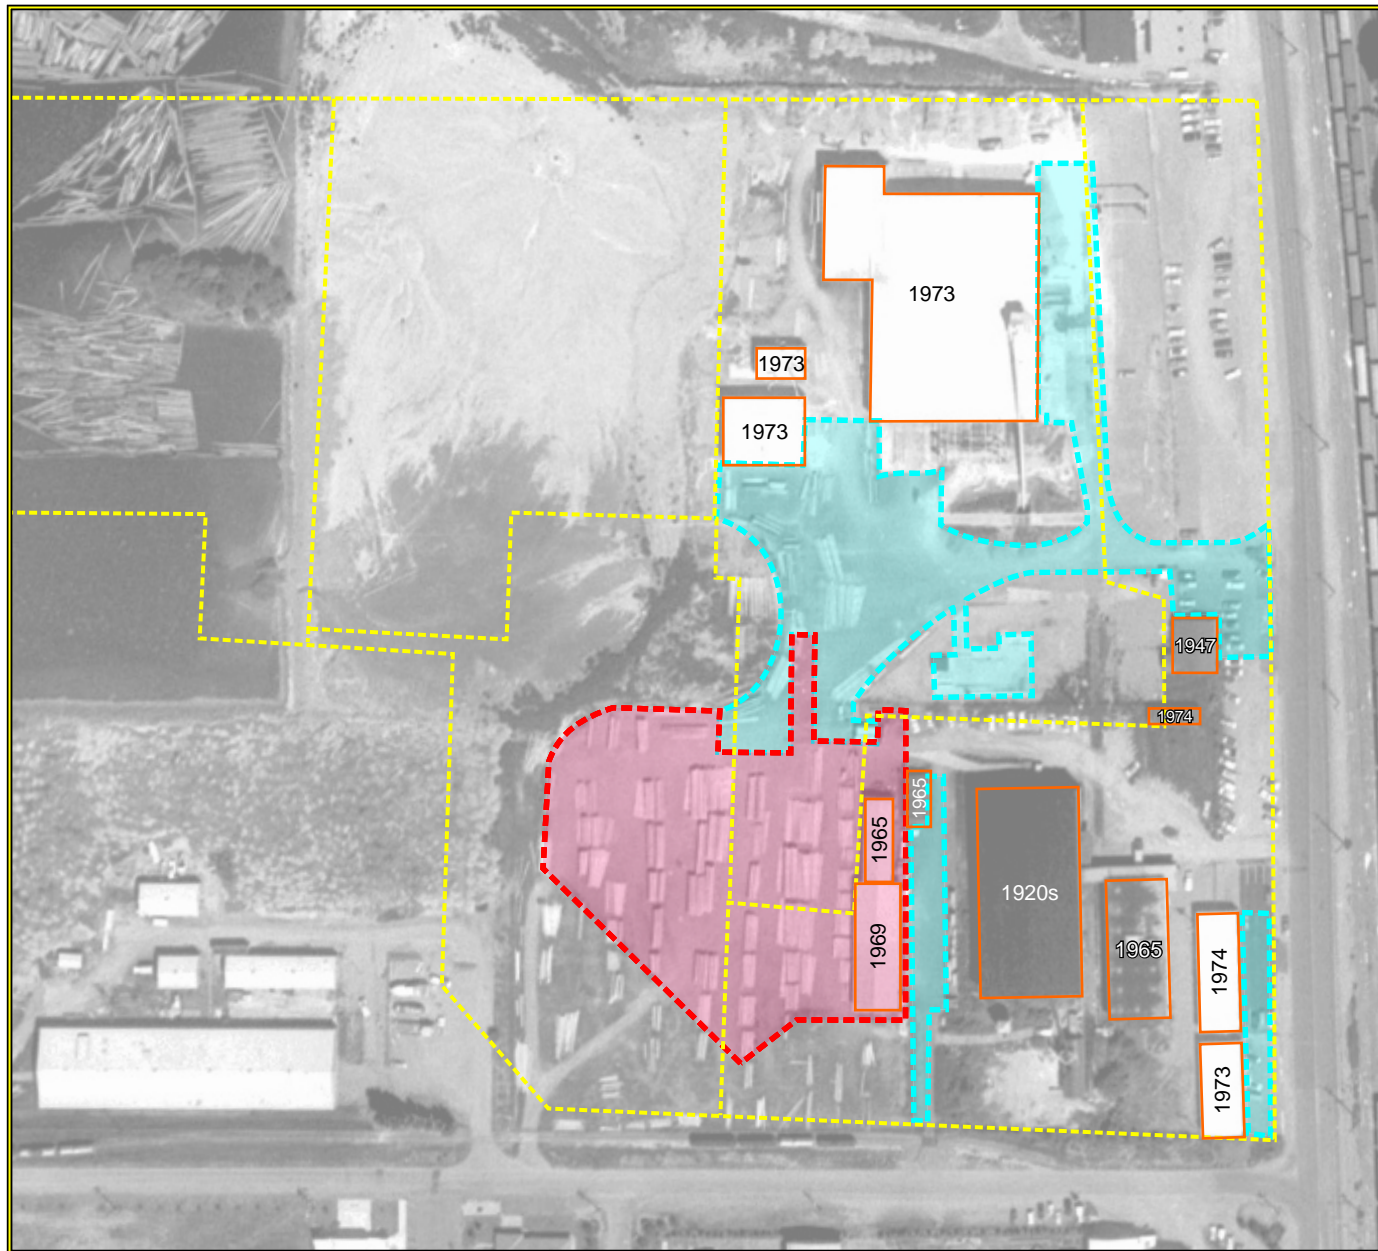
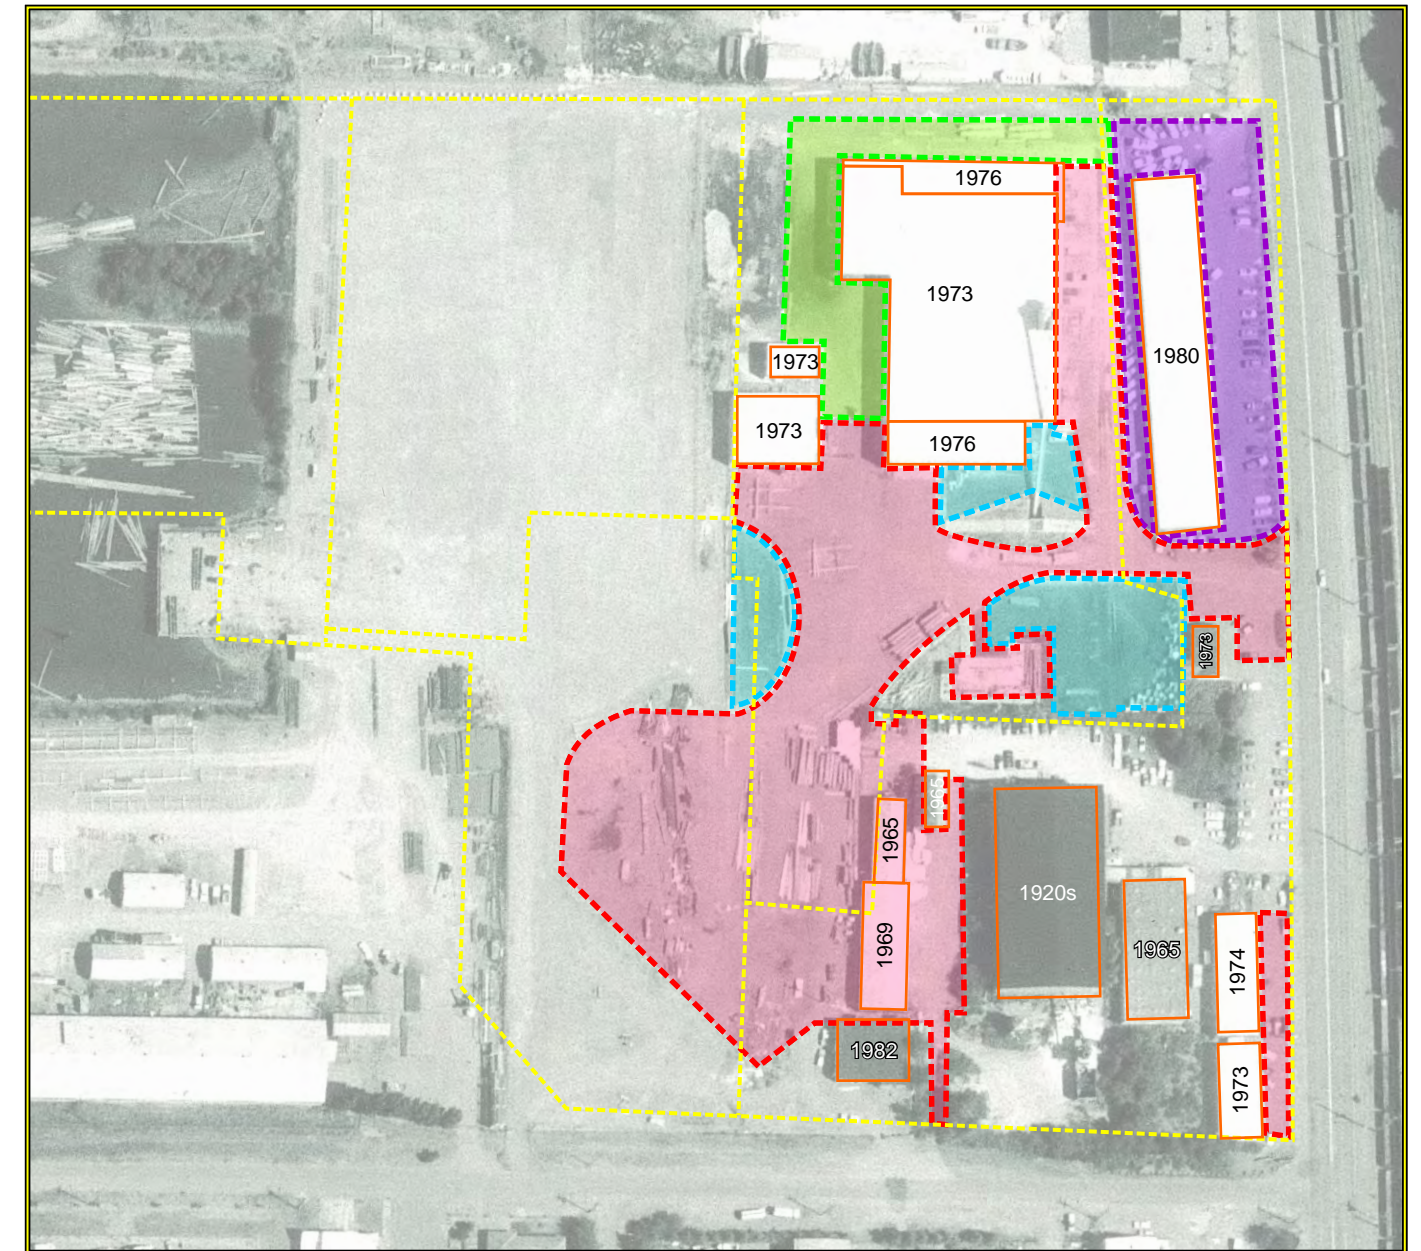
Figure 6
 Pavement History 1956 through 1982
 North Marina Ameron/Hulbert Site
 Everett, Washington

Shaded areas surrounded by dashed lines show areas of paving within the dates noted below each figure. Refer to notes at right.

Yellow dash lines show the approximate locations of areas of the site defined in the Agreed Order.

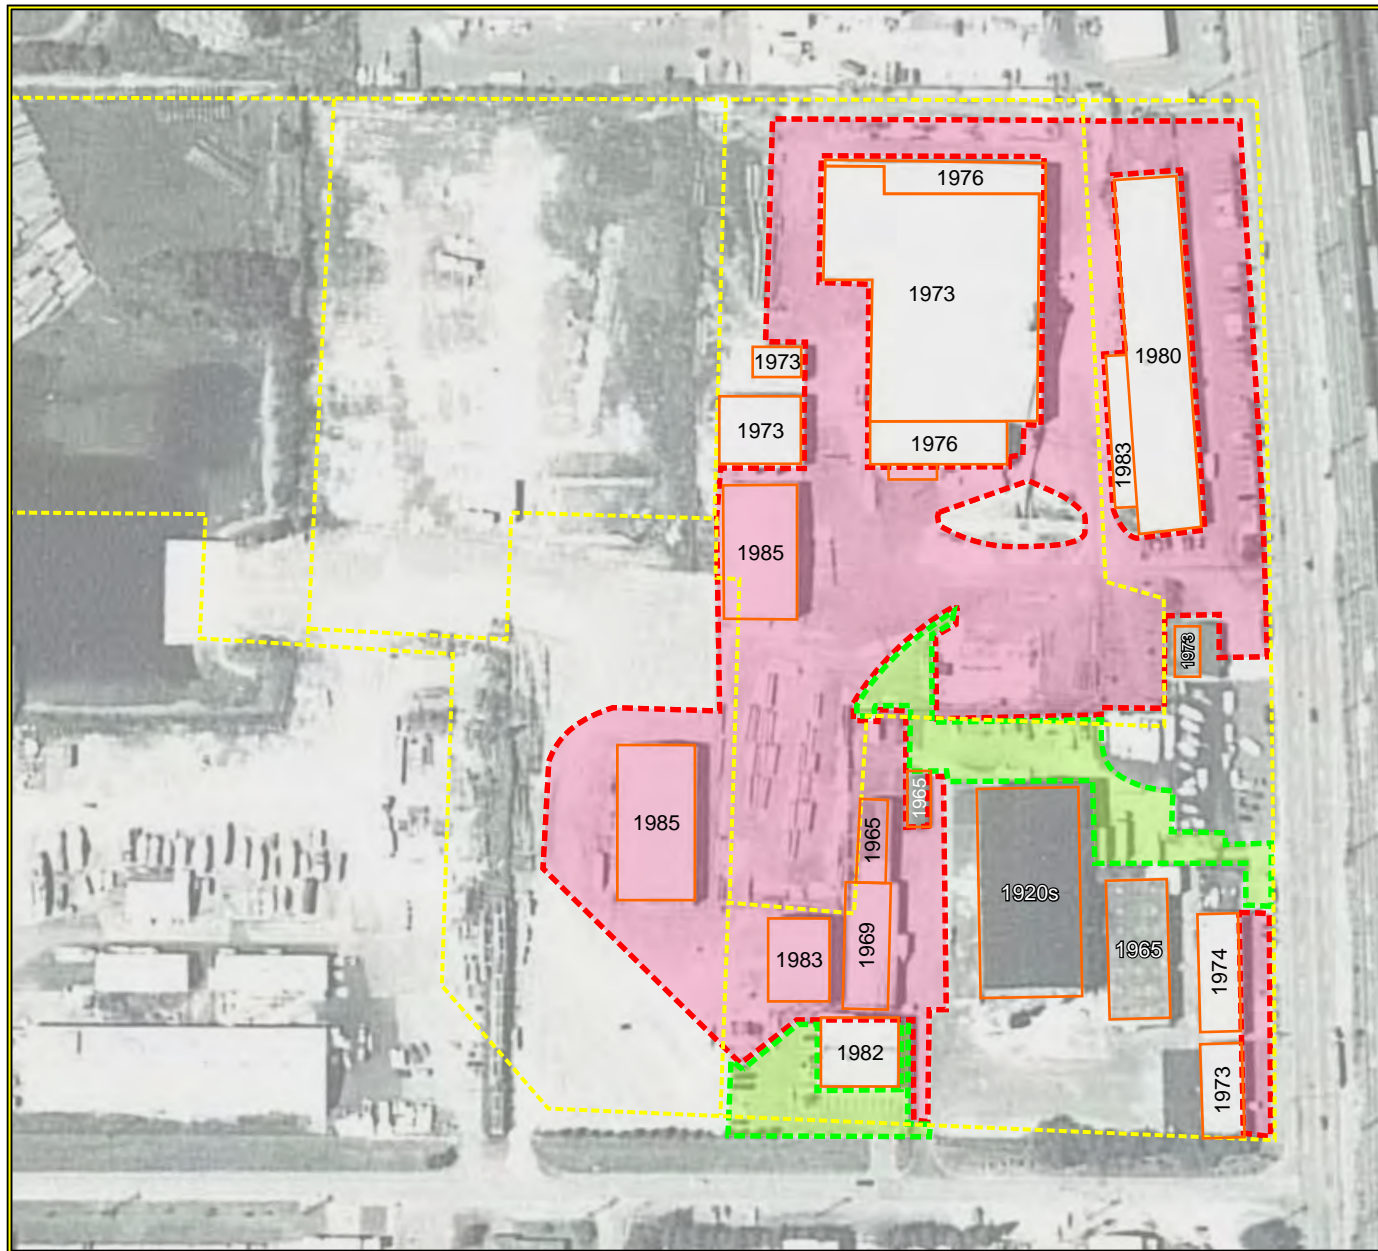
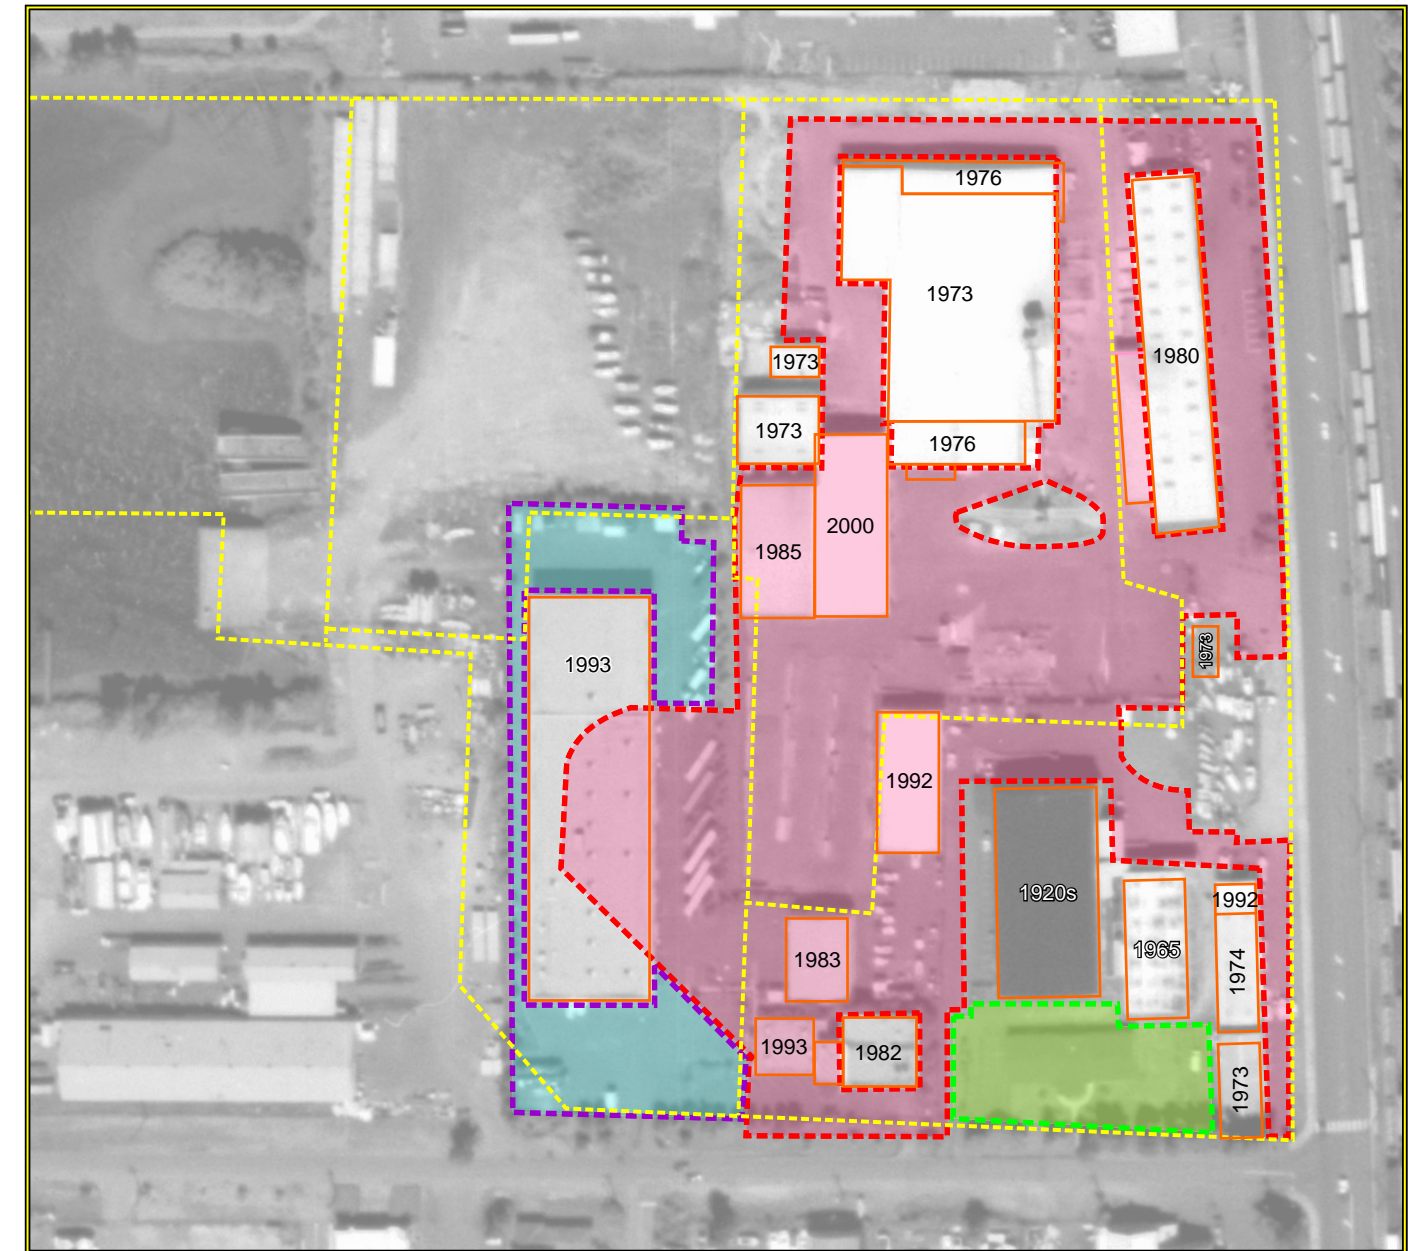
Shaded areas surrounded by dashed lines show areas of paving within the dates noted below each figure. Refer to notes at right.

Yellow dash lines show the approximate locations of areas of the site defined in the Agreed Order.

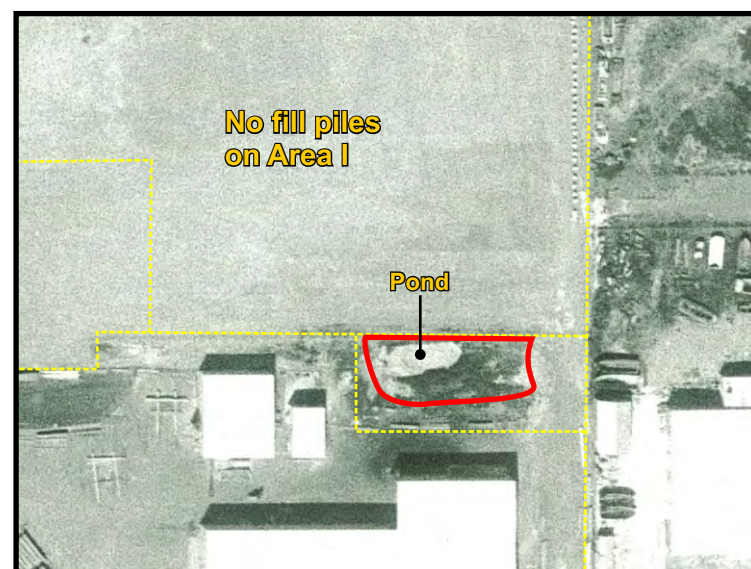
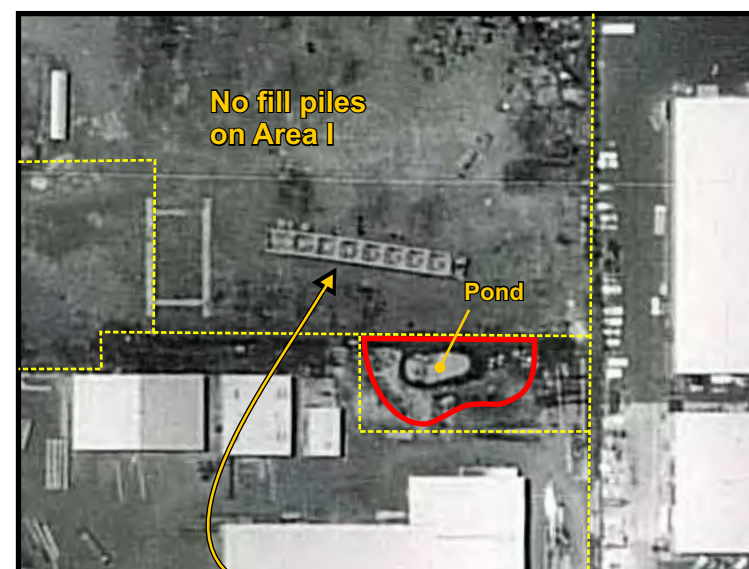
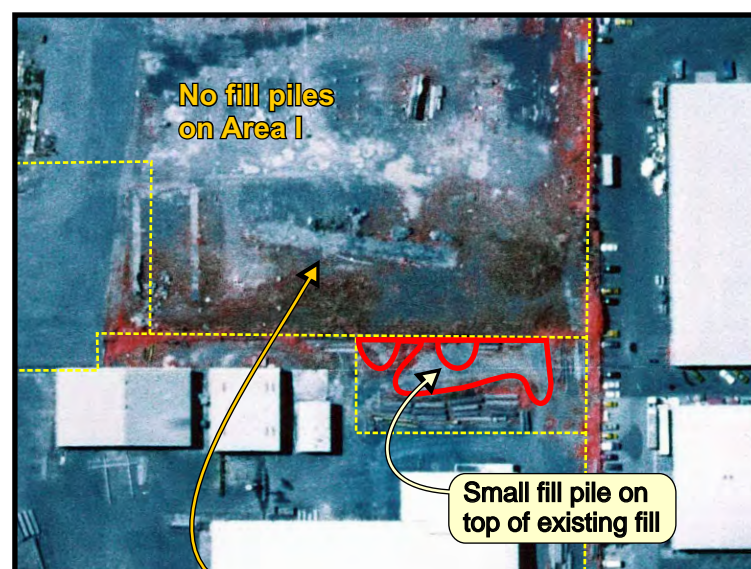
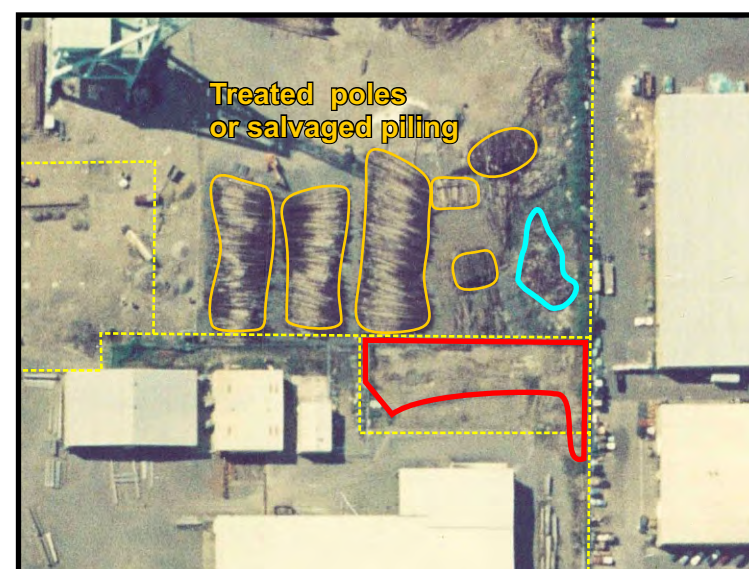
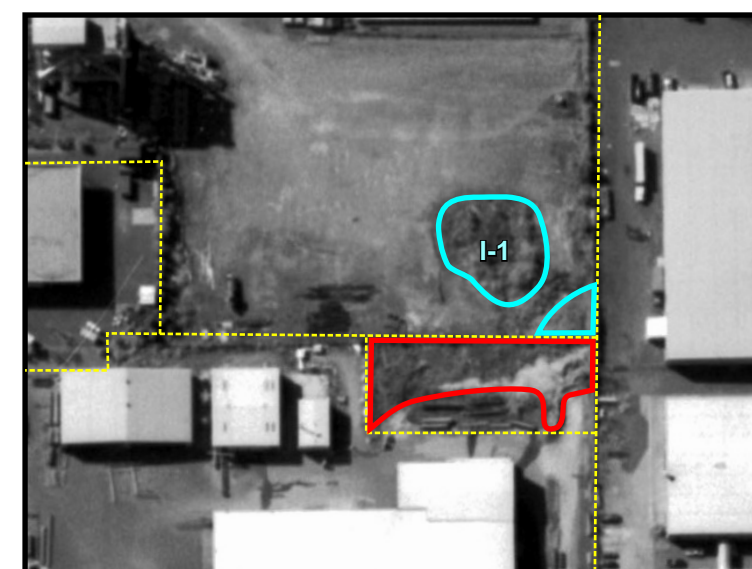
- Margins of dredge fill berm in 1973 and eastern margin of berm remnant thereafter.
- Log / Pipe / Slash / Debris piles.
- Fill piles on Area I on top of dredge fill.
- Approximate extent of fill on G-1 after 1982.

This figure illustrates the extent of fill in the northeastern part of Area I and the northwestern part of Area G (G-1). The comments below provide additional information about each aerial photograph:

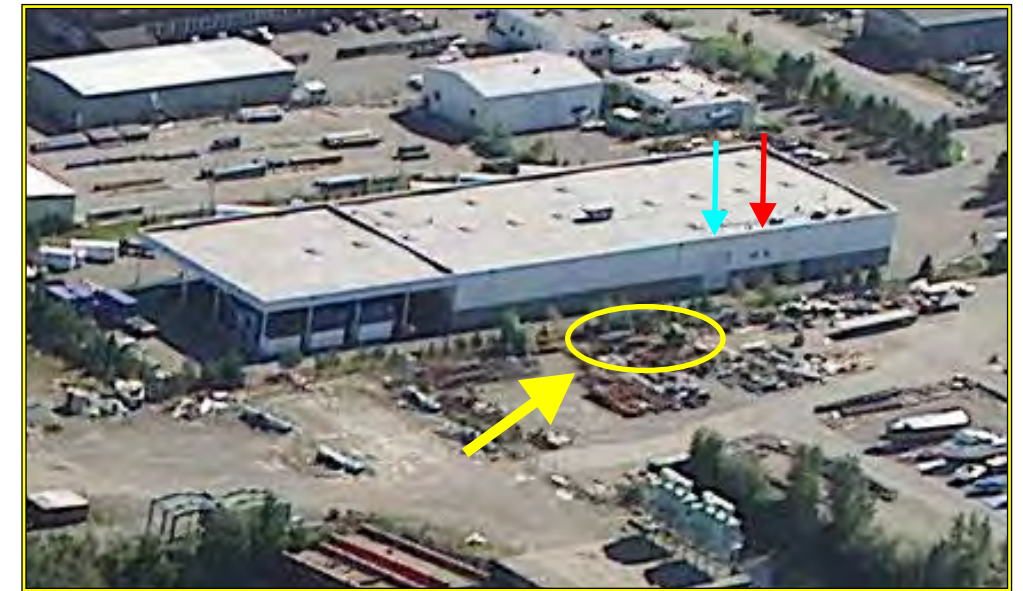
Recent photograph with features from Kleinfelder photograph identified as well as view angle and the location of the vault that was removed.

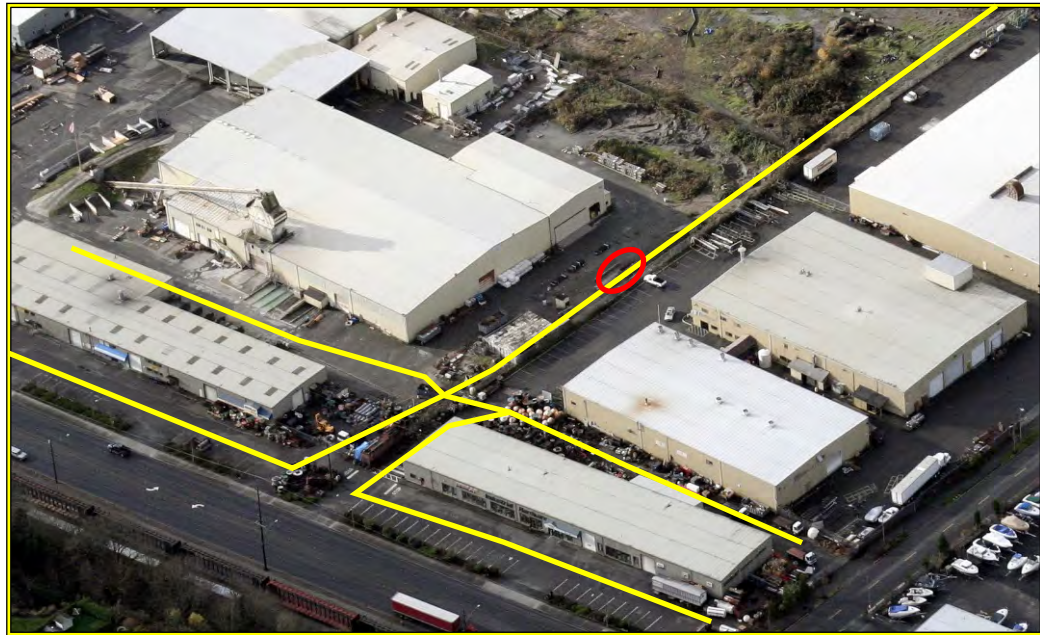
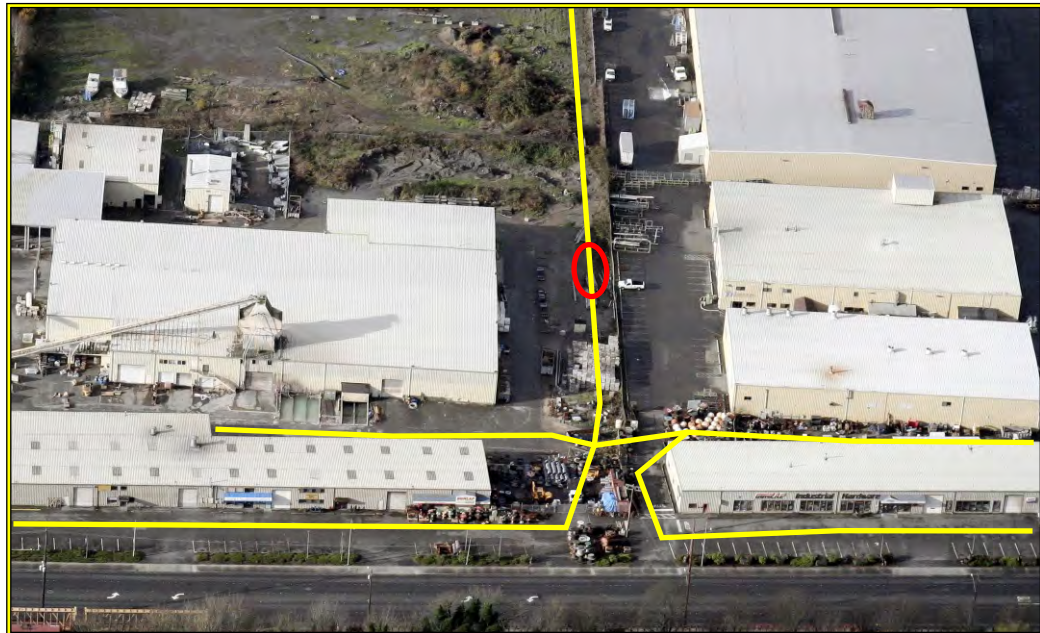
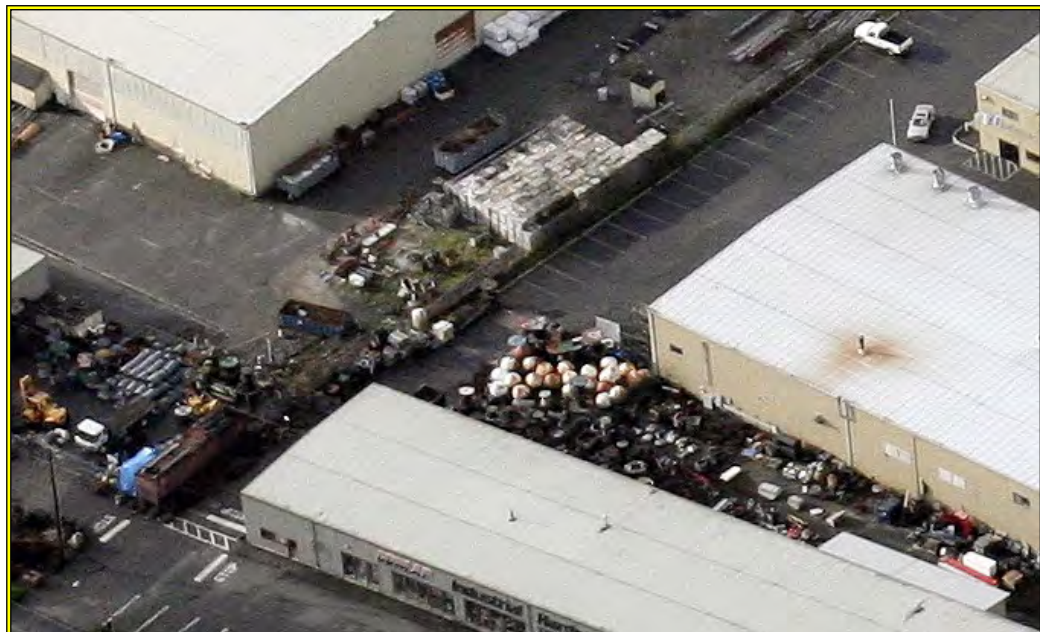
Figure 13
Sewer Line Repair Area on
Northern Area G
North Marina Ameron/Hulbert Site
Everett, Washington

The upper two photographs are oblique photographs taken on November 25, 2005. The general alignment of the storm drain system that discharges past the sewer line break location is shown in yellow on the upper two photographs. The lower photograph is an enlargement from the upper photograph of the areas on the subject property and the adjoining property where considerable items are stored on the ground surface.

This shows part of Figure 3a from Landau's November 28, 2001 Environmental Site Assessment for the North Marina Redevelopment Project. The figure illustrates the storm drain system. The yellow highlighted portion discharges past the sewer line break location.

The northern boundary of Area G is presently occupied by an underground storm sewer line. In late 2004 a repair was made to a storm drain line and evidence of contamination was noted in excavated soils. The location of this repair is shown in Figure 13. Analytical testing of the soil stockpile from the excavation showed low concentrations of mid-range to heavy-range petroleum hydrocarbons, several PCB aroclors and cPAHs. Furthermore, the soils encountered included concrete fragments and mixed fill suggesting that this area was used for disposal of demolition debris. Follow up testing by Landau Associates shortly after the repair (early 2005) encountered the mixed fill and found the contamination to be localized to the general area of the repair excavation. Samples tested by Landau found evidence of PCBs, PAHs and low concentration petroleum contamination. PCBs and PAHs were found in a soil sample from the initial excavation stockpile. Relatively high concentrations of volatile organic compounds were found in a sample obtained from a depth at or near the top of the storm drain line, close to the repair area. The suite of analyses performed was not consistent from sample to sample so it is difficult to identify patterns between different samples evaluated.

The area of concern lies between the Ameron Building and the northern property line. Figure 13 shows the succession of change in the area of concern between 1967 and 2005. This area was originally tide land and the first construction there was a pile supported dock used for storage. We do not know specifically when this area was initially filled, but by the 1960s the former mill dock structures appeared to be largely underlain by fill, including this area. Until mid-1977, the northern property line along most of Area G is clearly identified by the piling at the edge of the former dock and the much lower grade on the adjacent property to the north. Although the property to the north had been partially filled, a drainage ditch remained along its southern margin – just north of Area G. By mid-1978 the property to the north was filled to approximately the same grade as area G, including this drainage ditch. The storm line, which was likely installed in about 1981-1982, lies several feet south of the northern property line and discharges at the northwestern corner of Area I. The catchment for the portion of the drain line upgradient of the release location encompasses the building east of the Ameron Building and the eastern-most building on the property to the north. The basis for our estimate of the 1981-1982 date range for the installation of the storm sewer system is based on a combination of site development factors evident in aerial photographs including the presence and subsequent removal of substantial fill along the northern margin of Area G and the paving of areas where the storm sewer is now present.

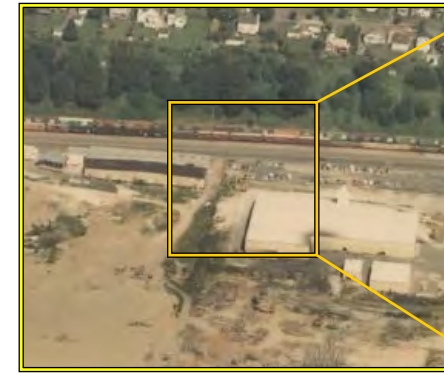
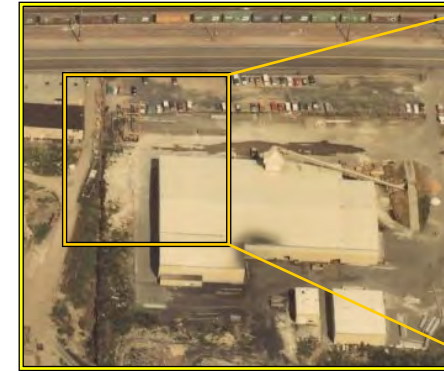
1977 (both oblique views)

The 1977 photographs show a structure that might be an electrical substation-type structure. The photographs are not suitable to clearly identify the item. The 1980 photograph documents the presence of pole mounted transformers at the northeastern corner of the subject property.

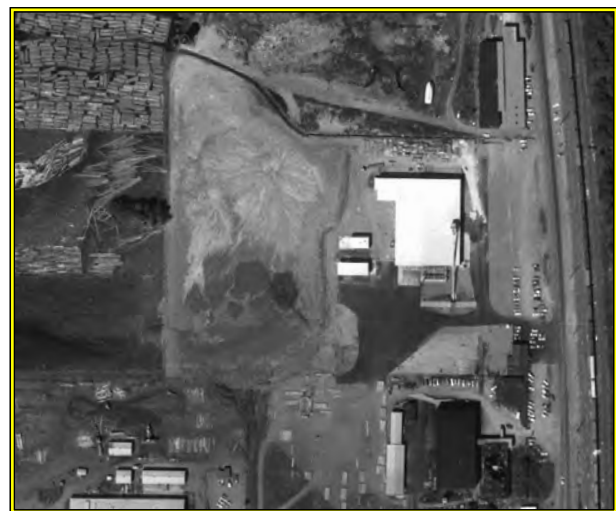
1973, September (without overlays)

Large Dredge Disposal Fill - 1973

- A:** Existing timber bulkhead
- B:** Borrow area for north dike
- C:** Stockpile area for logs and timber debris
- D:** Fill area, top elevation as required for dredging disposal
- E:** Northern Dike

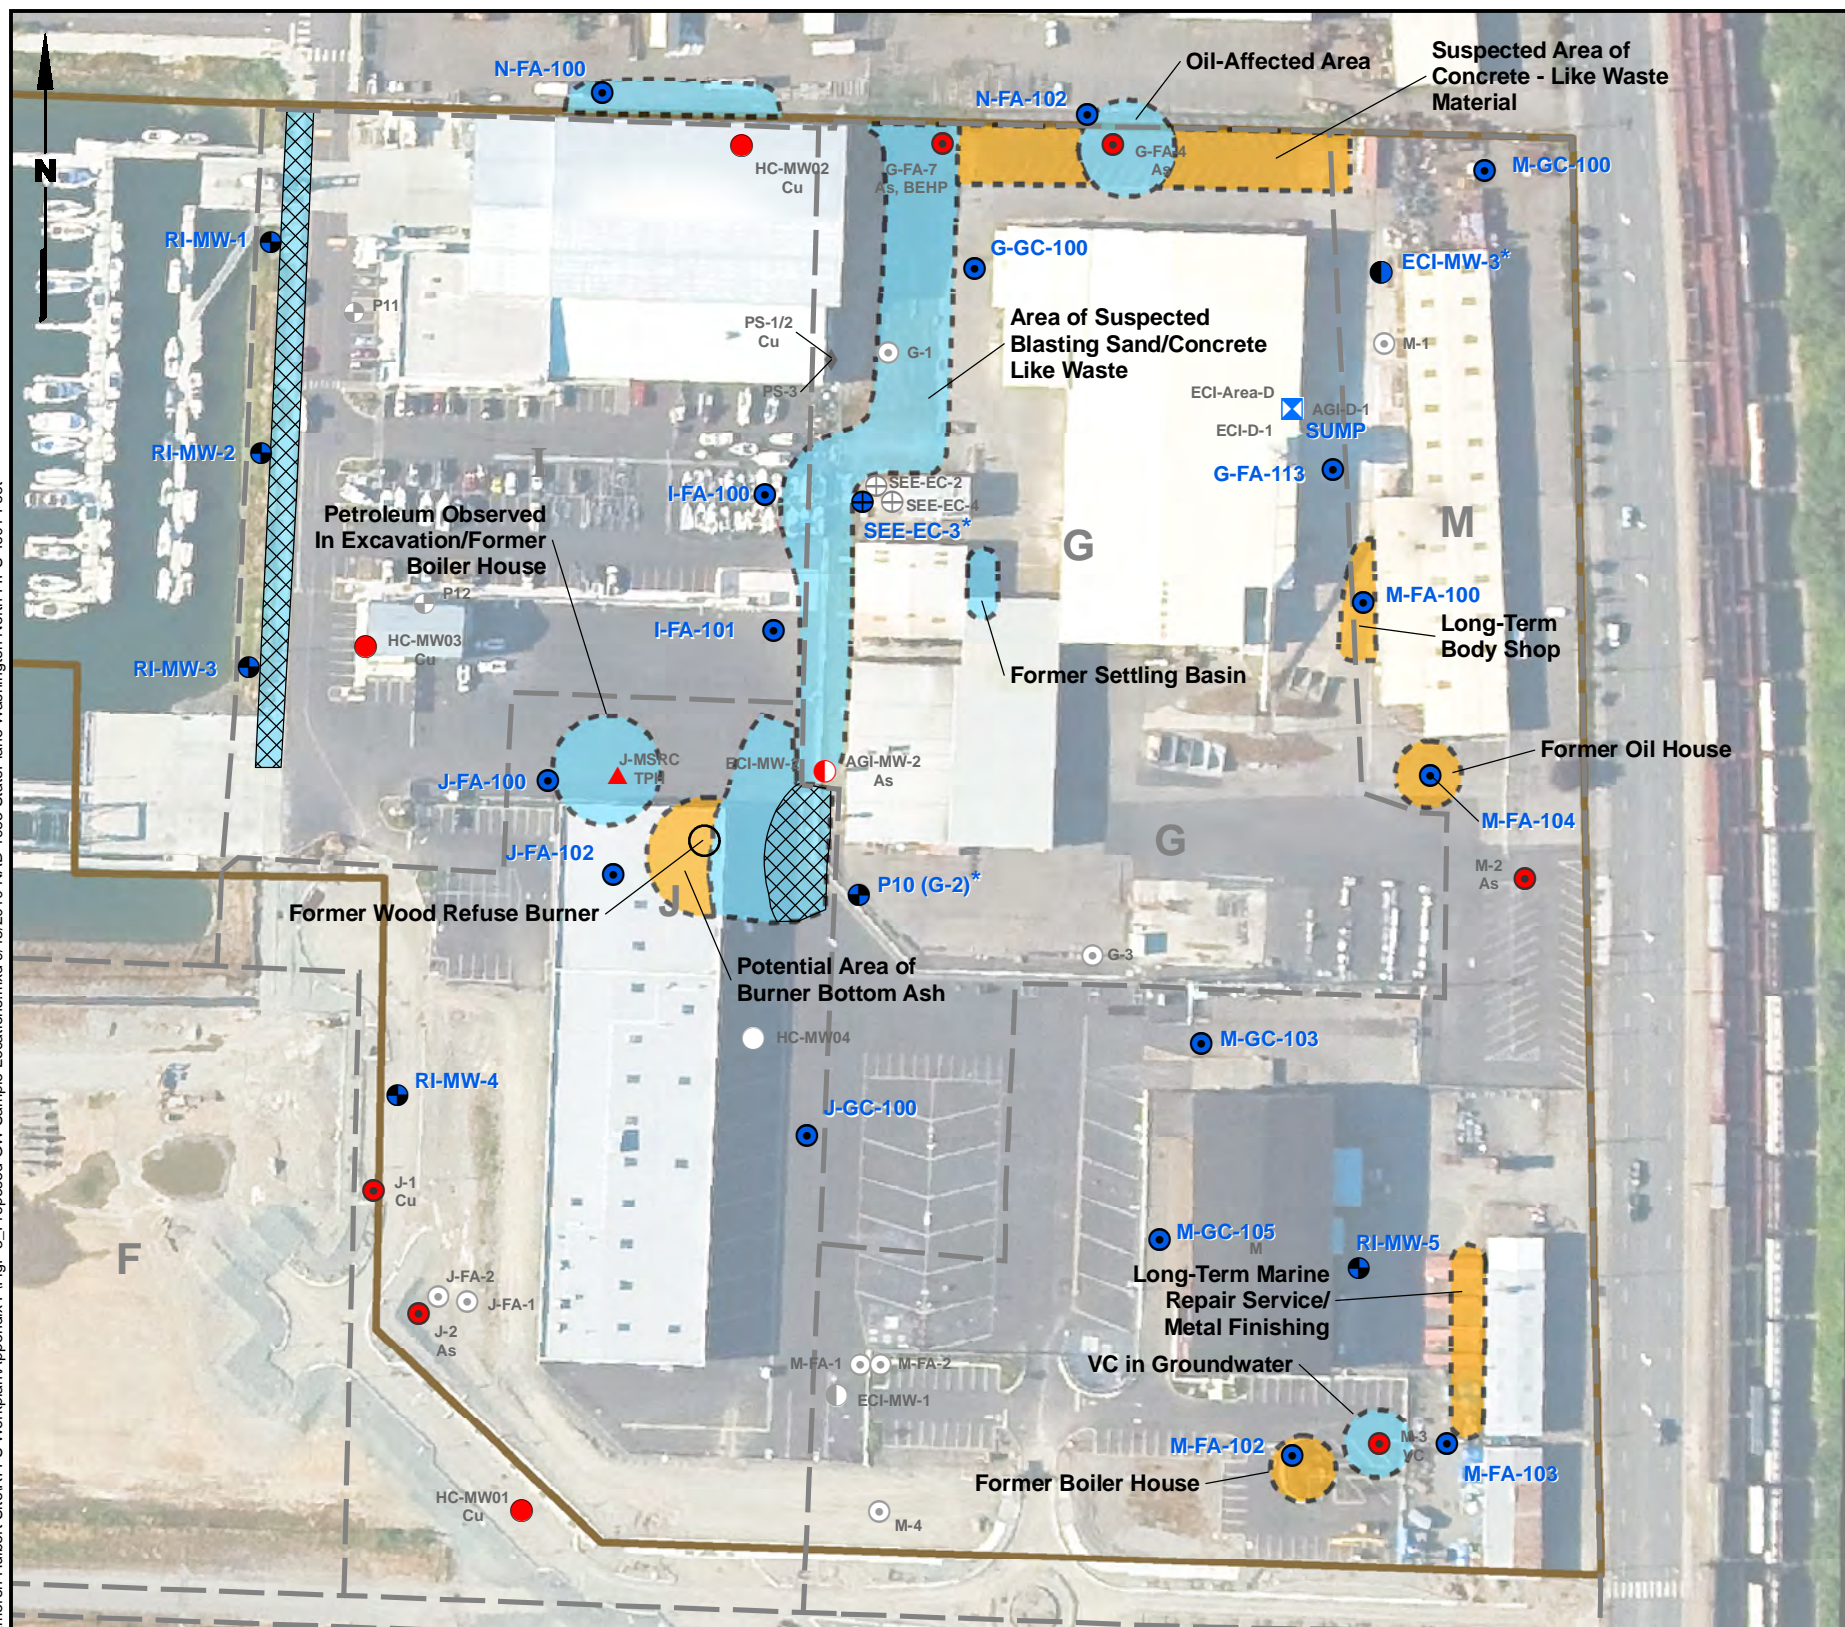
- Proposed Monitoring Well
- Proposed Soil Boring Location; I-FA-101
- ⊠ AGI & Earth Consultants, Inc. Concrete Settling Basin Sump Sample Location (1992)

1. **Blue** text indicates well or boring groundwater sampling locations  
**Gray** text indicates former well or groundwater sampling locations.
2. * Indicates sample is being collected from an existing monitoring well.
3. As = Arsenic, Cu = Copper, VC = Vinyl Chloride, BEHP = Bis(2-ethylhexyl) phthalate, TPH = Total Petroleum Hydrocarbons
4. Black and white reproduction of this color original may reduce its effectiveness and lead to incorrect interpretation.

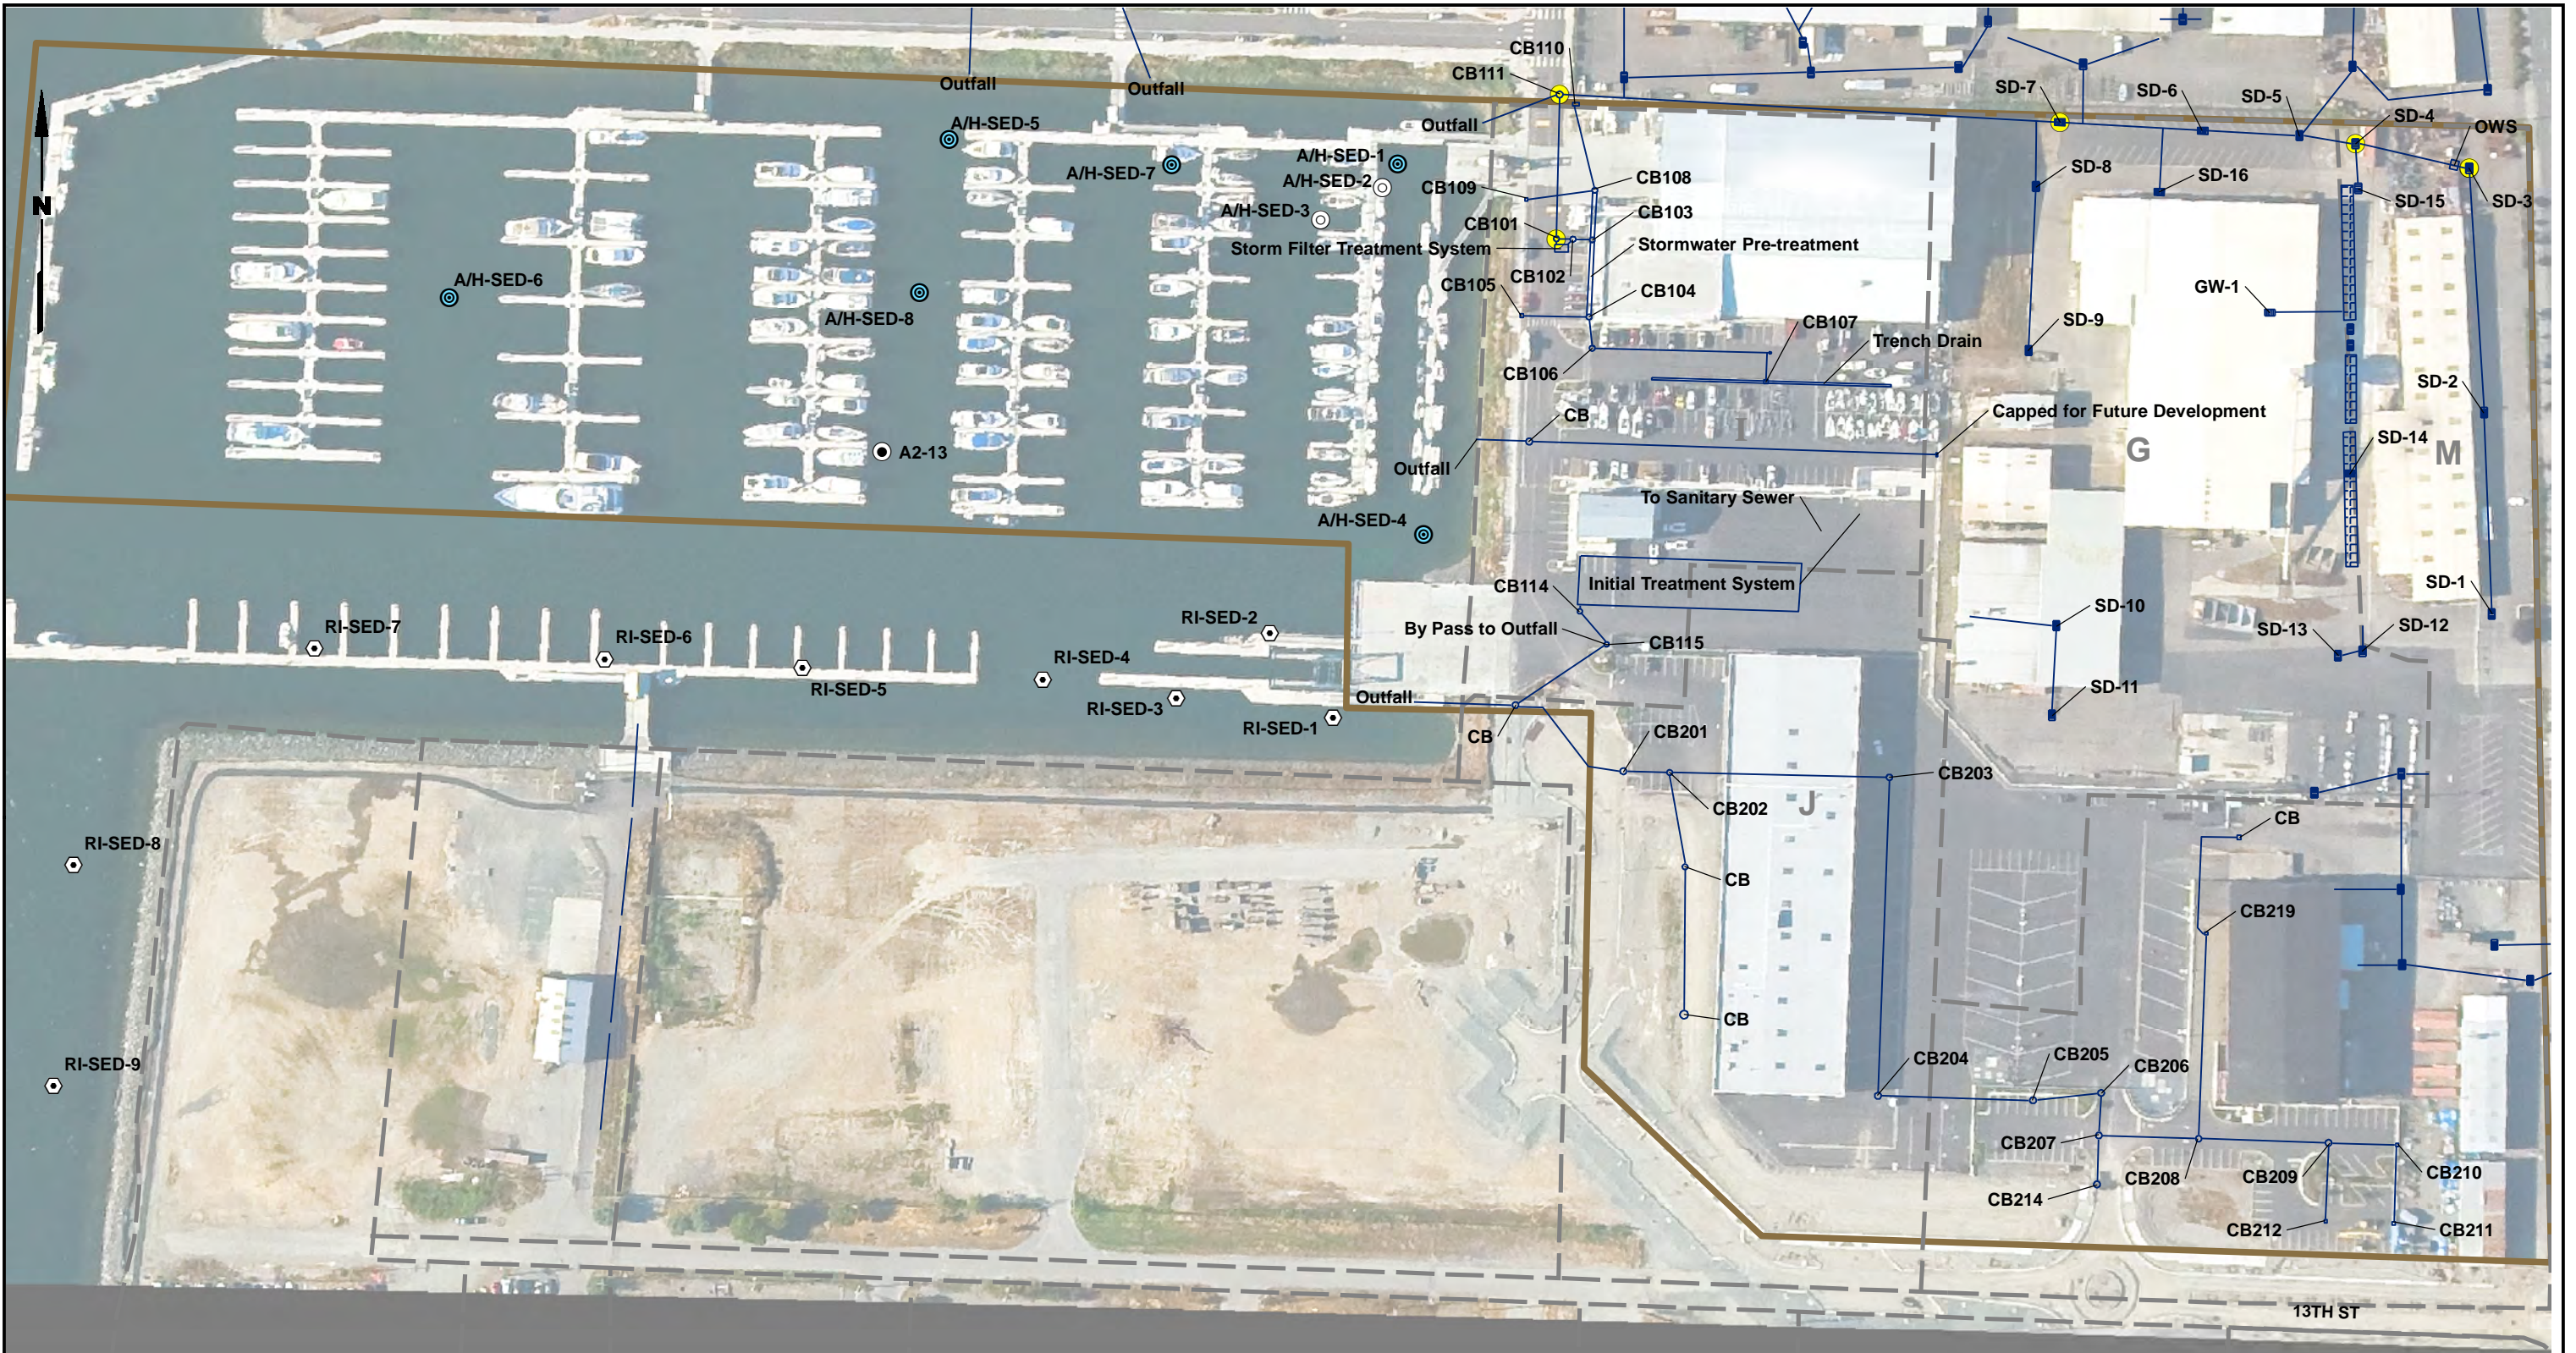
- ⊙ Proposed Sediment Sampling Locations
- ⊙ Samples to be Archived for Potential Laboratory Analysis
- Proposed Catch Basin Sediment Sampling Location
- ⊙ Landau Associates Sediment Sampling Locations (2009)
- SAIC Sediment Sample Location (2009)
- Catch Basin and Piping
- G - Area Designation
- Approximate Ameron/Hulbert Site Boundary
