**Summary of Previous Environmental Investigations
and Documents, Brief Descriptions of Previous
Investigations, and Data Tables Summarizing
Previous Investigation Results**

SUMMARY OF PREVIOUS INVESTIGATIONS

This Appendix provides brief descriptions of the previous environmental investigations conducted at the North Marina Area, which includes the Ameron/Hulbert Site and areas west and south of the Site. Information included in this appendix was also presented in the Interim Action Report (Landau Associates 2010). Figures A-1 through A-13 showing the site characterization sampling locations by parameter and tables A-1 through A-18 summarizing the site characterization analytical data are also included in this appendix.

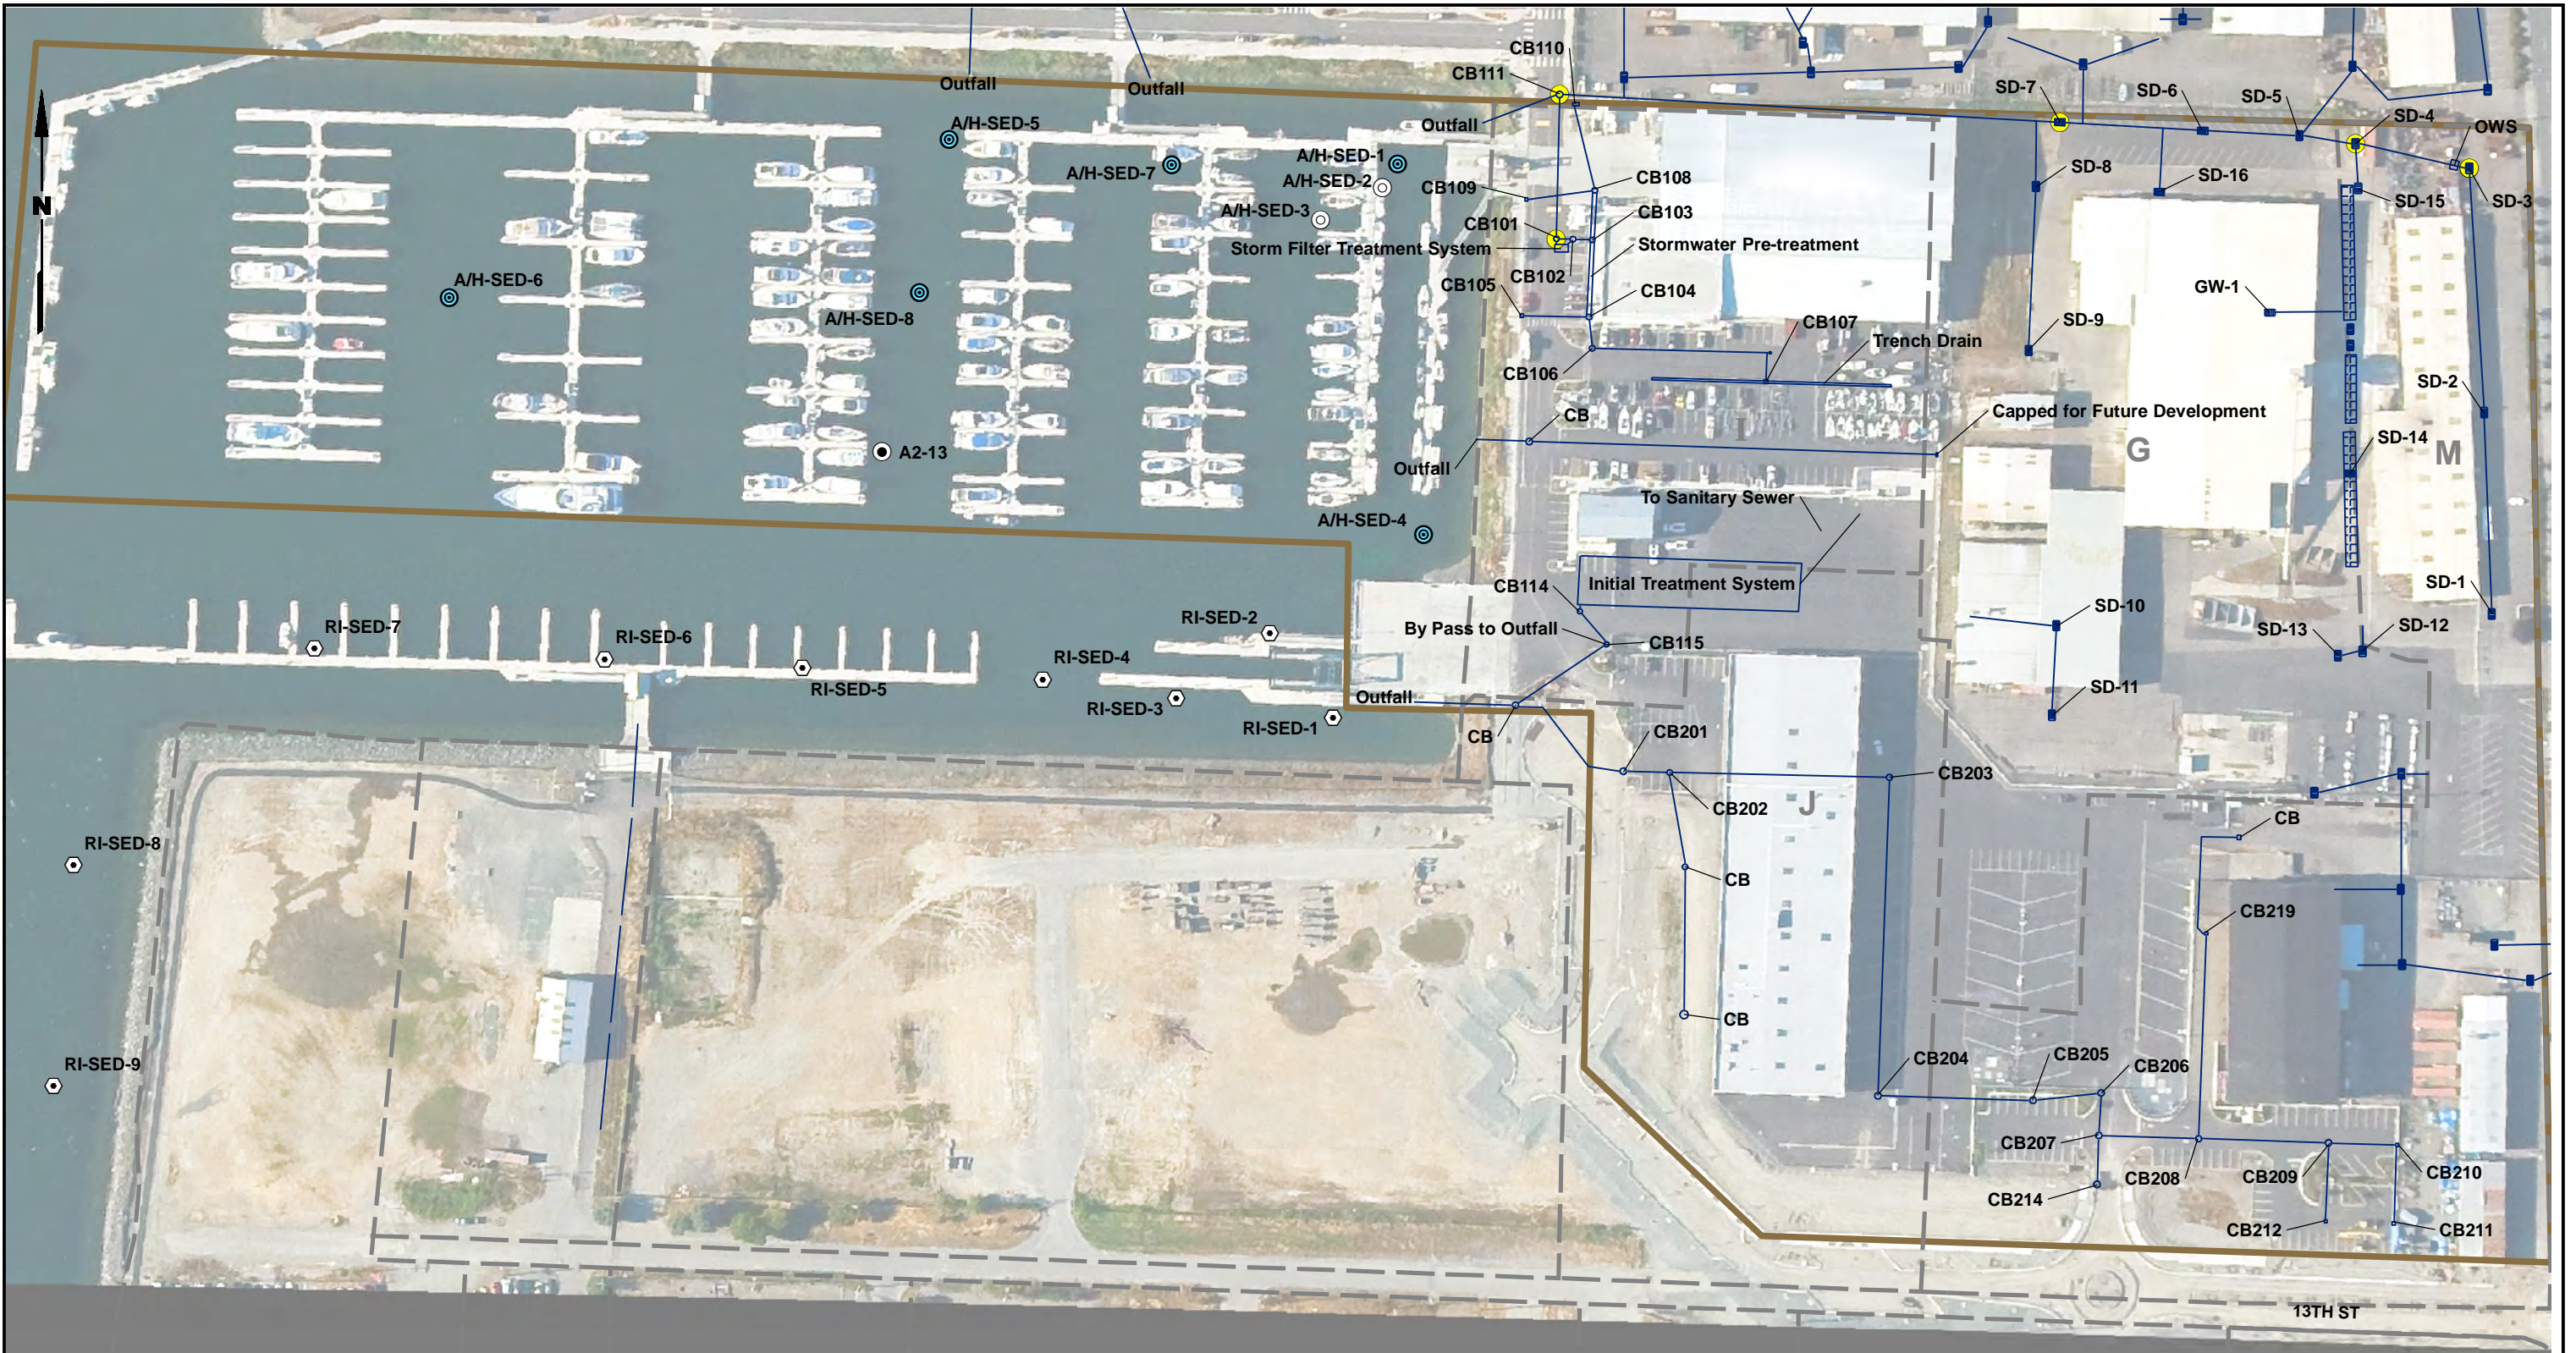
Y:\Projects\147029\Mapdocs\Ameron Hulbert Site\RI FS Workplan\Appendix G\FigG-4_Proposed Sediment and Stormwater Locations.mxd 8/25/2010 NAD 1983 StatePlane Washington North FIPS 4601 Feet
