Third Quarter 2016 Remedial Systems Operations and Maintenance (O&M) Report

TOC Holdings Co. Facility No. 01-176
24205, 24225, 24309 56th Avenue West
Mountlake Terrace, WA

Washington State Department of Ecology
Agreed Order No. DE 8661

HydroCon Project No: 01-176

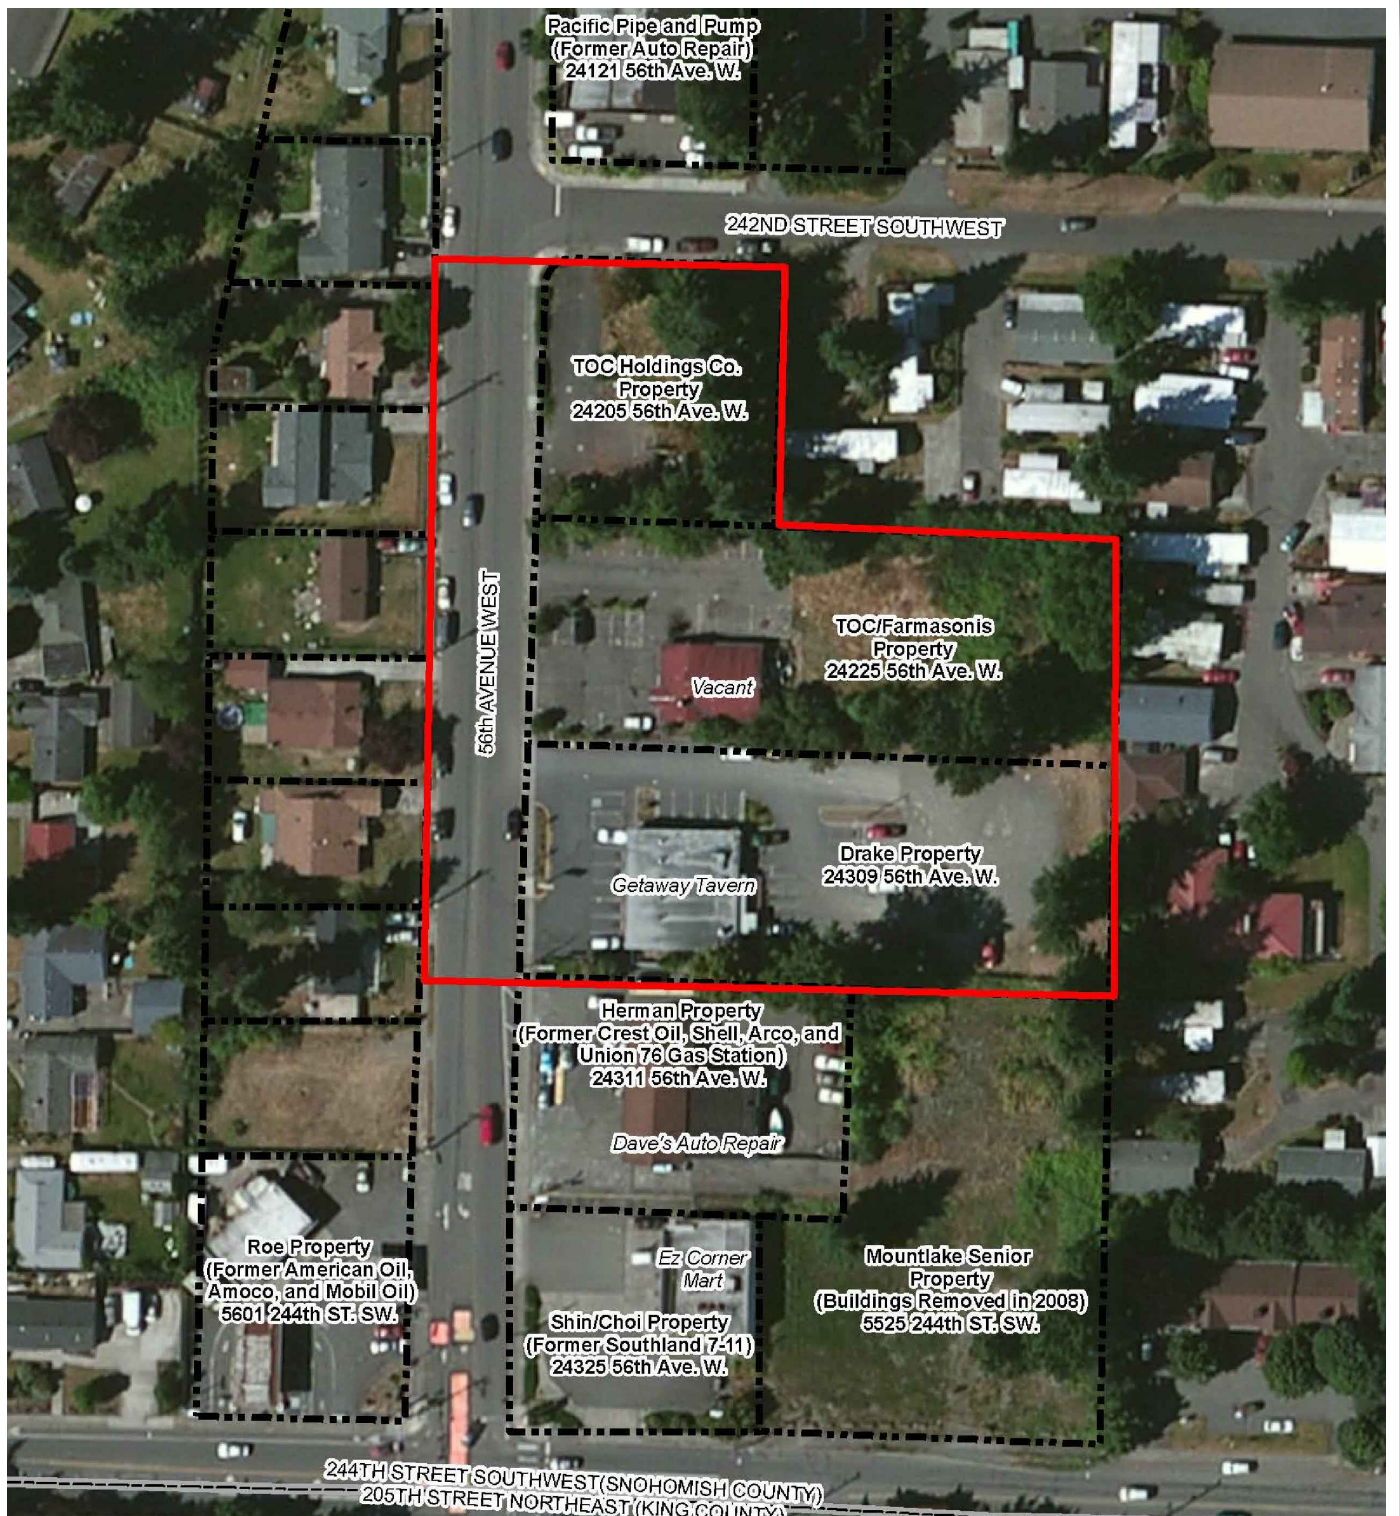
FIGURE 2
 SITE MAP

As described in the IRAWP, the TOC Facility No. 01-176 is termed the "Interim Remedial Project Area" (IRPA) and consists of the following four properties located in Mountlake Terrace, Washington (Figure 2):

- TOC Property: 24205 56th Avenue West
- TOC/Farmasonis Property: 24225 56th Avenue West
- Drake Property: 24309 56th Avenue West
- Portions of the 56th Avenue West Right-of-Way (ROW): adjacent to the TOC, TOC/Farmasonis and Drake properties
