**INDEPENDENT REMEDIAL ACTION REPORT
6361 WING POINT ROAD NE
BAINBRIDGE ISLAND, WA**

Resolve Project 16-054
October 15, 2016

**INDEPENDENT REMEDIAL ACTION REPORT
RECTOR PROPERTY; CONSTRUCTION EXCAVATION
6361 WING POINT ROAD
BAINBRIDGE ISLAND, WASHINGTON**

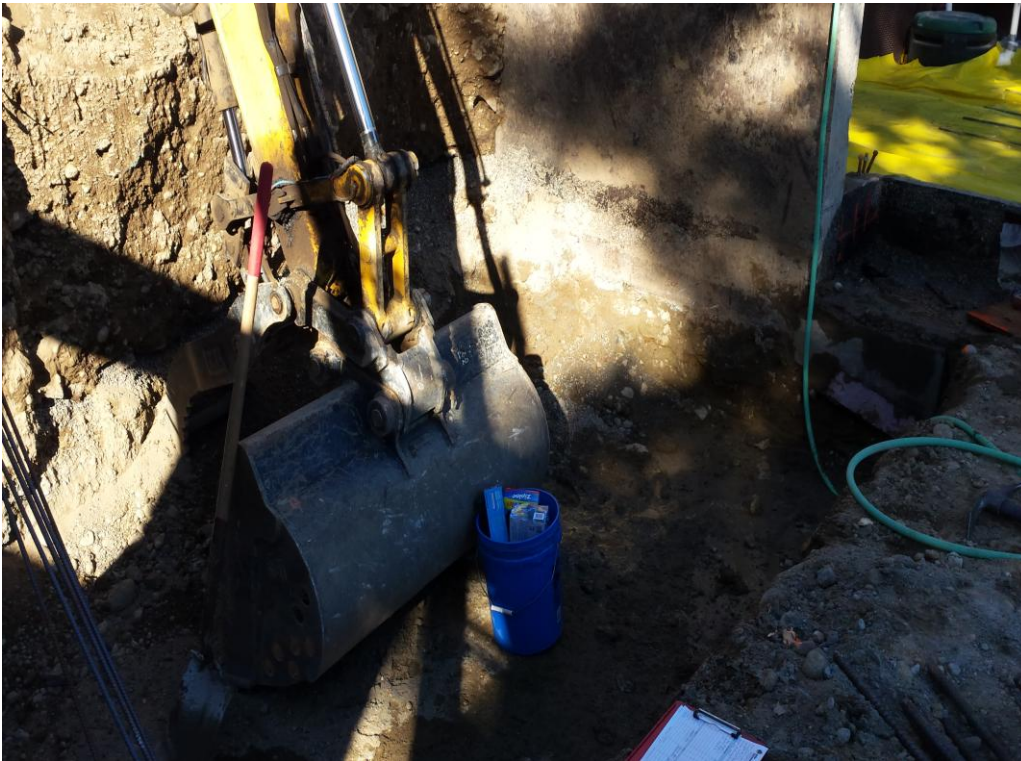
1. Initial observation of contamination was in an excavation for a retaining wall footing.

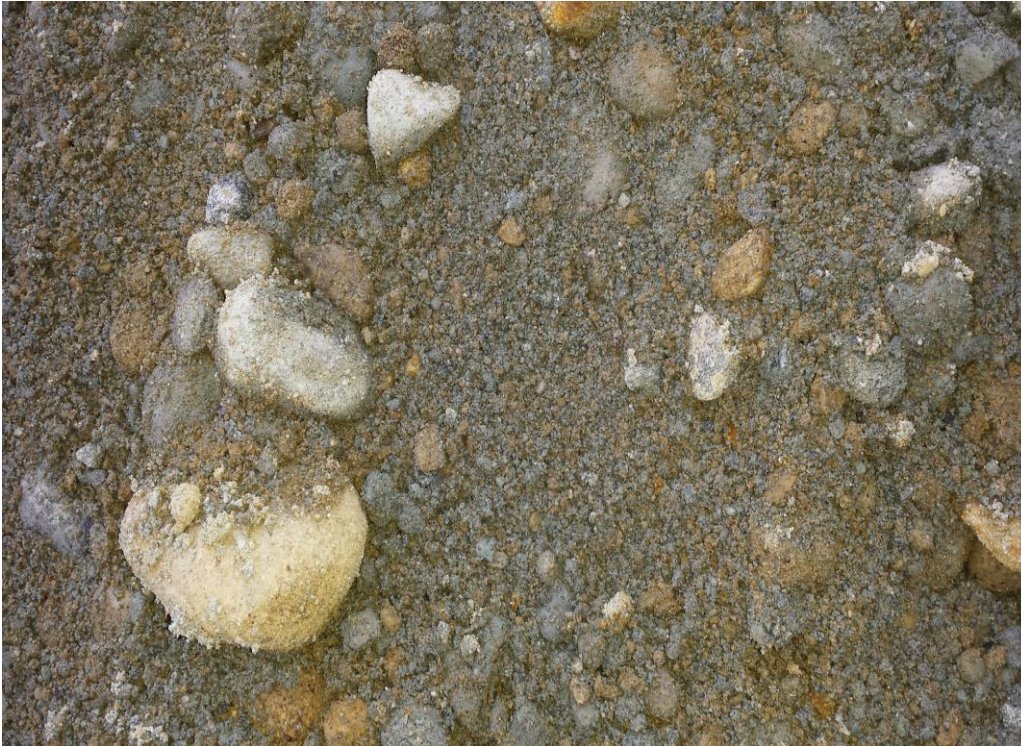
2. Soils initially observed were fill materials. Beneath the fill were brown and gray, damp, medium dense sand with gravel and minor silt (USCS SP to SM).

Subsurface soils encountered during the exploratory excavations were generally structural fill materials consisting of silty sand with gravel, (USCS SM), underlain by generally brown and light gray, dry to damp, dense, silty sand with gravel (USCS SM), interpreted in the field as lightly compacted outwash. Beneath these materials were impermeable glacial till soils, onto which the contaminant appeared to have settled without penetration or infiltration.

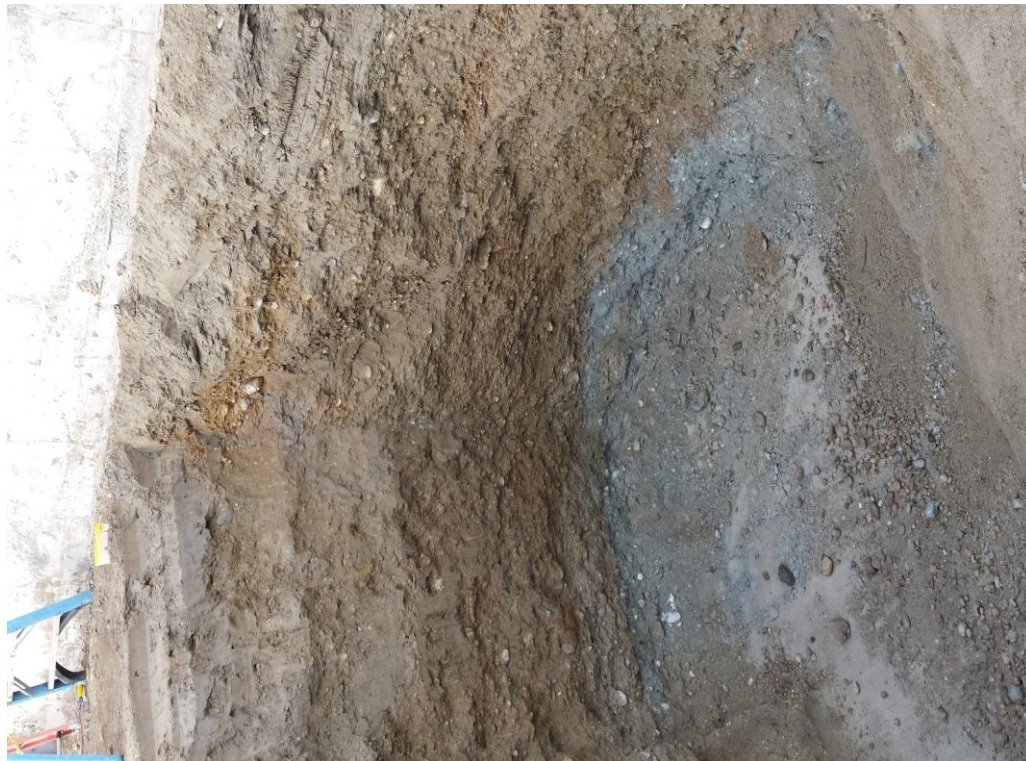
3. Contamination in the northeast corner was exposed, sampled, and tested. Concentration of diesel home heating oil was above MTCA Method A cleanup standards.

Initially, soils were sampled from the northeast corner of the excavation, the central-eastern portion of the excavation, and the southern wall of the excavation. Soils were found to have concentrations of diesel home heating oil in excess of MTCA Method A cleanup standards.

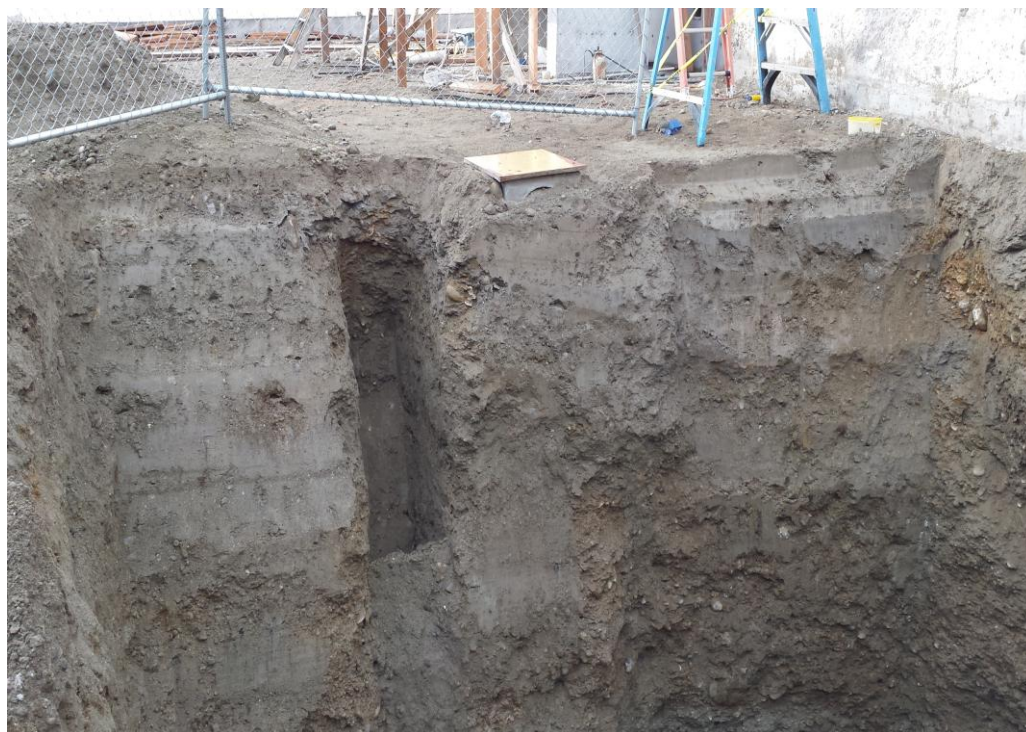
4. Delineation of plume began with a slot to the south. Contamination limits were recognized southward of the slot in this photo.

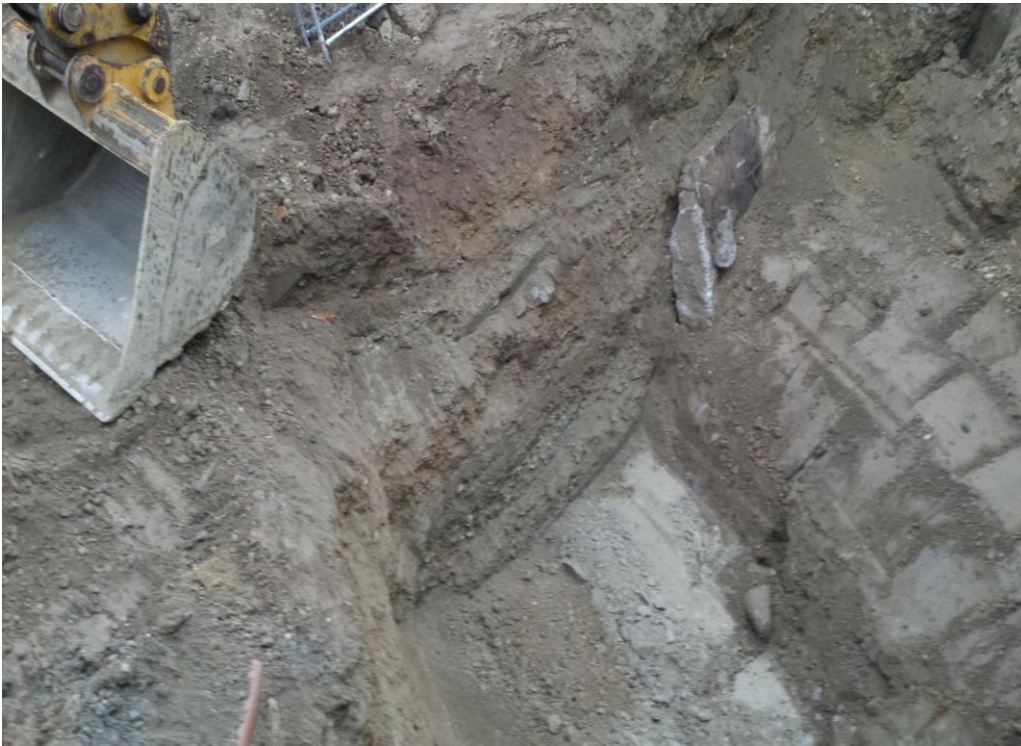
5. Higher concentrations of contamination were exposed as investigation and excavation continued. This was in the central area of the site.

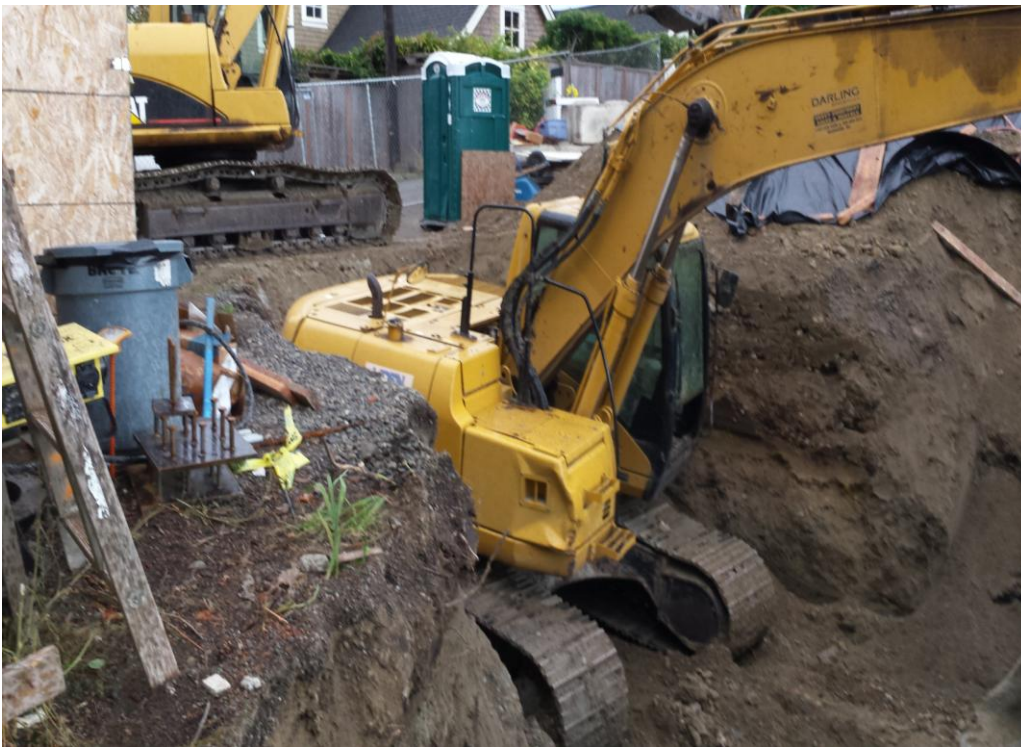
6. As contaminant continued deeper, a ramp was cut from the north.

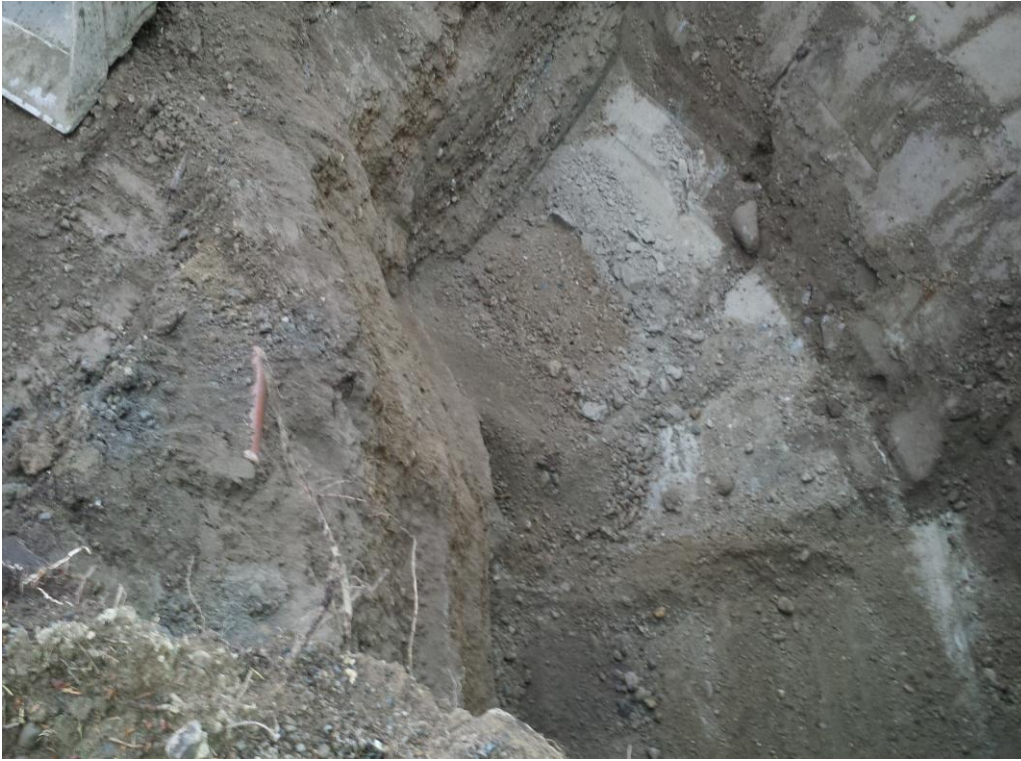
7. To find the extremities of the plume, a pit approximately 20 feet deep and 30 feet wide was excavated.

Excavation to a depth in the central areas of the contamination approached 20 feet bgs in places. The lens of contaminant began to shallow and thin toward the western margins of the property. It was noted on the western side of the excavation at a depth of approximately 12 feet, and within 3 feet of the subject property boundary, was thinning to an approximately 8-inch to one -foot lens. This thinning on all other margins (south, north, and east) to this extent yielded non-detect results within two feet of encounter.

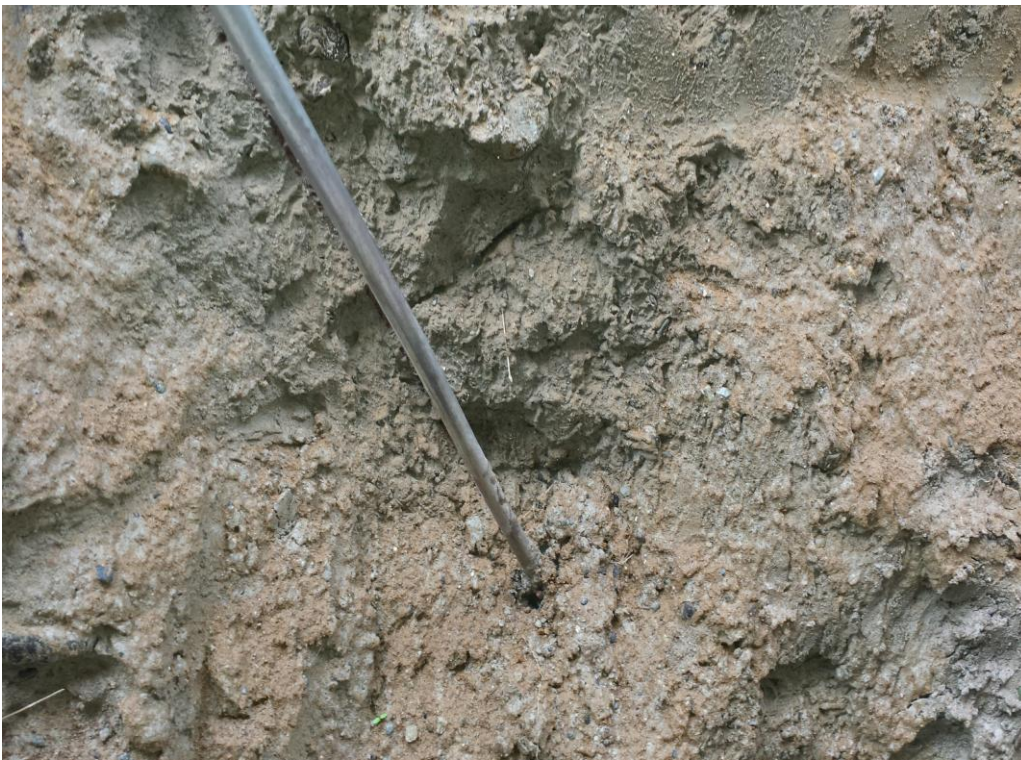
8. Verification samples were taken from walls and floors of the site, and confirmed that the contaminant had been removed.

As can be seen in the table above, none of the verification samples tested and analyzed had concentrations above MTCA cleanup standards for Diesel-range petroleum hydrocarbons. The significant excavation and testing efforts located the margins of the contaminant plume and successfully remediated the site (with some qualification noted below regarding the western margin). Based on laboratory results, visual, and olfactory field screening, it is our opinion that the contaminated soils have been removed from the site, and remaining soils do not exceed MTCA Method A cleanup standards.
