UNDERGROUND STORAGE TANK REMOVAL AND SITE ASSESSMENT REPORT

5400 Airport Way South
Seattle, Washington

May 2015

Project No. 0146970060

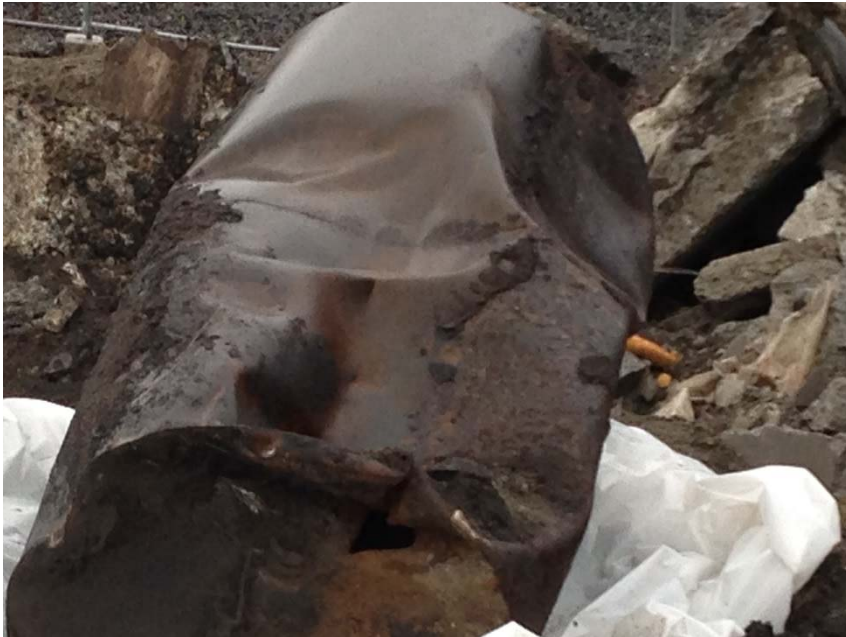
Because the tank was hit inadvertently with a large excavator, the tank was dislodged and was partially damaged. Upon inspection, a small quantity of fluid was visible through a hole ripped in the top of the tank, and several small pin-holes were visible through the rusted metal tank walls. The fluid in the tank appeared to be rusty water, and some of it was observed leaking through the pin holes in the lower portion of the tank walls. To prevent further releases from the tank, the tank was carefully moved with an excavator and placed onto a visqueen liner in a shallow containment berm. Later in the day on March 5, the contents of the tank and the visqueen containment berm were pumped out by Ingenium, a waste disposal company based in Kent, Washington. The tank liquids were pumped into a 55-gallon drum, which was labeled and left on site for later removal.

Photograph 1 Close-up of the underground storage tank (UST) after moving to temporary staging area.

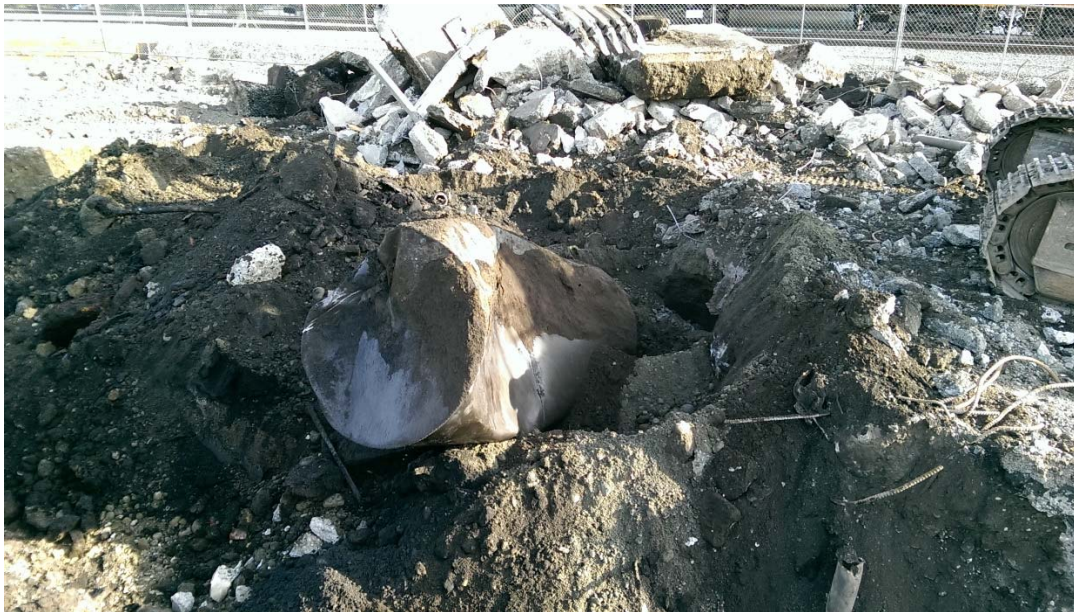
The UST was located approximately 5 feet east of a series of underground pipes that were awaiting removal, along with associated petroleum contaminated soil. These pipes were left in place following the decommissioning of nine USTs in 2009 (AMEC Geomatrix, 2010). The pipes could not be removed completely at that time because they ran beneath a building. That building was demolished in February 2015, allowing for the remaining piping and associated contaminated soil to be removed (Figure 2). Because the UST was covered by two separate concrete slabs, the tank is assumed to predate the buildings constructed above it. There was no piping connected to the UST or in the immediate vicinity. Soil surrounding the tank is a sandy fill material.

Photograph 2 UST after discovery on March 5, 2015. View is to the east.

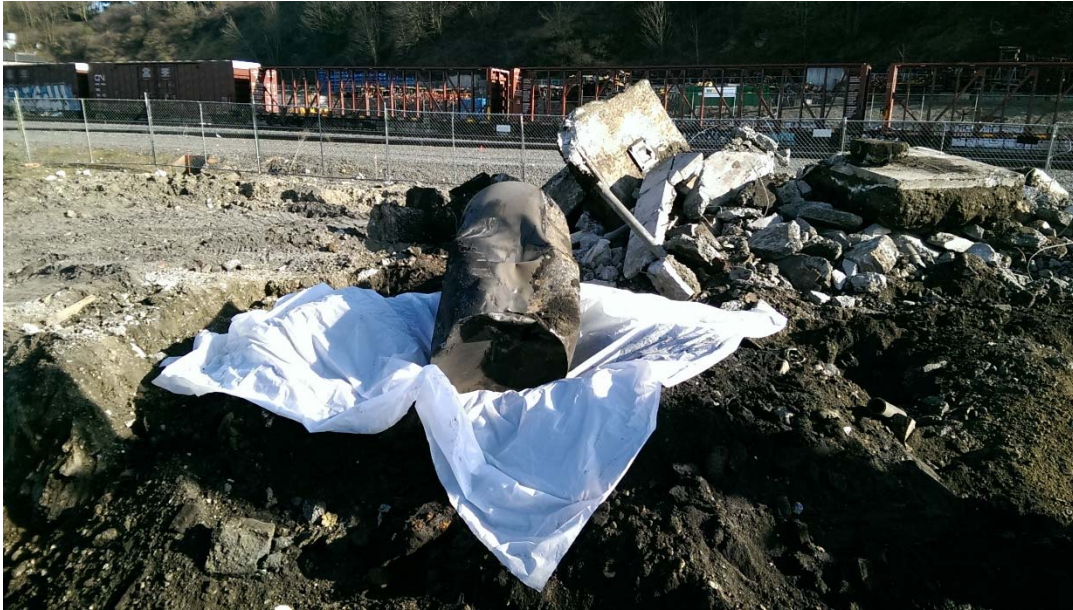
Photograph 3 UST after moving to temporary staging area. View is to the east.
