**ProLogis
Taylor Way Property**

Remedial Investigation

October 3, 2006

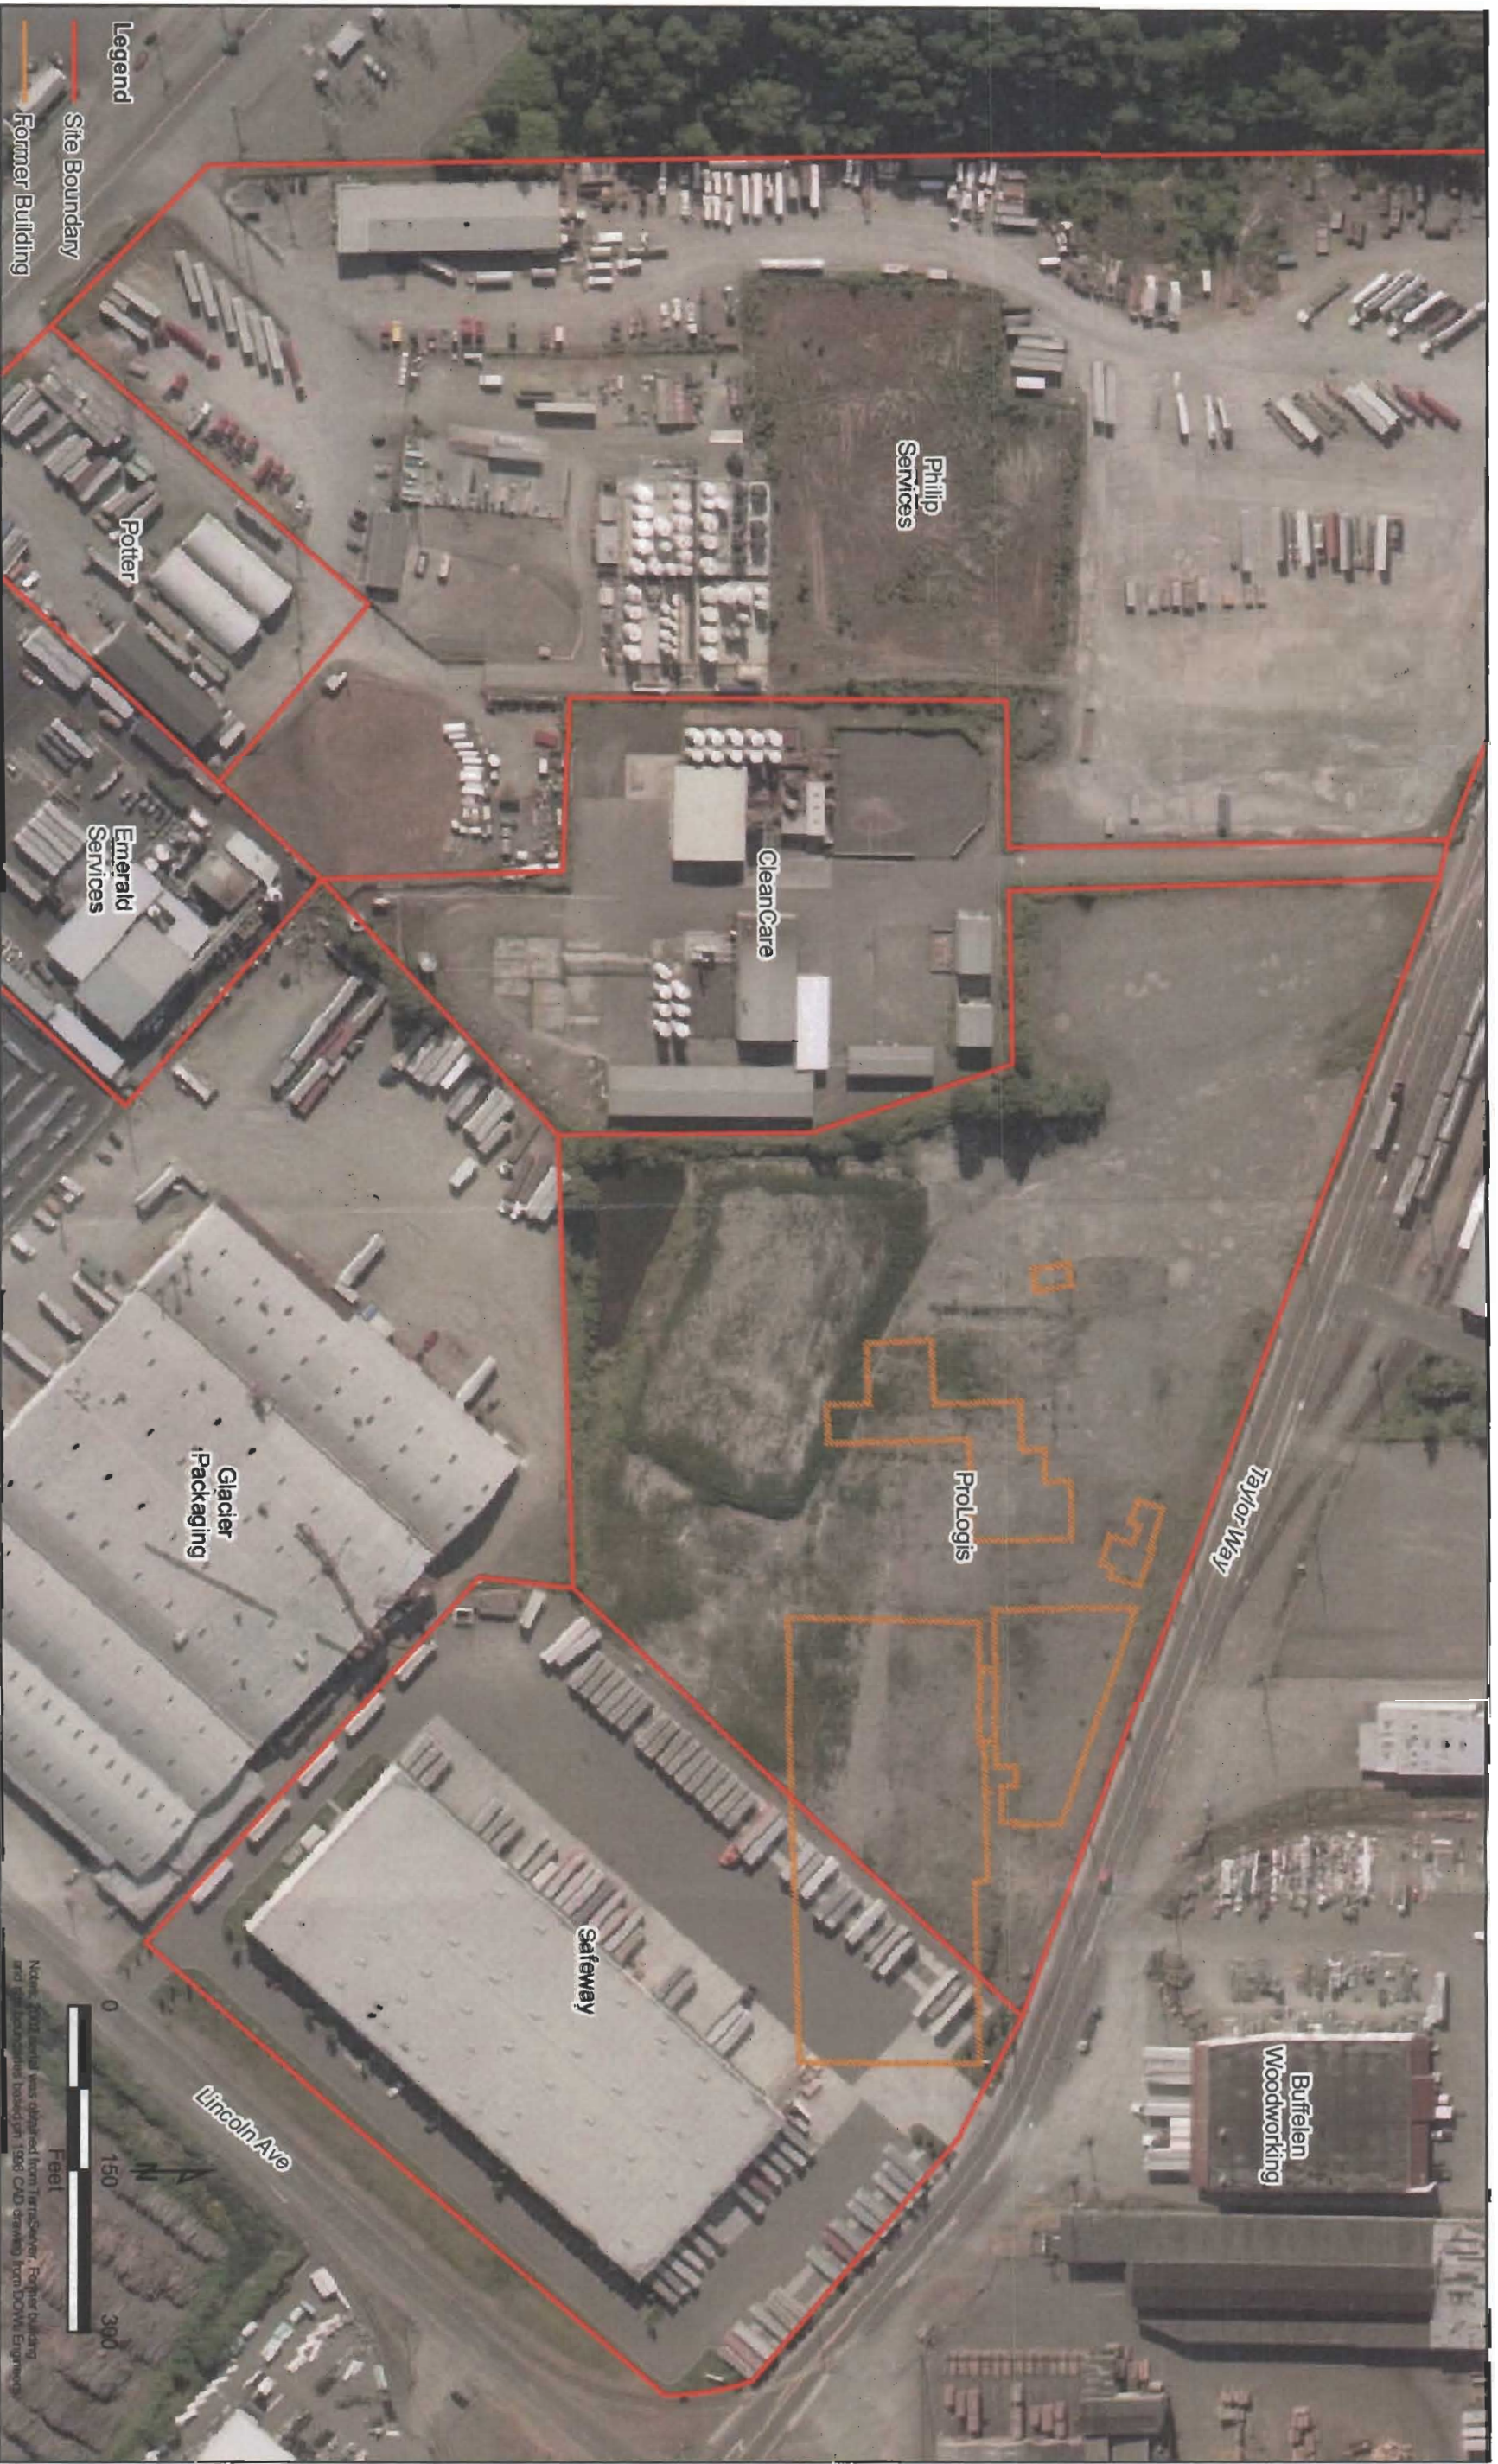
Note: 2002 aerial was obtained from TerraServer, former building and other landmarks based upon 1998 CAD drawings from DOWM Engineering
