Data Gap Investigation

Model Remedy LUST Sites
Yakima County Fire District No. 12
7707 Tieton Drive
Yakima, Washington

Washington State Department of Ecology

January 11, 2017

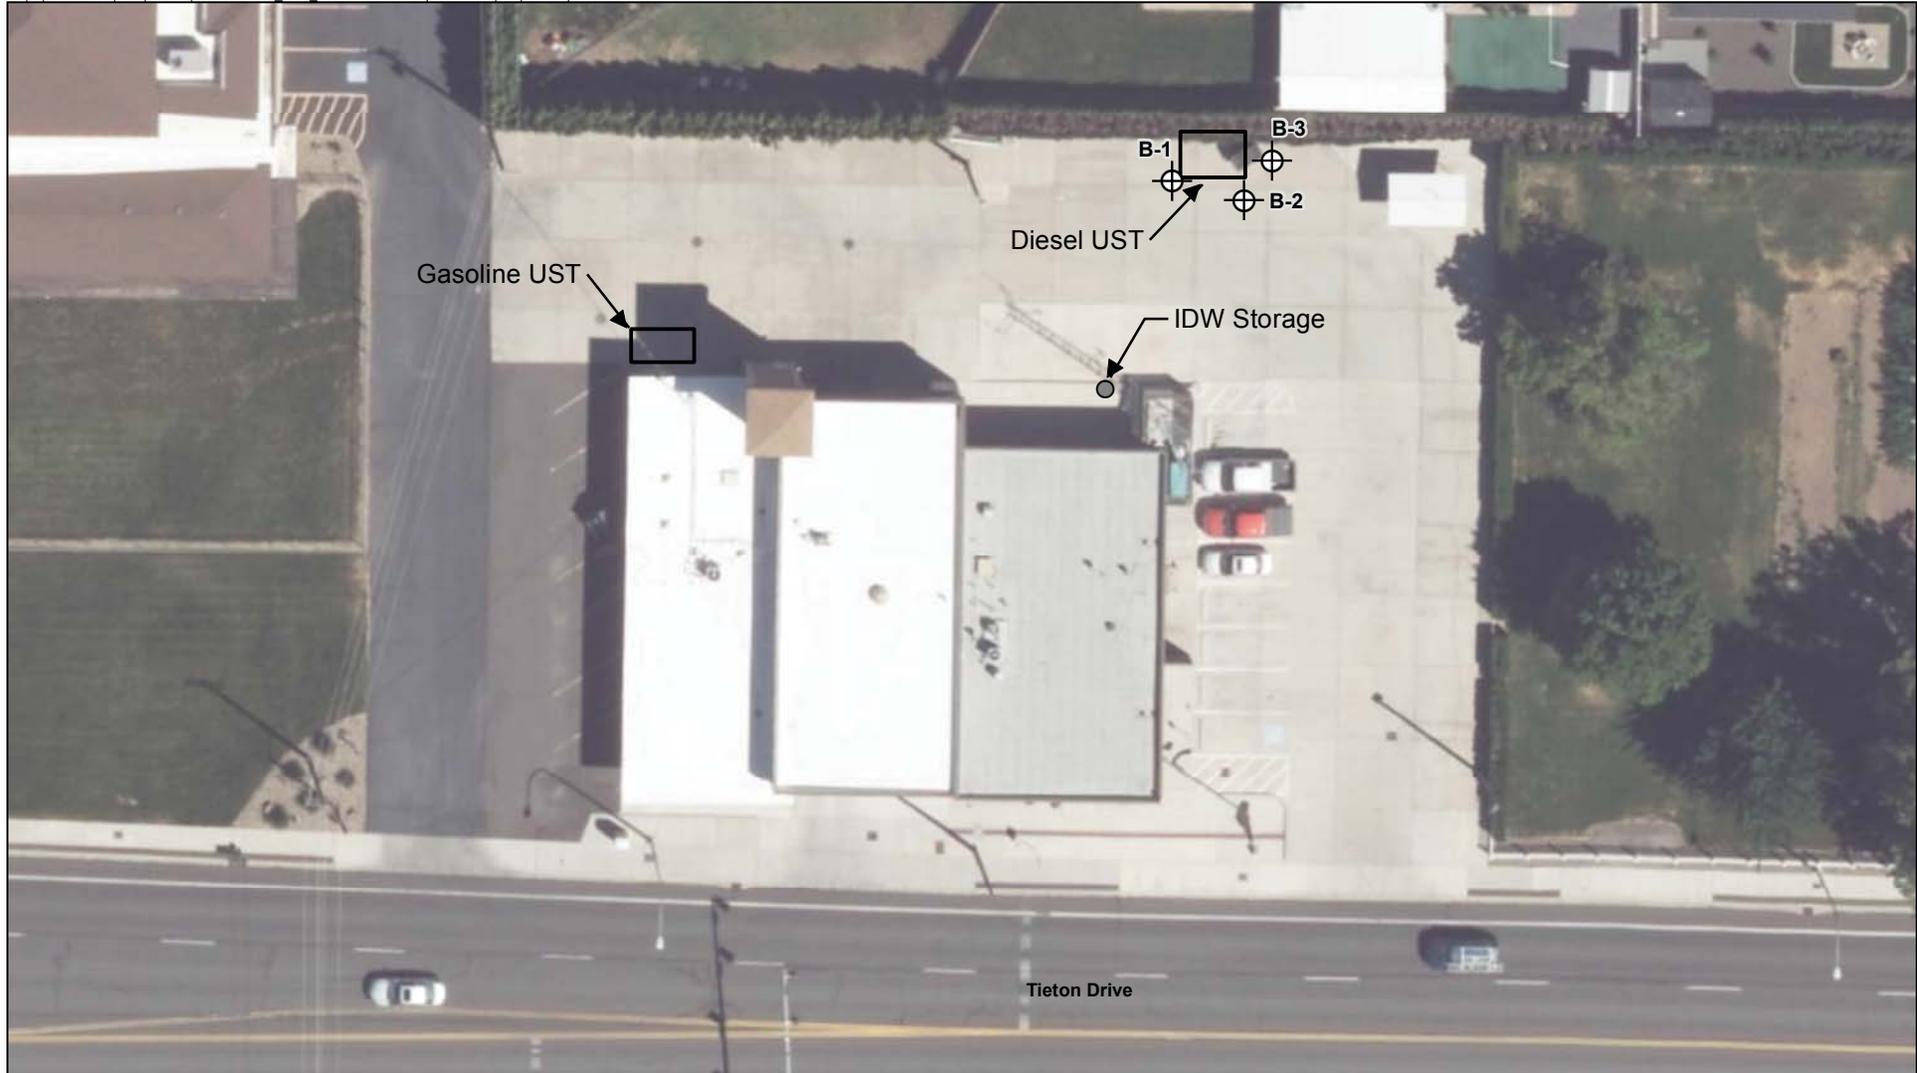
Figure 2

● Investigation Derived Waste (IDW) Storage □ Former UST Approximate Location

⊕ Boring Number and Approximate Location

Site Plan

- Soil boring B-1 was drilled at the southwest corner of the former diesel UST excavation to a depth of about 15½ feet bgs. SPT soil samples were obtained from the 5-, 10-, 12½- and 15-foot-depth intervals for potential chemical analysis.
- Soil boring B-2 was drilled near the southeast corner of the former diesel UST excavation to a depth of about 15 feet bgs. SPT soil samples were collected from the 5-, 7½-, 10-, 12½- and 15-foot-depth intervals for potential chemical analysis.
- Soil boring B-3 was drilled east of the former diesel UST excavation to a depth of 15 feet bgs. SPT soil samples were collected from the 5-, 10- and 12½-foot-depth intervals for potential chemical analysis.

Subsurface conditions at the Yakima County Fire District No 12 site were explored on November 8, 2016, by advancing three air rotary borings at the approximate locations shown on Figure 2. The borings were advanced between 15 and 16 feet below existing site grade using an air-rotary drill rig. Boring locations were established in the field using a site plan and measurements from onsite structures. Consequently, exploration locations should be considered accurate to the degree implied by the method used.
