STATE OF WASHINGTON
DEPARTMENT OF ECOLOGY

Re: No Further Action at the following Site:

- **Site Name:** Flintstone Fuel Inc.
- **Site Address:** 2840c Black Lake Blvd, Tumwater, Thurston Co., WA
- **Facility/Site No.:** 79995945
- **Cleanup Site No.:** 12365
- **VCP Project No.:** SW1563

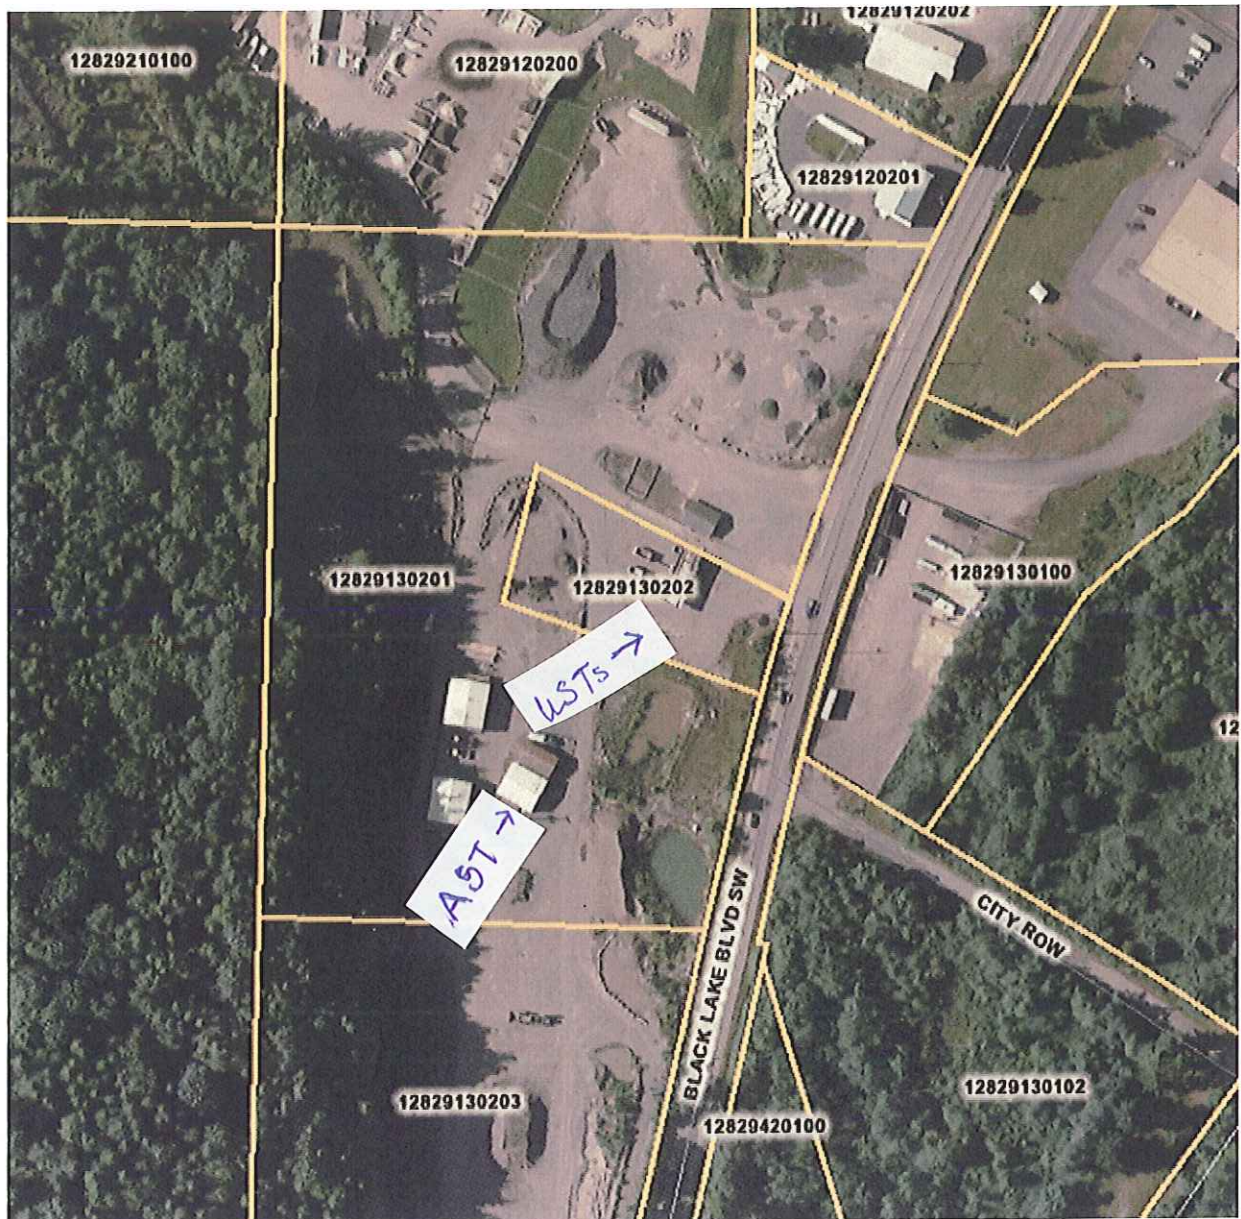
Figure 2 shows the parcel outlines and the locations of the subject facilities.

- The former fueling area, located on Thurston county tax parcel 12829130202. This parcel is 0.90 acres.
- A former above ground storage tank (AST), formerly located on Thurston county tax parcel 12829130201. This parcel is 9.10 acres.

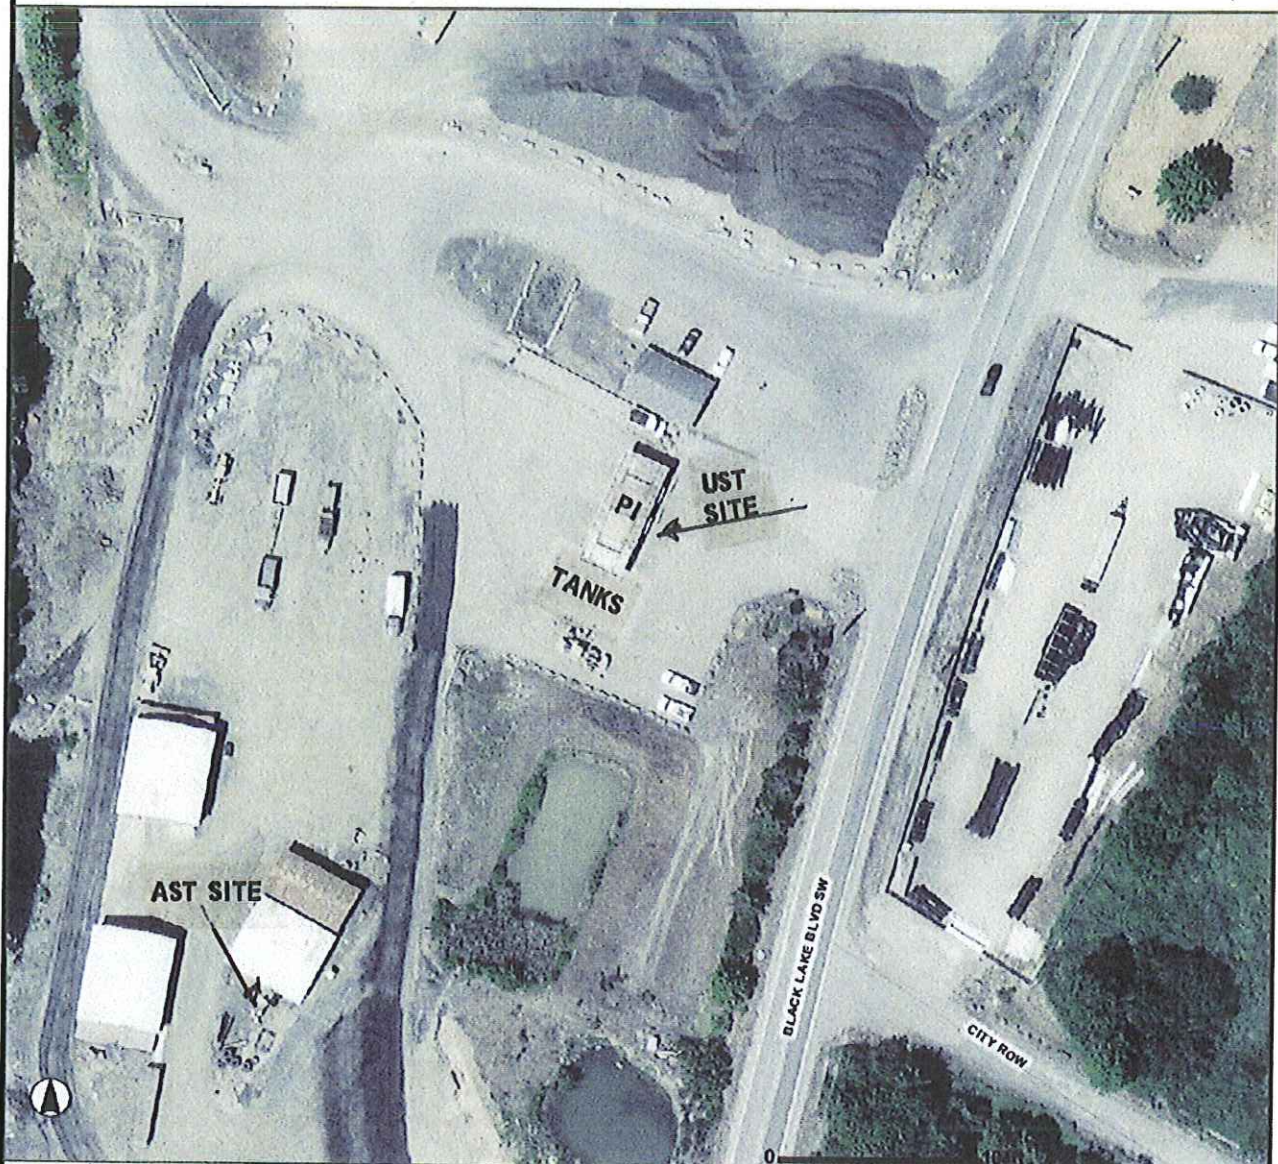
FIGURE 3

The underground storage tank (UST) system was installed in 1987 (Figure 3). All tanks were of single wall construction. It consisted of:

The AST had a 500-gallon capacity and was used to store used motor oil. The tank was located at the side of a building beneath an overhang of the building's roof. The surface beneath the tank was gravel (Figure 3).

- Two 10,000-gallon diesel tanks
- Two 10,000-gallon unleaded gasoline tank
- One 8,000-gallon motor oil tank
- One 8,000-gallon lube oil tank
- Three pump islands

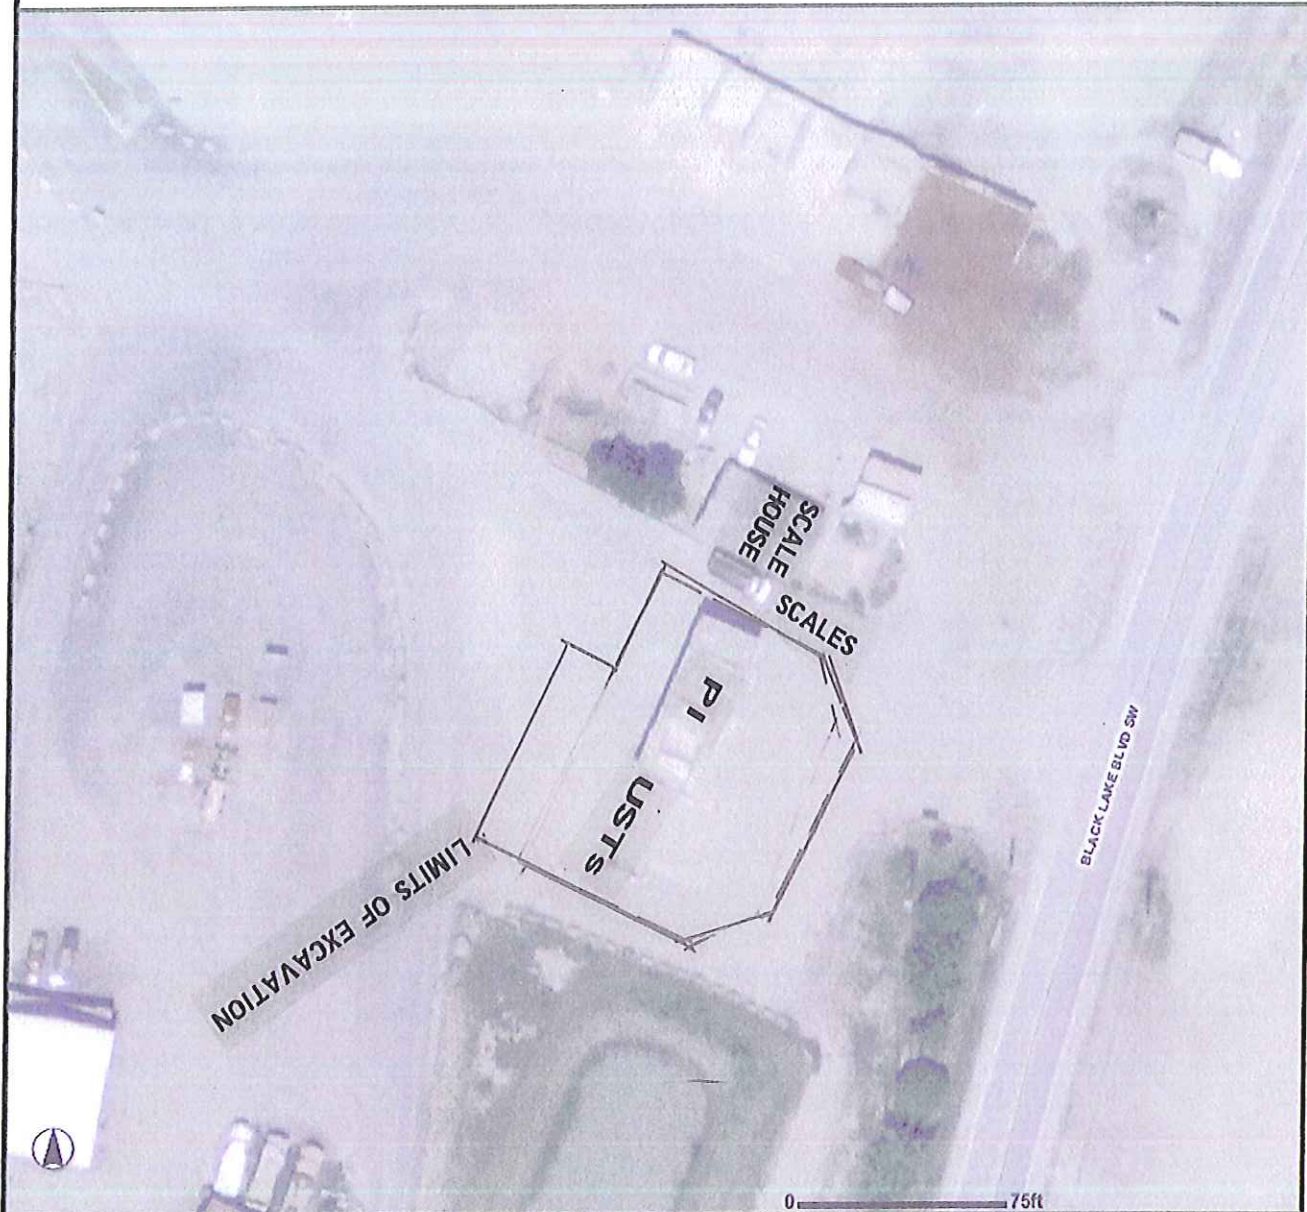
FIGURE 4

Once field screening indicated that all contamination was removed, a total of 54 confirmation samples were taken from the sidewalls and base of the excavation. Figure 4 shows the lateral extent of the excavation; Figure 5 shows the confirmation sampling locations. These samples were analyzed for Total Petroleum Hydrocarbons-Gasoline (TPH-G), TPH-D, Total Petroleum Hydrocarbons-Lube Oil (TPH-LO), and benzene, toluene, ethylbenzene, and total xylenes (BTEX). The only detections above the detection limits were TPH-D at 62 mg/kg, and four detections of total xylenes. The respective Method A cleanup levels for these constituents are 2,000 mg/kg and 9 mg/kg.

The final size of the excavation was approximately 9,500 square feet with a depth of approximately 15 feet bgs at the deepest area. A total of 3,633.90 tons of contaminated soils were transported to the Cowlitz County Landfill in Longview, Washington. Water removed from the Site for treatment totaled 25,129 gallons.

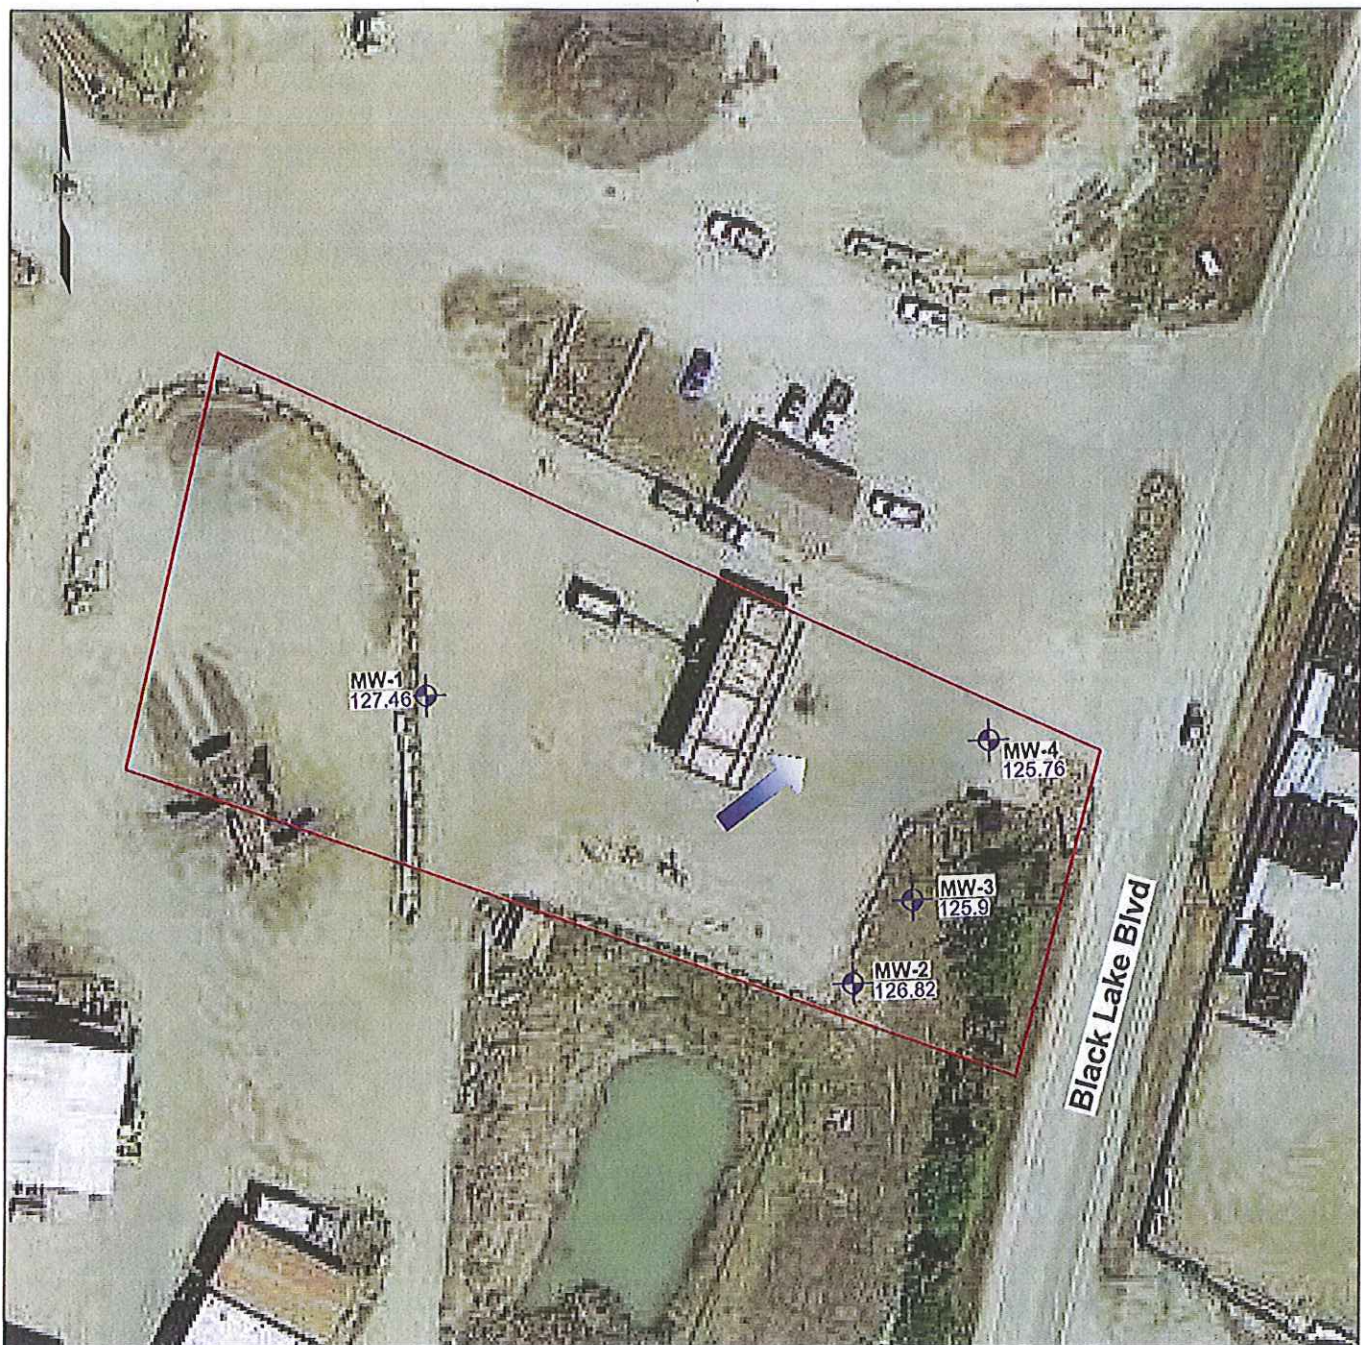
Figure 6
Site Plan with
Groundwater Elevations
(12/14/2015)

On February 19, 2015, four groundwater monitoring wells were installed around the excavated area (Figure 6). The well screens were set at approximately 5 feet to 25 feet bgs. Four rounds of depth to groundwater measurements were taken during groundwater sample collection to determine the groundwater flow direction.

The depth to groundwater in the UST area is approximately 3 feet to 7 feet bgs, as determined when monitoring wells were installed. The flow direction was found to vary up to nearly 150 degrees but was predominantly toward the northeast. The depth to groundwater at the AST location was 5 feet bgs.

Four groundwater monitoring wells were installed at locations around the excavation. Four rounds of quarterly samples were collected and analyzed for the contaminants of concern. All results were non-detect.
