STATE OF WASHINGTON
DEPARTMENT OF ECOLOGY

Re: No Further Action at the following Site:

- **Site Name:** 2911 W Fort George Wright Drive
- **Site Address:** 2911 W Fort George Wright Drive, Spokane, WA
- **Facility/Site No.:** 18251
- **VCP Project No.:** EA0320

Maintenance and Repair Plan for Engineered Controls

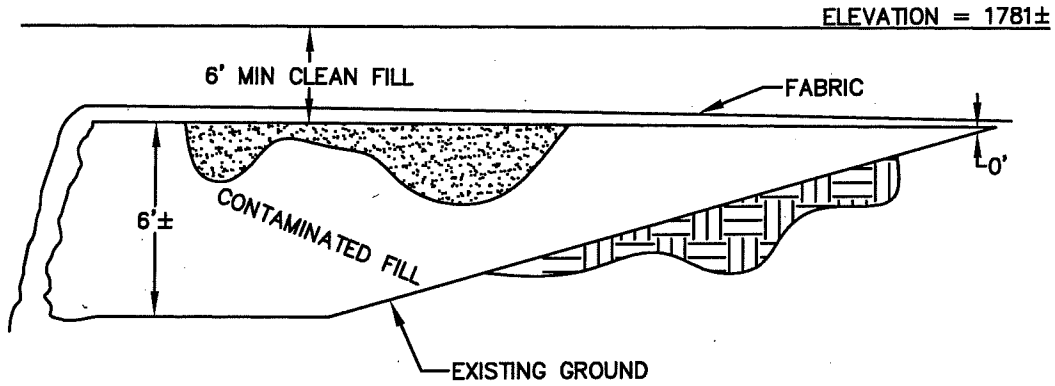
SECTION A-A

CONTAMINATED FILL

**CONTAMINATED FILL
APPROXIMATE
CROSS-SECTIONS**

- A cap was constructed over the contaminated soil. The cap was constructed as follows:
 - Geotextile fabric (WINFAB 400N, data sheet included in Appendix A of the Maintenance and Repair Plan) was placed over the contaminated soil. The geotextile extends approximately 4 feet further than the contamination on all sides and is covered by at least 6 feet of clean fill soil. Soil was compacted using the tracks of an excavator after each approximately 2 foot lift was placed. See Exhibits C and D in **Enclosure B** for figures.

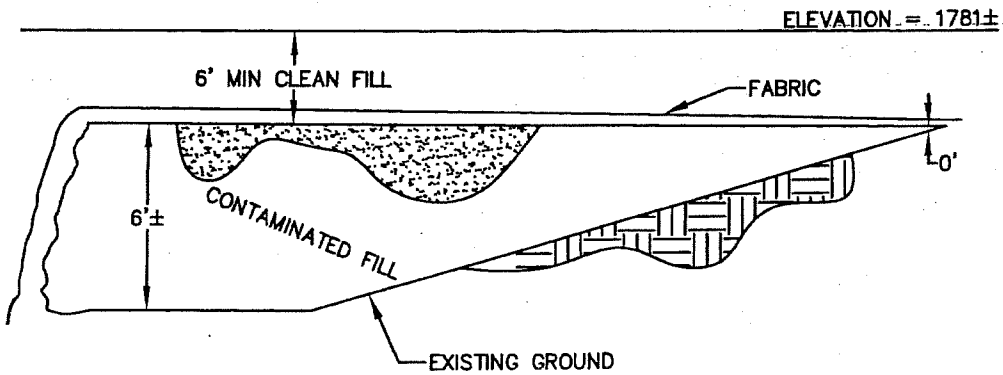
SECTION A-A

CONTAMINATED FILL

**CONTAMINATED FILL
APPROXIMATE
CROSS-SECTIONS**

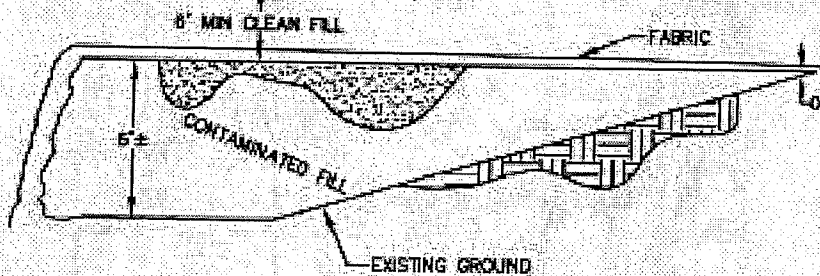
SECTION A-A

ELEVATION = 1781±

CONTAMINATED FILL

CONTAMINATED FILL
APPROXIMATE
CROSS-SECTIONS

CROSS-SECTIONS OF CONTAMINATED SOIL
Lot 7 of Short Plat 216-659FPLT
Spokane, Washington

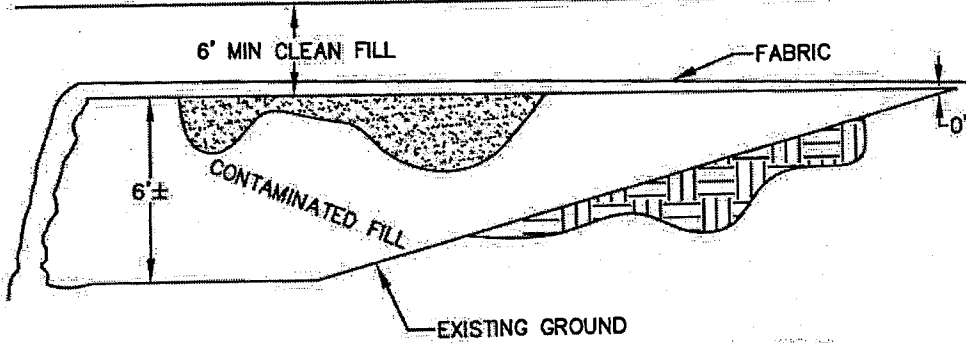
SECTION A-A

ELEVATION = 1781±

CONTAMINATED FILL

**CONTAMINATED FILL
APPROXIMATE
CROSS-SECTIONS**
DURYEY & ASSOCIATES, P.S.
2702 N. Perry Street, Spokane WA 99207
tel: (509) 465-8007
www.duryea-associates.com
JOB NO. 14-1838A
