Feasibility Study

Van Stone Mine
Onion Creek, Washington

for
Washington State Department of Ecology

May 2, 2017

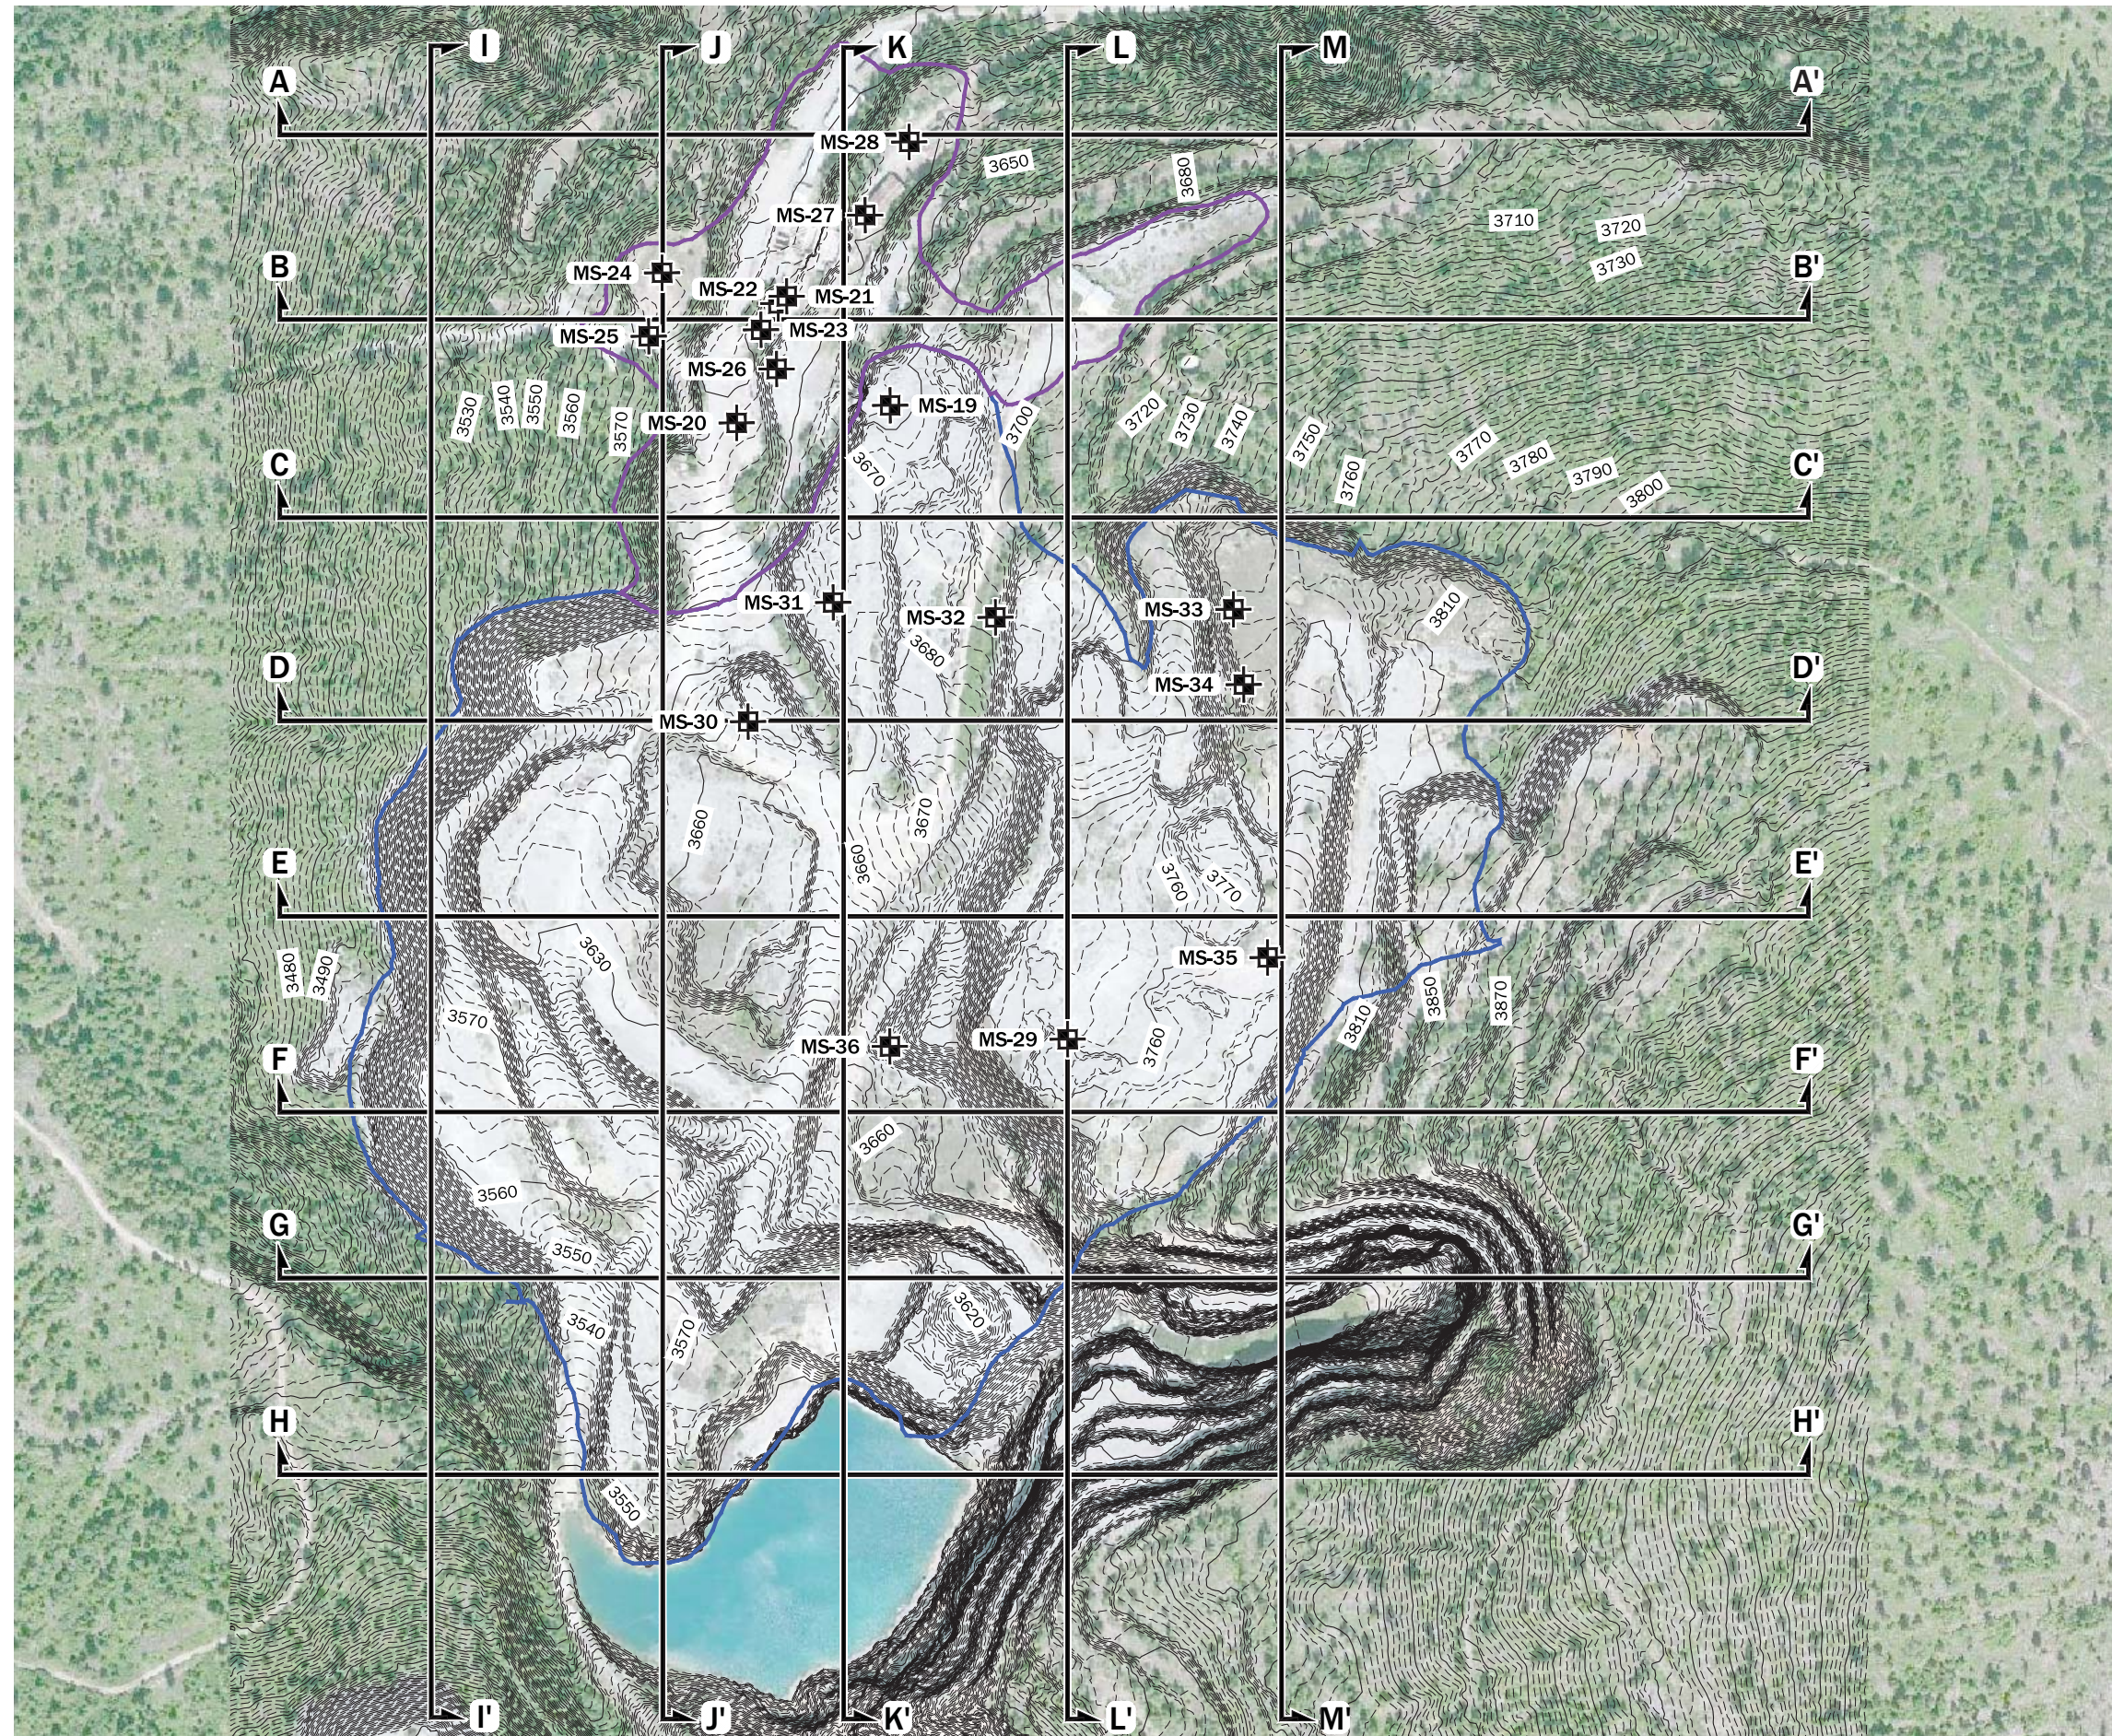
Figure 6

The Lower Tailings Pile and Seepage Recovery Pond comprise the primary site features of AOI-3 (AOI-3 Explorations – Lower Tailings Area, Figure 6). The Lower Tailings Pile was constructed after the 1961 Upper Tailings Pile breach and used until ASARCO ceased operations in 1970. The Lower Tailings Pile was reconfigured by Equinox in the late 1980's and early 1990's to accommodate the 1992 mine reopening. Reconfiguration included re-sloping the existing pile and constructing a PVC-lined containment on top of the tailings deposited prior to 1970.

Five hollow stem borings (HSA-7 through HSA-11) were advanced in AOI-3 (Figure 6) to depths of about 27 to 97 feet bgs to further characterize the area. In addition, two shallow test pits (LT-NS-1 and LT-NS-2) were excavated downstream of the lower tailings pile near a historic water detention pond. Multiple soil samples were collected from various depths in each boring and analyzed for various parameters. Boring logs are provided in Appendix B.
