**SUBJECT: REMEDIAL INVESTIGATION, CLEANUP ACTION REPORT, AND NO FURTHER ACTION DETERMINATION REQUEST
Yale Ave N Parking Garage – Concrete Cutter (CSID 11077)
Seattle, Washington**

PEMCO Eastlake

Remedial Investigation and Cleanup Action Report— 1992 Fuel Line Release

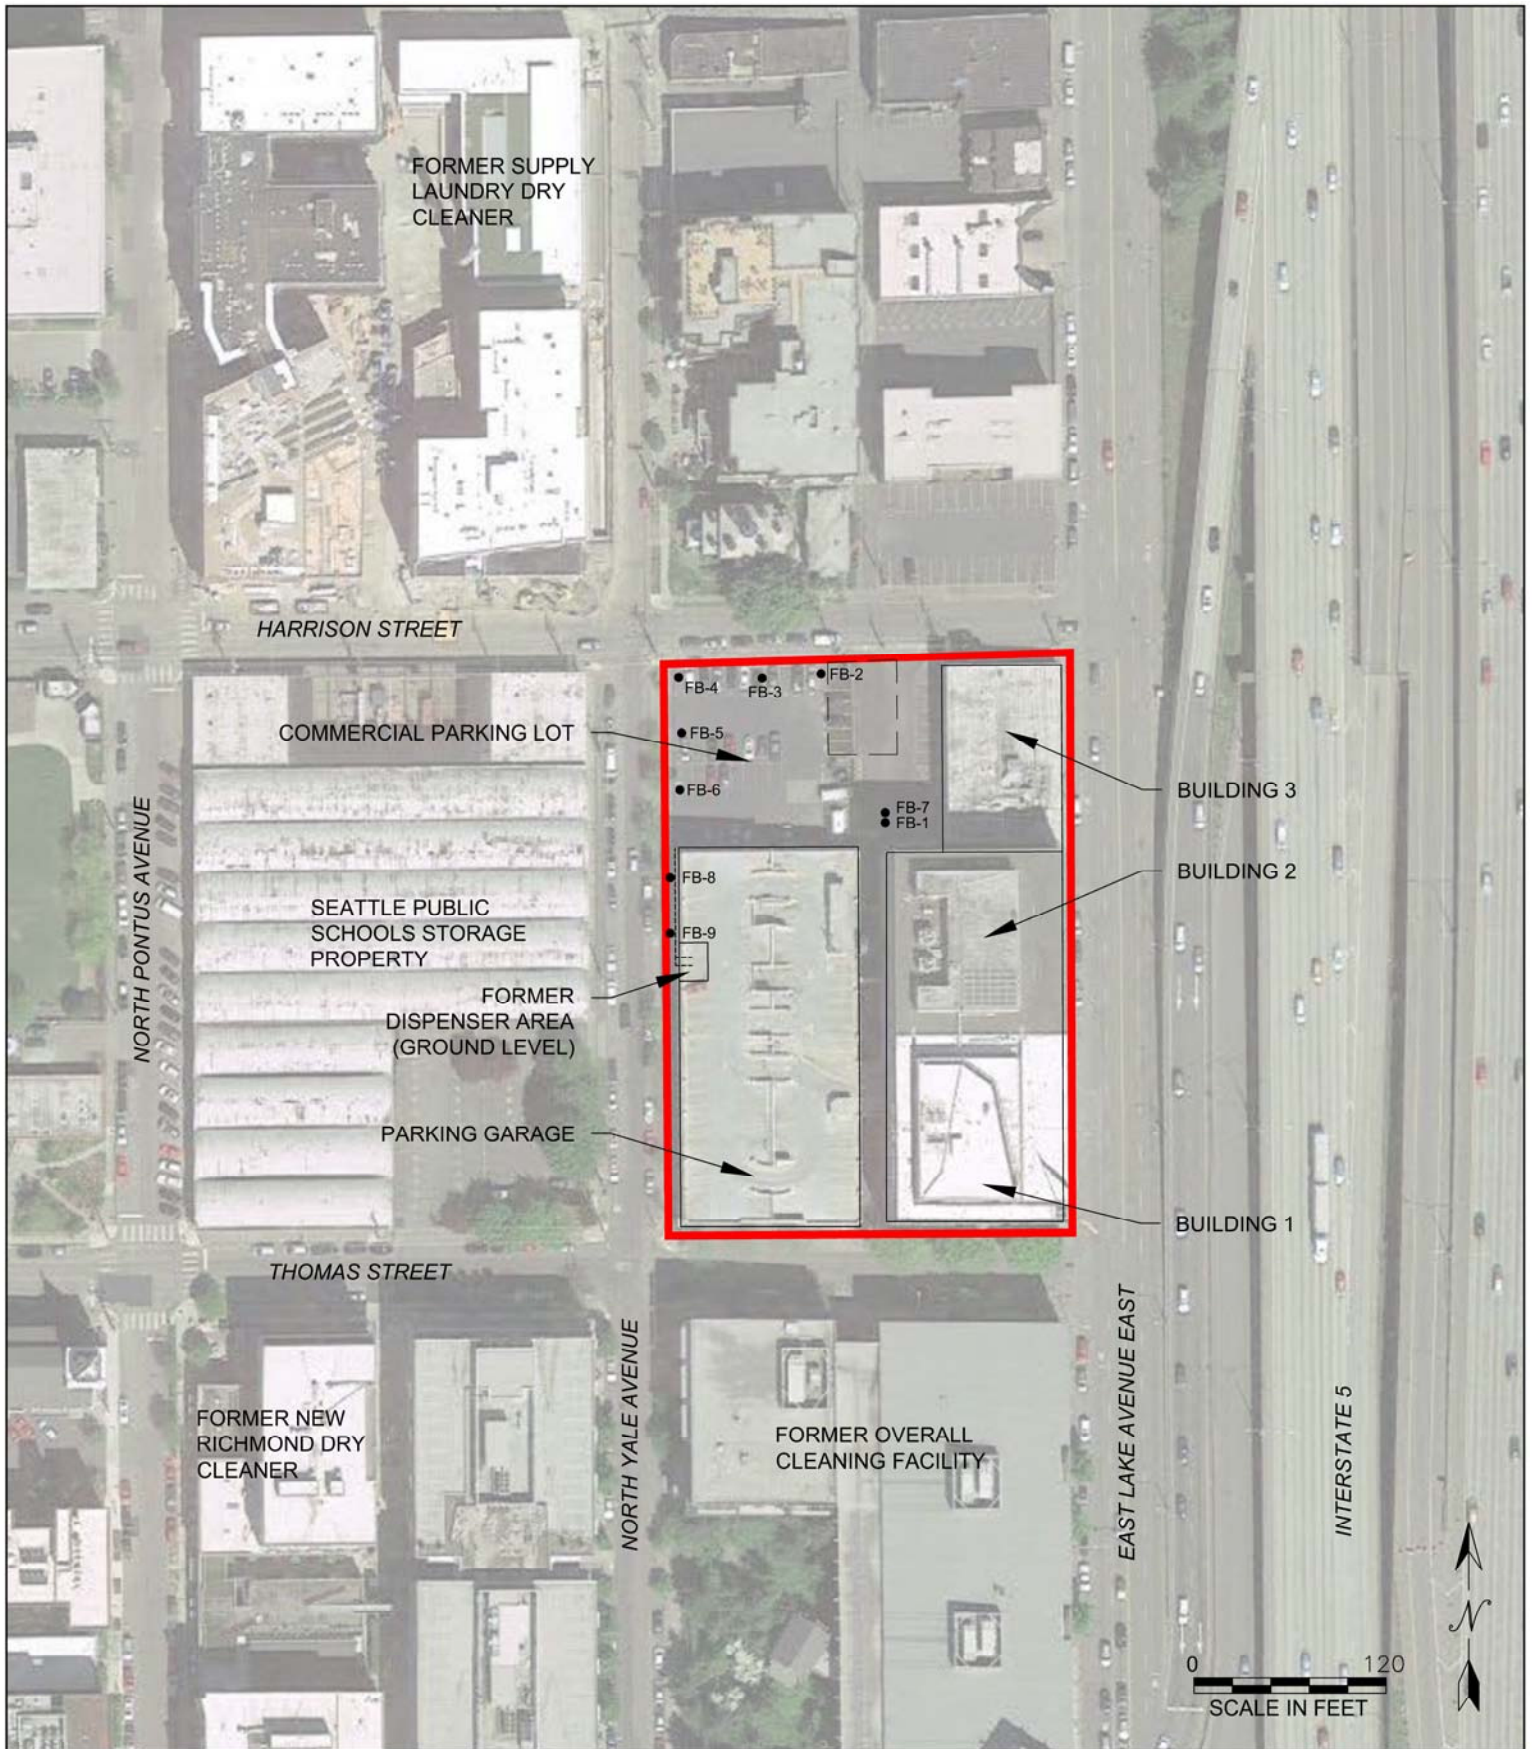
LEGEND	
	SITE BOUNDARY
FB-1 ●	BORING LOCATION (FARALLON, 2015)
	PARCEL BOUNDARY
ALL LOCATIONS APPROXIMATE

Soil samples were collected continuously during the advancement of borings FB-1 through FB-6, FB-8, and FB-9 using a direct-push drill rig. Soil samples were collected every 5 feet during the advancement of boring FB-7 using a hollow-stem auger drill rig. A Farallon Geologist observed subsurface conditions and retained soil samples from selected intervals for laboratory analysis based on field indications of potential contamination. Soil samples collected from borings FB-1 through FB-9 were collected and preserved in accordance with U.S. Environmental Protection Agency (EPA) Method 5035A. The soil samples were transferred directly into laboratory-prepared glass sample containers, placed on ice in a cooler, and delivered under standard chain-of-custody protocols to OnSite Environmental Inc. of Redmond, Washington (OnSite). The information recorded on the boring logs included soil types encountered, visual and olfactory evidence of potential contamination, and volatile organic vapor concentrations as measured using a photoionization detector. The completed boring logs are provided in Attachment A.

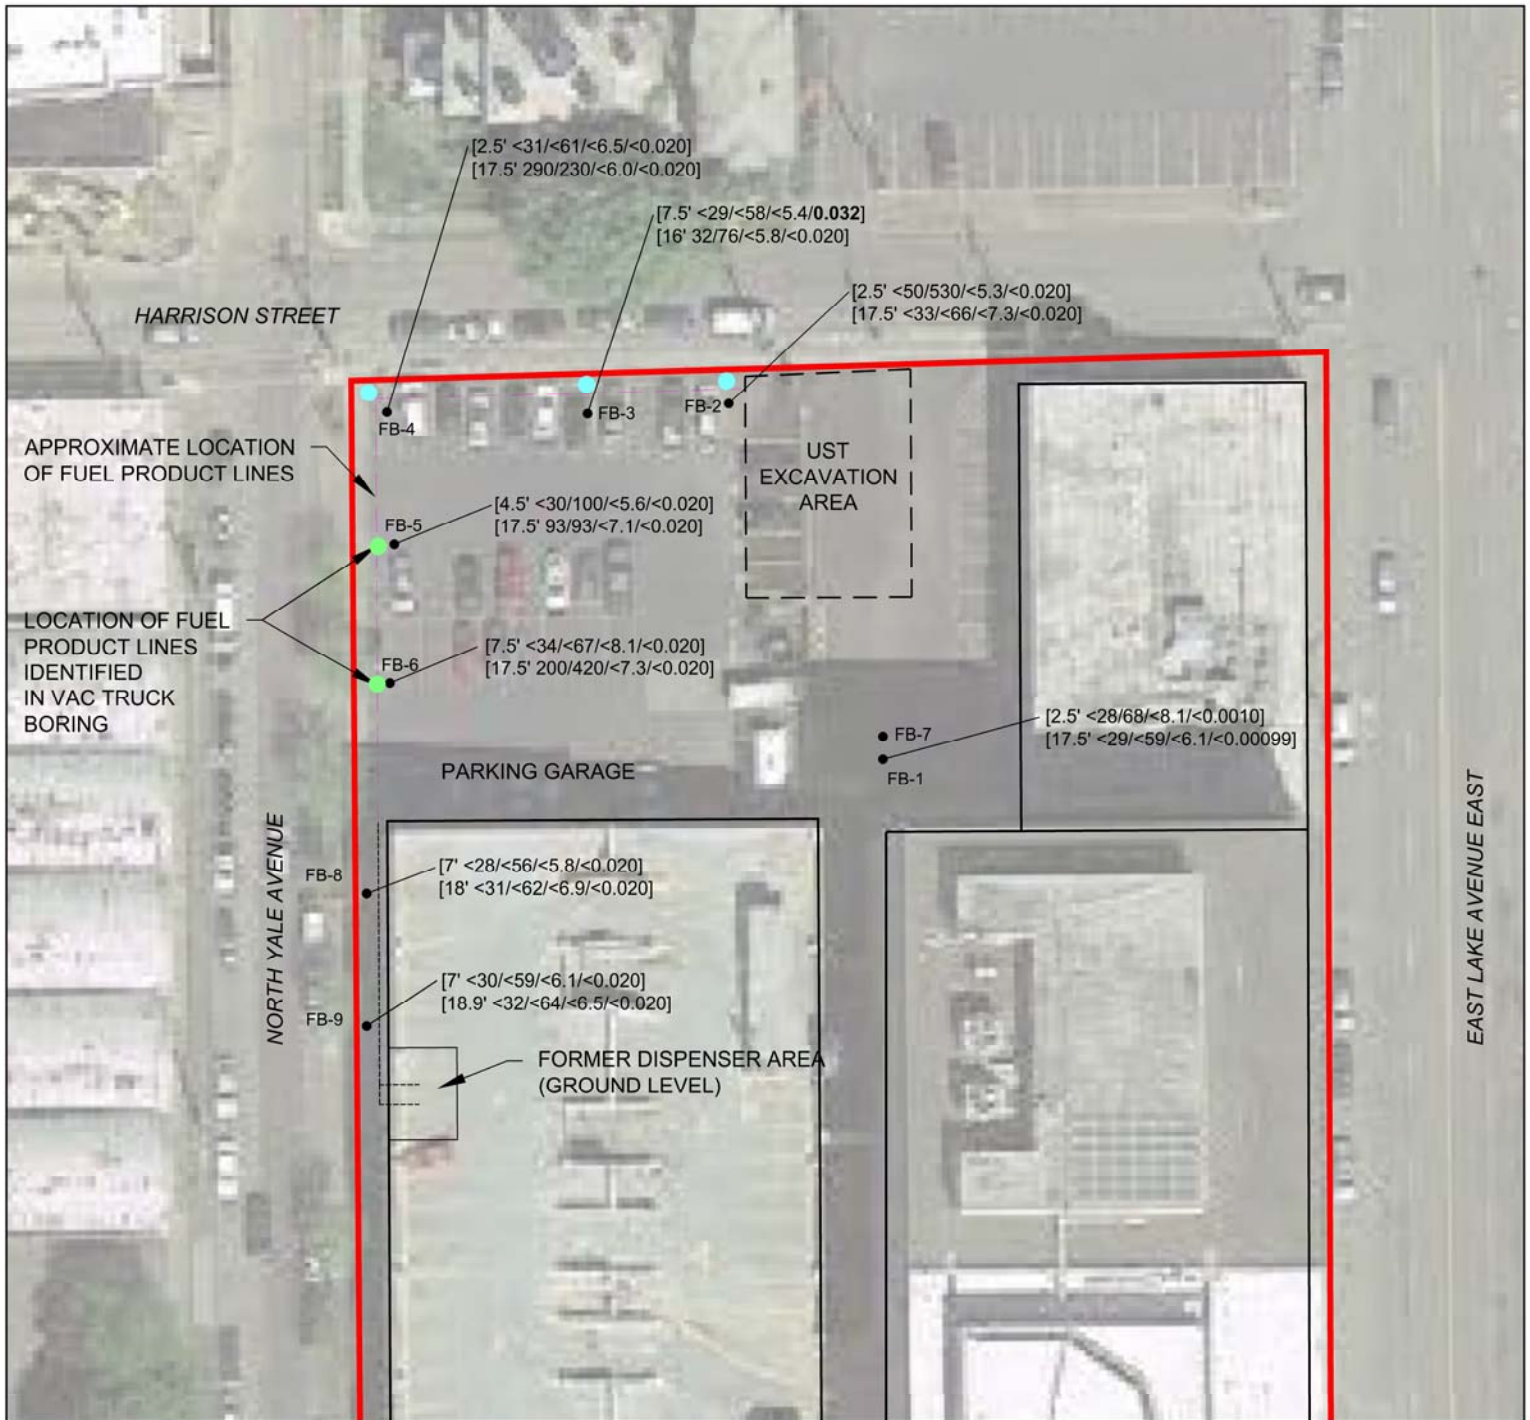
- PARCEL BOUNDARY
- SITE BOUNDARY
- FB-1 BORING LOCATION (FARALLON, 2015)
- CONFIRMED LOCATION OF FUEL PRODUCT LINES IN VAC TRUCK BORING
- BORING LOCATION BY VAC TRUCK - NO PRODUCT LINES ENCOUNTERED

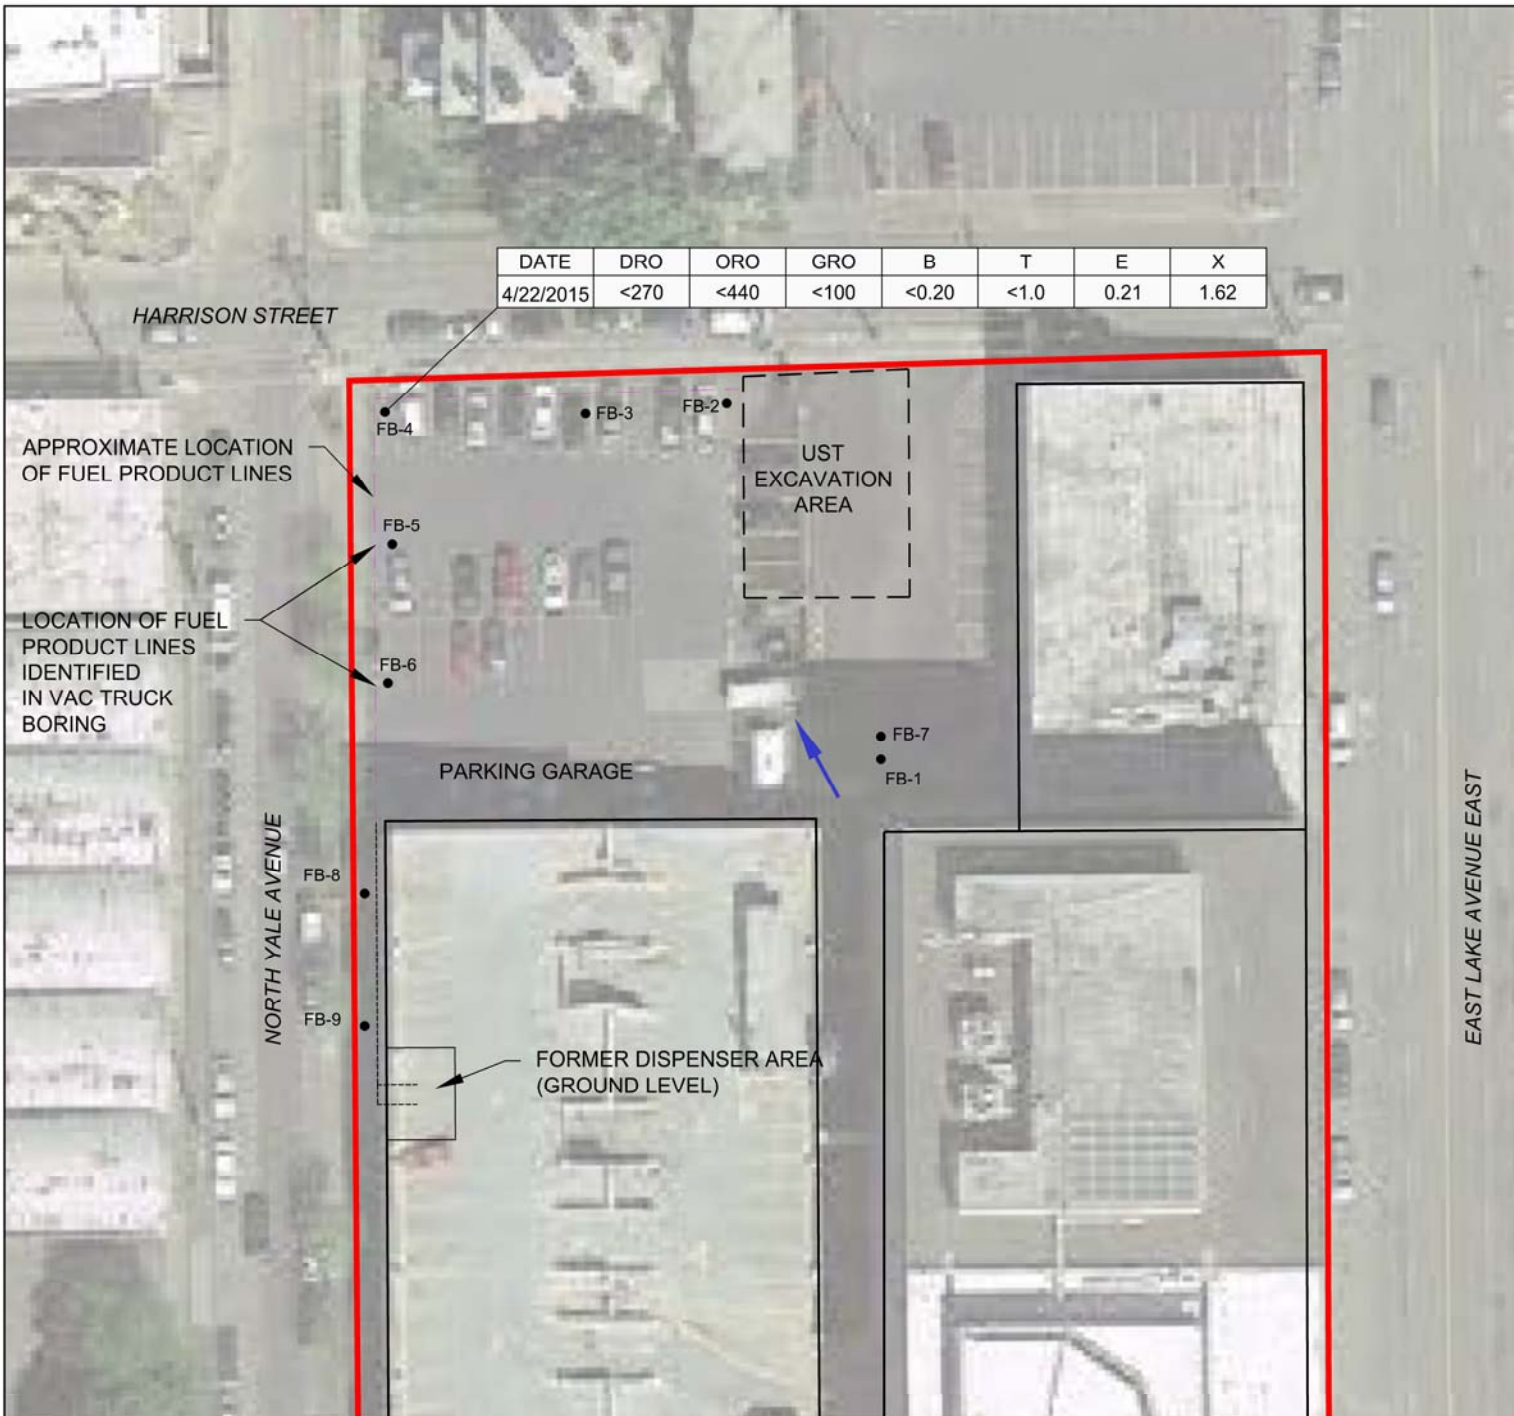
- PARCEL BOUNDARY
 - SITE BOUNDARY
 - FB-1 BORING LOCATION (FARALLON, 2015)
 - ← APPROXIMATE DIRECTION OF GROUNDWATER FLOW
- GROUNDWATER RESULTS IN MICROGRAMS PER LITER
 DRO = TOTAL PETROLEUM HYDROCARBONS (TPH) AS DIESEL-RANGE ORGANICS
 ORO = TPH AS OIL-RANGE ORGANICS
 GRO = TPH AS GASOLINE-RANGE ORGANICS
