# CLEANUP ACTION REPORT (CAR)

14610 Purdy Drive Northwest  
Gig Harbor, Washington 98332

April 26, 2017

ECI Project No. 0359-01-04

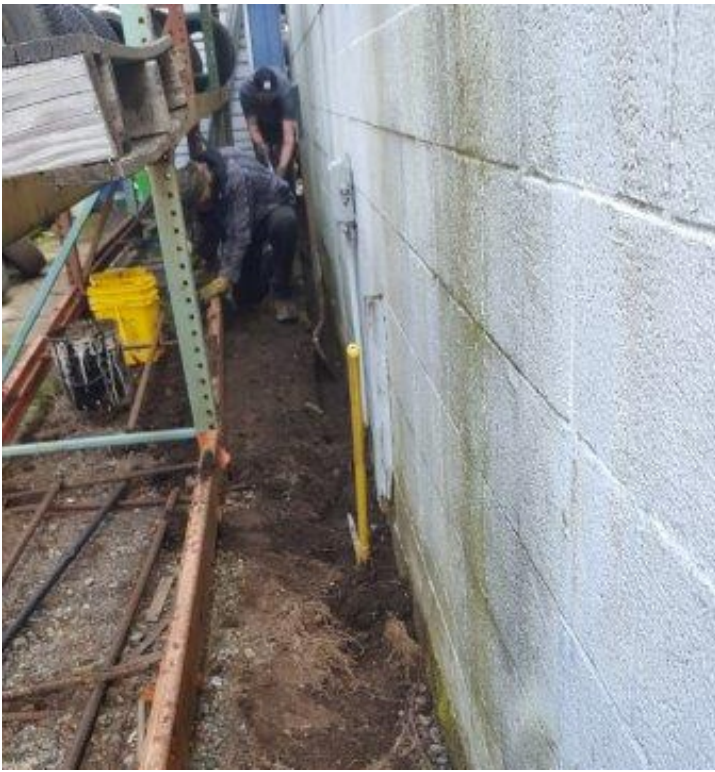
Digging Out Southern Drainage Trench

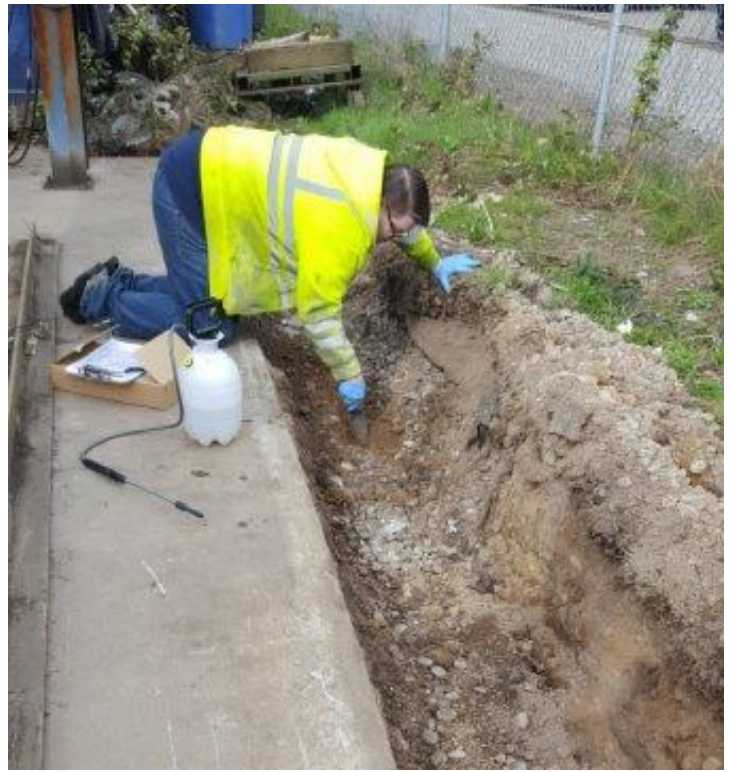
Sampling Northern Drainage Trench

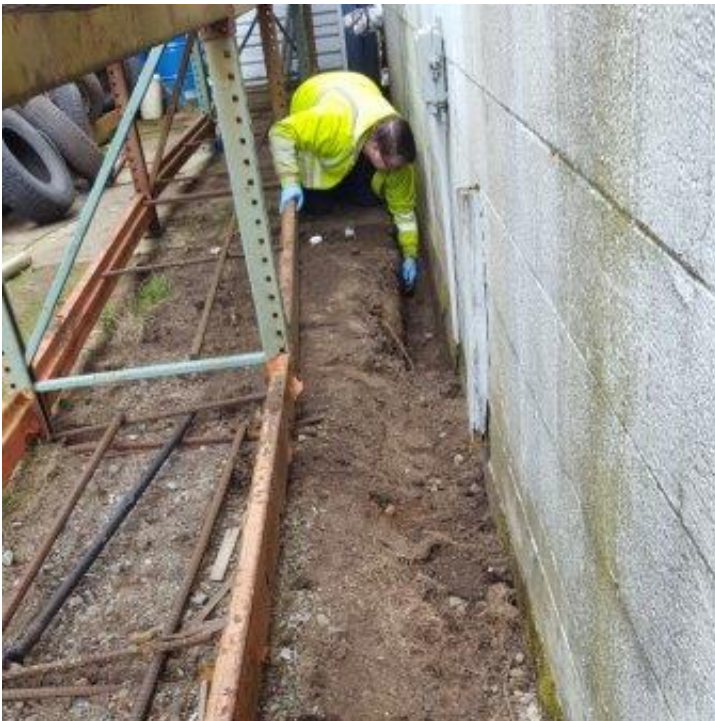
Sampling Southern Drainage Trench

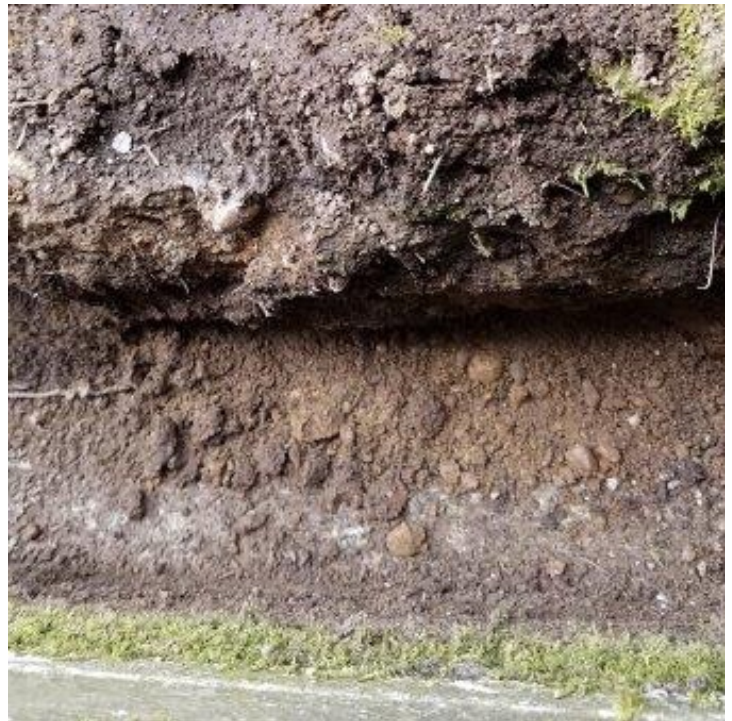
Close-up of Base of Footing Abutting Concrete Slab

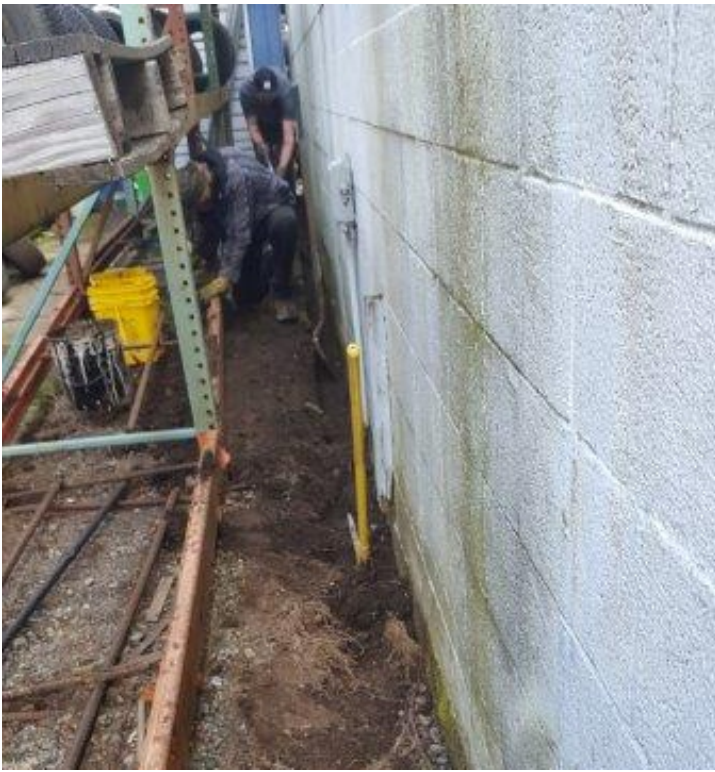
Digging Out Southern Drainage Trench

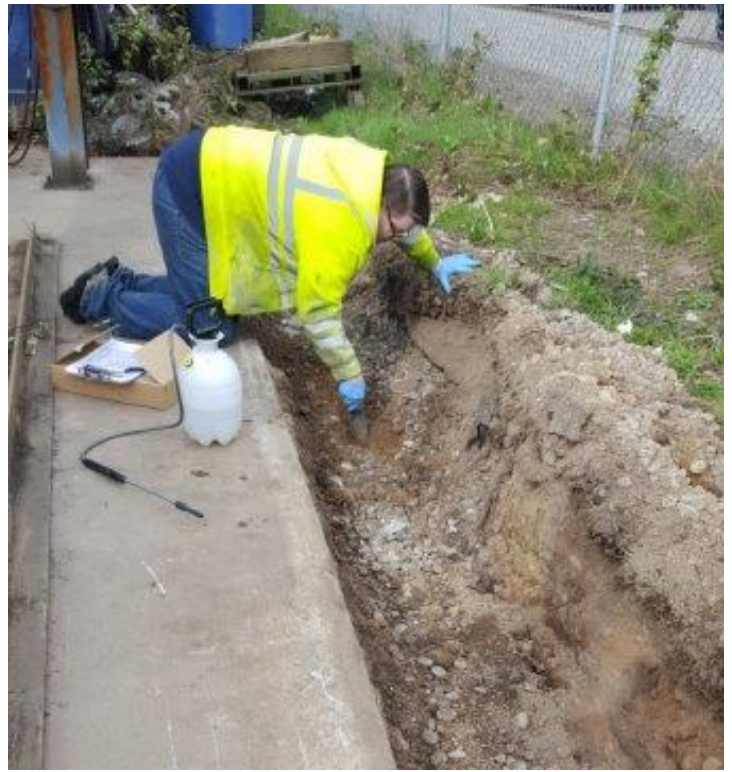
Sampling Northern Drainage Trench

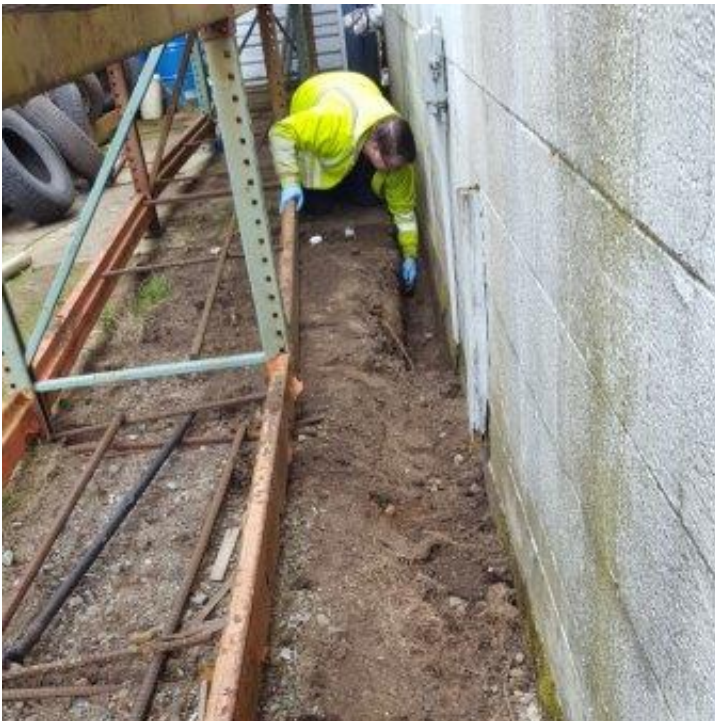
Sampling Southern Drainage Trench

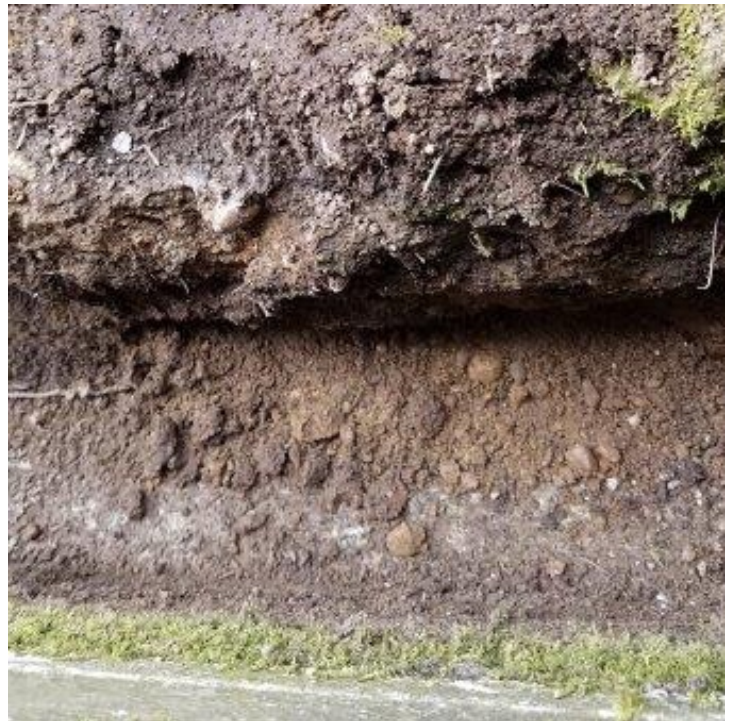
Close-up of Base of Footing Abutting Concrete Slab
