INITIAL INVESTIGATION FIELD REPORT

<u>Site Name (Name over door):</u> Hollywood Video Property	<u>Site Address (including City, State and Zip):</u> 5314 15th Ave NW Seattle, WA 98107	<u>Phone</u> <u>Email</u>
<u>Site Contact, Title, Business:</u> Timothy Johnson GeoTech Consultants, Inc	<u>Site Contact Address (including City, State and Zip):</u> 13256 NE 20th St, Ste 16 Bellevue, WA 98005	<u>Phone</u> (425) 747-5618 <u>Email</u> TimJ@geotechnw.com
<u>Site Owner, Title, Business:</u> William Oseran, Manager ETI4 LLC	<u>Site Owner Address (including City, State and Zip):</u> 2030 Dexter Ave N #400 Seattle, WA 98109	<u>Phone</u> <u>Email</u>
<u>Site Owner Contact, Title, Business:</u> ETI4 LLC	<u>Site Owner Contact Address (including City, State and Zip):</u> 2030 Dexter Ave N #400 Seattle, WA 98109	<u>Phone</u> <u>Email</u>
<u>Previous Site Owner(s):</u> Several	<u>Additional Info (for any Site Information Item):</u> ENL to William Oseran, ETI4 LLC E-cc: Timothy Johnson

This II was referred to Roger Nye but not immediately completed. PCE levels in GW are high enough to trigger vapor intrusion concerns in a building on site. It is unknown if the source of contamination is from this

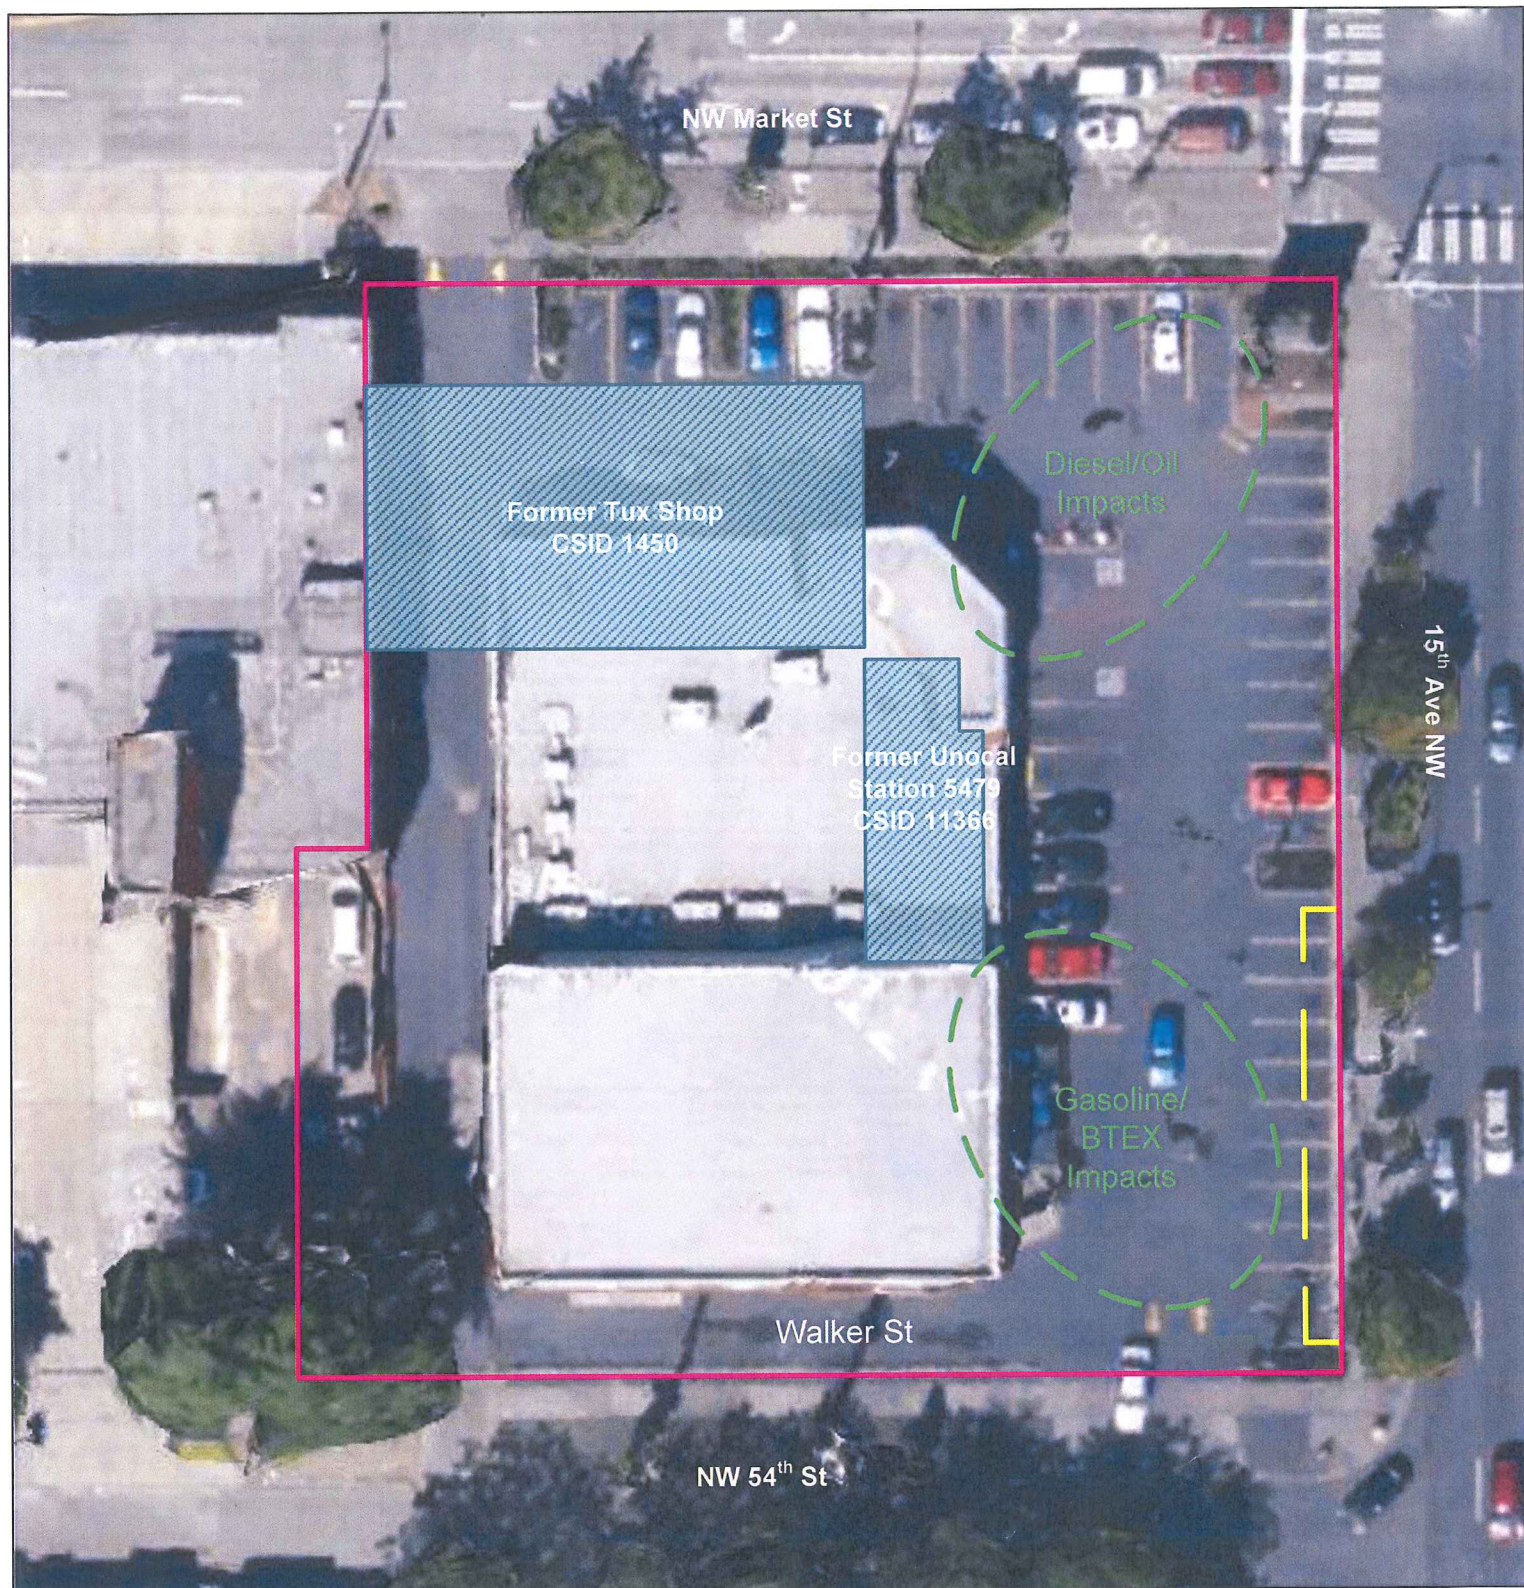
Site Overview Map

- Property Location (approximate)
- Former Building Location (approximate)
- Excavated Impacted Soil (approximate)
- Remaining Impacted Soil (approximate)

Unocal 5479
5409 15th Avenue NW
Seattle, WA 98107

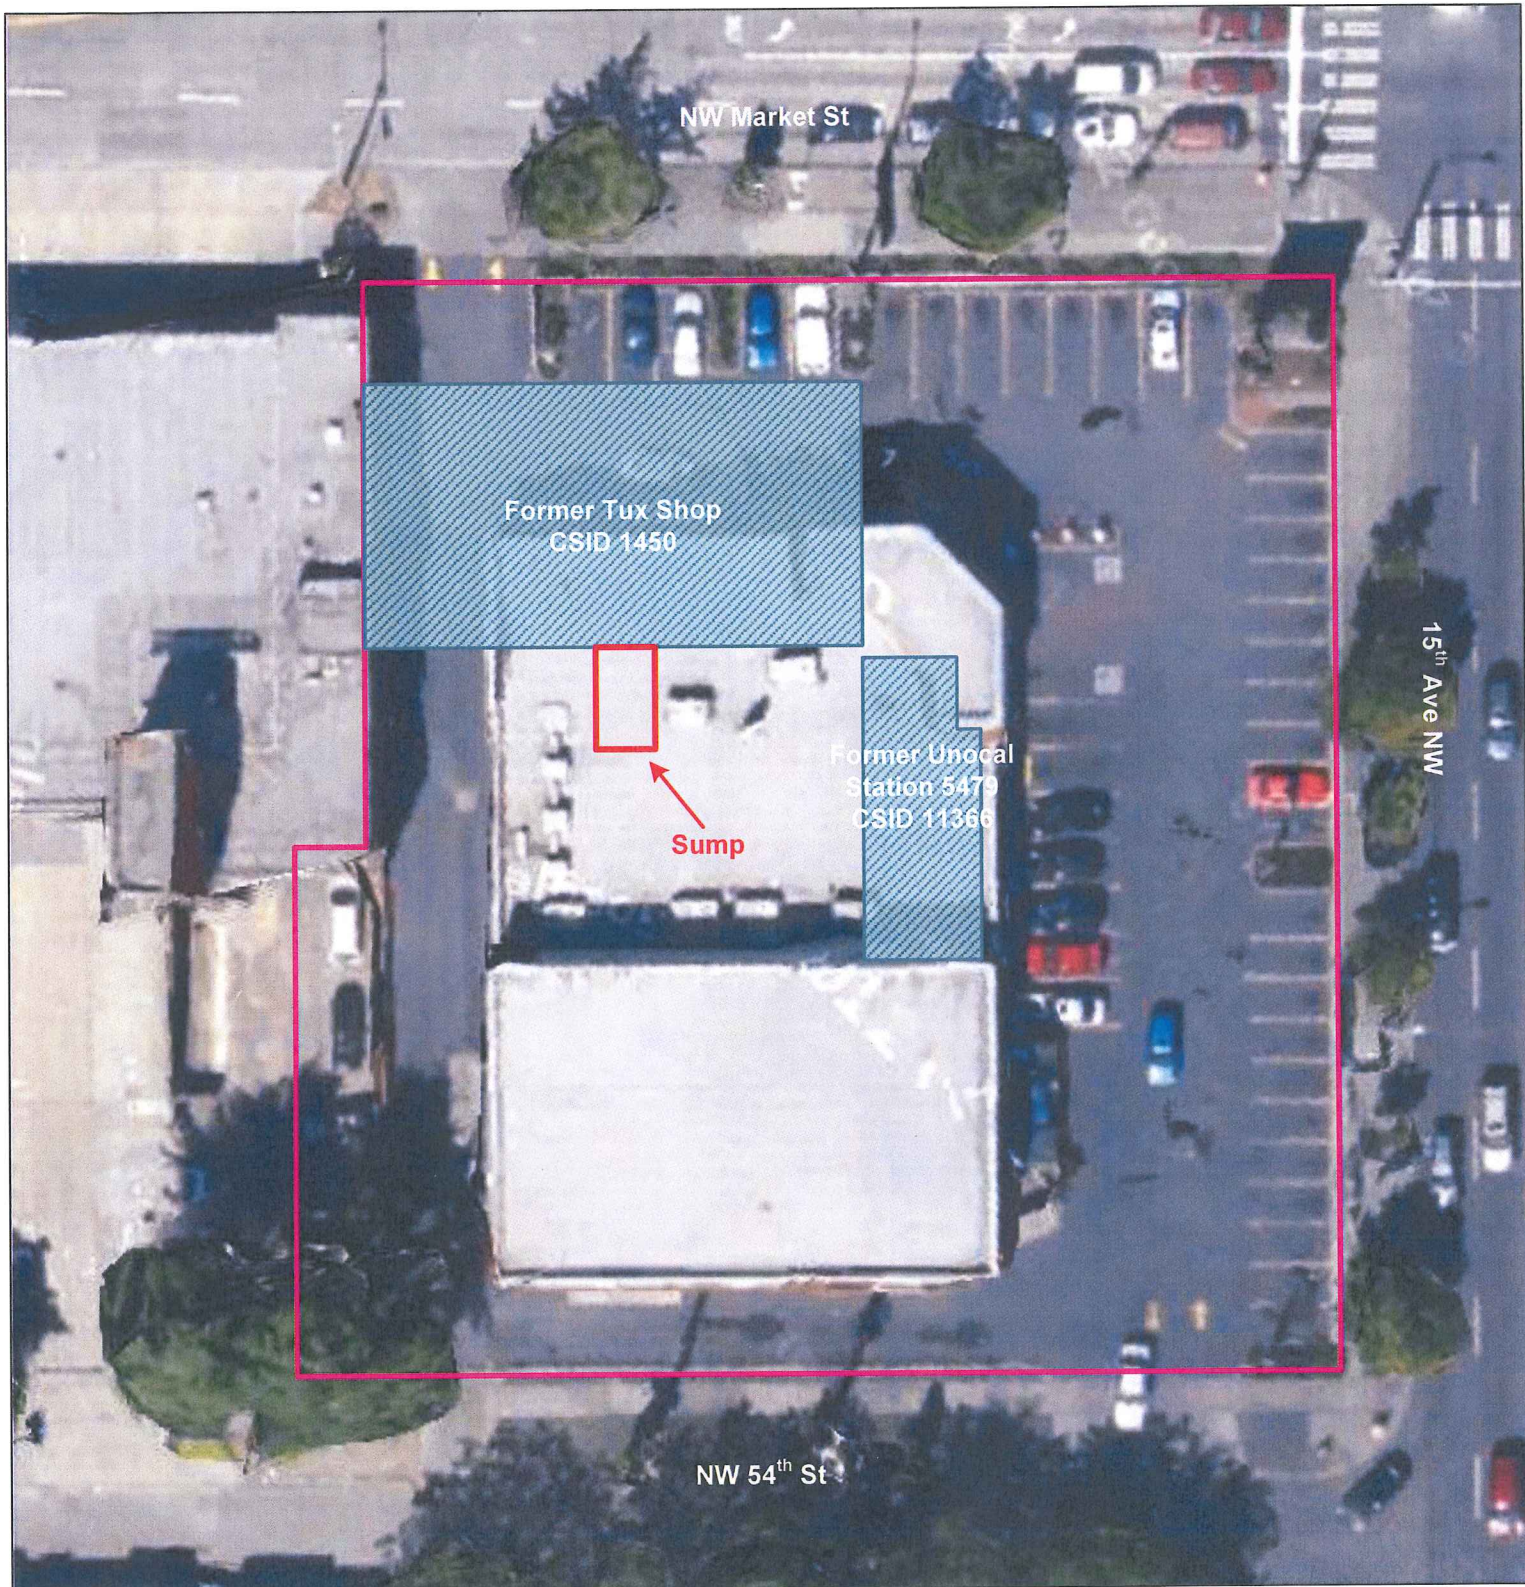
Site Overview Map

- Property Location (approximate)
- Sump Excavation Location (approximate)
- Former Building Location (approximate)

The Tux Shop
5409 15th Avenue NW
Seattle, WA 98107
