Whitman
Environmental Sciences

February 21, 2014

Subject: Environmental Site Investigation
7514 to 7536 15th Avenue NW
Seattle, Washington

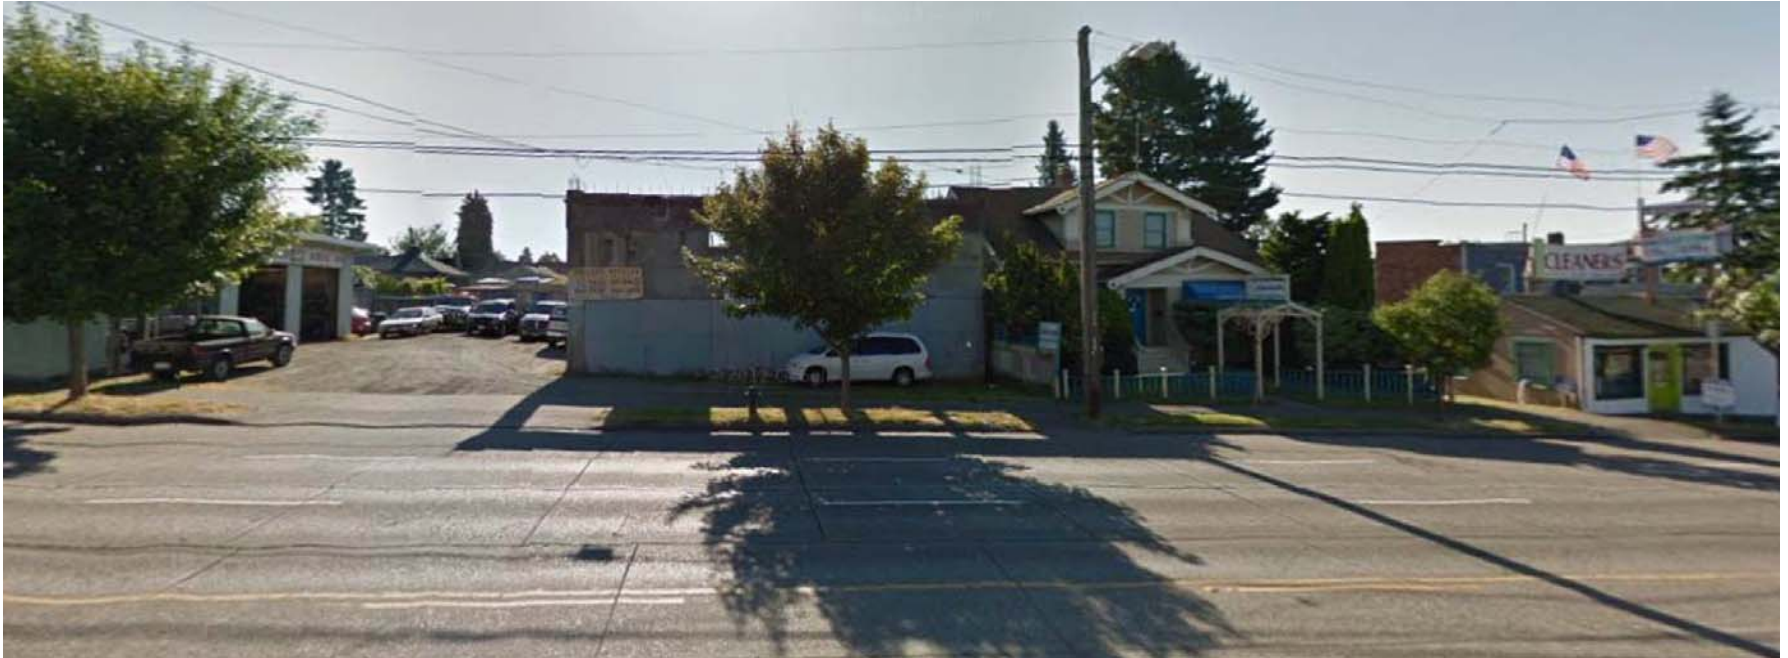
1.) View of 7530, the abandoned structure, 7518 and 7514 15th Avenue NW, facing east.

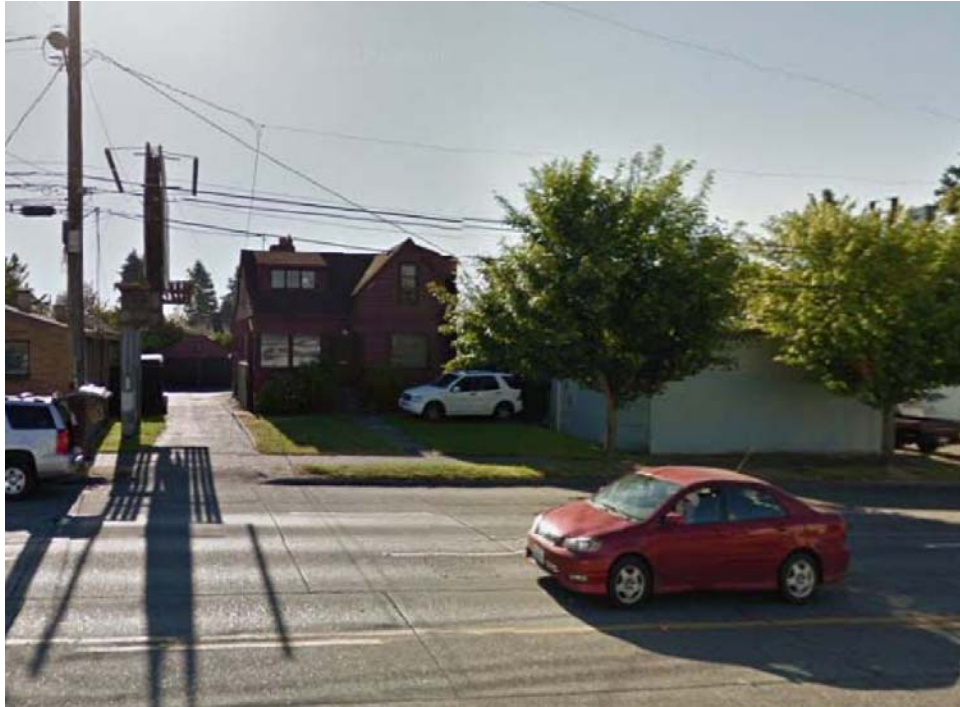
2.) View of 7536 15th Avenue NW, facing east.

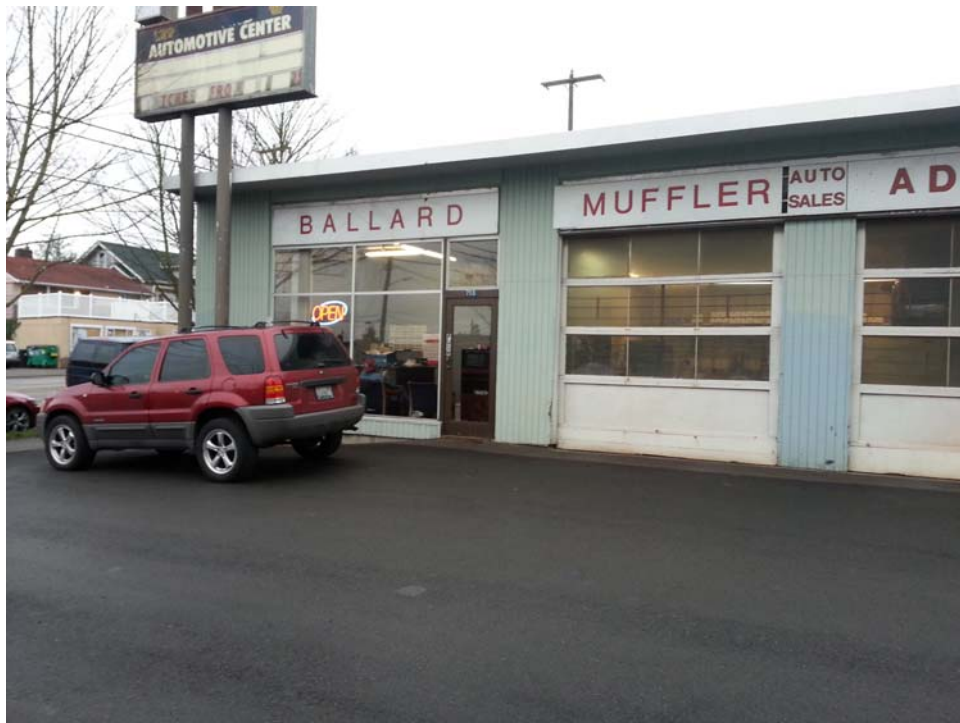
3.) View of the front of the Muffler shop at 7530 15th Avenue NW.

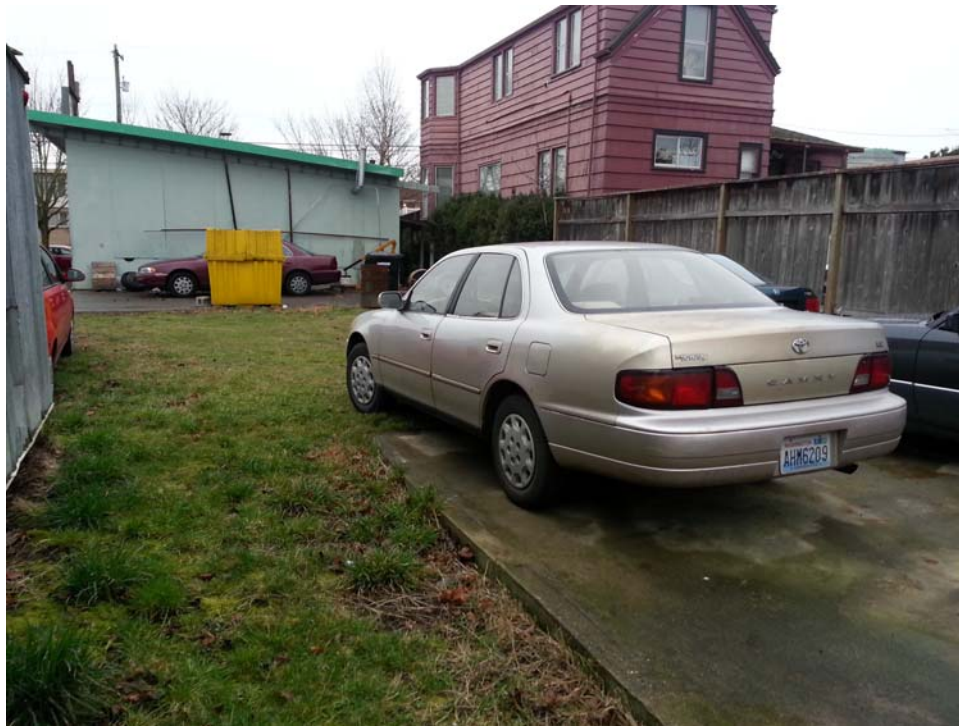
different names. In the past the building was larger than its current dimensions, with a shed type roof on the eastern side of the building holding two additional service bays. There was also a small garage located at the northeastern corner of the lot until about 2010, when the dilapidated structure was removed. The concrete slabs from both of these features remain in place.

- 4.) View of the area adjacent to the muffler shop. The concrete slabs remain from prior garages that have been removed.

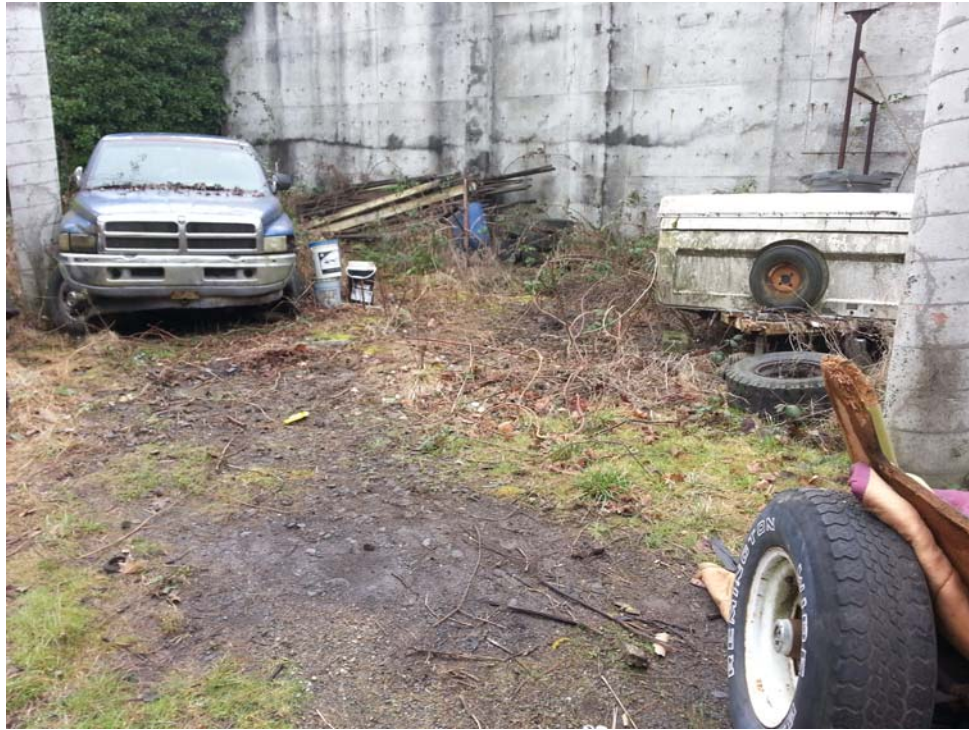
The abandoned structure is a partially built two story concrete building that has no roof or floor slabs. The window and door openings have been boarded over. By all appearances, construction was halted abruptly. Aerial photographs show the structure in place since at least 1990. There is no address on the building, but King County property records associate the parcel with the muffler shop at 7530 15th. The structure is not in a useable condition and has since become a disposal site for unwanted debris, tires, vehicles and oil containers, mostly in poor condition. Historical aerial photographs show the structure has been used for storage various vehicles and debris throughout most of its history. At the time of our site reconnaissance there were at least two 55-gallon drums of oil that were poorly secured and in poor condition inside the structure.

6.) View of vehicles and debris stored in the abandoned structure.

Although no widespread indications of contamination were found in the environmental sampling, it should be assumed that there will be at least minor conditions which will need to be addressed as part of the redevelopment of the property. Surficial staining in the abandoned structure will need to be addressed, which could generate 8-10 cubic yards of petroleum contaminated soil. Other staining could become evident in that area once debris and vehicles have been removed.

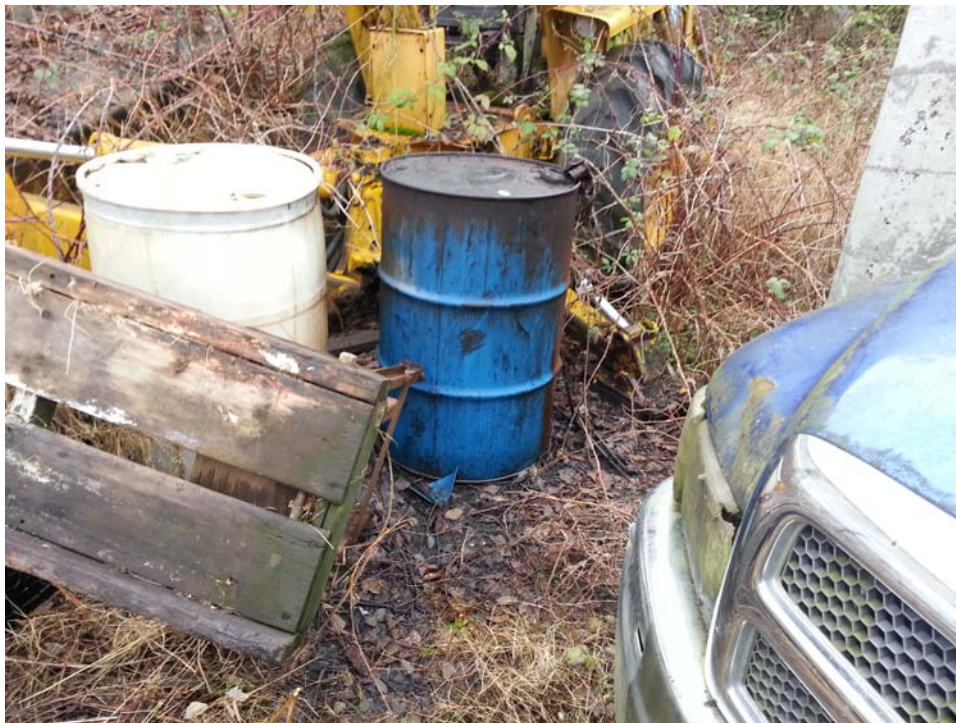
7.) View of poorly secured drums in the abandoned structure.

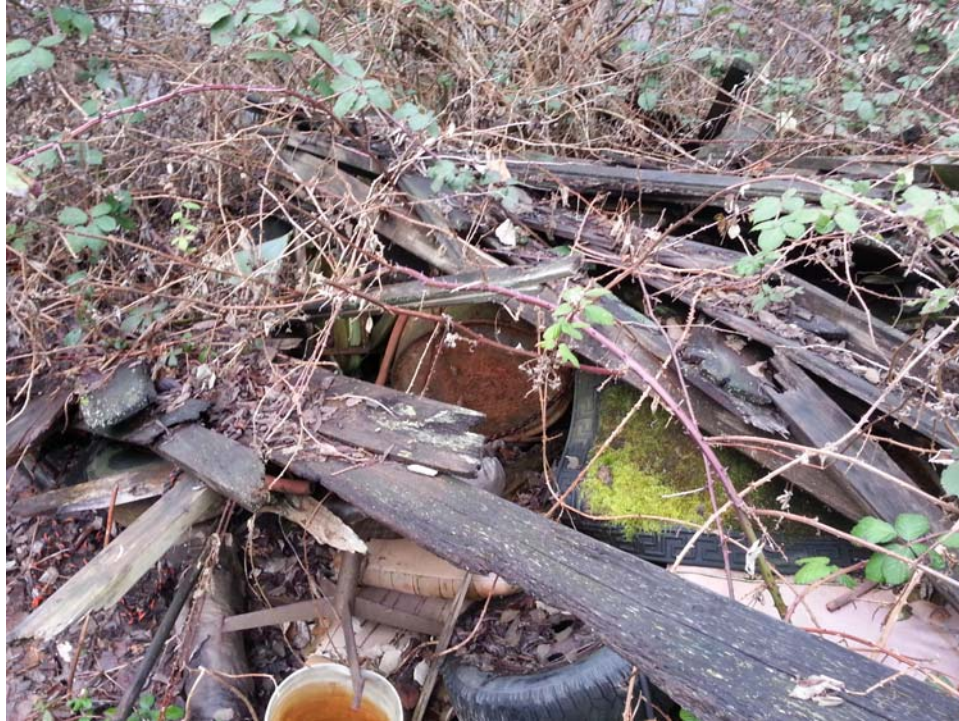
- 8.) View of debris pile containing at least one more drum and other containers inside the abandoned structure.

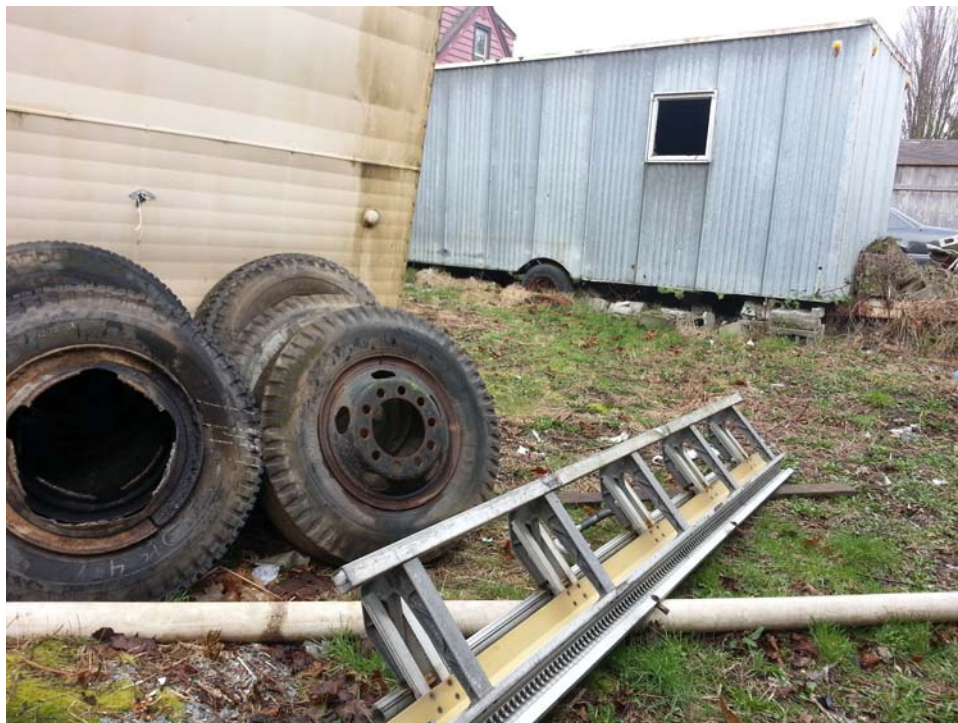
The business does not sell fuel or do routine fluid changes on cars, so there are no underground storage tanks or large quantities of oil stored on the property. There are three drums held on a concrete pad to the east of the muffler shop, two of which are held in a drum caddy which serves as secondary containment. The third drum is not used by the current business operator and is labeled to contain waste anti-freeze. The drum is rusted and should be properly disposed. There are two dilapidated trailers located on the east side of the muffler shop property. These appear to be filled with debris.

- 9.) View of two trailers filled with debris in the area adjacent to the muffler shop.
