SUPPLEMENTAL REMEDIAL INVESTIGATION AND SOIL CLEANUP REPORT

**Bellevue North Property
(Former Dodge of Bellevue Site and
Former Eastside Jeep Eagle Site)**

**316-400 116th Avenue NE
Bellevue, Washington**

August 3, 2016
SCS File No. 04215046.00
File: BellevueNorthCleanupRpt.v2.0

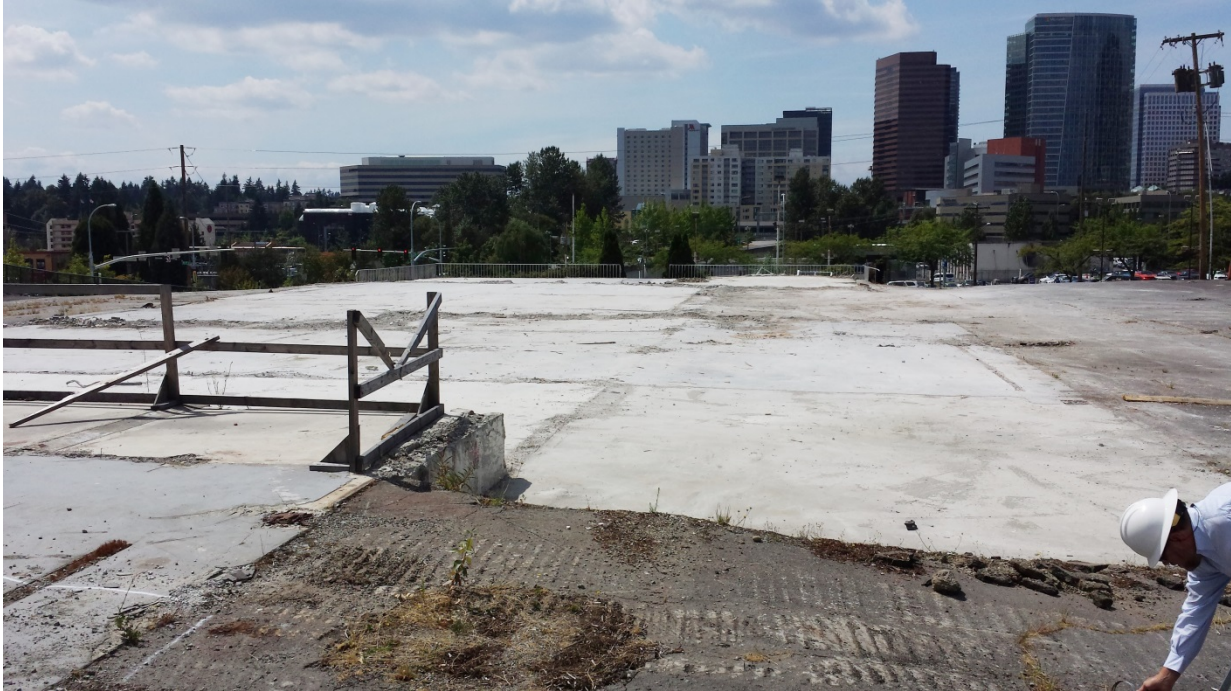
Photo 1: July 22, 2015. View looking west across the former DOB service bay area. Surviving surface features were helpful for locating the initial test pits installed during the supplemental RI.

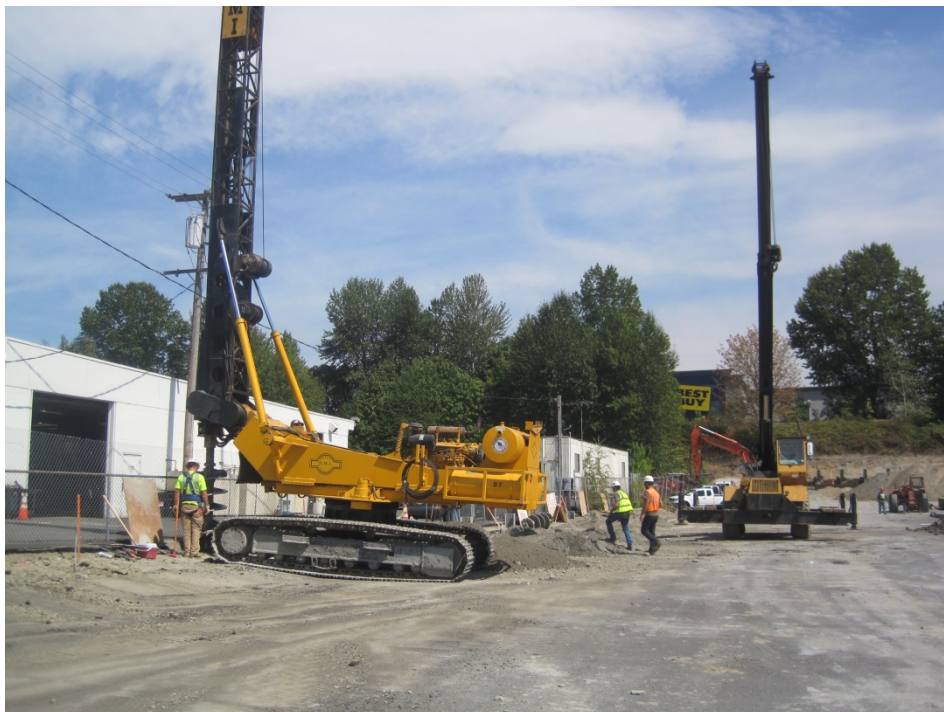
Photo 2: August 10, 2015. Large diameter borings for soldier piles were installed on 10-foot centers along the north side of the Property adjoining the former Bellevue Lincoln Mercury site. No evidence of potential contamination was identified during the drilling. Soldier piles were also installed along the east and south edges of the Property.

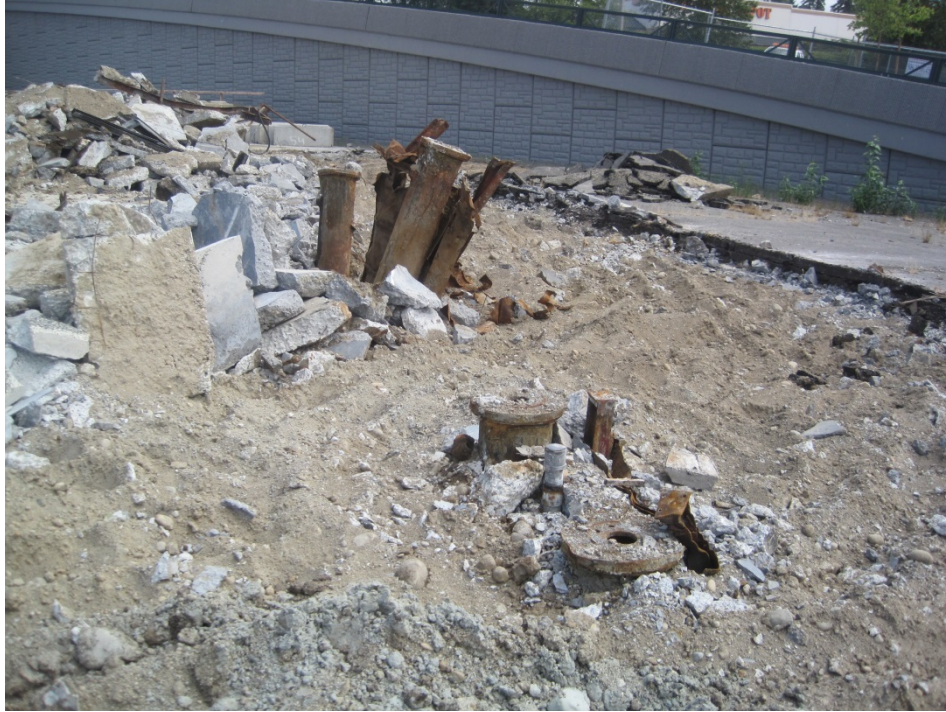
Photo 3: August 5, 2015. View of two of the dual-piston hydraulic lifts that were discovered and removed from the DOB site.

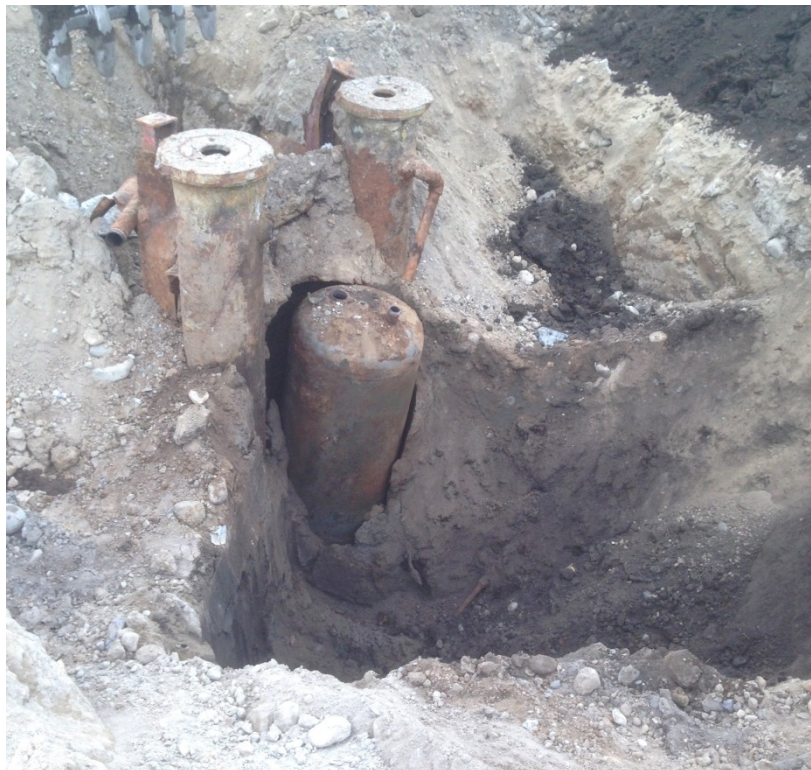
Photo 4: August 28, 2015. View one of the hydraulic lifts being removed. The two lift pistons and the hydraulic fluid reservoir are visible.

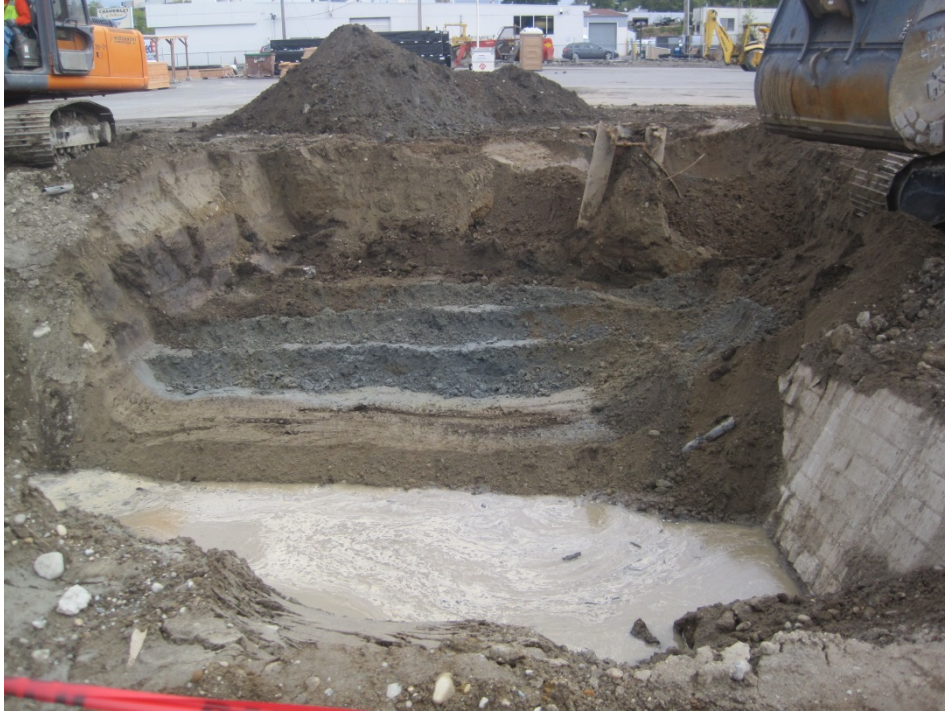
Photo 5: September 3, 2015. View looking north at the excavation being installed to remove PCS that was identified beneath the hydraulic lifts at approximately 4 to 8 feet bgs. Analytical chromatographs and on-site odors indicated that the contaminant was mineral spirits.

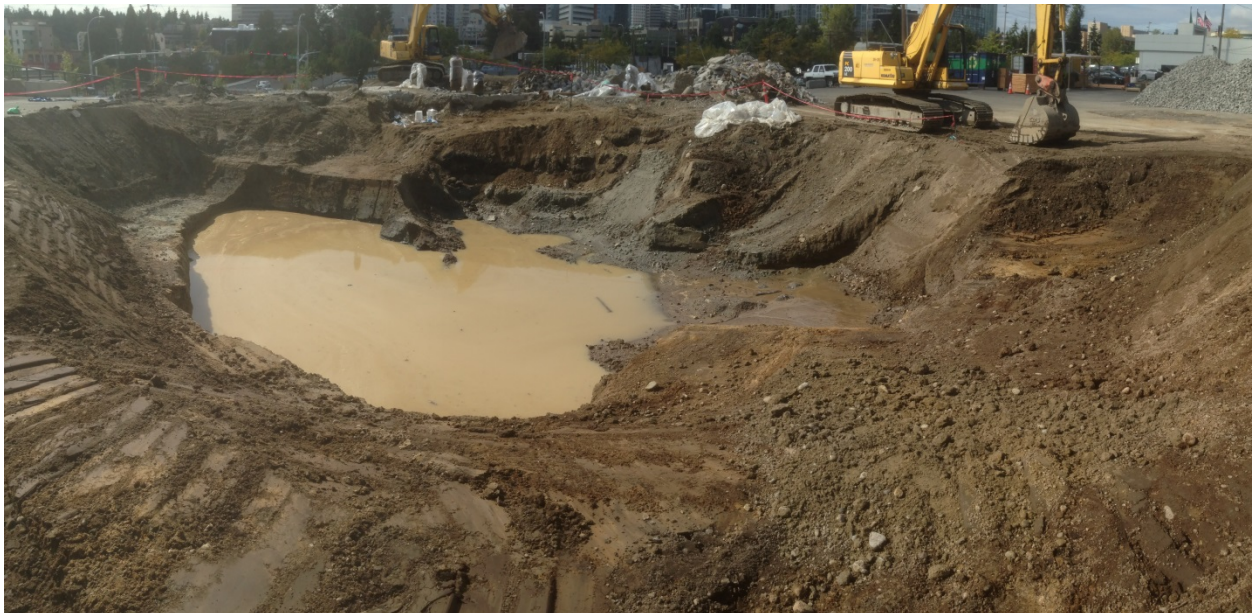
Photo 6: September 8, 2015. View looking west at the enlarged hydraulic lift excavation. Water was periodically pumped from the excavation and hauled for proper off-site disposal.

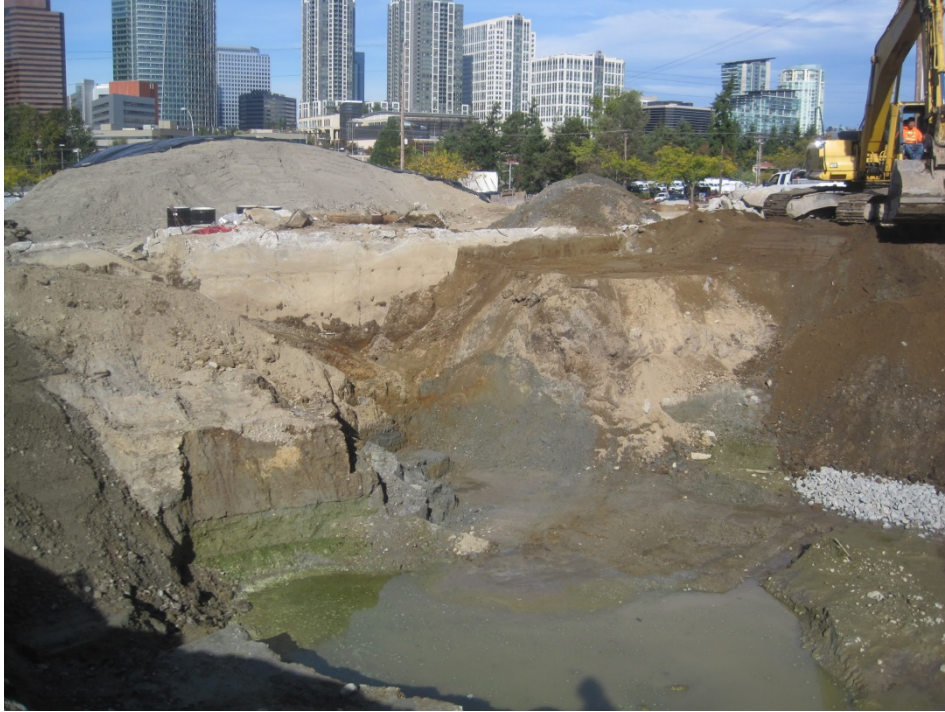
Photo 7: September 24, 2015. View looking northwest at the hydraulic lift excavation. The excavation water supported an algae bloom during the two weeks that the excavation was open and site activities were devoted to construction.

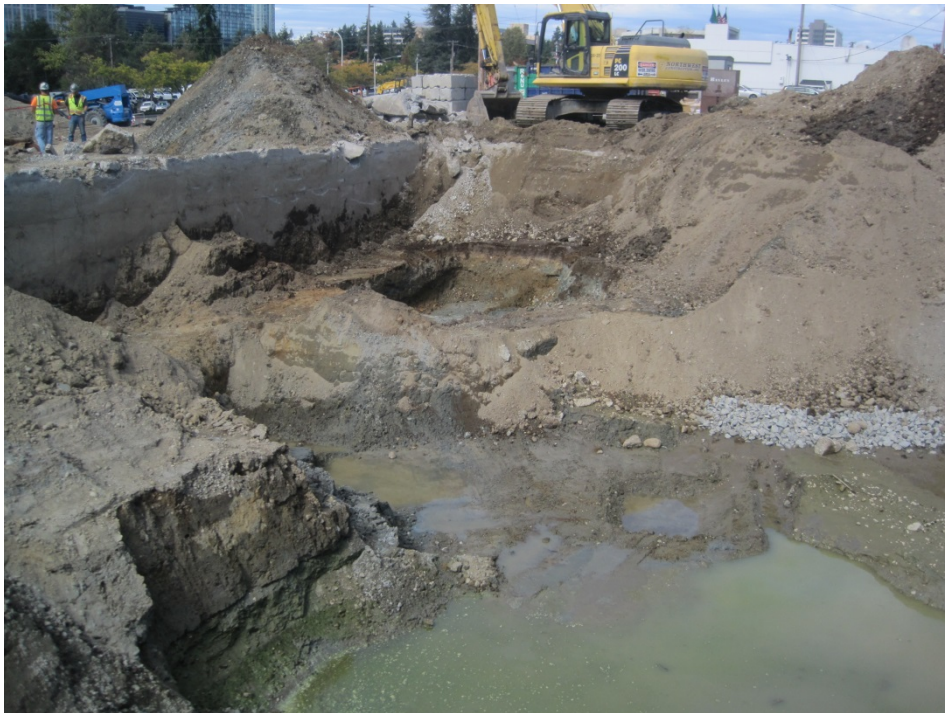
Photo 8: September 24, 2015. Another view of the same excavation later in the day, after the former lube pit area had been excavated (upper center).

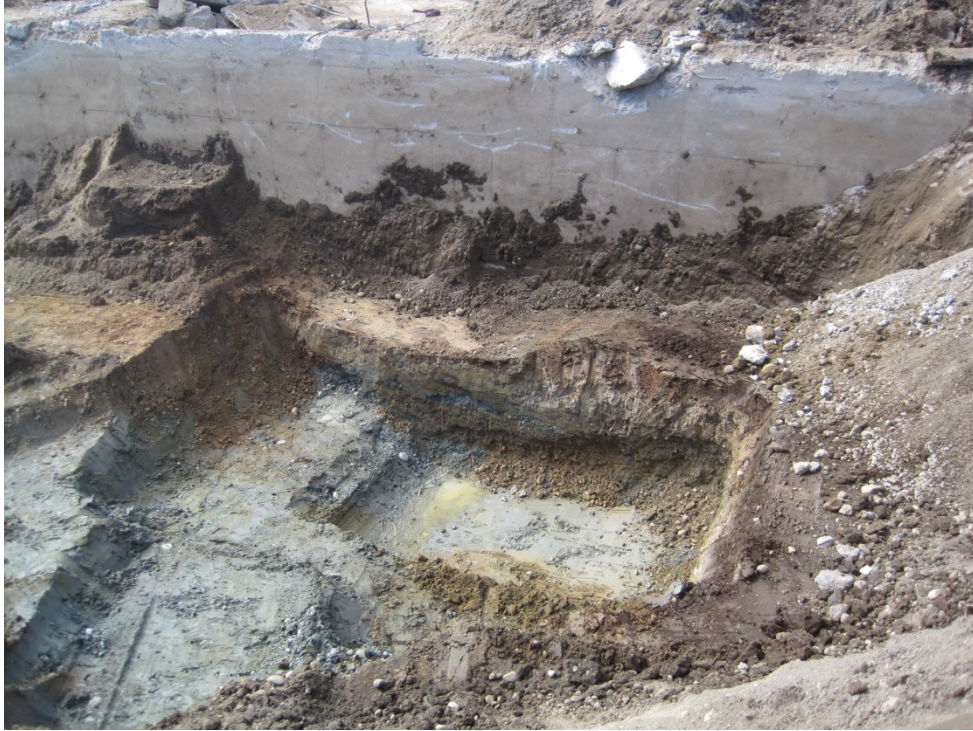
Photo 9: September 24, 2015. View looking west at the completed excavation at the former lube pit. The subsurface concrete wall was present along the west edge of the service bay area.

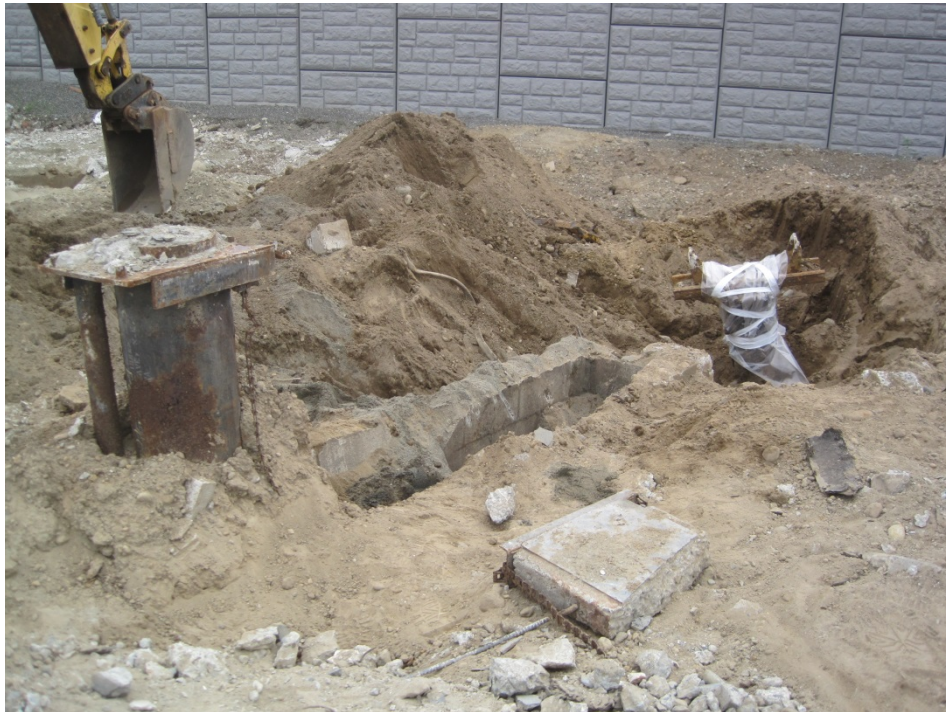
Photo 10: August 14, 2015. View looking southeast at the additional hydraulic lift vault. This lift assembly and vault were situated east of the other lifts. (See also Photo 11.)

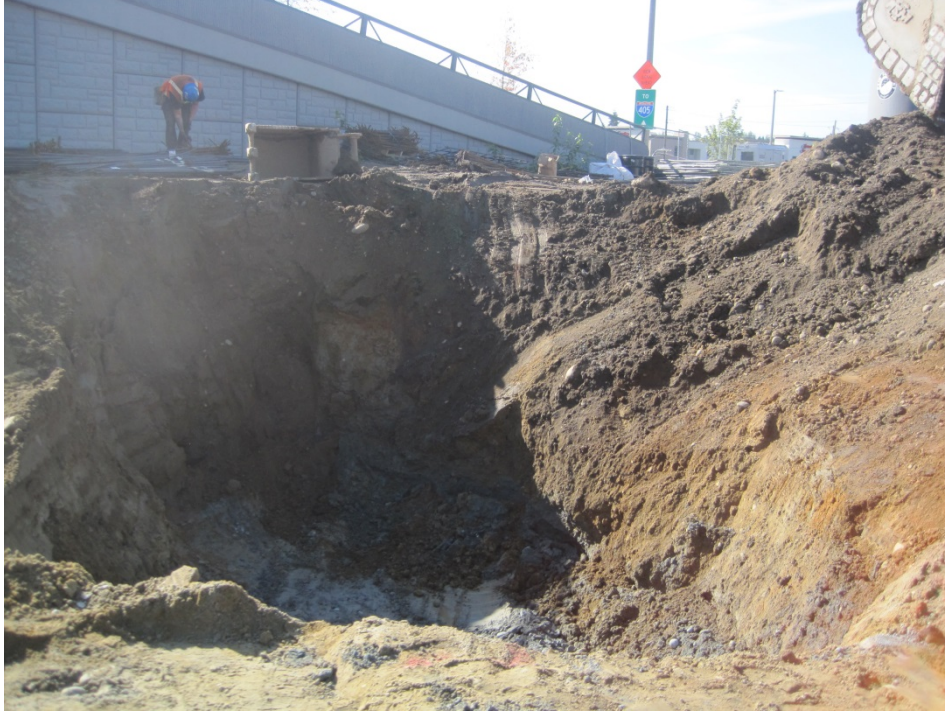
Photo 11: October 16, 2015. Excavation of the additional hydraulic lift vault. A limited volume of contaminated soil was identified on the west side of the vault footing.

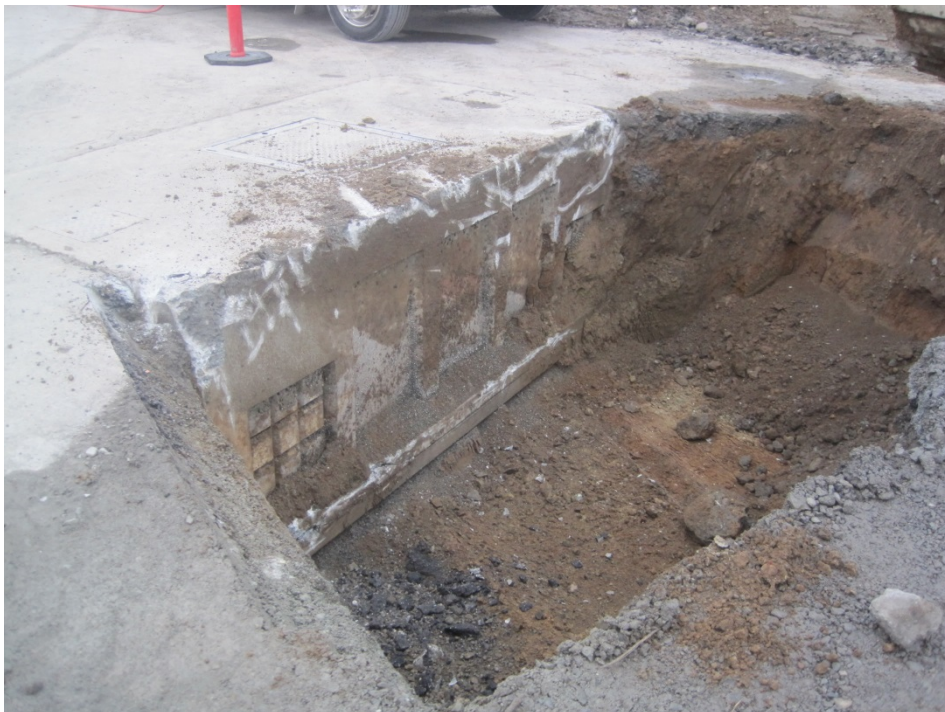
Photo 12: October 14, 2015. View of the removal of the north oil/water separator. Two smaller oil/water separators were removed on the same day. Field observations, PID readings, and the analytical results of confirmation soil samples indicated that the surrounding soils were clean.

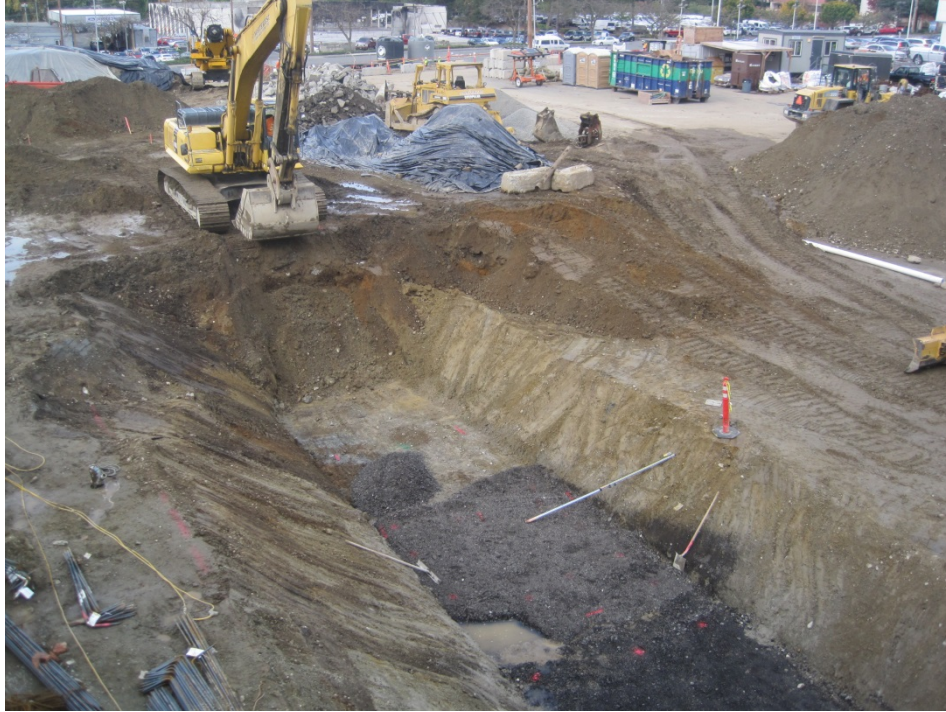
Photo 13: October 21, 2015. View looking northwest at a footing excavation being advanced into the area of the hydraulic lift remedial excavation. Note the difference in elevation between the original grade (left and top), the construction grade (right), and the footing grade (bottom center).

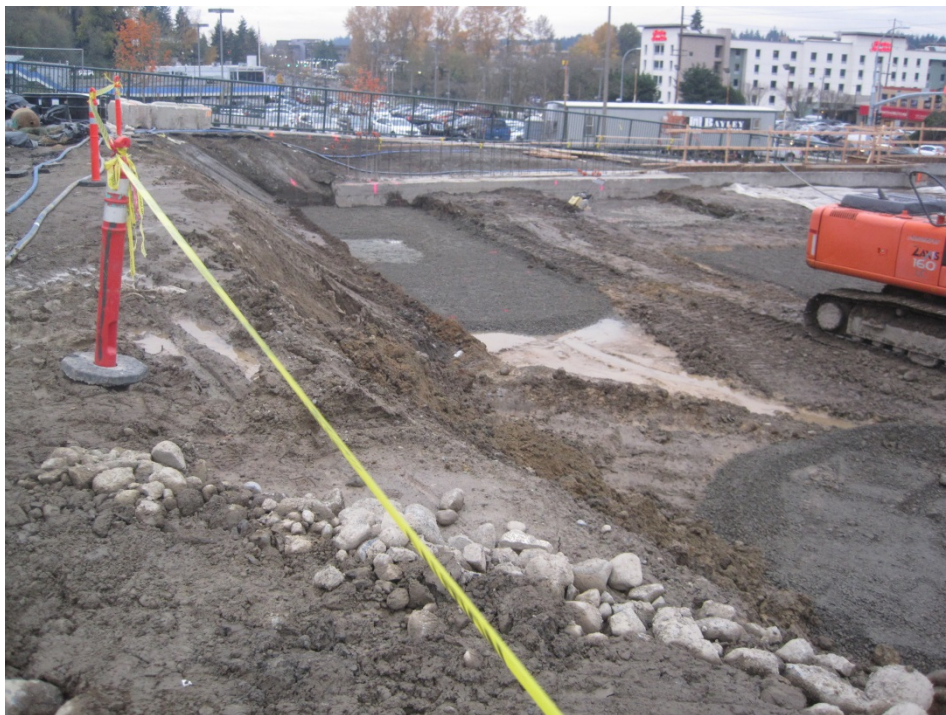
Photo 14: November 23, 2015. View looking south from near the location of the former lube pit. Water discharging from the toe of the slope contained no detectible diesel- or oil-range TPH.

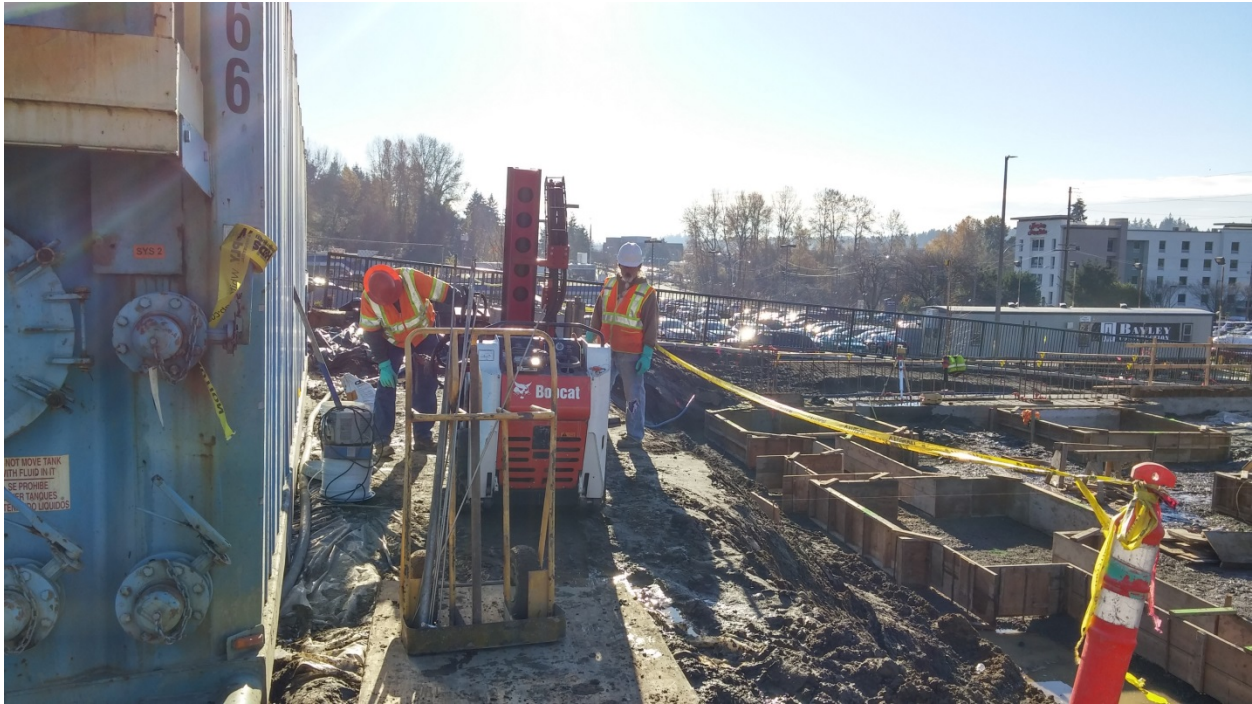
Photo 15: November 30, 2015. View of the limited-access direct-push sampling rig that was used to collect groundwater samples from five locations within the footprint of the main remedial excavation. Diesel- and oil-range TPH were detected below MTCA Method A cleanup levels.

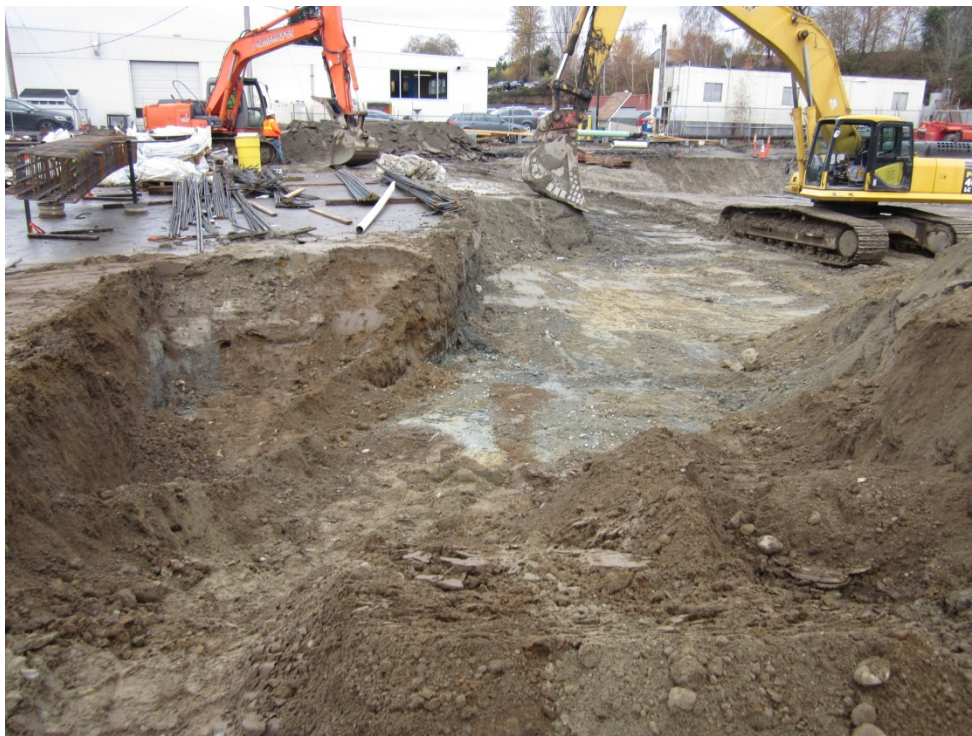
Photo 16: December 2, 2015. View looking north at the TP-16 excavation. The floor of the excavation was at 4 feet below the original grade and coincident with the construction grade.
