# **BASELINE ENVIRONMENTAL SUMMARY**

**FORMER CASCADE LAUNDRY  
205 PROSPECT STREET  
WHATCOM COUNTY PARCEL 380330111249  
BELLINGHAM, WASHINGTON 98225  
ECOLOGY FS ID: 21786898**

March 12, 2015

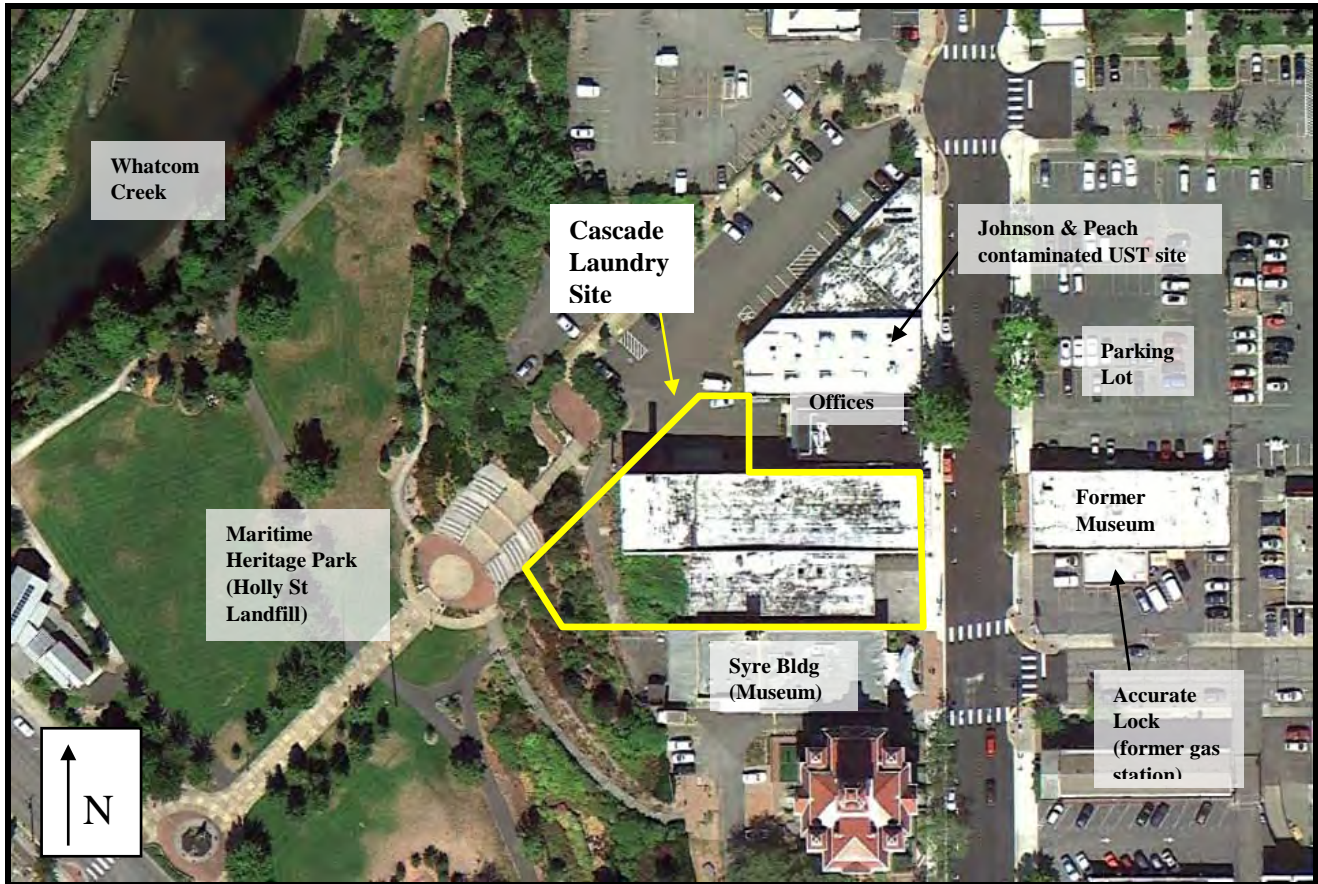
**Figure 2.** Aerial photo of site and surrounding land uses

An aerial photograph with the site layout and adjacent properties is provided below in Figure 2.

The subject property consists of one tax parcel that is approximately 0.54 acres in size and is irregularly shaped. The site is developed with one building. The building has a footprint that covers approximately 13,150 square feet. The building has a second story, main floor, and basement. The building is currently vacant.

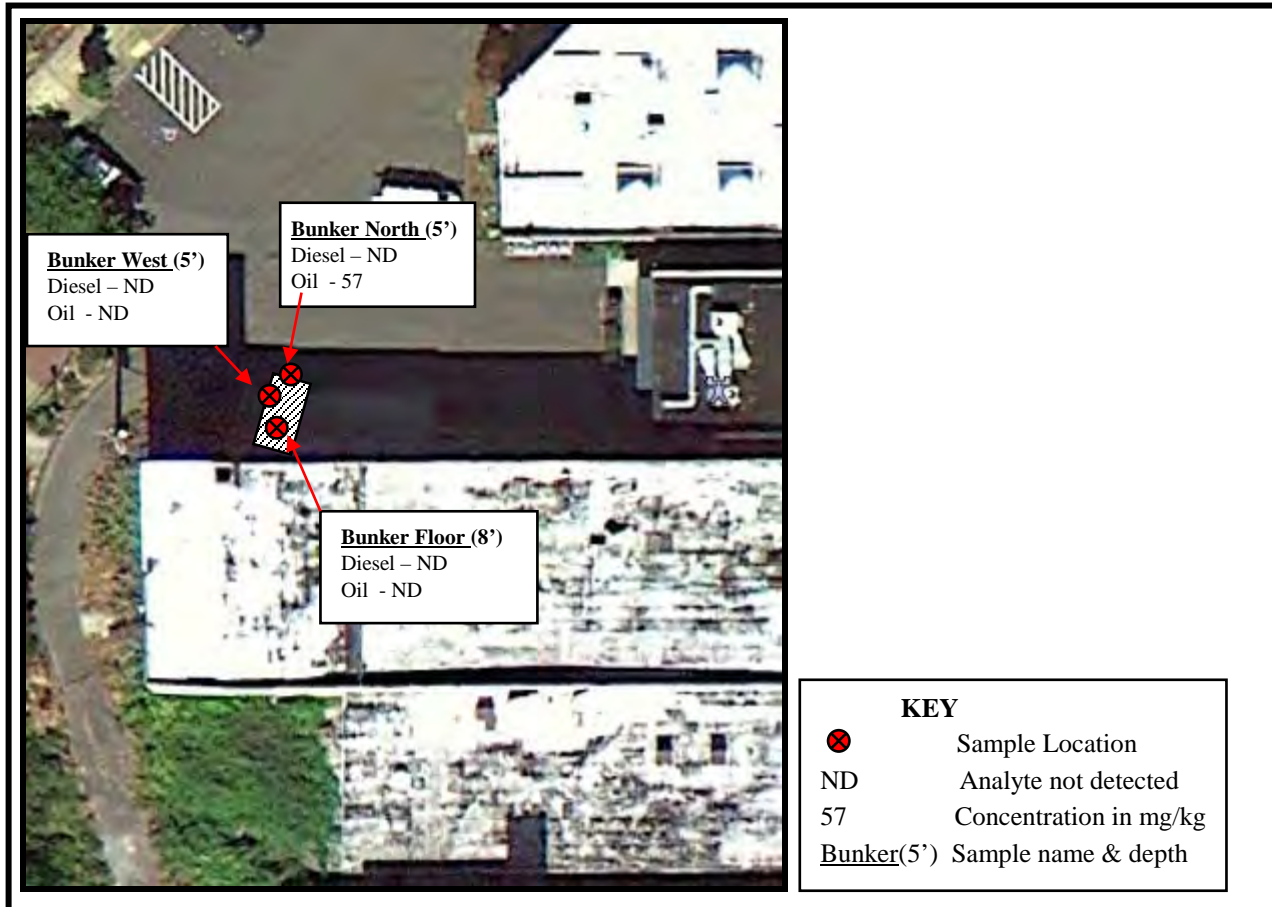
**Figure 5.** Sample results from heating oil UST removal

former bottom of the tank location.

A map of the soil samples collected around the former heating oil UST is provided in Figure 5.

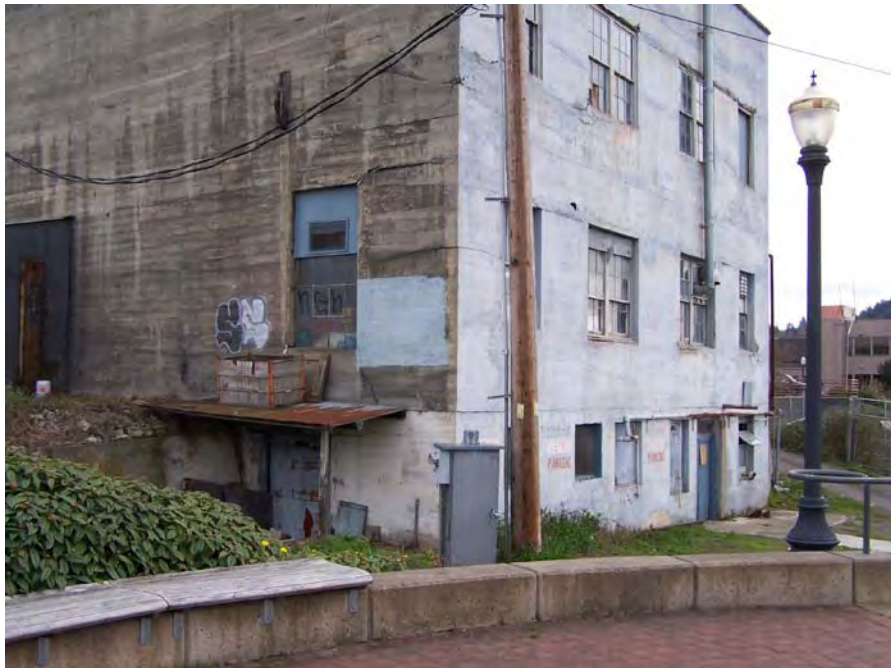
Figure 5. View of northwest corner of the Cascade Laundry building, looking southeast. Note the retaining wall and fill material on the left side of the photo. The underground storage tank used to hold fuel for the boiler is located near the building within the fill material.

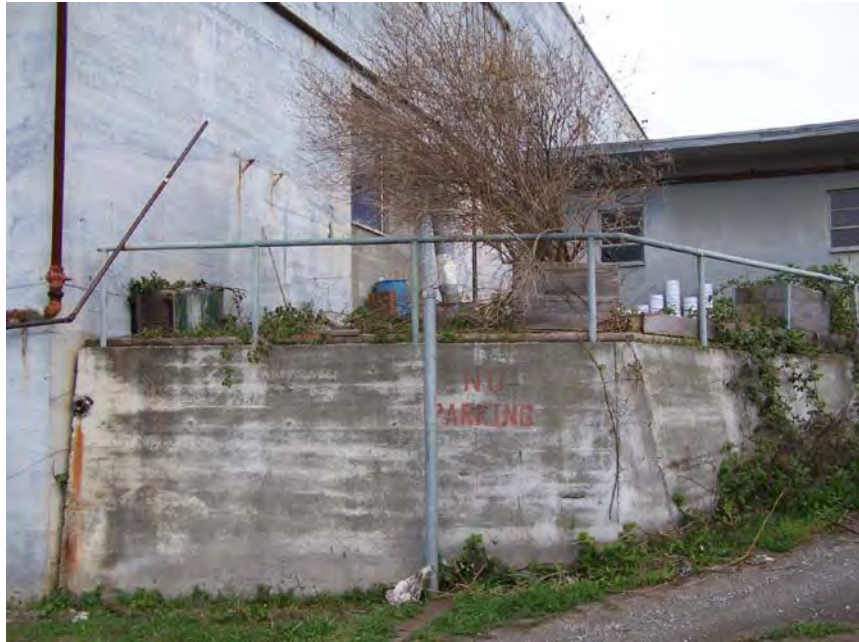
Figure 6. View of the retaining wall south of the southwestern portion of the building, looking east. The dry cleaning operations occurred within the main building in the left side of the photo and the building addition is visible in the background on the right hand side of the photo.

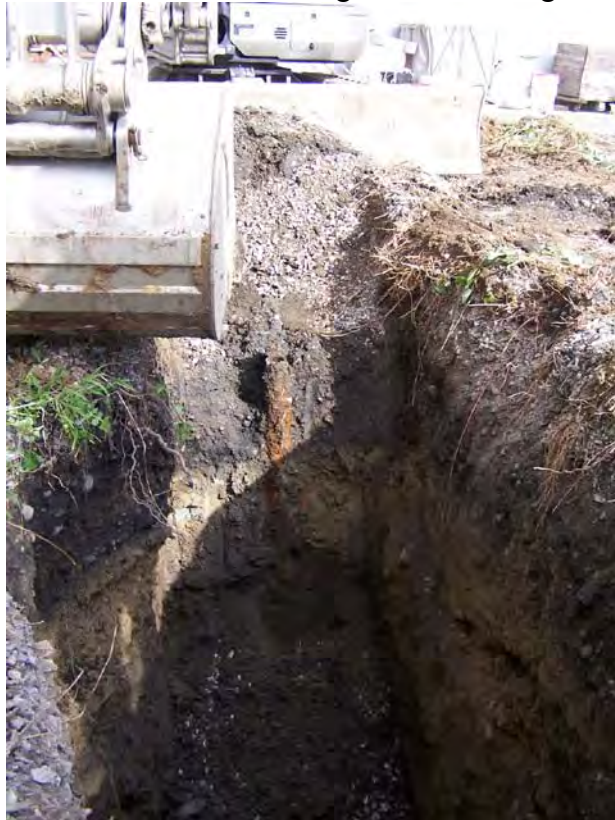
Figure 7. View of test pit #2 in the fill material south of the southwest corner of the building, looking east. The vertical pipe in the far side of the test pit is attached to an underground storage tank.

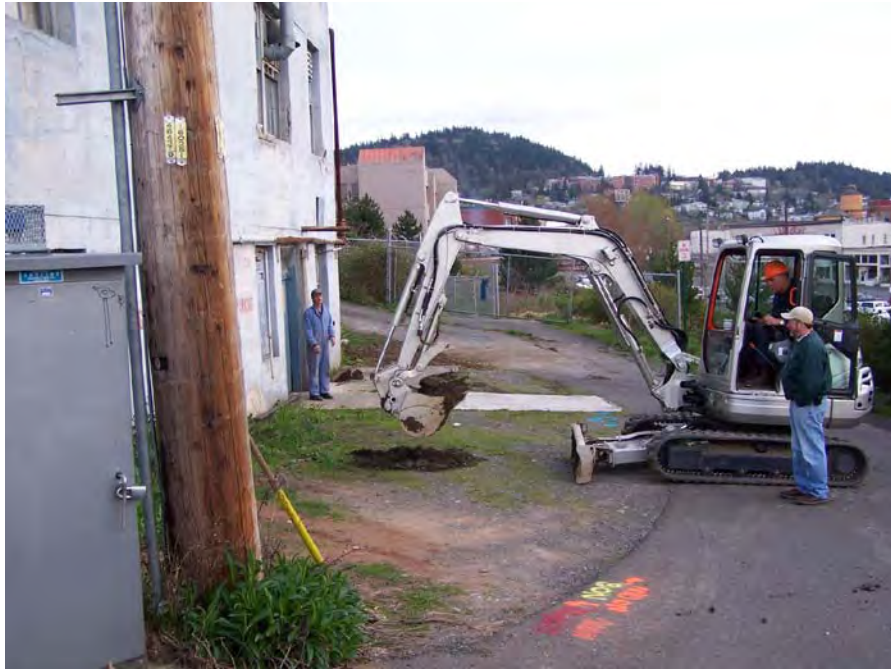
Figure 8. View of test pit #5 being excavated along the west side of the building, looking south. Disturbed material is visible in the back-central of the photo where test pit #3 was excavated. The closed-in-place underground gasoline tank is located just beyond the telephone pole in the forefront of the photo where the dirt looks reddish.
