FOCUSED SITE INVESTIGATION

LAKESIDE SERVICE STATION
16835 LEWIS RIVER ROAD
COUGAR, WASHINGTON 98616

May 25, 2017

ENW Project No. 1162-17001-02

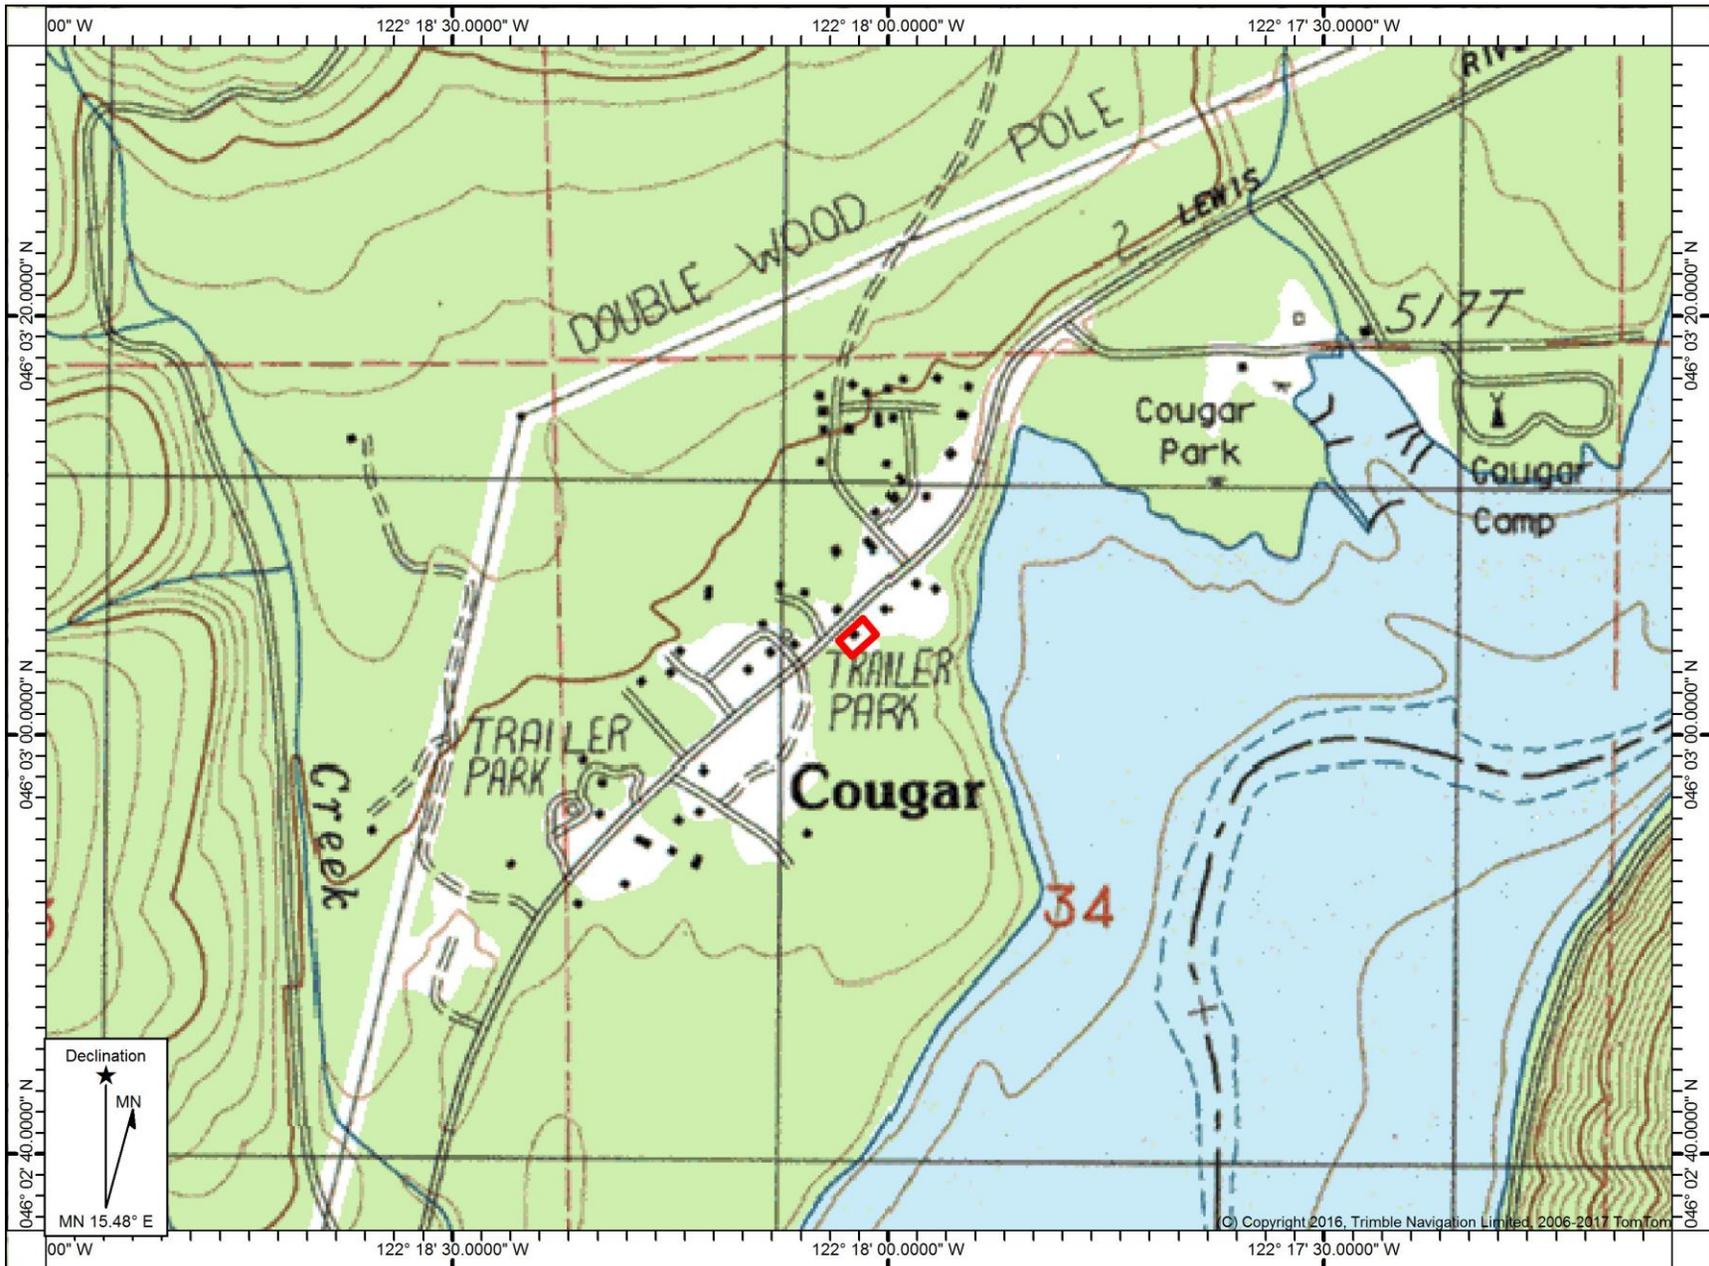
Site Vicinity Map

The subject site is located within the US Geological Survey Cougar, Washington 7.5-minute quadrangle at an approximate elevation of 583 feet above mean sea level (Figure 1). The surface topography of the subject property is generally level. Surface topography near the subject site slopes to the east and south, towards Yale Lake. There is a steep upward rise to the north and west of the subject site.

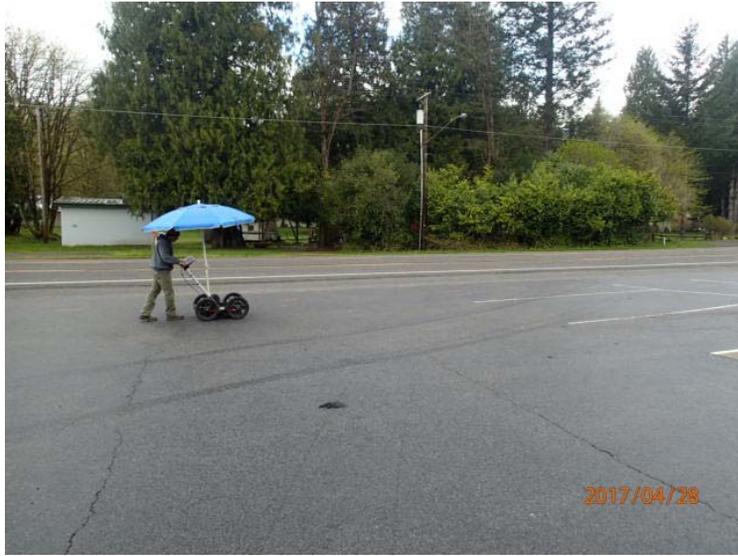
A geophysical survey was conducted to clear boring locations and confirm buried historical features.

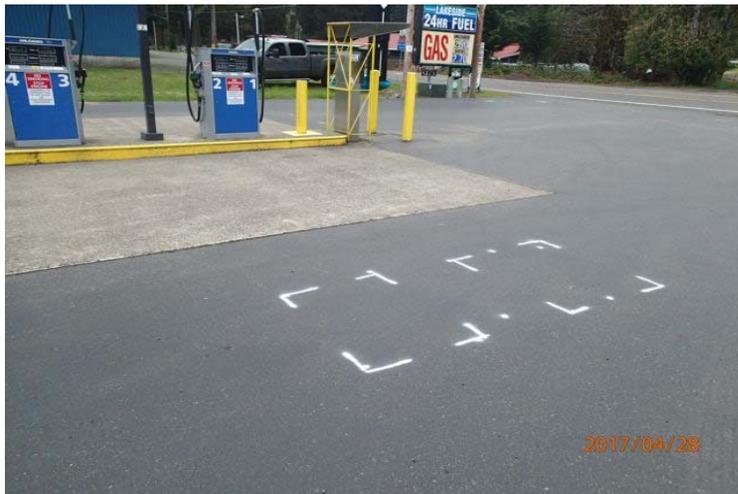
Magnetic anomalies were marked in white paint, and boring locations were sited in appropriate locations to assess suspect underground features.

- Magnetic anomalies MA01 and MA02 – located east of the current cardlock pump island, these two anomalies were three feet in diameter with high magnetic response near their perimeters. The apparent “rim” features are interpreted as possible abandoned septic features or vertical drains. Boring B04 was sited equidistant from MA01 and MA02.
- Geophysical anomaly GA01 – located northwest of the convenience store building, this anomaly measuring approximately 22 feet by 23 feet did not have a magnetic response, but did have a GPR response interpreted as a former excavation. Borings B02 and B03 were sited within this anomaly.
- The survey did not identify any evidence of buried USTs, other than the current regulated UST servicing the onsite service station, or other features of potential environmental concern, although not all areas of the site were scanned during the survey.

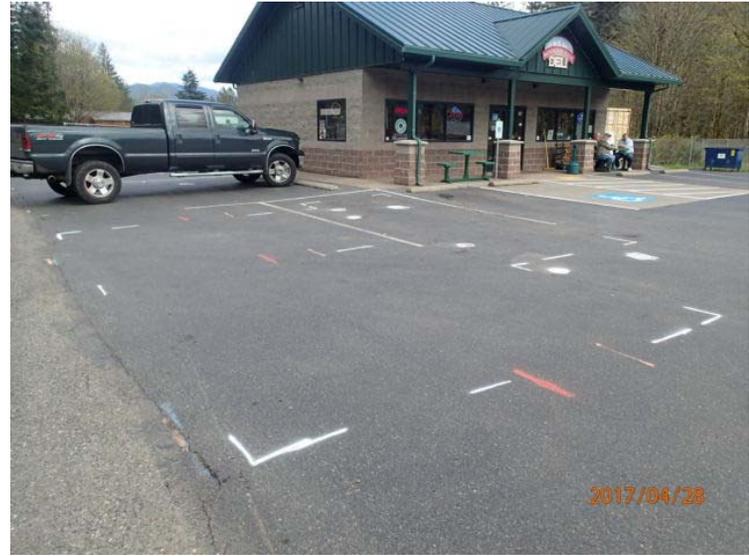
One large area at the NW corner of the building was interpreted as a former excavation. An old fuel dispenser was reportedly located further east (behind the black truck).

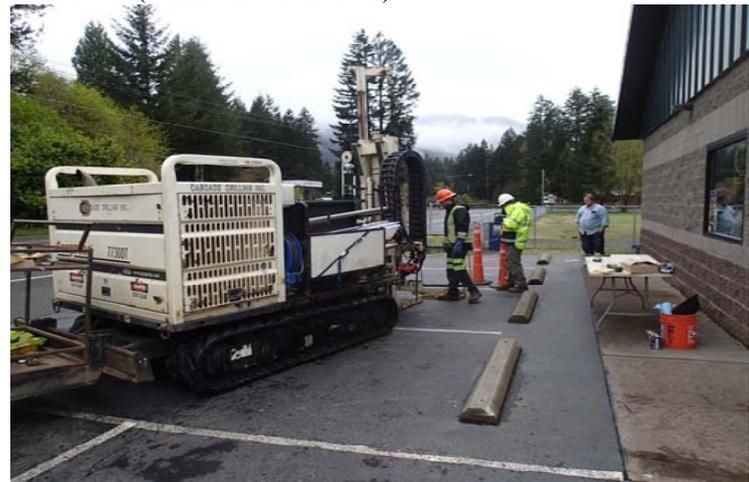
A GeoProbe drill rig was used to advance eight exploratory borings at selected locations.

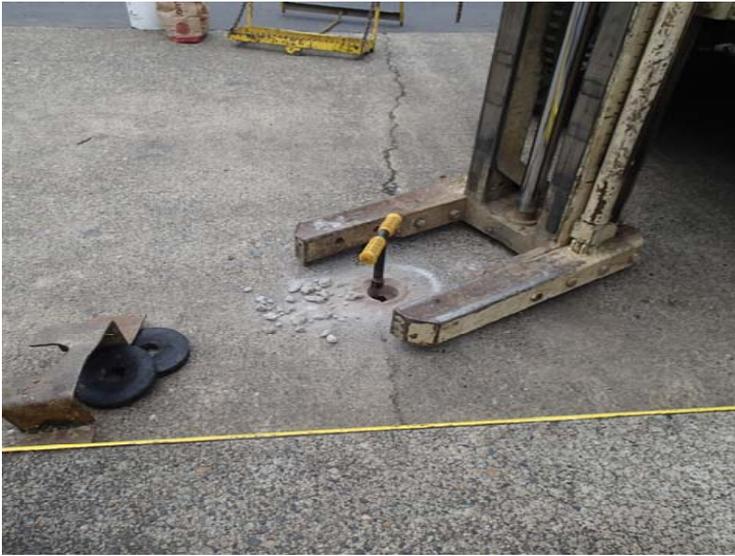
A 6-foot tile probe was used to manually clear holes prior to drilling to avoid damaging underground utilities near the existing tanks and pump island.

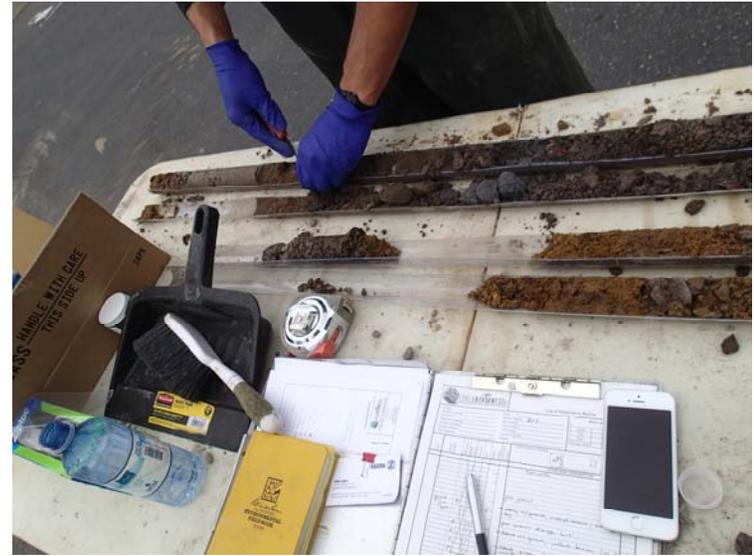
Observations were recorded onto a field notebook and boring log.

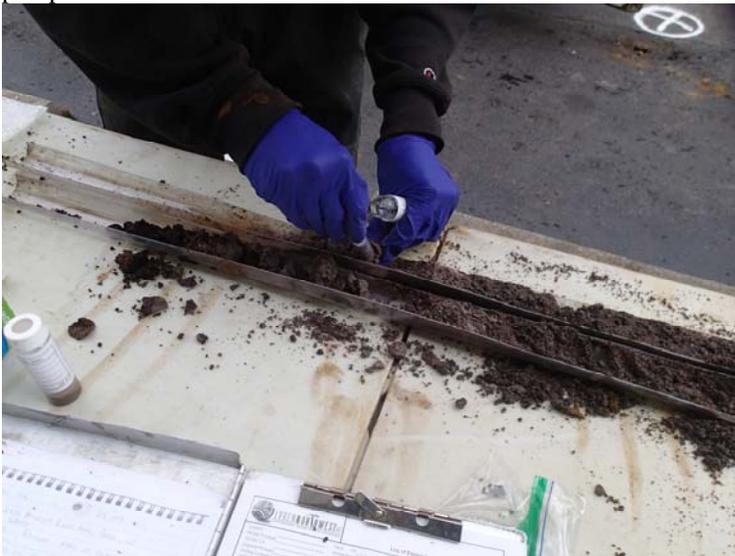
Continuous soil cores retained within plastic sleeves were inspected from the ground surface to total depth at each boring.

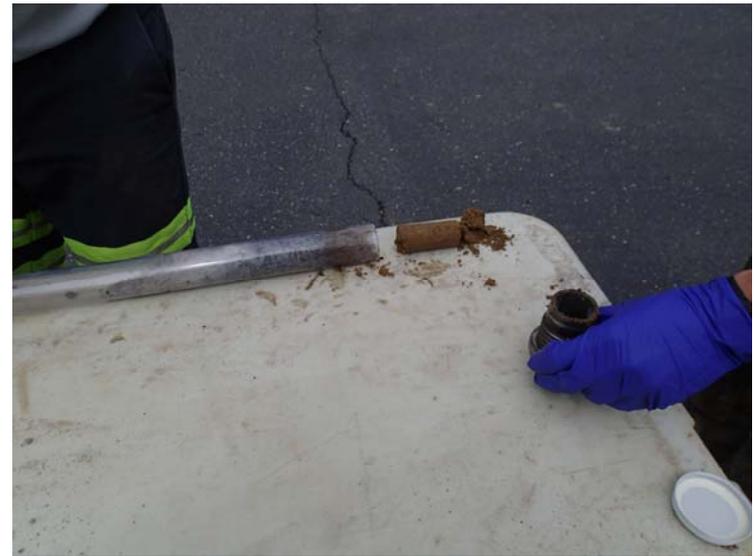
Soil samples were placed into laboratory-prepared sample jars for possible analysis.

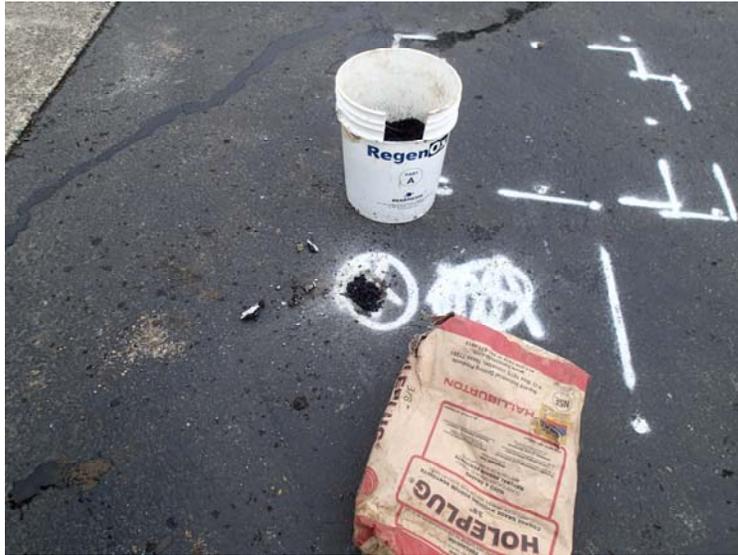
After drilling and sampling, each boring was backfilled with bentonite chips and sealed at the surface.

Direct-push construction notices (start cards) and reports (well logs) were prepared and submitted to Ecology as required by Washington Administrative Code (WAC) 173-160. On the same day as drilling, each of the direct-push borings was backfilled with bentonite and sealed at the surface using appropriate materials to match existing conditions.
