Remedial Investigation / Feasibility Study Report

Kountry Korner

27099 Miller Bay Road NE
Kingston, Washington 98346-9473

AEG Project #: 16-132
Date of Report: May 25, 2017

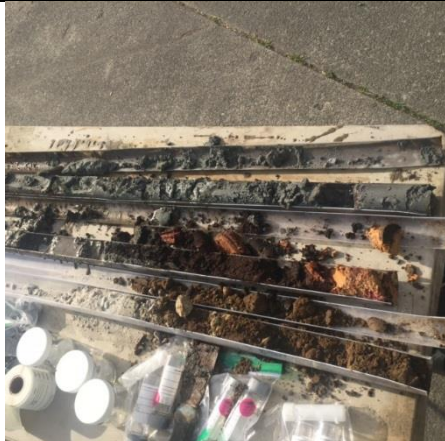
Photo # 1	Photo looking at soil cores from boring B-1.

Boring Depth (feet)	Soil Description	Unified Soil Symbol	Sample Depth	Sample Recovery	Sample Number	Time	Blows/Foot	PID Reading	Sheen	Observations
	4 inch concrete surface underlain by;		1				N/A		None	
			2							
			3							
	Brown, moist, medium dense, SAND ; fine grained sand, trace gravel, coarse grained gravel	SW	4							
5			5		B1-5	8:24		55.4		
			6							
		▼	7							
	At 7 feet; Gray, wet, medium dense, SAND ; fine grained sand	SP	8		B1-7.5	8:27		20.8		
			9							
	At 8.5 feet; Dark brown, moist, medium stiff, SANDY SILT ; fine grained sand	ML	10		B1-10	8:27		40.3		
10	At 9.5 feet; Woody debris		11							
	At 10 feet; Gray, wet, medium dense, GRAVEL ; with sand, fine grained sand, fine grained gravel	GW	12							
			13							
	At 12 feet; Woody debris		14							
	At 12.5 feet; Gray, moist, medium stiff, SILT ; trace gravel, coarse grained gravel	ML	15		B1-15	8:30		18.4		
15										
	Total Depth = 15 feet

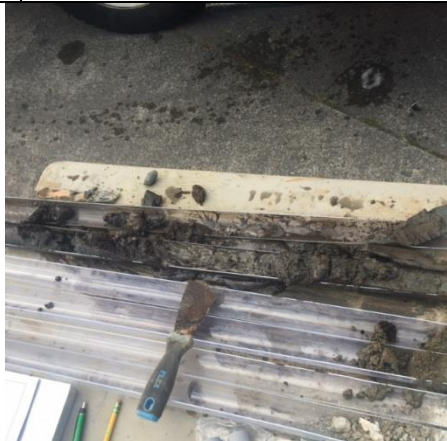
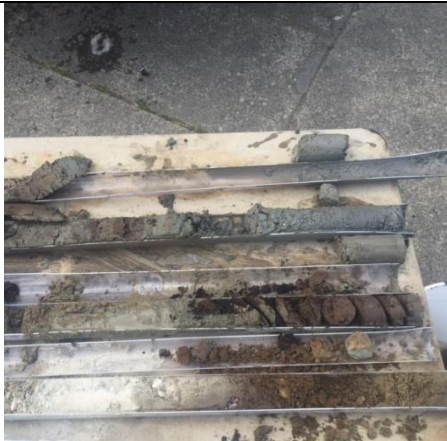
Photo # 2	Photo looking at soil cores from boring B-2.	Photo # 3 Photo looking at soil cores from boring B-2.

Boring Depth (feet)	Soil Description	Unified Soil Symbol	Sample Depth	Sample Recovery	Sample Number	Time	Blows/Foot	PID Reading	Sheen	Observations
	4 inch concrete surface underlain by;		1				N/A		None	
			2							
			3							
	Brown, moist, medium dense, <u>SAND</u> ; fine grained sand, trace gravel, coarse grained gravel	SW	4							
5			5		B2-5	8:53		1.7		
			6							
			7							
			8							
	At 8 feet; Gray, wet, medium dense, <u>SAND</u> ; fine grained sand	SP	9							
10	At 9.5 feet; Brown, moist, medium stiff, <u>SILT</u> ; with woody debris	ML	10		B2-10	8:56		74.9		
	At 10 feet; Brown, wet, medium dense, <u>SAND</u> ; fine grained sand	SP	11							
	At 11 feet; Brown, wet, medium dense, <u>SILTY SAND</u> ; fine grained sand	SM	12							
			13							
			14							
15	At 14 feet; Gray, wet, medium dense, <u>SANDY GRAVEL</u> ; fine grained sand, coarse grained gravel	GW	15		B2-14	9:00		3.7		
	Total Depth = 15 feet

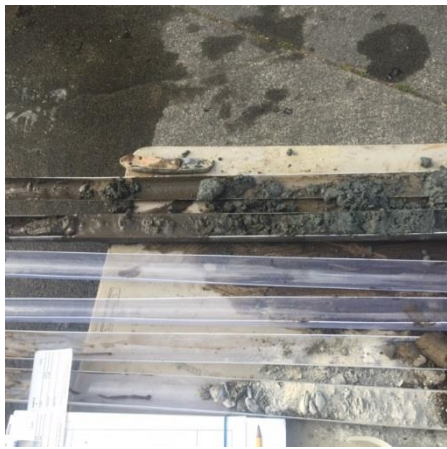
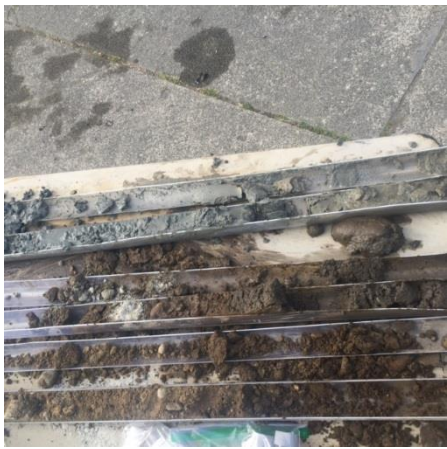
Photo # 4	Photo looking at soil cores from boring B-3.	Photo # 5 Photo looking at soil cores from boring B-3.

Boring Depth (feet)	Soil Description	Unified Soil Symbol	Sample Depth	Sample Recovery	Sample Number	Time	Blows/Foot	PID Reading	Sheen	Observations
5	4 inch concrete surface underlain by; Brown, moist, medium dense, <u>GRAVELLY SAND</u> ; coarse grained gravel, fine grained sand	SW	1		B3-5	9:17	N/A	0.3	None	
			2							
			3							
			4							
			5							
			6							
			7							
			8							
10	At 8 feet; some silt	ML	9		B3-10	9:19		2.6		
			10							
			11							
			12							
			13							
			14							
			15							
15	At 11 feet; Gray, wet, medium stiff, <u>SANDY SILT</u> ; fine grained sand				B3-15	9:23		0.0		
20	Total Depth = 15 feet									
25

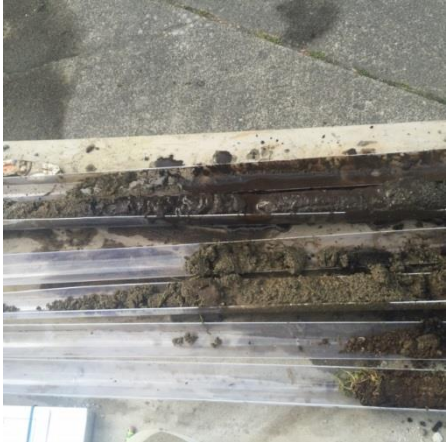
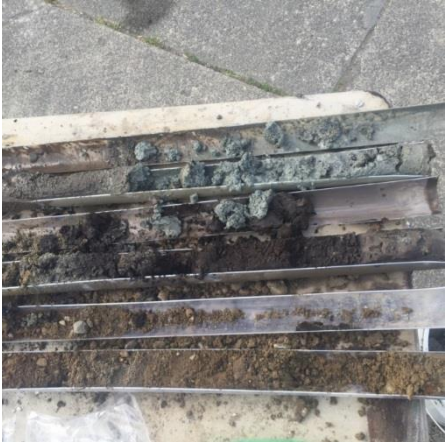
Photo # 6	Photo looking at soil cores from boring B-4.	Photo # 7	Photo looking at soil cores from boring B-4.

Boring Depth (feet)	Soil Description	Unified Soil Symbol	Sample Depth	Sample Recovery	Sample Number	Time	Blows/Foot	PID Reading	Sheen	Observations
	Grass surface underlain by;		1				N/A		None	
			2							
			3							
	Brown, moist, medium dense, GRAVELLY SAND ; fine grained gravel, fine grained sand	SW	4							
5			5		B4-5	9:43		0.5		
			6							
	At 7 feet; No gravel, wet

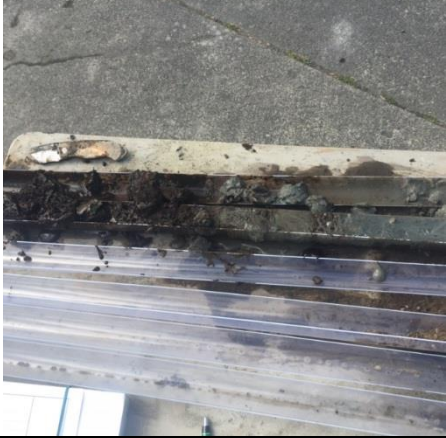
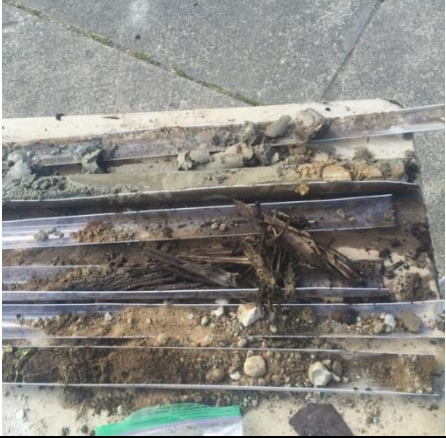
Photo # 8	Photo looking at soil cores from boring B-5.	Photo # 9	Photo looking at soil cores from boring B-5.

Boring Depth (feet)	Soil Description	Unified Soil Symbol	Sample Depth	Sample Recovery	Sample Number	Time	Blows/Foot	PID Reading	Sheen	Observations
	Grass surface underlain by; 9 inch dirt underlain by;		1				N/A		None	
			2							
			3							
	Brown, moist, medium dense, GRAVELLY SAND ; fine grained gravel, fine grained sand	SW	4							
5			5		B5-5	10:10		0.3		
			6							
			7							
			8							
	At 8.5 feet; Woody debris		9							
10			10							
	At 10 feet; Dark brown, wet, medium dense, SILTY SAND ; fine grained sand, woody debris	SM	11		B5-11	10:17		0.8		
			12							
	At 12 feet; Gray, wet, medium dense, SAND ; coarse grained sand	SP	13							
			14							
15	At 14 feet; Tan, wet, stiff, SILT	ML	15		B5-15	10:17		1.1		
	Total Depth = 15 feet									
20										
25

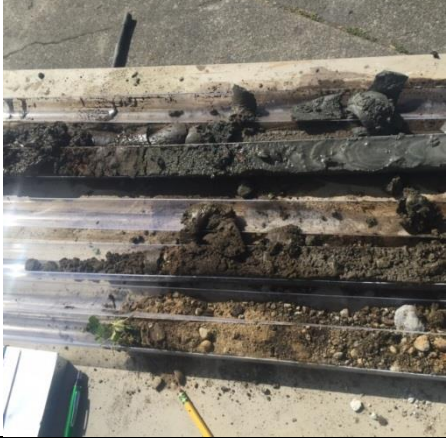
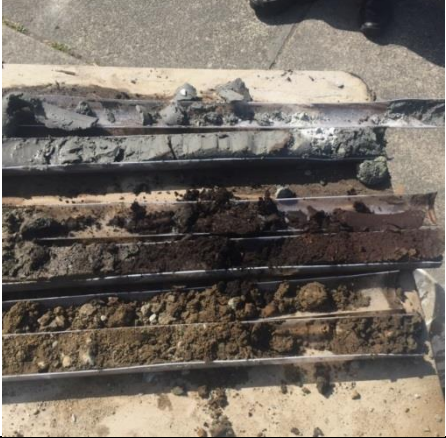
Photo # 10	Photo looking at soil cores from boring B-6.	Photo # 11	Photo looking at soil cores from boring B-6.

Boring Depth (feet)	Soil Description	Unified Soil Symbol	Sample Depth	Sample Recovery	Sample Number	Time	Blows/Foot	PID Reading	Sheen	Observations
	Grass surface underlain by;		1				N/A		None	
			2							
	Brown, moist, medium dense, GRAVELLY SAND ; fine grained gravel, fine grained sand	SW	3							
			4							
5			5		B6-5	10:31		35.1		
			6							
			7							
		▼	8							
	At 8 feet; Brown, wet, medium dense, SAND ; fine grained sand, trace gravel, coarse grained gravel	SP	9							
10	At 9 feet; Dark brown, wet, medium stiff, SANDY SILT ; fine grained sand, woody debris	ML	10		B6-9	10:33		618		
			11							
			12							
	At 12 feet; Gray, wet, medium dense, SAND ; coarse grained sand	SP	13							
			14							
15	At 13.5 feet; Gray, wet, stiff, SANDY SILT ; fine grained sand	ML	15		B6-14	10:36		0.8		
	Total Depth = 15 feet									
20										
25

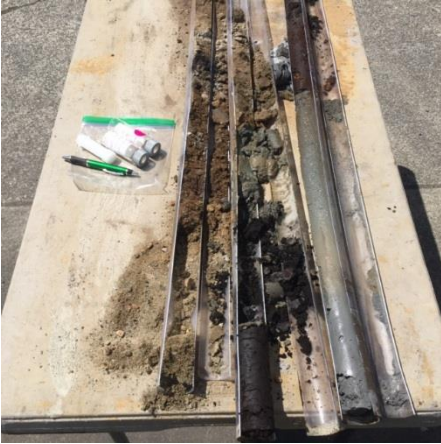
Photo # 7	Photo looking northwest at the location of boring B-7.	Photo # 8	Photo looking at soil cores from boring B-7.

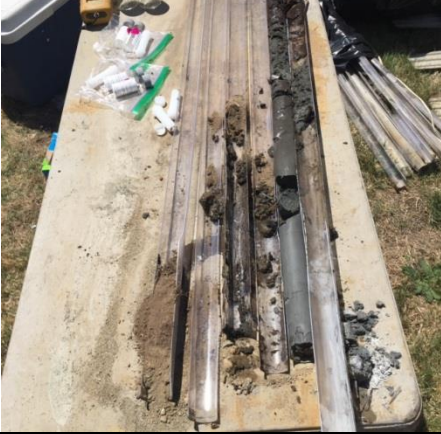
Photo # 9	Photo looking west at the location of boring B-8.	Photo # 10	Photo looking at soil cores from boring B-8.

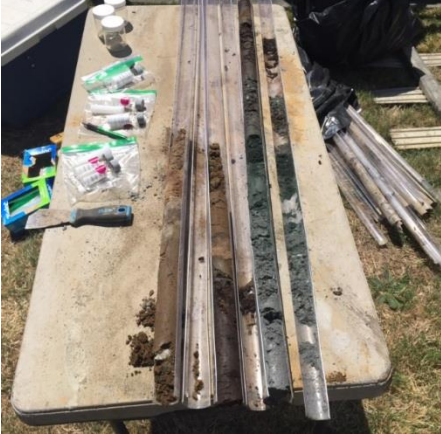
Photo # 11	Photo looking west at the location of boring B-9.	Photo # 12	Photo looking at soil cores from boring B-9.

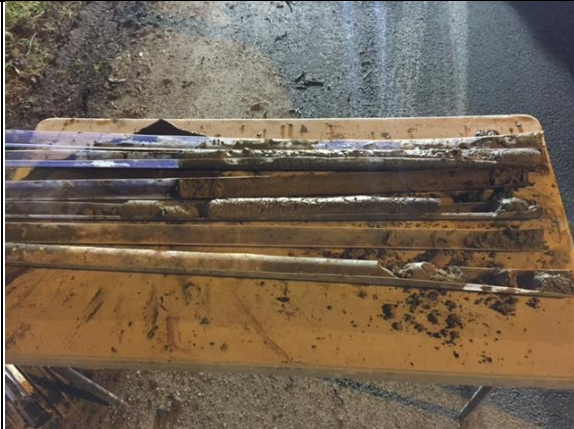
Photo #7:	Looking west at location of boring B-12.	Photo #8: Soil cores from boring B-12.
