IN THE UNITED STATES DISTRICT COURT WESTERN DISTRICT OF WASHINGTON AT TACOMA

PRETRIAL ORDER

CHEMPRO TACOMA
SITE EXPLORATION MAP

SOLID WASTE MANAGEMENT UNITS AT CHEMPRO PARCEL A

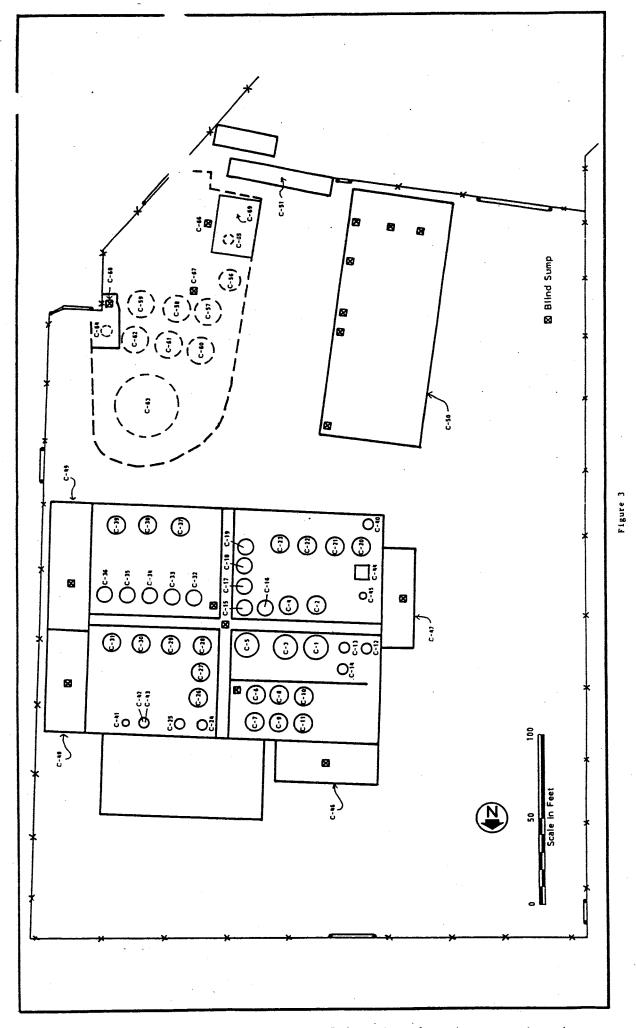
SOLID WASTE MANAGEMENT UNIT LOCATIONS CHEMPRO MAIN PROCESSING AREA

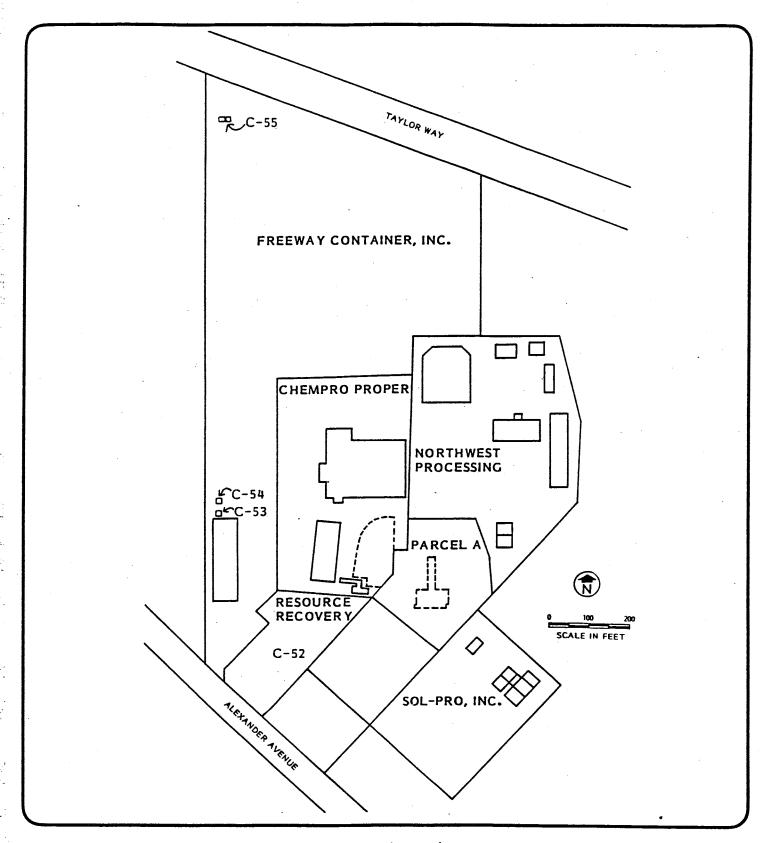
Figure 4

SOLID WASTE MANAGEMENT UNIT LOCATIONS FREEWAY CONTAINER AND RESOURCE RECOVERY

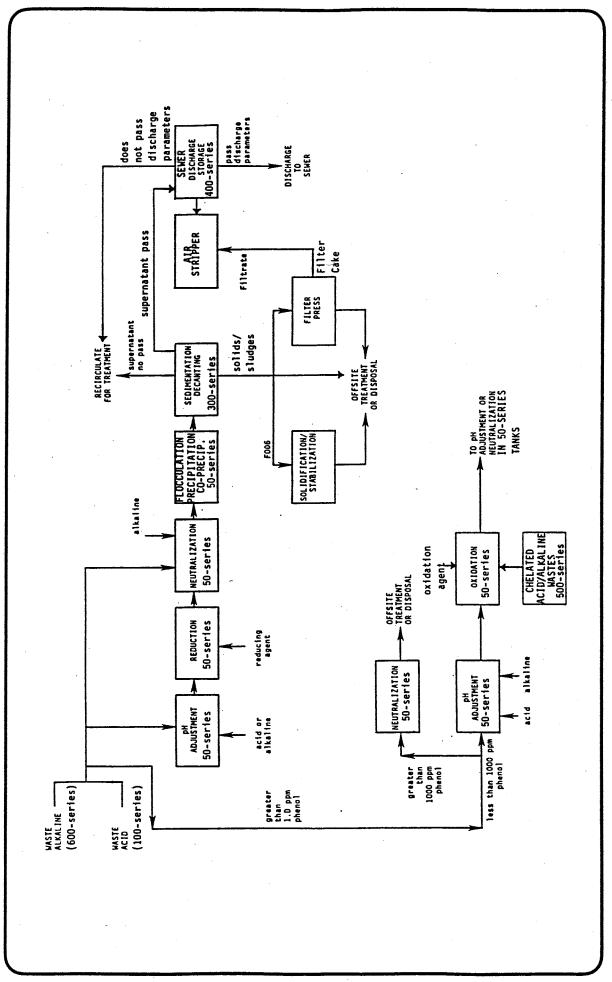
Acid/Alkaline Waste Process Flow - Figure 5 depicts the general process flow for acid and alkaline wastes at Chempro. Incoming acids are stored in the 100-series tanks (SWMUs C-6 to C-11) and alkaline wastes are stored in the 600-series tanks (SWMUs C-26 to C-29). They are tested for pH, chromium, phenolics, sulfide (alkaline wastes only), and cyanide. Following testing they are pumped to the appropriate 50-series tank (SWMUs C-1 to C-5) for treatment. If phenolics are detected, treatment by pH adjustment and oxidation is performed. Waste streams containing chromium are treated by use of a reducing agent in an alkaline medium. For waste streams containing cyanide, additional treatment through alkaline chlorination is necessary. The waste stream then undergoes neutralization and metals precipitation followed by flocculation in the 50-series tanks.

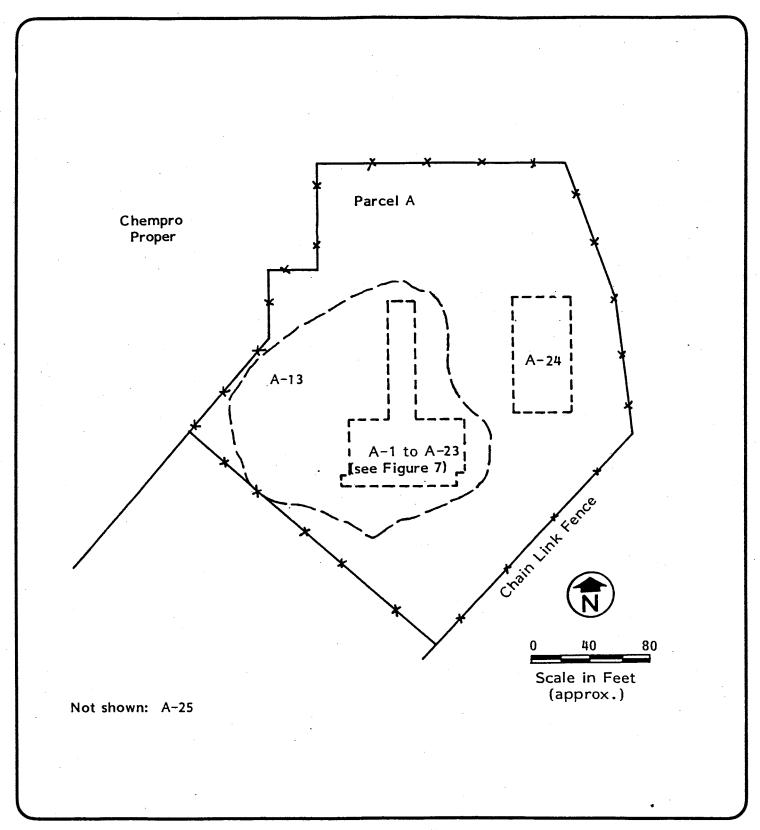
Figure 6

SOLID WASTE MANAGEMENT UNIT LOCATIONS PARCEL A

SWMU NO.	DESCRIPTION
A-1	Alkaline Storage and Treatment Tank 6
A-2	Alkaline Storage and Treatment Tank 7
A-3	Paint Waste Storage Tank 8S
A-4	Acid Storage Tank 9N
A-5	Acid Storage Tank 9E
A-6	Acid Storage Tank 9W
A-7	Sludge Treatment and Storage Tank 10
A-8	Sludge Treatment and Storage Tank 11
A-9	Alkaline Storage and Treatment Tank 12
A-10	Acid/Alkaline Storage and Treatment Tank SS1
A-11	Acid/Alkaline Storage and Treatment Tank SS2
A-12	Acid/Alkaline Storage and Treatment Tank SS3
A-13	Former Waste Oil Pond
A-14	Tank NT1
A-15	Tank NT2
A-16	Tank NT3
A-17	Tank NT4
A-18	Tank NT5
A-19	Poly 1
A-20	Poly 2
A-21	Poly 3
A-22	Sumps
A-23	Rinse Pit
A-24	Acology/Aero/PSIP/Chempro Waste Oil Recycling Facility
A-25	Area of Auto Fluff and Lime Fill

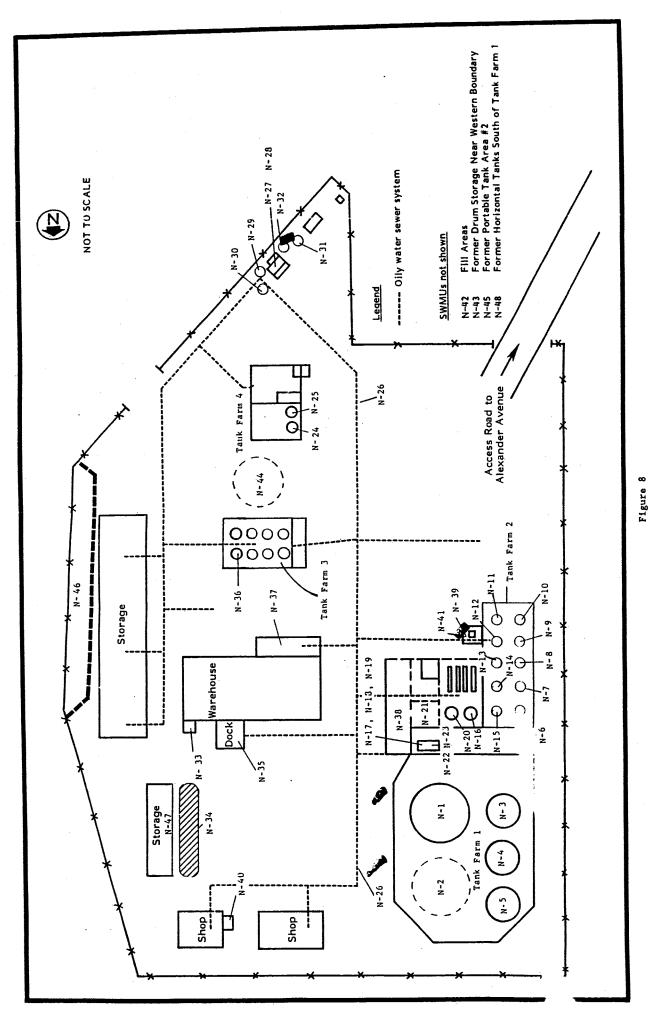
SOLID WASTE MANAGEMENT UNIT LOCATIONS NORTHWEST PROCESSING, INC.

SWMU NO.	DESCRIPTION
N-36	Tank 21, Boiler Feed Tank
N-37	Hot Oil Heater (Boiler)
N-38	Loading/Unloading Area #1
N-39	Loading/Unloading Area #2
N-40	Tire Pyrolysis Unit
N-41	Portable 500-gallon Tanks
N-42	Fill Areas
N-43	Former Drum Storage Area Near Western Boundary
N-44	Former Portable Tank Area #1
N-45	Former Portable Tank Area #2
N-46	Former Drum Storage Area East of Main Warehouse
N-47	Former Drum Storage Building
N-48	Former Horizontal Tanks South of
	Tank Farm 1

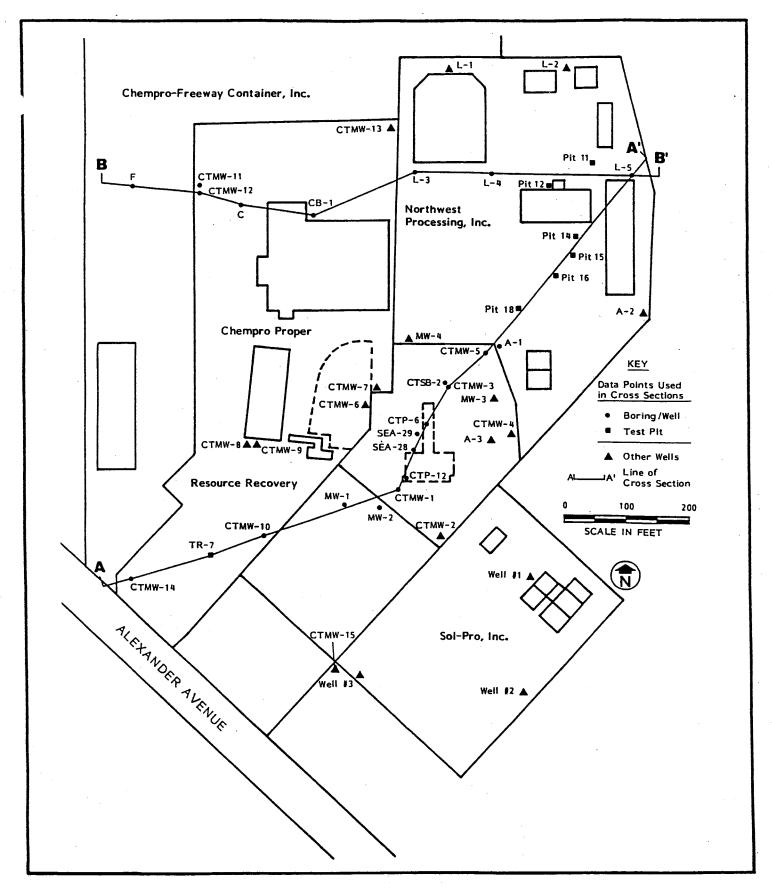
Figure 12

LOCATION OF LINES OF CROSS SECTIONS
AND BORINGS/WELLS AND TEST PITS

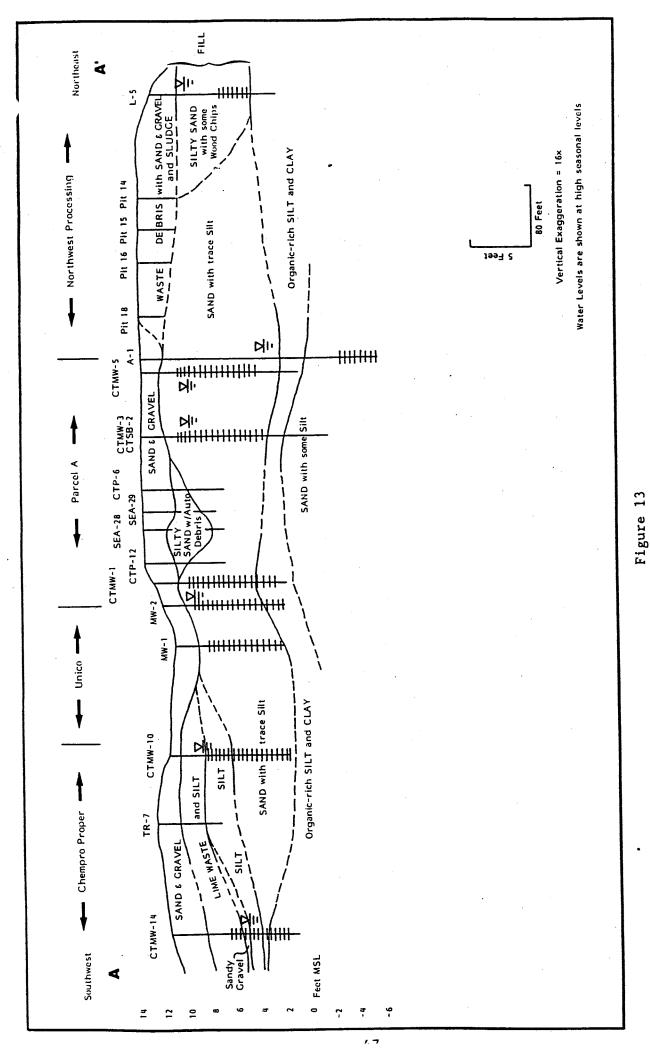
GEOLOGIC CROSS SECTION

• Sand with trace Silt	1 to 8.5 ft	1 to 9 ft	 Fine to medium sand, with trace shell fragments Widespread unit on top of tideflat deposits Hydraulic dredge fill from waterways
■ Organic-rich Silt and Clay (with some silty sand)	1 to 7 ft	6.5 to 14.5 ft	 Widespread, possibly continuous unit Tideflat deposits
■ Sand with some/trace Silt	11 to 14 ft	12 to 21 ft	 Widespread, continuous unit Alluvial deposits
Interbedded Silt and Sand	>4.5 to >6.5 ft	26 to 31 ft	 Widespread, continuous unit Alluvial deposits

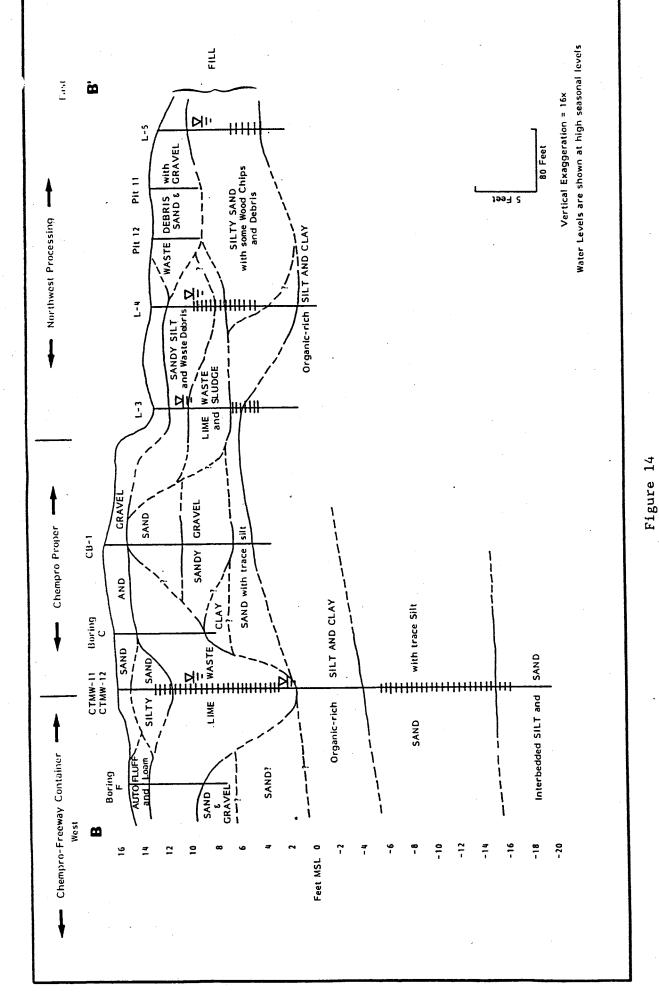
GEOLOGIC CROSS SECTION

Three units resulting from industrial activities are included in the fill material and will be described here: lime waste, auto body fluff (auto debris), and silty sand with woodchips. An outline of the known areal distribution of these wastes is depicted in Figures 15, 16, and 17. Data in these figures were compiled from a variety of sources, which include information from boring logs and historical photographs and drawings in previous reports. The greatest weight was given to boring logs, and secondarily to historic information.

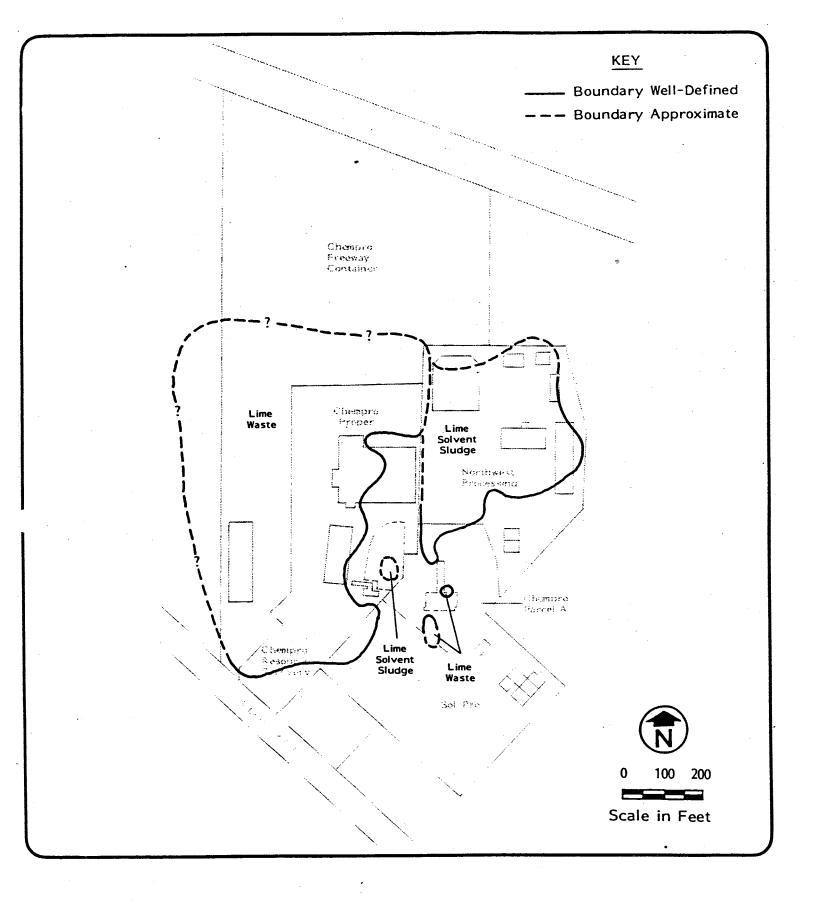
Figure 15

AREAL EXTENT OF LIME WASTE FILL

There appear to be two periods of filling with lime waste, with the first episode being the most volumetrically significant, occurring primarily during the period 1972 to 1976 (22). Lime waste fill is typically a white to gray, firm, clayor silt-like, chalky material. It may occur in sand to cobble size fragments and is commonly admixed with silt. Apparently, all or most of the lime waste dumped by Domtar Industries consists of powdered hydrated limestone that is free of solvent contamination. Most of the lime waste from Hooker Chemical is spent catalyst from the production of chlorinated solvents, and it is referred to as "lime solvent sludge." In boring logs, this lime waste is described as being soft, clay-like, sludge-like, and with a solvent odor. It apparently contains chlorinated hydrocarbons, heavy metals, and asbestos (22). This solvent sludge material is known from at least the following areas: throughout much of the Northwest Processing property and extending into Parcel A, plus an area in the center of Parcel B, and possibly some areas within Chempro Proper (Figure 15) (22, 52, 16). All of this material apparently originated as solvent sludge waste at Hooker Chemical (33, 24, 6, 22). A less significant period of lime waste infilling took place later, as evidenced by near-surface sand, gravel, and lime in the southern part of Parcel A and at scattered areas of the Chempro facility (locations of borings are shown in Section 4.0).

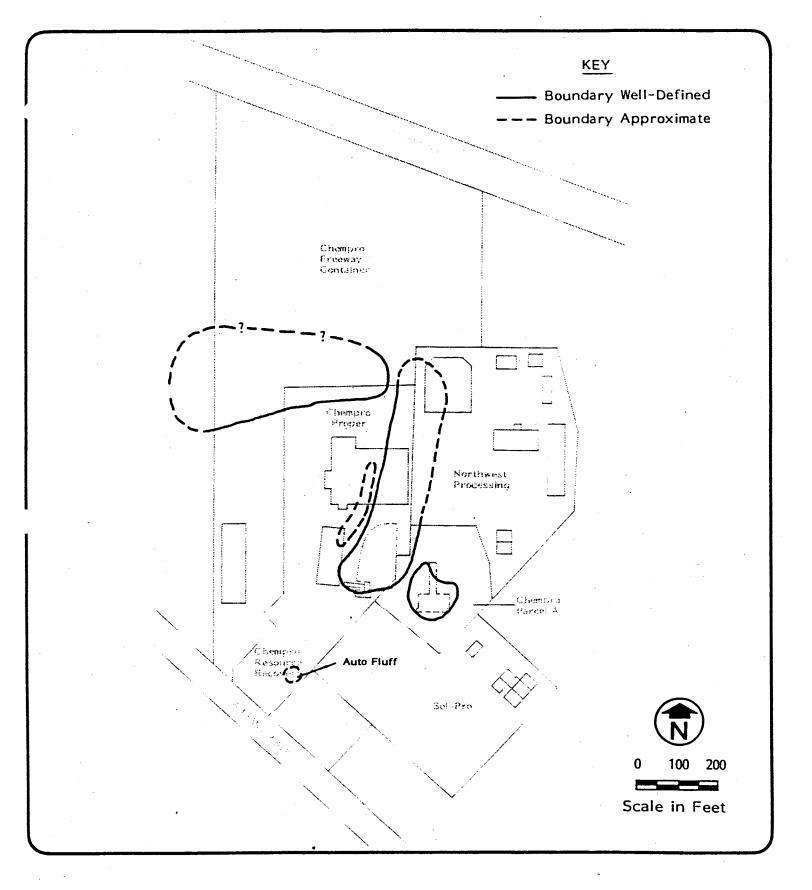
Figure 16

AREAL EXTENT OF AUTO FLUFF FILL

Auto fluff is pulverized or fragmented auto debris, including wire, glass shards, upholstery, tire shreds, paint chips, metal, string, plastic, and rubber, intermixed with sand, gravel, or silt. There were at least two periods of auto debris filling. The first period of disposal occurred prior to the main lime waste fill and included a sandy gravel or silty matrix in the eastern part of Chempro Proper. A second generation of auto fluff disposal occurs in near-surface silty sand, sandy silt, or clean sand on the Chempro property and in

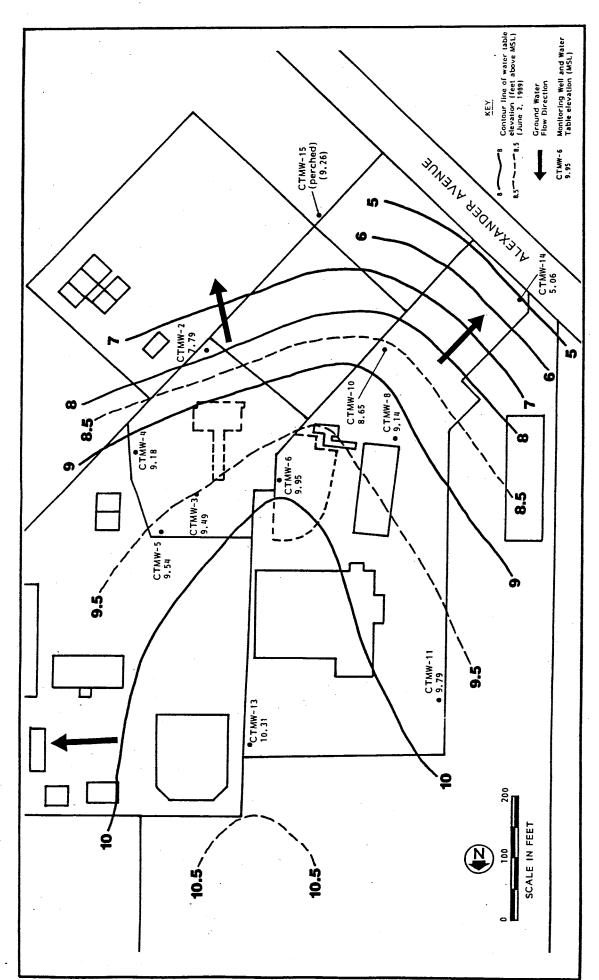
Figure 18

CONTOURS OF WATER TABLE ELEVATION Source: Modified from Sweet-Edwards/EMCON, 1989

The hydraulic conductivity of the shallow aquifer as determined from slug tests in shallow wells (excluding CTMW-15) ranges from 1×10^4 to 3×10^3 cm/sec (8). Using a geometrically averaged hydraulic conductivity of $K = 2 \times 10^4$ cm/sec, a gradient of 0.0040 (for Parcel A and Chempro Proper north of CTMW-10), and an effective porosity of 0.25, produces a calculated flow rate of 0.009 feet/day (3 feet/year).

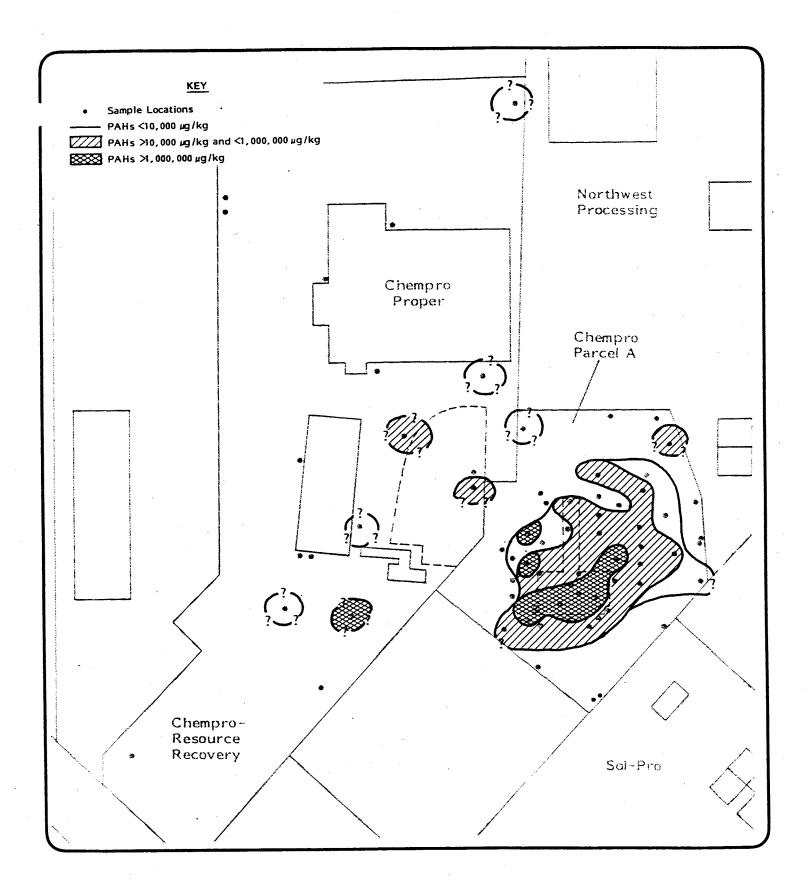
Figure 20

CONCENTRATIONS OF PAHs IN SOIL

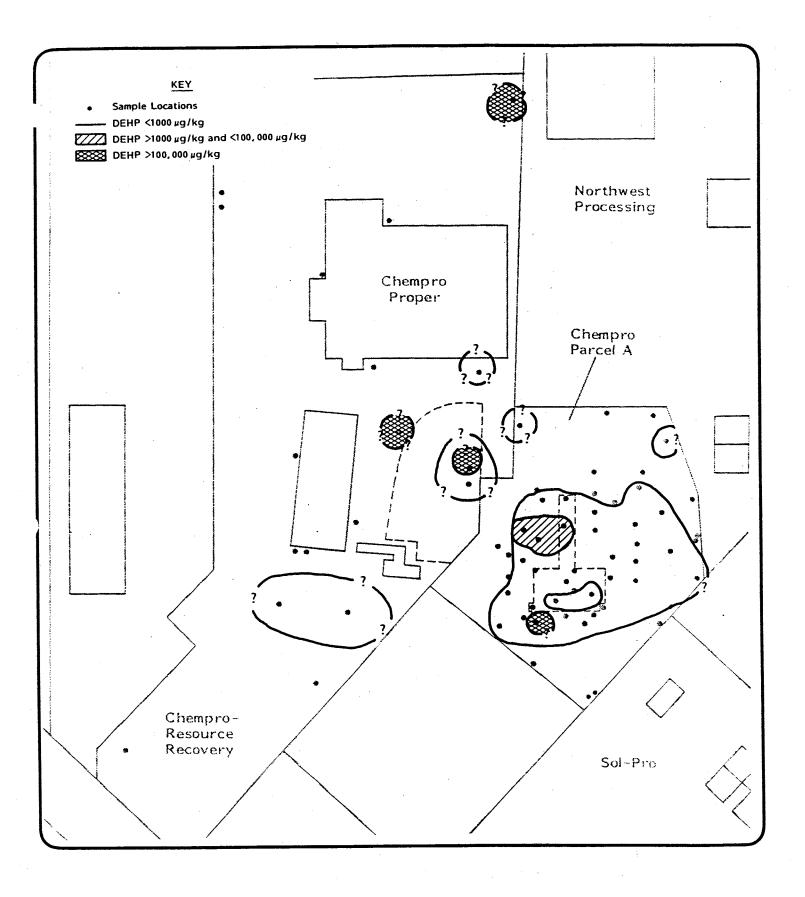
Figure 21
CONCENTRATIONS OF DEHP IN SOIL

The other class of base neutral organic compounds detected at a large number of locations are the phthalate esters (Figure 21). These compounds are used as plasticizers and are commonly detected in the environment due to anthropogenic

sources. Four species of phthalate esters have been detected in soils at the Chempro facilities, with bis(2-ethylhexyl)phthalate being the predominant component. Di-n-octyl phthalate, butylbenzyl phthalate and di-n-butyl phthalate are also present in areas south and east of the former waste treatment units at These compounds also contribute to the Parcel A (SEA-24,29; CTP-3,4,6). contamination observed at borings placed in the area around the former letter tank farm on Chempro Proper (CTMW-6,7; CB-6,9). High levels of phthalate ester contamination are also found in the northeast corner of Chempro Proper (CTMW-This distribution is generally similar to the observed distribution of PAHs. While the area of contamination at Parcel A generally occurs in the area of the former oil pond, contamination at Chempro Proper may represent isolated or more widespread contamination in that area. As with PAHs, the contamination detected in the northeast corner of Chempro Proper may reflect the influence of Northwest Processing on conditions at the Chempro site. The phthalate esters present in soils may be present as oily waste constituents and as components of the plastic materials present in the auto fluff. Phthalate esters present in oily waste will be more mobile in the environment due to their occurrence as constituents in a complex organic liquid, while phthalate esters in auto fluff are present in a solid matrix that are not as available to migrate in the The contribution of each of these sources to the subsurface flow system. observed concentrations of phthalate esters in soil cannot be determined from available information.

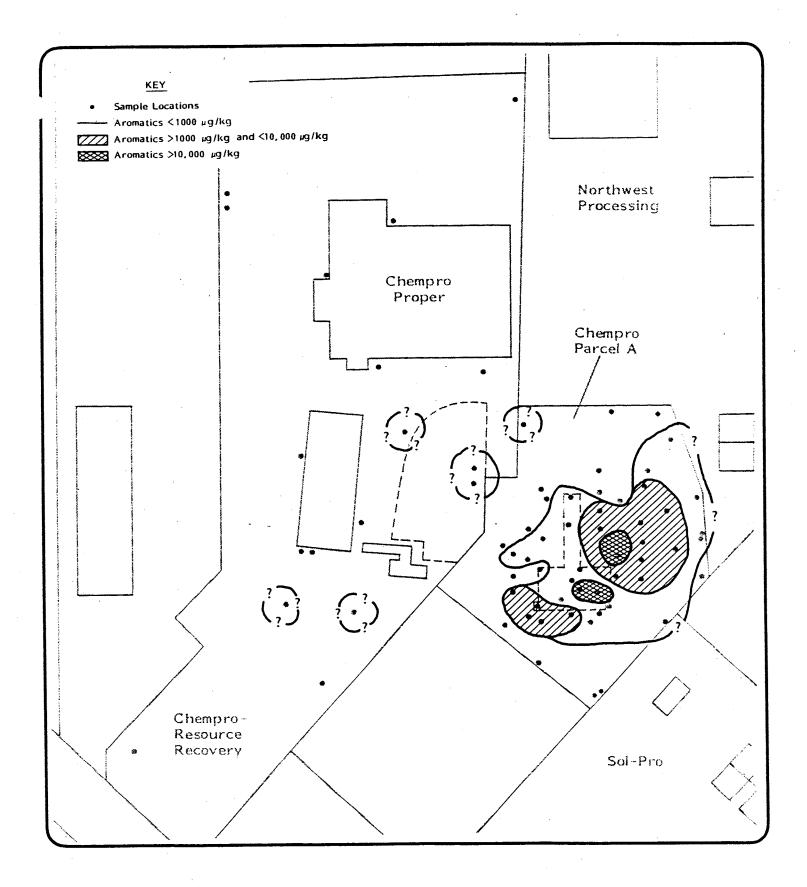
Figure 22
CONCENTRATIONS OF AROMATICS IN SOIL

Significant concentrations of aromatic hydrocarbons and purgeable halocarbons were detected in soils at several areas of the Chempro facilities. Figures 22 and 23 show the distribution of these two groups of contaminants detected at the site. Aromatic hydrocarbons found in soils include benzene, ethyl benzene, toluene and xylenes. Xylenes are the predominant aromatic compounds in the samples, occurring at concentrations up to 240,000 μ g/kg. Toluene and ethylbenzene are significant components of the aromatic compounds present in soils. Benzene occurs less frequently and is usually present in lower concentrations (up to 16,000 μ g/kg) in subsurface soils.

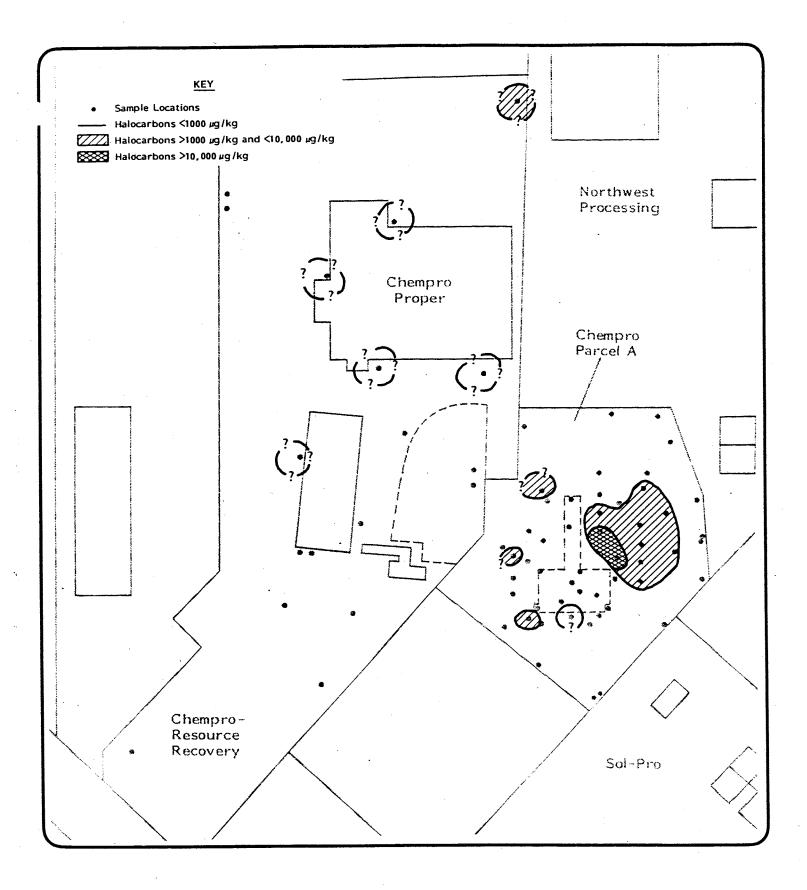
Figure 23

CONCENTRATIONS OF HALOCARBONS IN SOIL

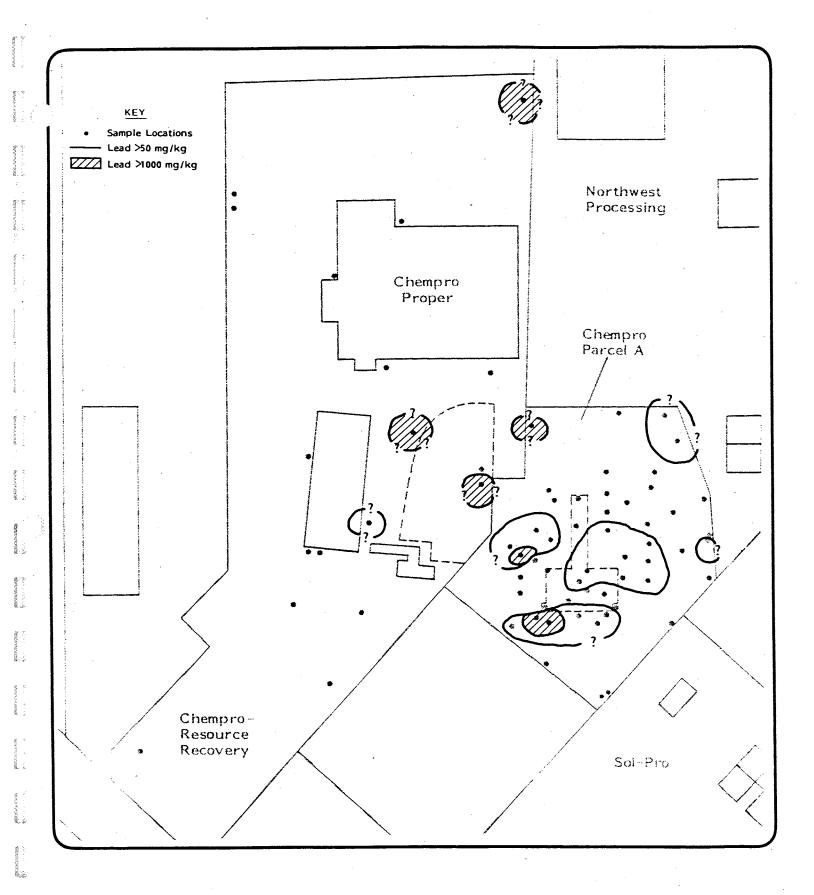
Figure 24
CONCENTRATIONS OF LEAD IN SOIL

The values shown on Figures 24 and 25 represent the maximum value for these metals at each location from the Phase I and II studies for Parcels A and Chempro Additional sampling conducted for the closure of Parcel A provided additional information on the distribution of metals with depth in the upper 3 feet of soils in the former waste treatment area of Parcel A. Chromium was found to decrease with depth in soil until auto fluff was encountered. Cadmium and copper were present in very low levels in soil until auto fluff was encountered, where concentrations increased significantly. The trend of decreasing chromium concentration with depth was attributed to limited depth of impact due to releases from the facility, while elevated concentrations at depth were These depth distributions may reflect the attributed to auto fluff. contributions of different sources to the metals concentrations in soils; however, an attempt to determine the contributions of metals in different forms to the total concentrations was not attempted. The Parcel A closure excavation did result in the removal of shallow contaminated soils, but elevated metals concentrations remain that Chempro attributes to auto fluff beneath the site.

Significant chromium and lead contamination (up to 284 and 6720 mg/kg, respectively) was encountered at Chempro Proper. Shallow soil samples were collected in the location of the former letter tank farm during Parcel B closure activities. These results may indicate two separate areas of contamination at either side of the tank farm (SEA-24; CTMW-7; CB-9). This distribution may reflect releases that ran off the pad or escaped containment at the letter tank

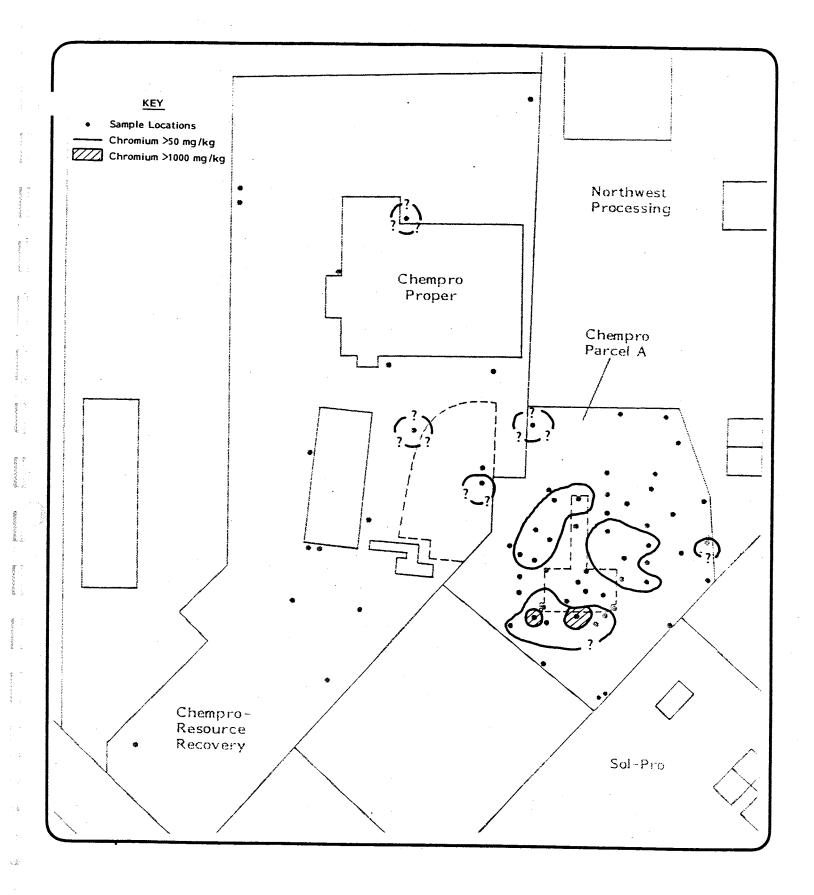
Figure 25
CONCENTRATIONS OF CHROMIUM IN SOIL

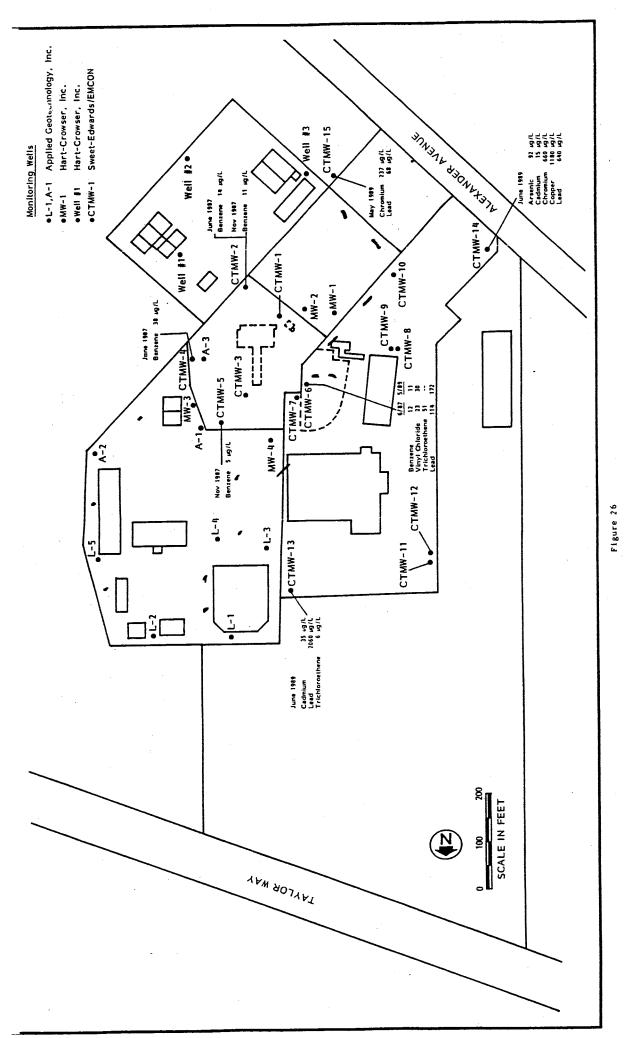
MONITORING WELL LOCATIONS AND METALS AND ORGANIC COMPOUNDS EXCEEDING MAXIMUM CONTAMINANT LEVELS 11

Figure 26 shows total metals concentrations exceeding Maximum Contaminant Levels (MCLs) at wells CTMW-6 (June 1987, May 1989), CTMW-13 (May 1989), CTMW-14 (May 1989), and CTMW-15 (May 1989). MCLs for these compounds are listed in Table 10. Total lead concentrations at CTMW-6 exceeded the MCL of 50 ug/L in 1987 and 1989. Total arsenic concentrations also exceeded the MCL at well CTMW-6 in

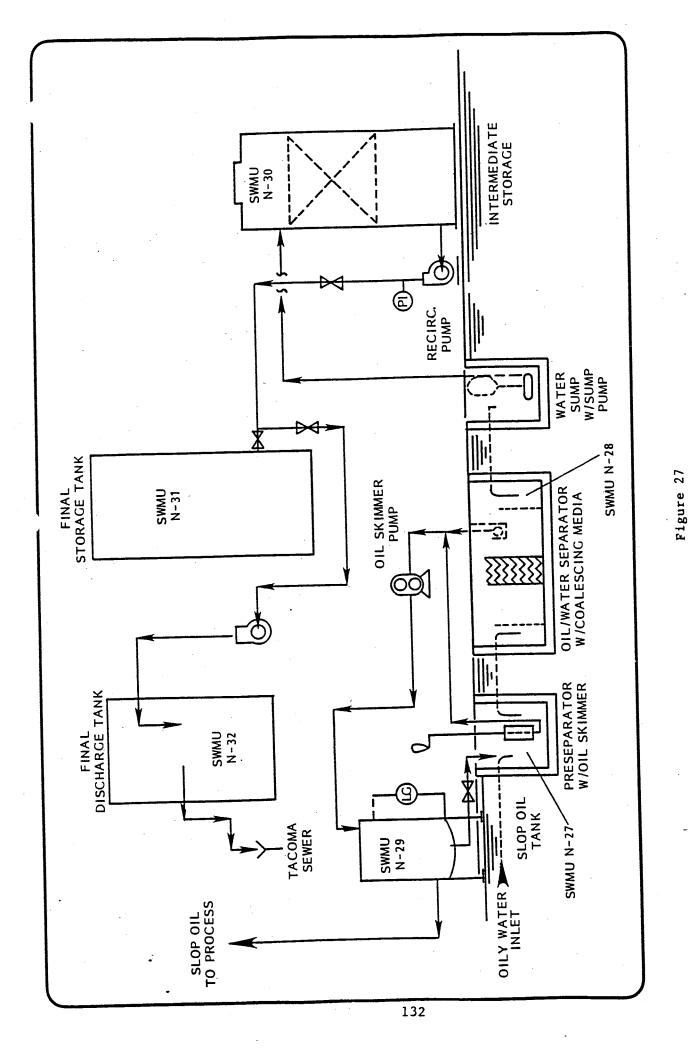
OILY WASTE TREATMENT SYSTEM NORTHWEST PROCESSING

The oily water treatment system is used for oil/water/solids separation for wastewaters collected in the oily water sewer system (SWMU N-26) (51). The system consists of an API preseparator (SWMU N-27), a coalescing separator (SWMU N-28), a skim tank for slop oil skimmed off the separator units (SWMU N-29), a biotower (SWMU N-30), a storage tank known as the "pink tank" (SWMU N-31), and a sewer discharge tank (SWMU N-32). The biotower is constructed of carbon steel with dimensions of 25 feet tall by 13 feet diameter, and a capacity of approximately 25,000 gallons (51). Process flow for these SWMUs is shown in Figure 27.

Oily wastewaters enter the preseparator where an oil skimmer removes free oil; this is pumped to the skim tank. The water then passes through the coalescing separator which is designed to reduce the oil content to less than 50 ppm (37). The oil collected in this unit is pumped to the skim tank. Water leaving the separators is pumped to the biotower, which is not currently operating as a biological treatment unit. The effluent is stored in a holding tank (the "pink tank") for final analysis before being discharged on a batch basis to the sanitary sewer system or shipped off-site for disposal. An earlier Tacoma City Sewer discharge permit for contact stormwater has limitations in the permit for metals, total oil and grease, pH, phenols, cyanide, PCBs, BETX and purgeable halocarbons (46).
