Remedial Construction Services, L.P.

June 19, 2017

Re: Remedial Action Letter Report – Former Lubes Facility Decommissioning  
Shell Harbor Island Terminal  
Seattle, Washington  
Consent Decree 99-2-07176-0SEA

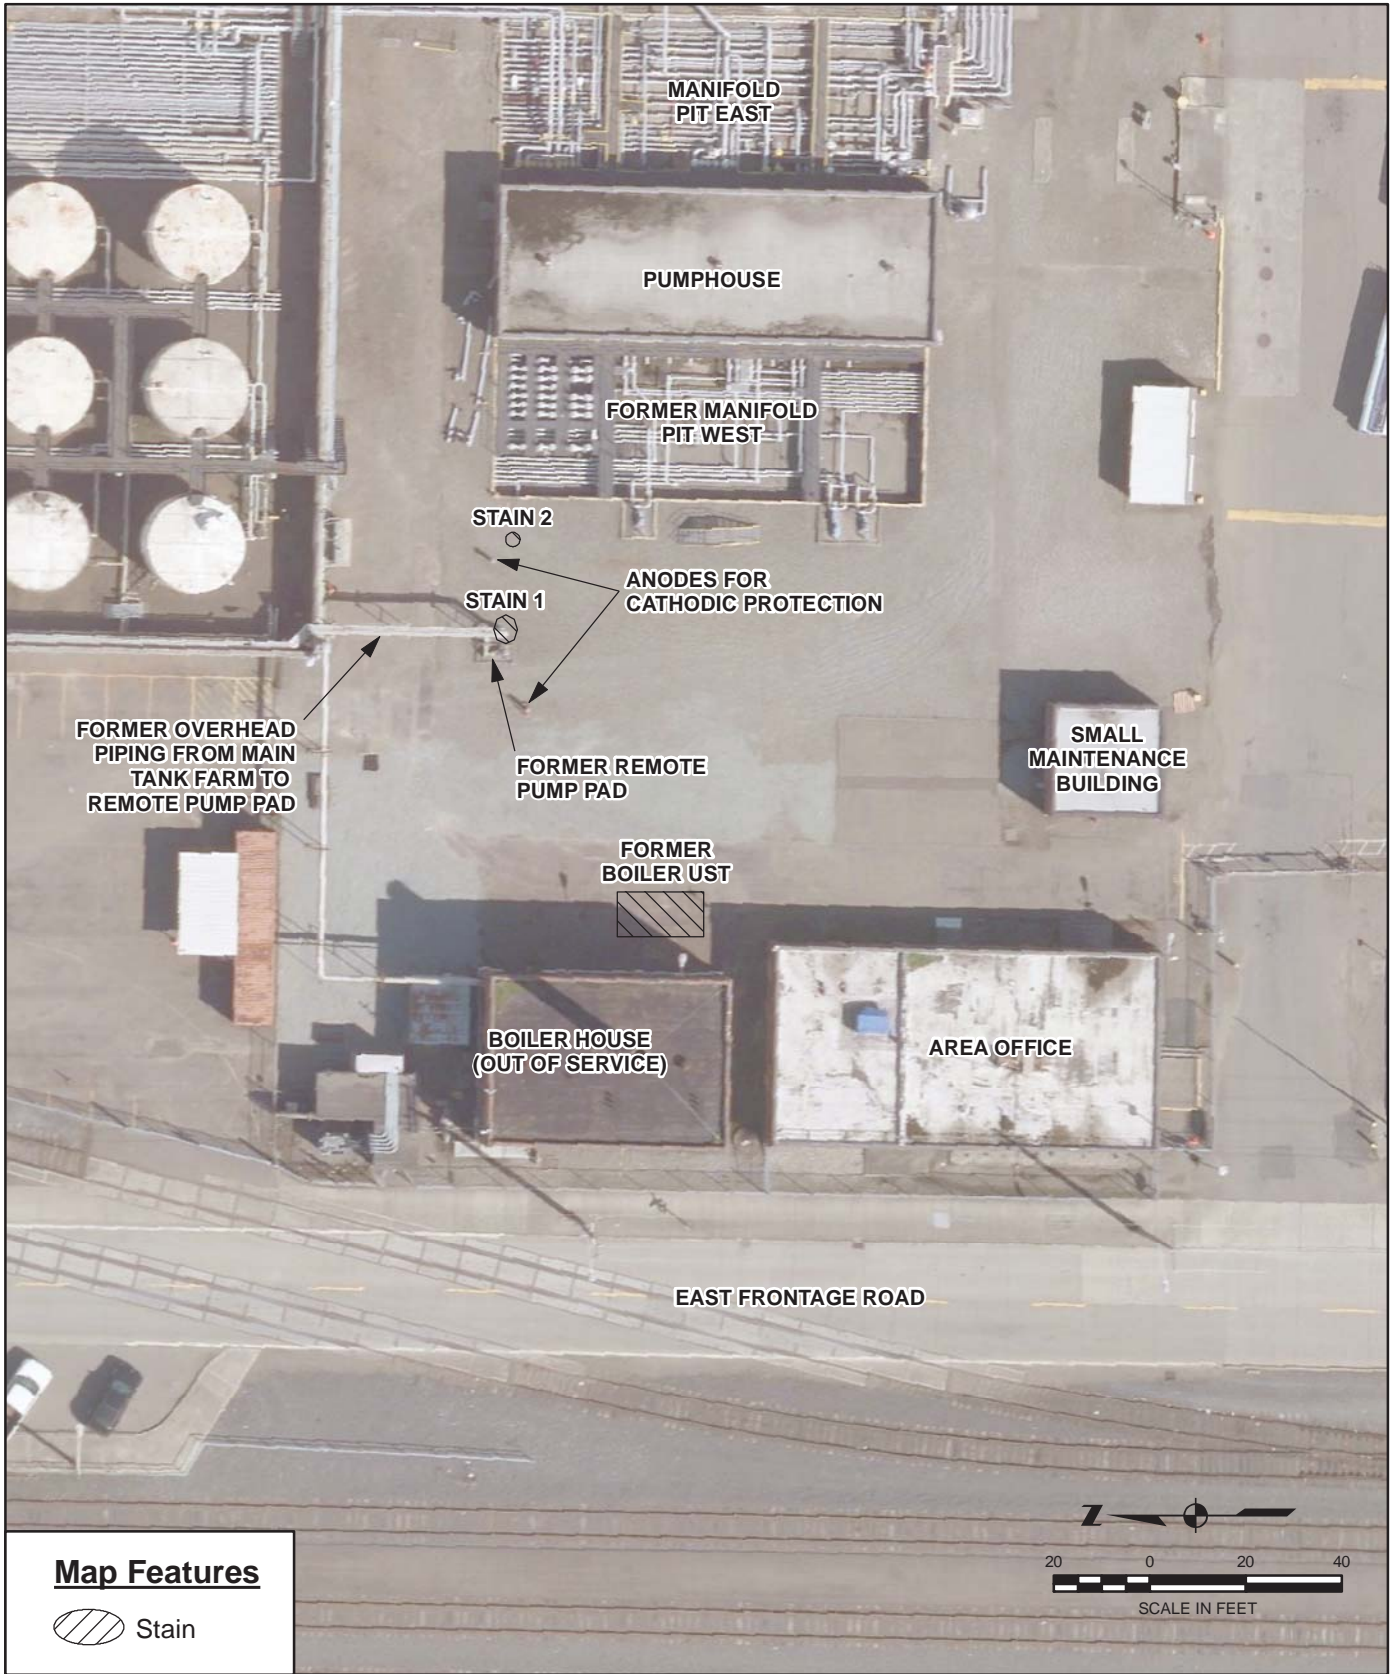
FIGURE 2

At Stain 1, the pipes are approximately 12-inches below the gravel surface, and at Stain 2, a small yellow-jacketed pipe was observed approximately 18-inches below the gravel surface with no indication of any leaks.

### LUBE FACILITY DETAILS

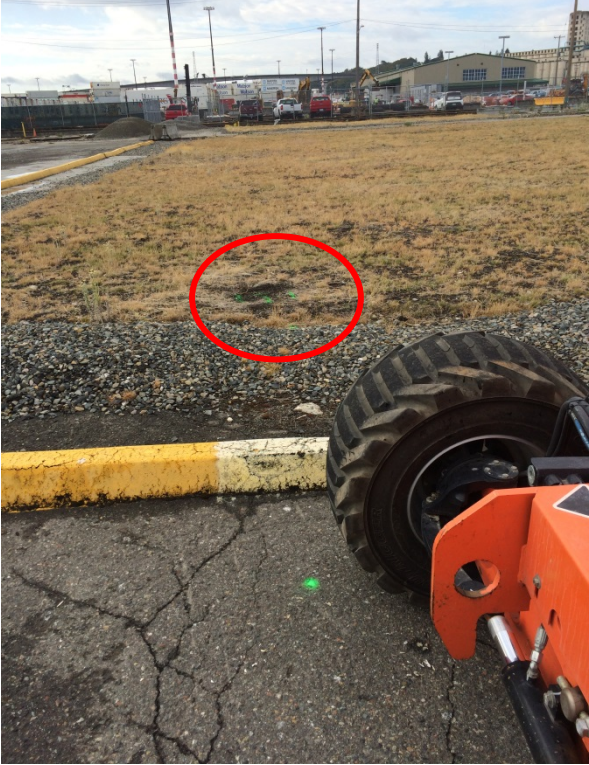
<b>Client Name:</b> Shell (Equilon)		<b>Project:</b> Remedial Action Letter– Former Lubes Facility Decommissioning Shell Harbor Island Terminal	
<b>Photo No.</b> 1	<b>Date:</b> 9/19/2016

<b>Direction Photo Taken:</b> South			
<b>Description:</b> View of the southern terminus of the pipes at the former South Blending Area.

<b>Photo No.</b> 2	<b>Date:</b> 9/19/2016	 	
<b>Direction Photo Taken:</b> North			
<b>Description:</b> View of the southern terminus of the pipes at the former South Blending Area.

The four pipes leading from Stain 1 to the former South Blending Area were traced to a terminus location using the utility locate company. No additional excavation or sampling was deemed necessary at the former South Blending Area terminus location based on the following conclusions:

- Lack of staining on the ground surface at the former South Blending Area terminus location.

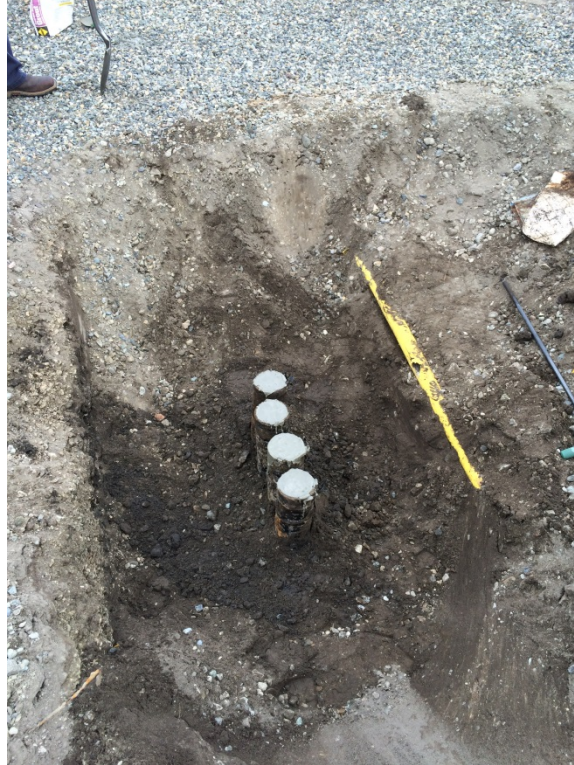
**Photo No.**  
3

View of the final excavation limits, grouted four pipes, and single yellow pipe at Stain 1.

observed in any of the pipes. Shell confirmed that there were no residual liquids present and that the pipes had sufficiently been historically cleaned and pigged. Shell authorized RECON to install grout plugs in the 18-inch vertical sections of the pipes. RECON used approximately 10 pounds of grout in each of the 18-inch vertical sections.

- The impacted soils at the two stained areas were remediated to below the inland soil cleanup level of 20,000 mg/kg.
- The four abandoned pipes at Stain 1 were deemed to have been historically cleaned and pigged but not plugged. RECON therefore plugged the four pipes during this action.
