Interim Remedial Action Status Report

Plaid Pantry Store #112

1002 W. Fourth Plain Boulevard

EES Project 1179-02

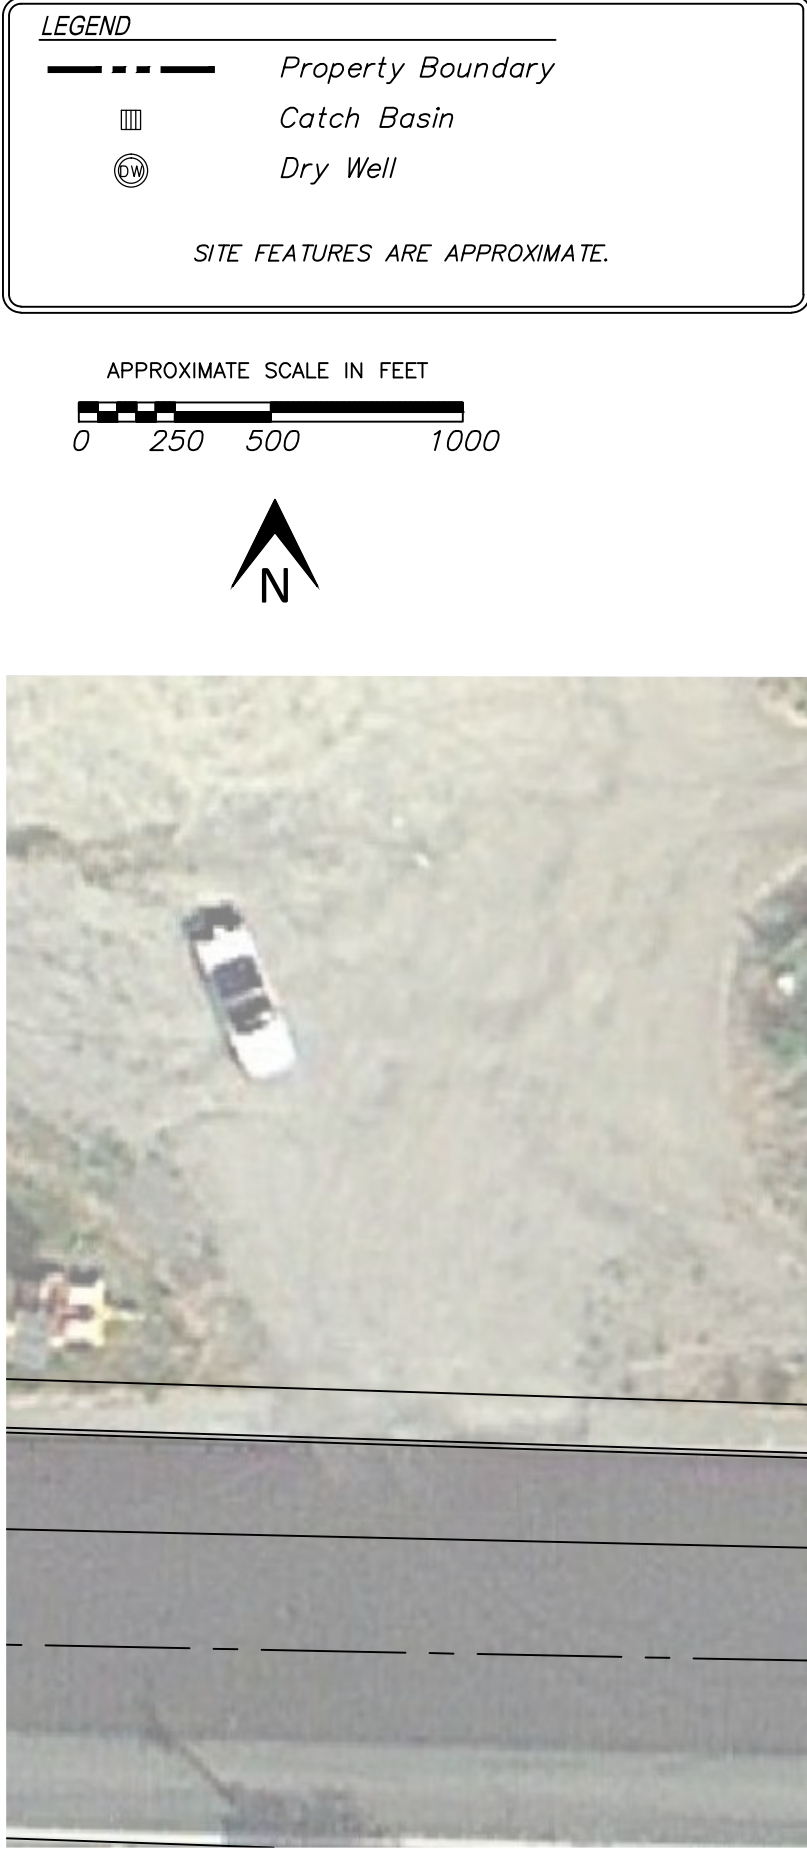
DATE:	12-18-13	PROJECT NO.	
FILE:	1179-01	1179-01	
DRAWN:	JJT	FIGURE NO.	2
APPROVED:	CR

SITE FEATURES

(Figure 2). The following facility identification numbers have been assigned to the Property for reference by Ecology:

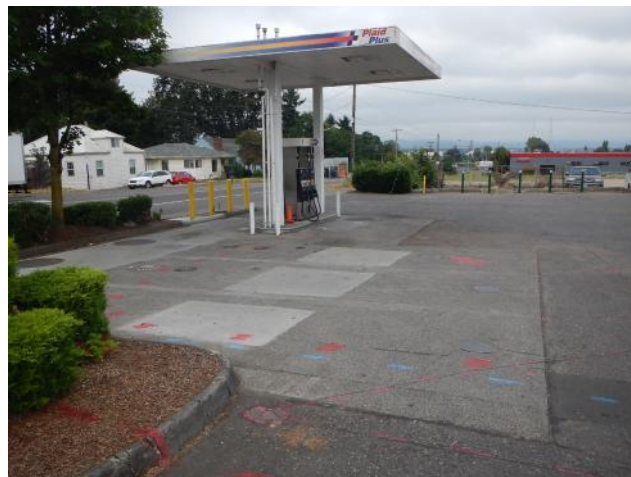
Fueling station.

Abandoned tank located just south of canopied fueling station.
