SITE DISCOVERY AND INDEPENDENT REMEDIAL ACTION REPORT

*Olympic Pipeline Company
Tacoma Junction
2660 Frank Albert Road East
Fife, Washington*

October 12, 2015

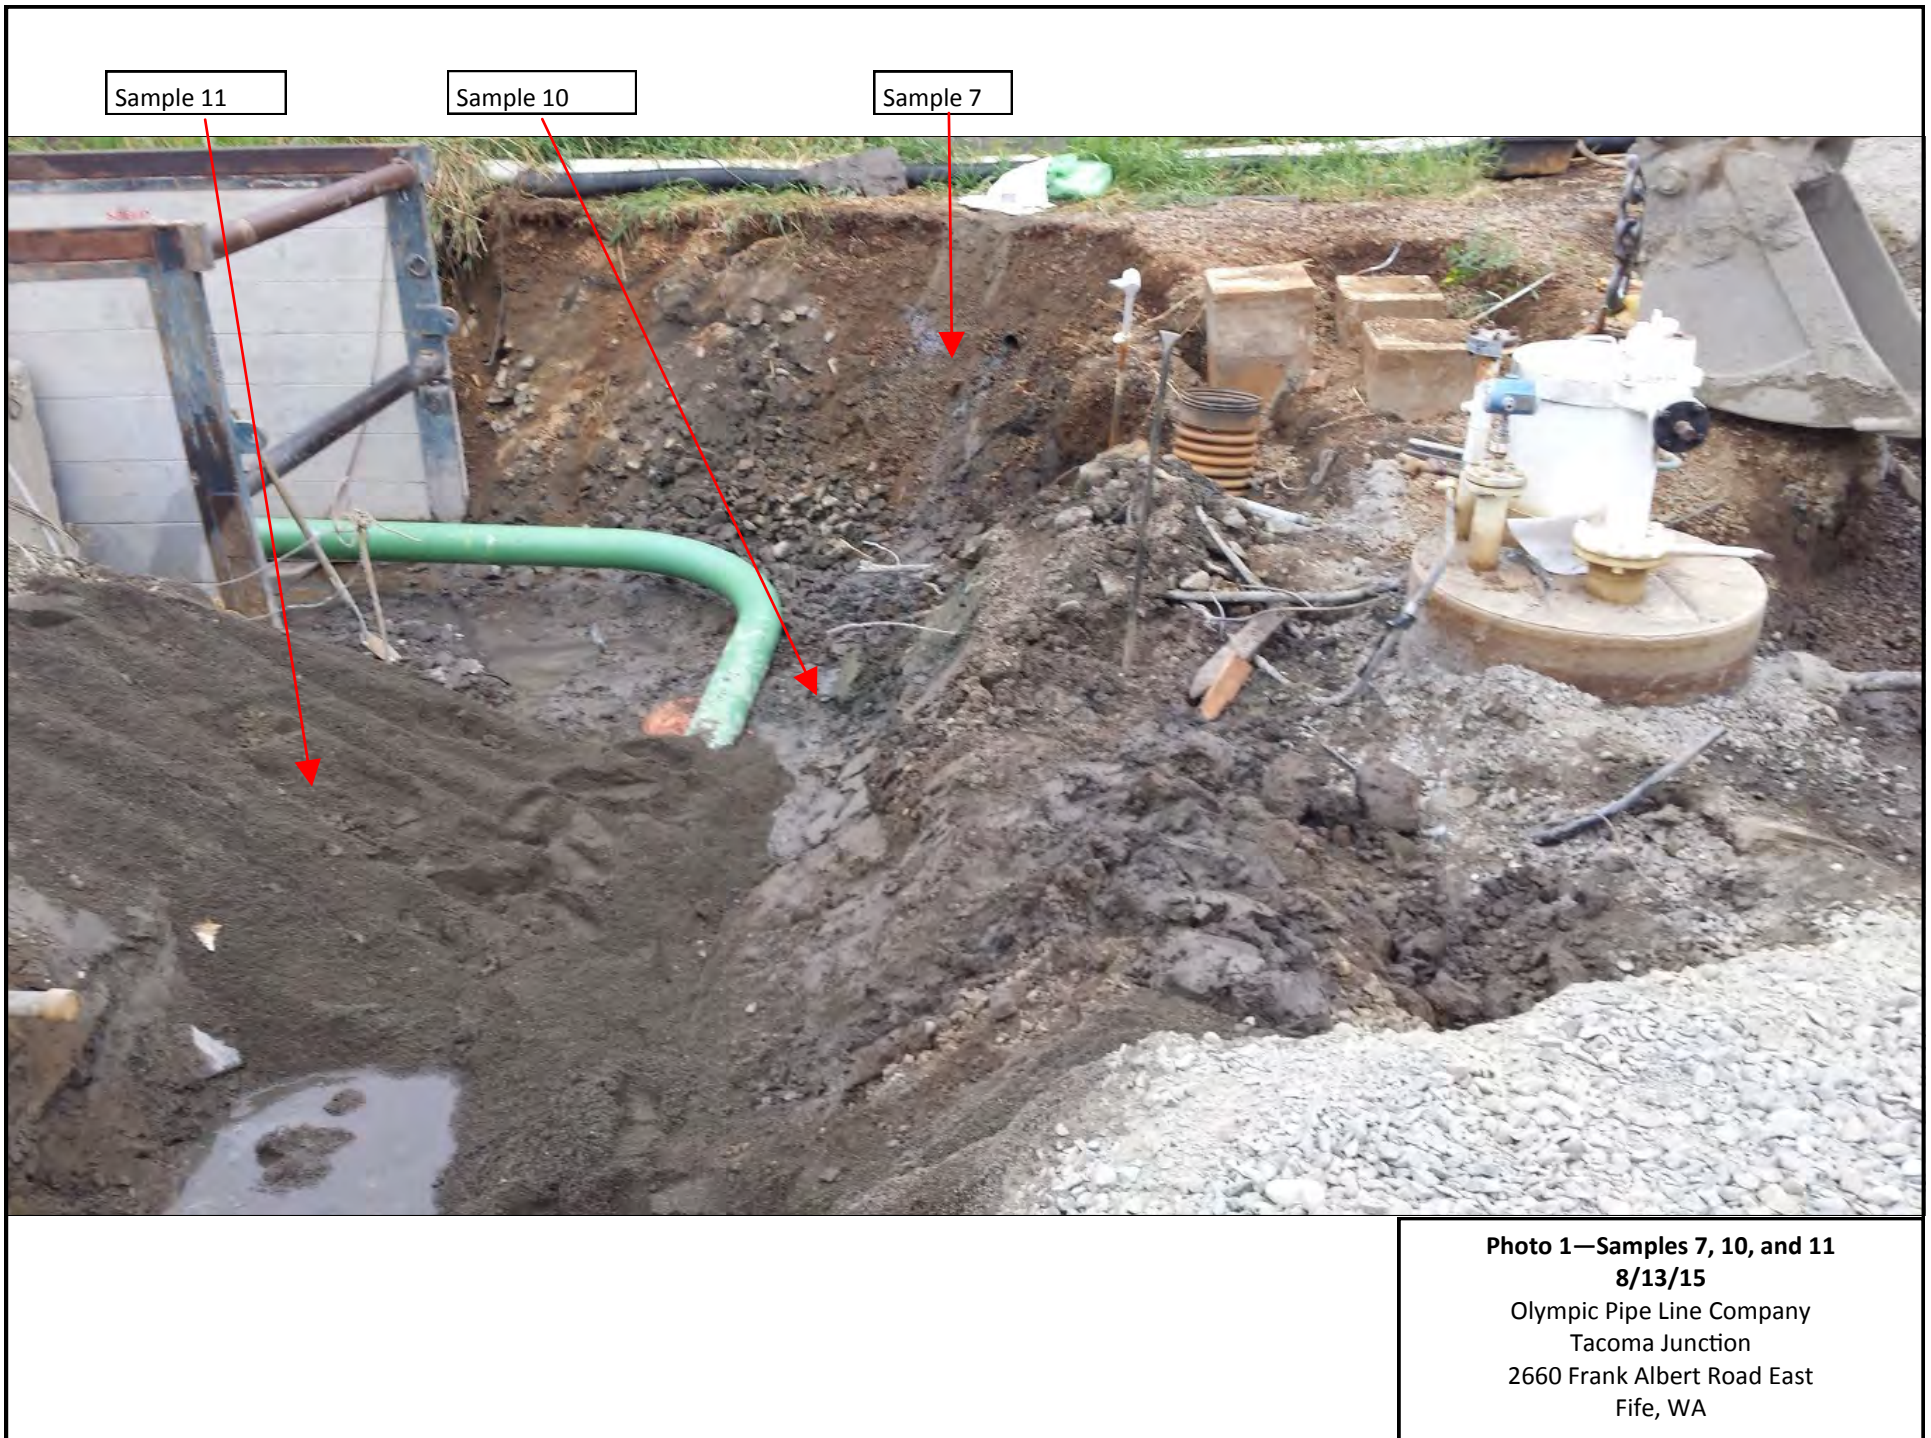
**Photo 1—Samples 7, 10, and 11
8/13/15**

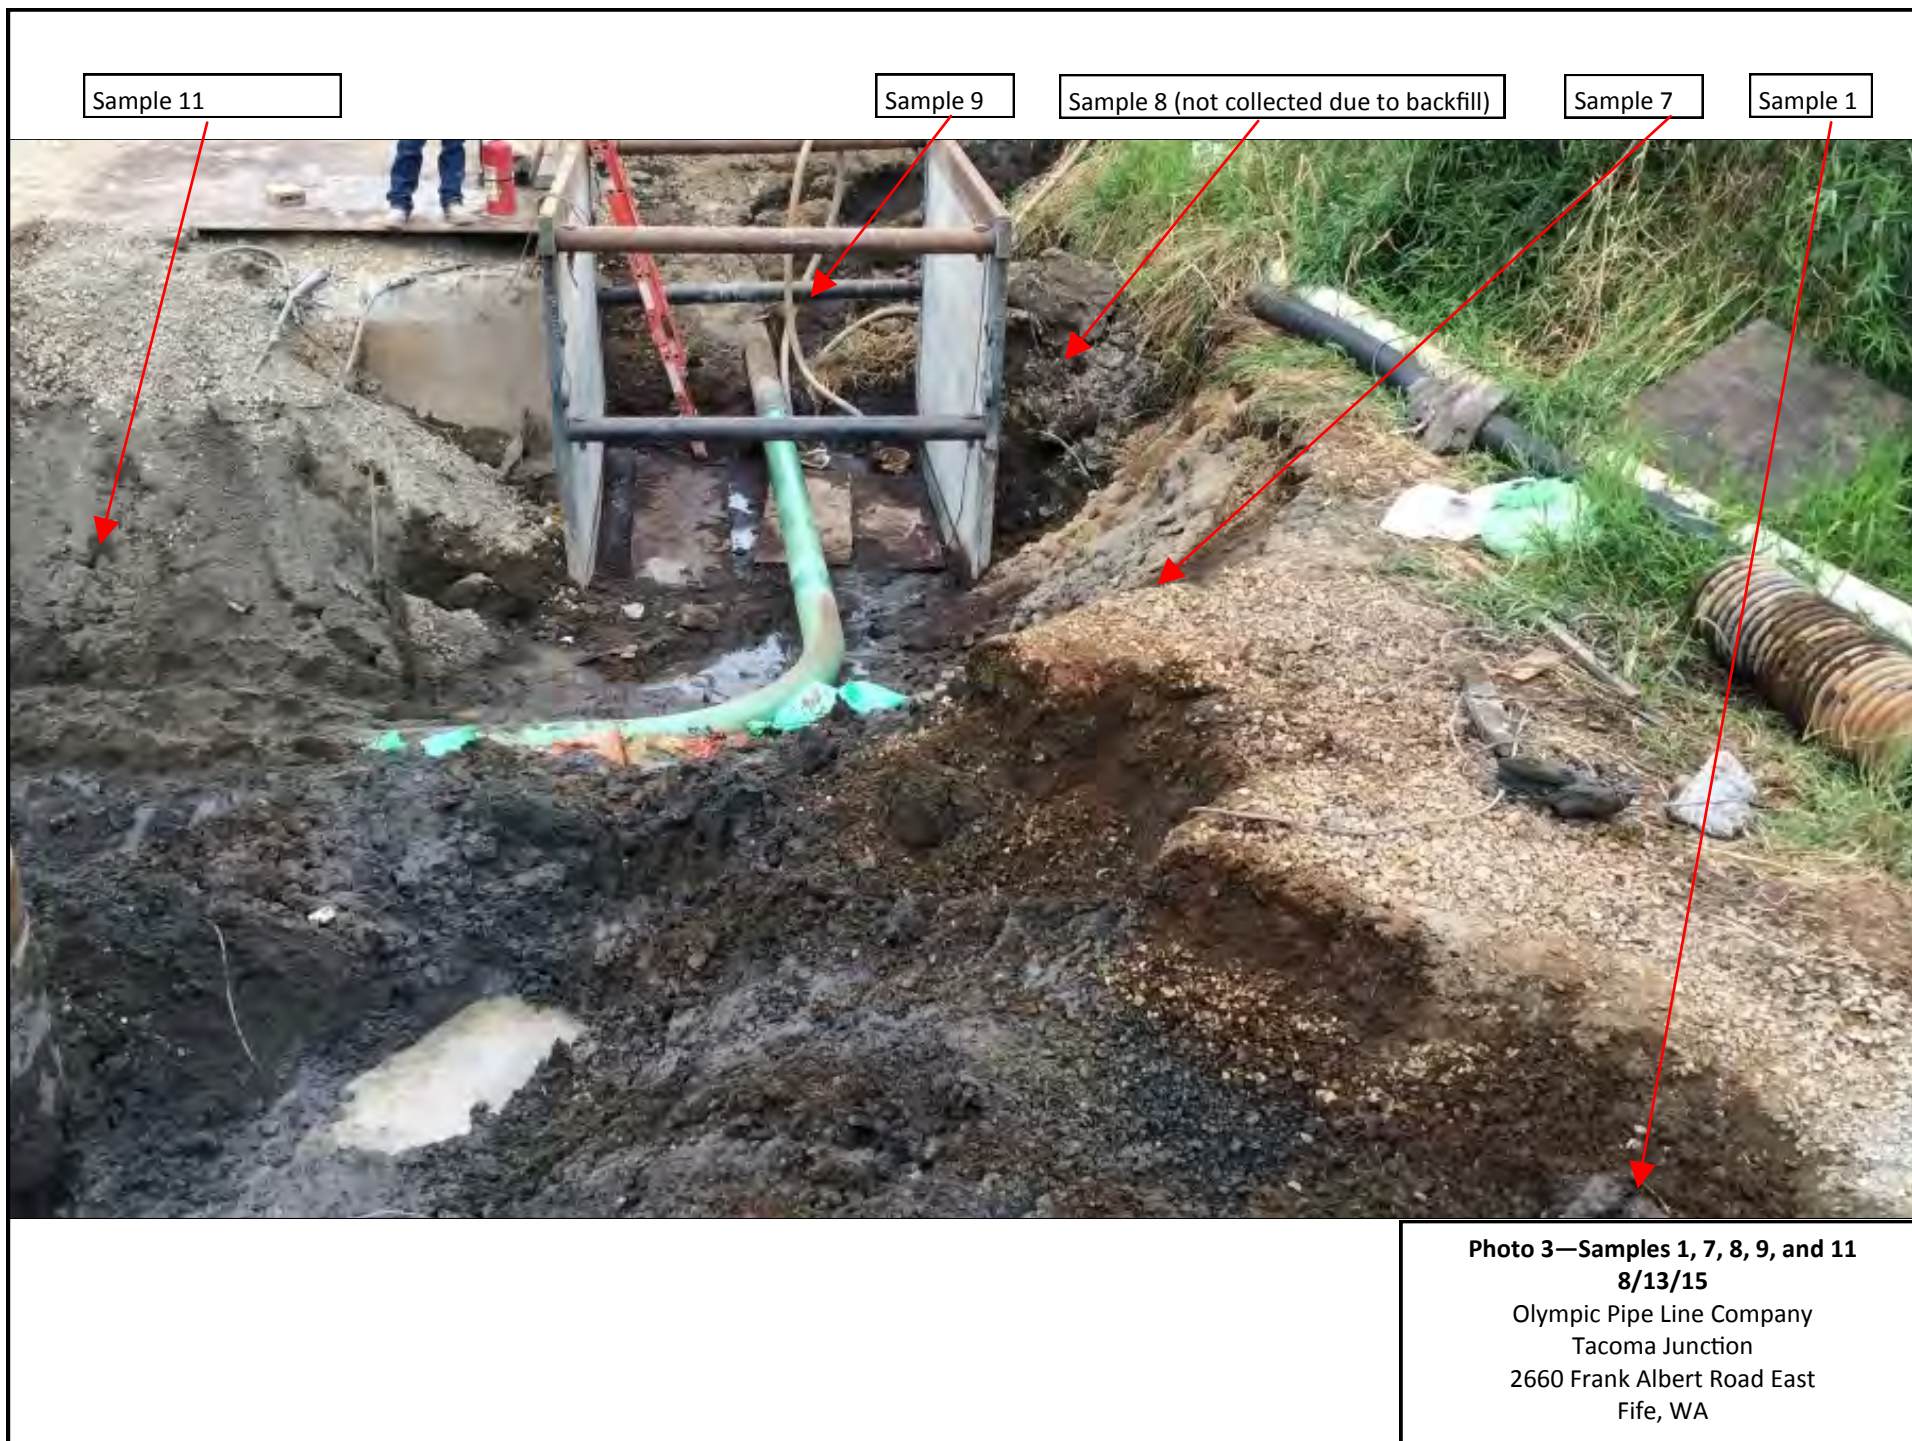
**Photo 3—Samples 1, 7, 8, 9, and 11
8/13/15**

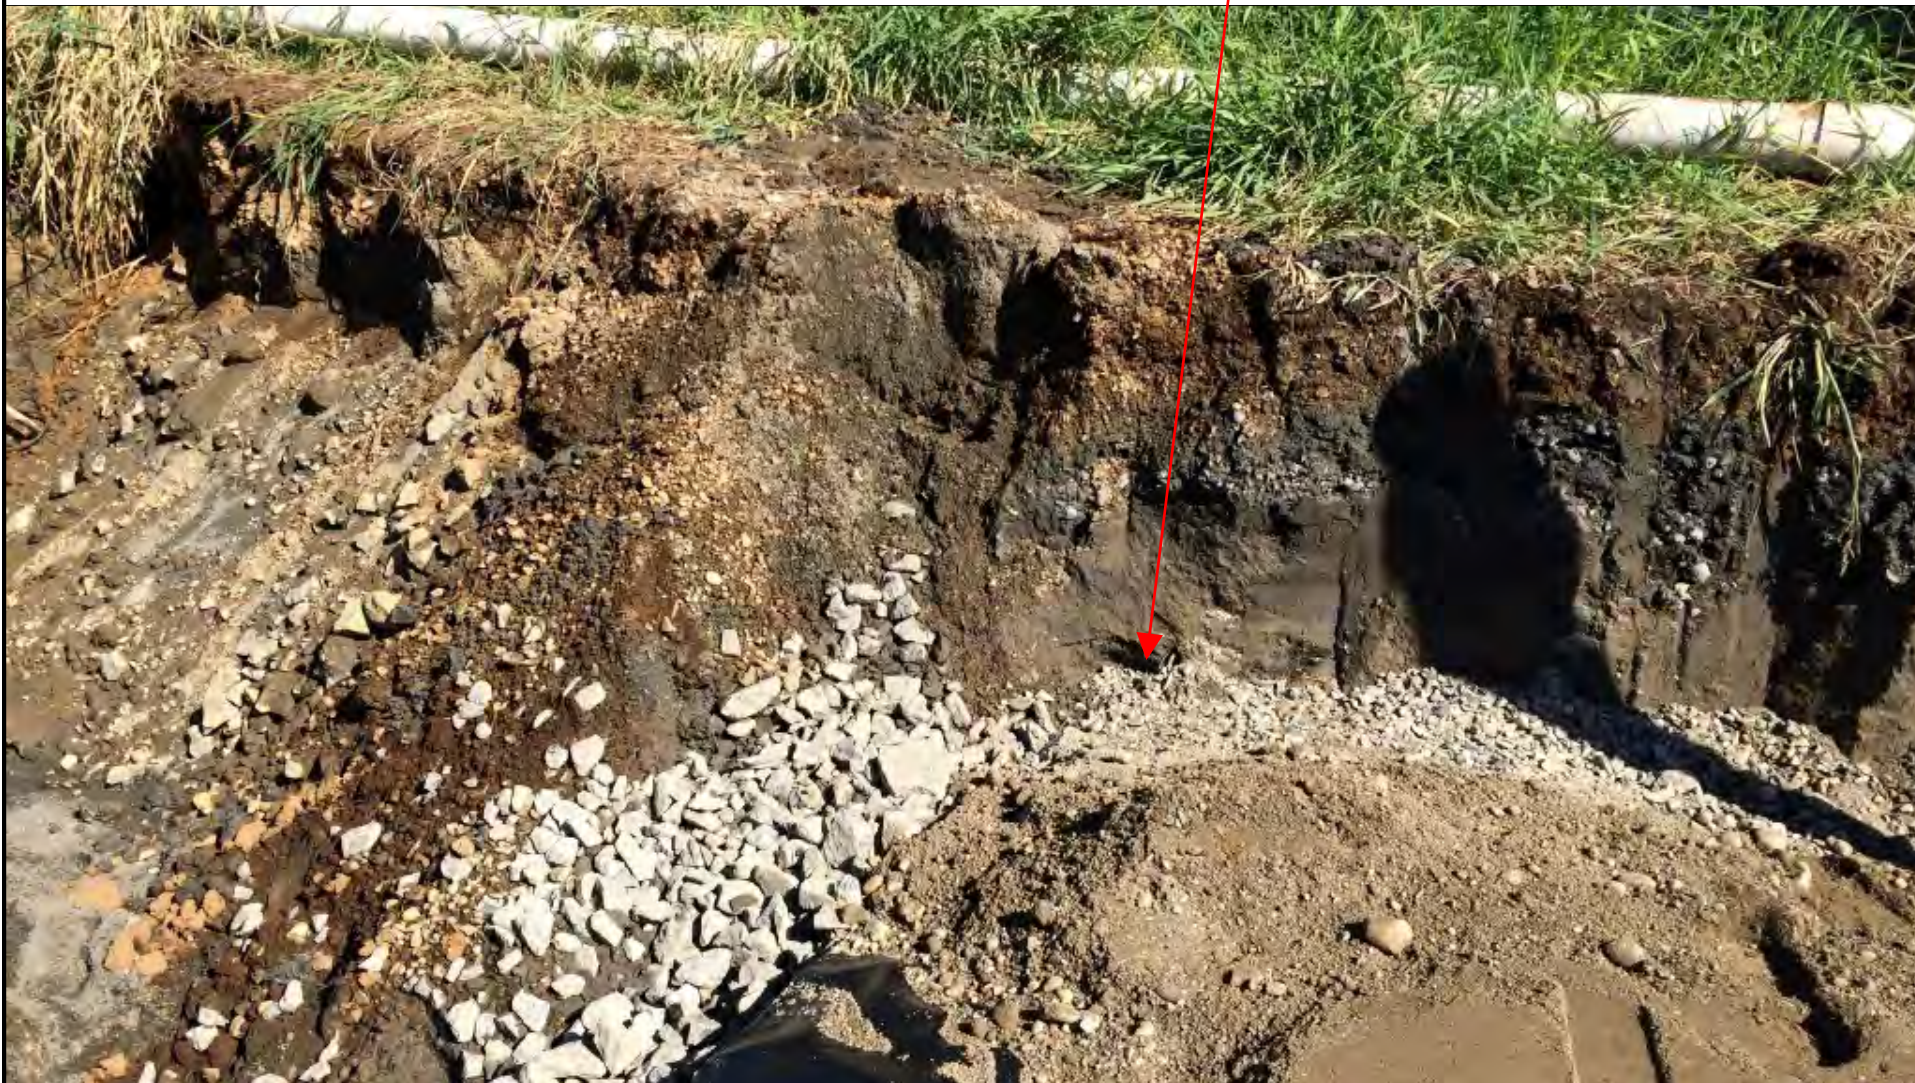
Sample 7.2

Photo 5—Sample 7.2
8/13/15

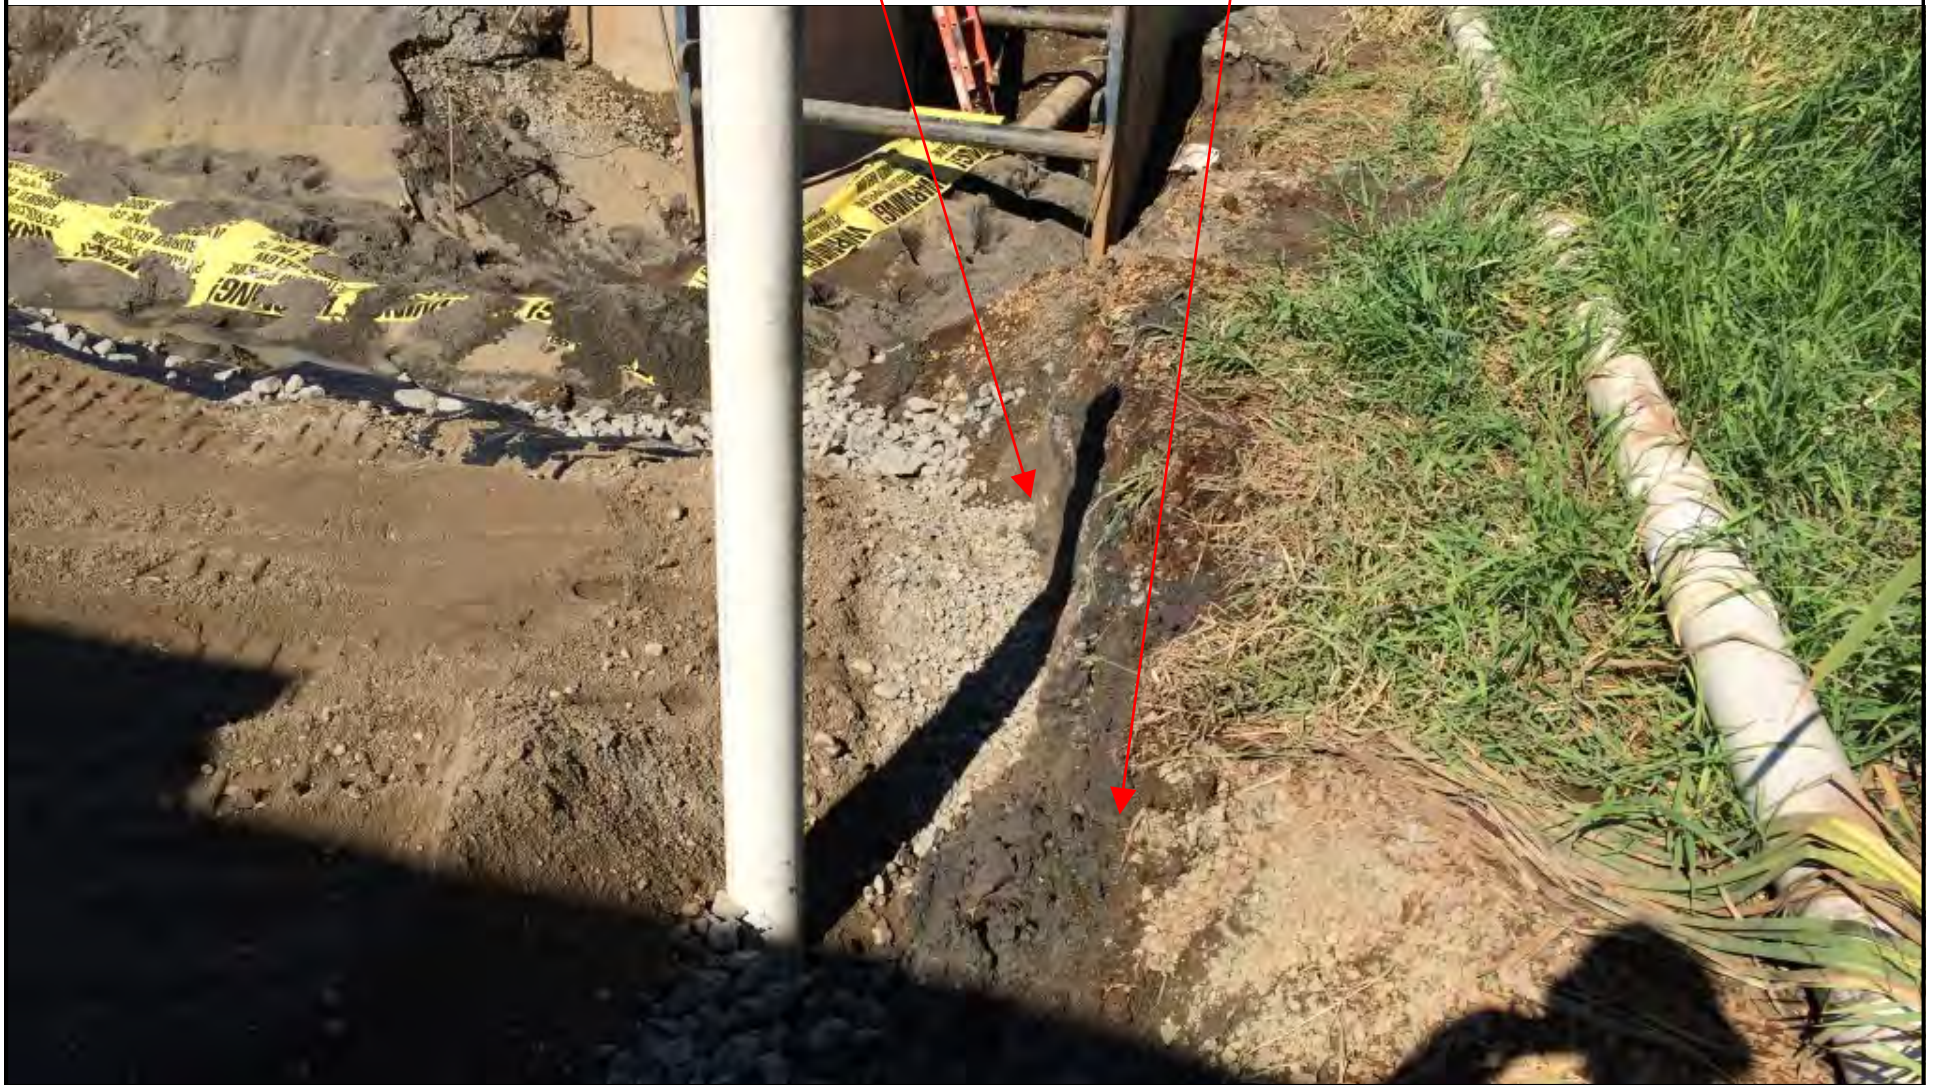
Sample 7.2

Sample 1.2

**Photo 6—Samples 1.2 and 7.2
8/13/15**

On August 17, 2015, the northeast portion of the excavation was expanded and approximately 15 additional yards of petroleum impacted soil was removed. The northern limit of the excavation was dictated by the presence of quarry spalls which were used as the bedding for the drainage ditch that runs along the northern property boundary. The drainage ditch serves as an outlet for the pond located on the east side of Frank Albert Rd E and flows consistently. As the excavation limit approached the side of the drainage ditch, an increasing volume of water flowed into the excavation. Digging to the north was stopped when it appeared that water flow from the ditch would lead to sidewall instability. On August 17, 2015, soil samples 1.2 and 7.2 were collected from the final limits of the north sidewall. Sample 1.2 contained TPH-G and TPH-D at concentrations of 1,100 mg/kg and 2,600 mg/kg, respectively. Sample 7.2 contained TPH-G at a concentration of 110 mg/kg. All other constituents in these two samples were not detected above the respective MTCA Method A Cleanup Levels and/or the laboratory method reporting limits (MRLs). On August 18 and 19, soil from within the foundation of the former control building was removed. The western portion of the excavation was also extended along the 8 inch pipe to remove any additional impacted soil. On August 19, soil samples 8, 9.2, 11.2, and 12 were collected from the western portion of the excavation and from the base of the former control building foundation. Petroleum hydrocarbon concentrations were detected in samples 8, 9.2, 11.2, and 12 in the form of TPH-G and/or benzene at concentrations ranging from 34 to 550 mg/kg for TPH-G, and ranging from 0.036 to 0.042 mg/kg for benzene. Upon reaching the practical limits of the excavation in each direction, the excavation was backfilled with quarry spalls and pit run, compacted, and finished with crushed gravel. During excavation activities, a total of 302.49 tons of petroleum impacted soil was removed from the Site and transported to Roosevelt Landfill in Roosevelt, WA and

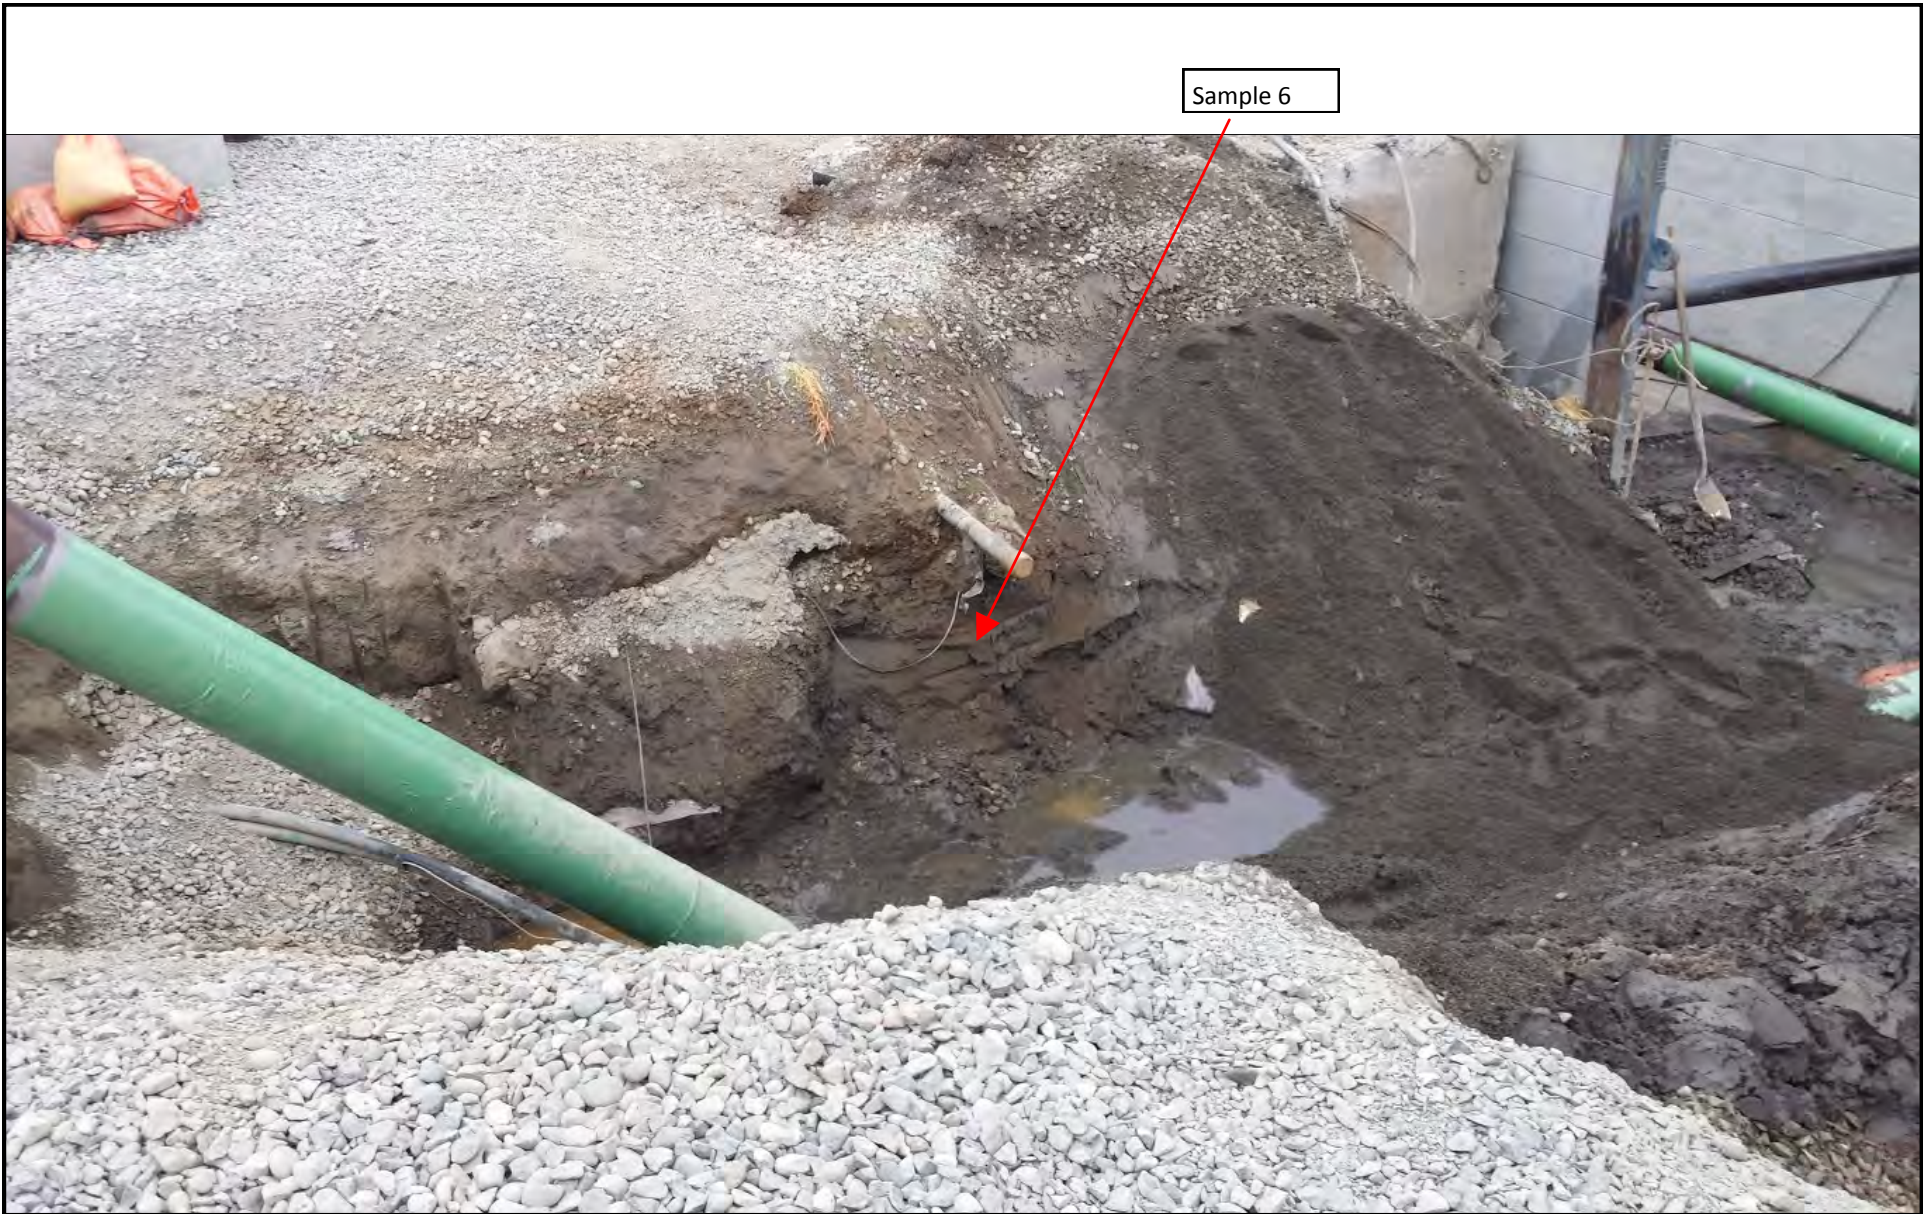
Sample 6

Photo 7—Sample 6
8/13/15

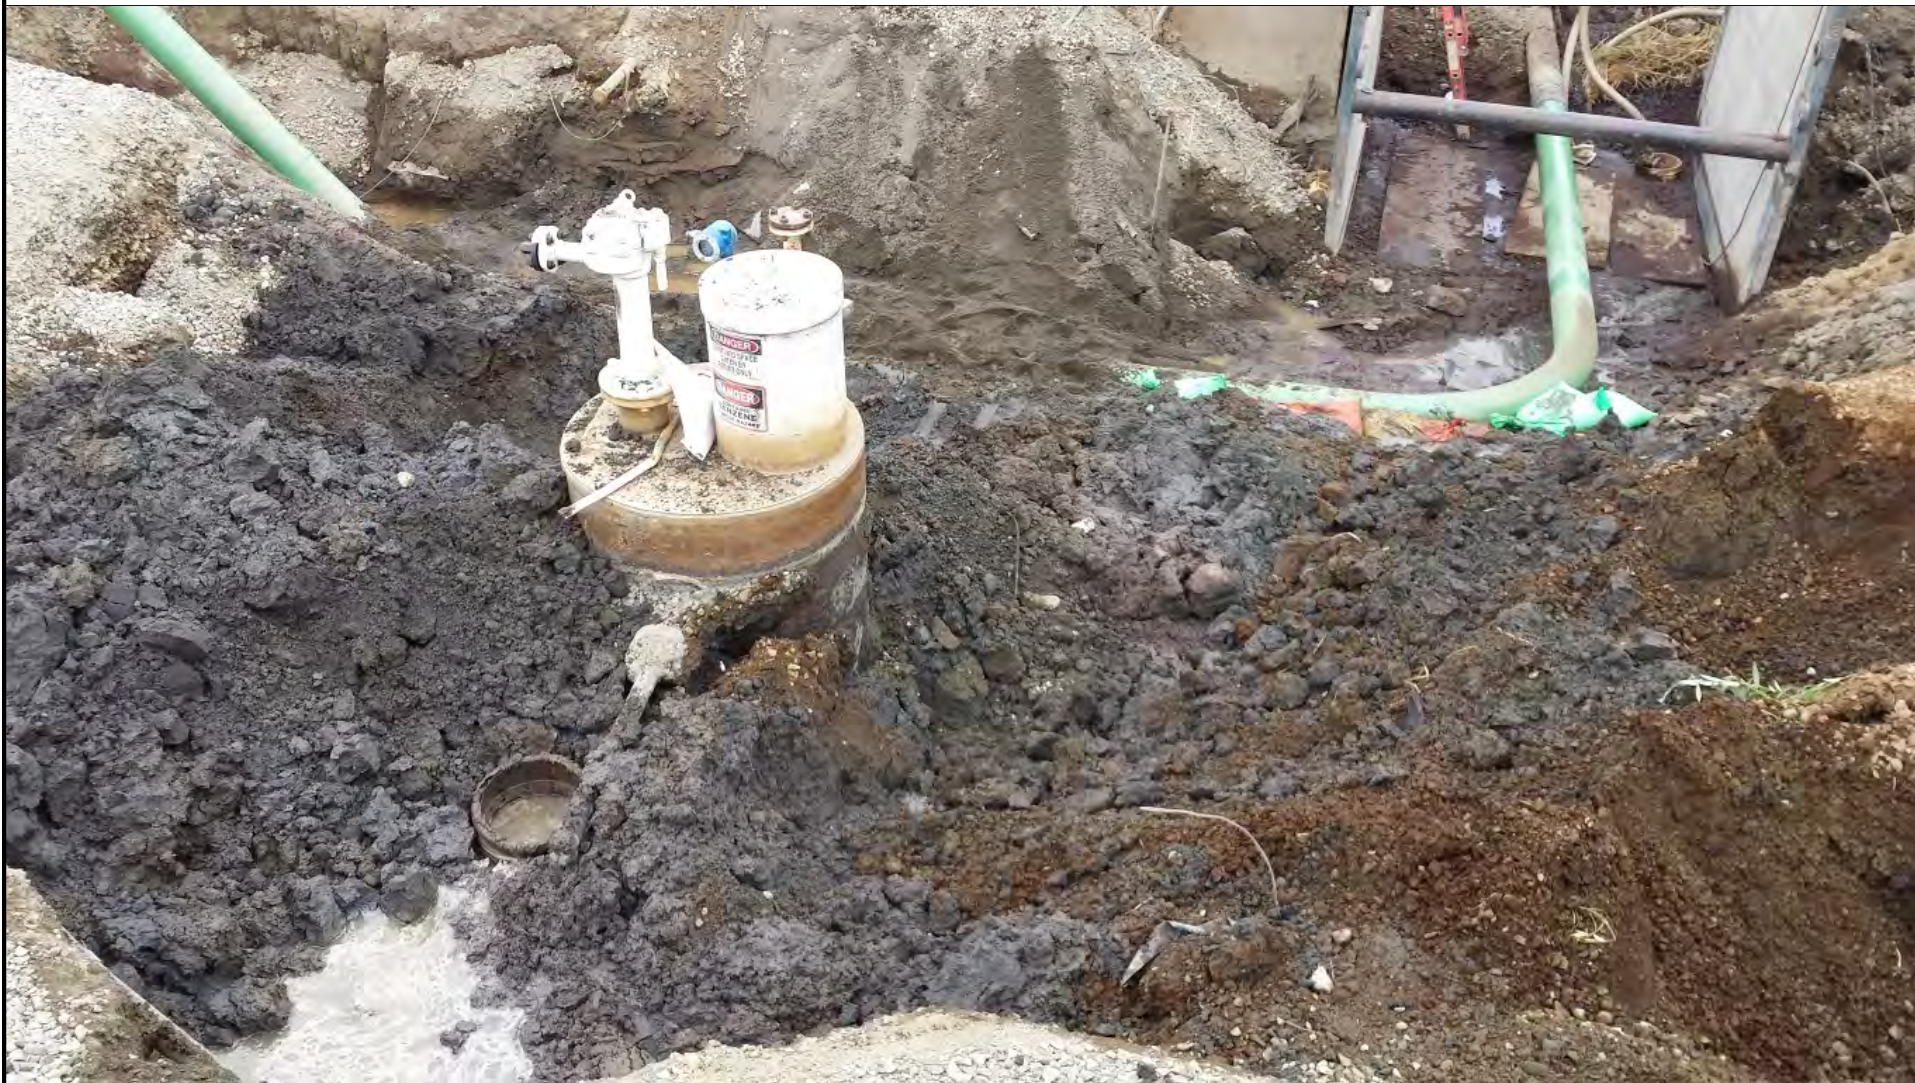
**Photo 8—Sump Prior to Removal
8/13/15**

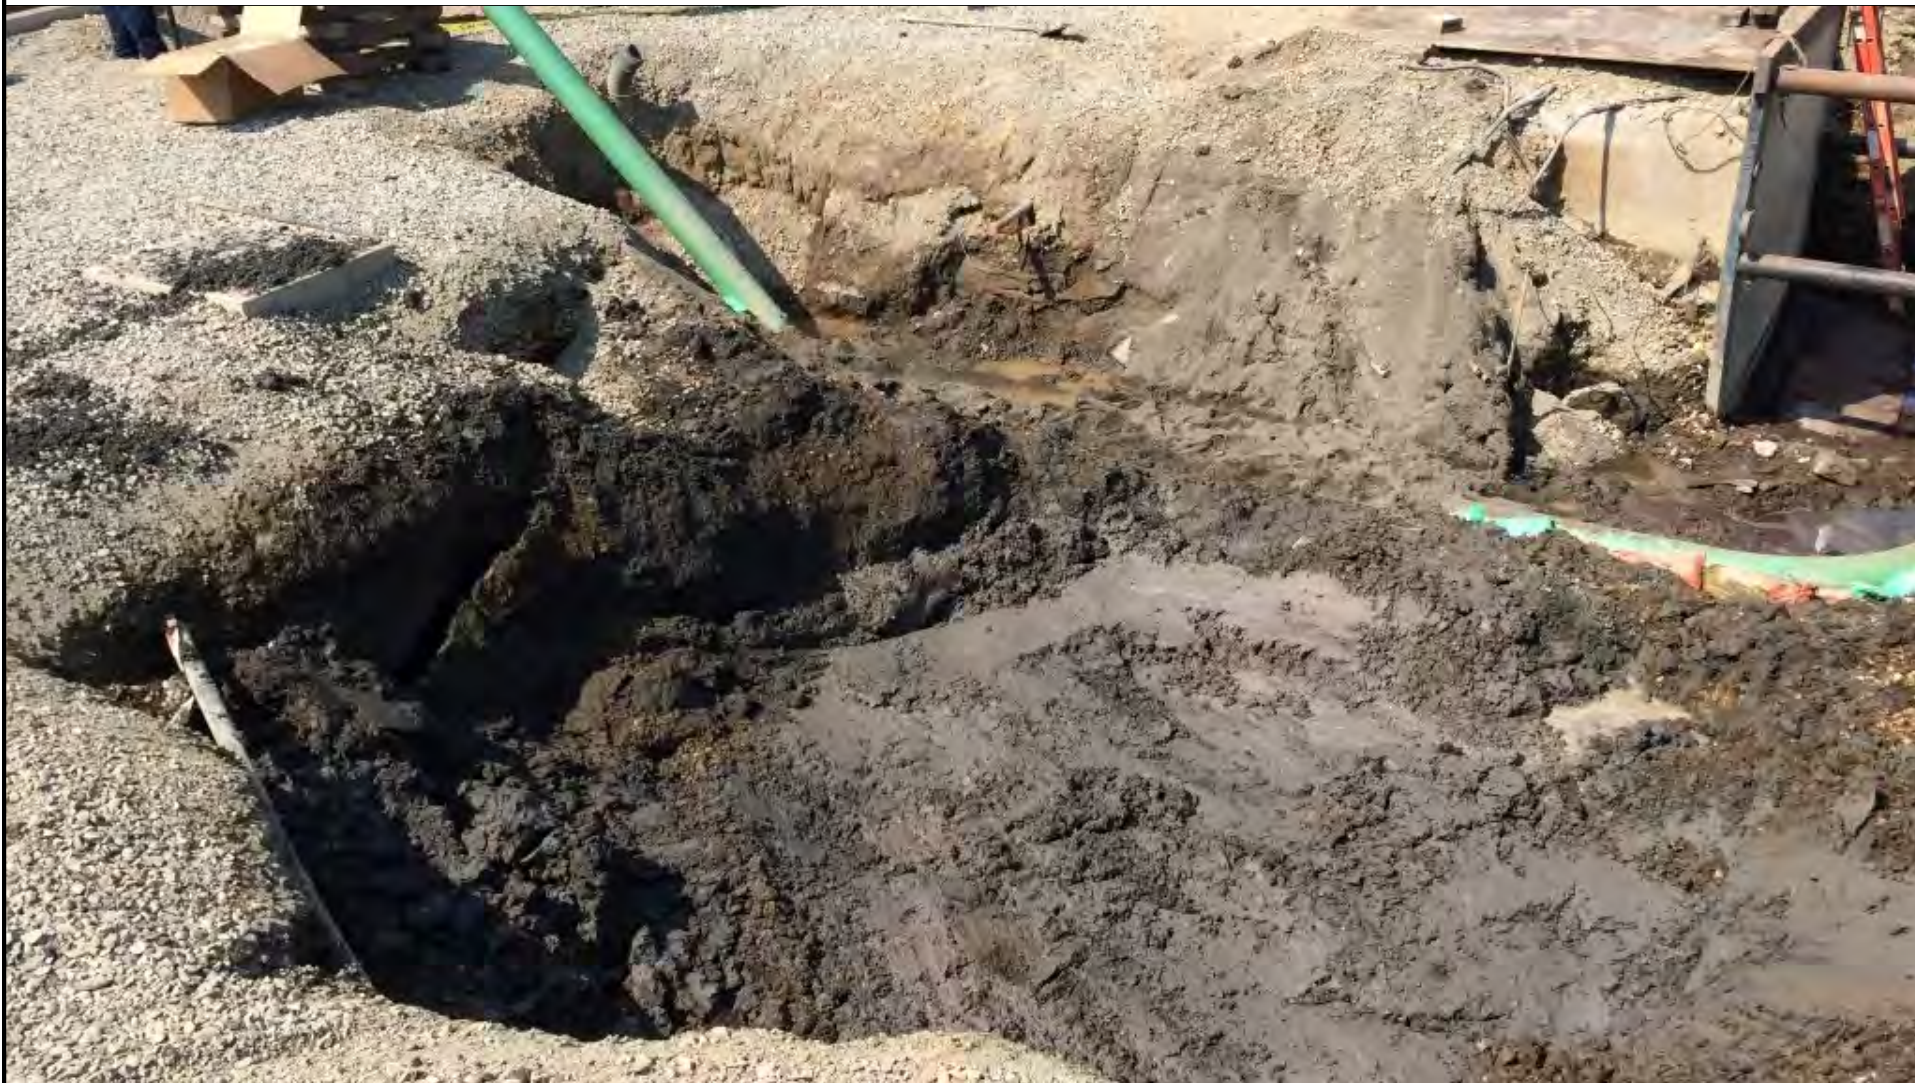
**Photo 9—Excavation After Removing Sump
8/13/15**

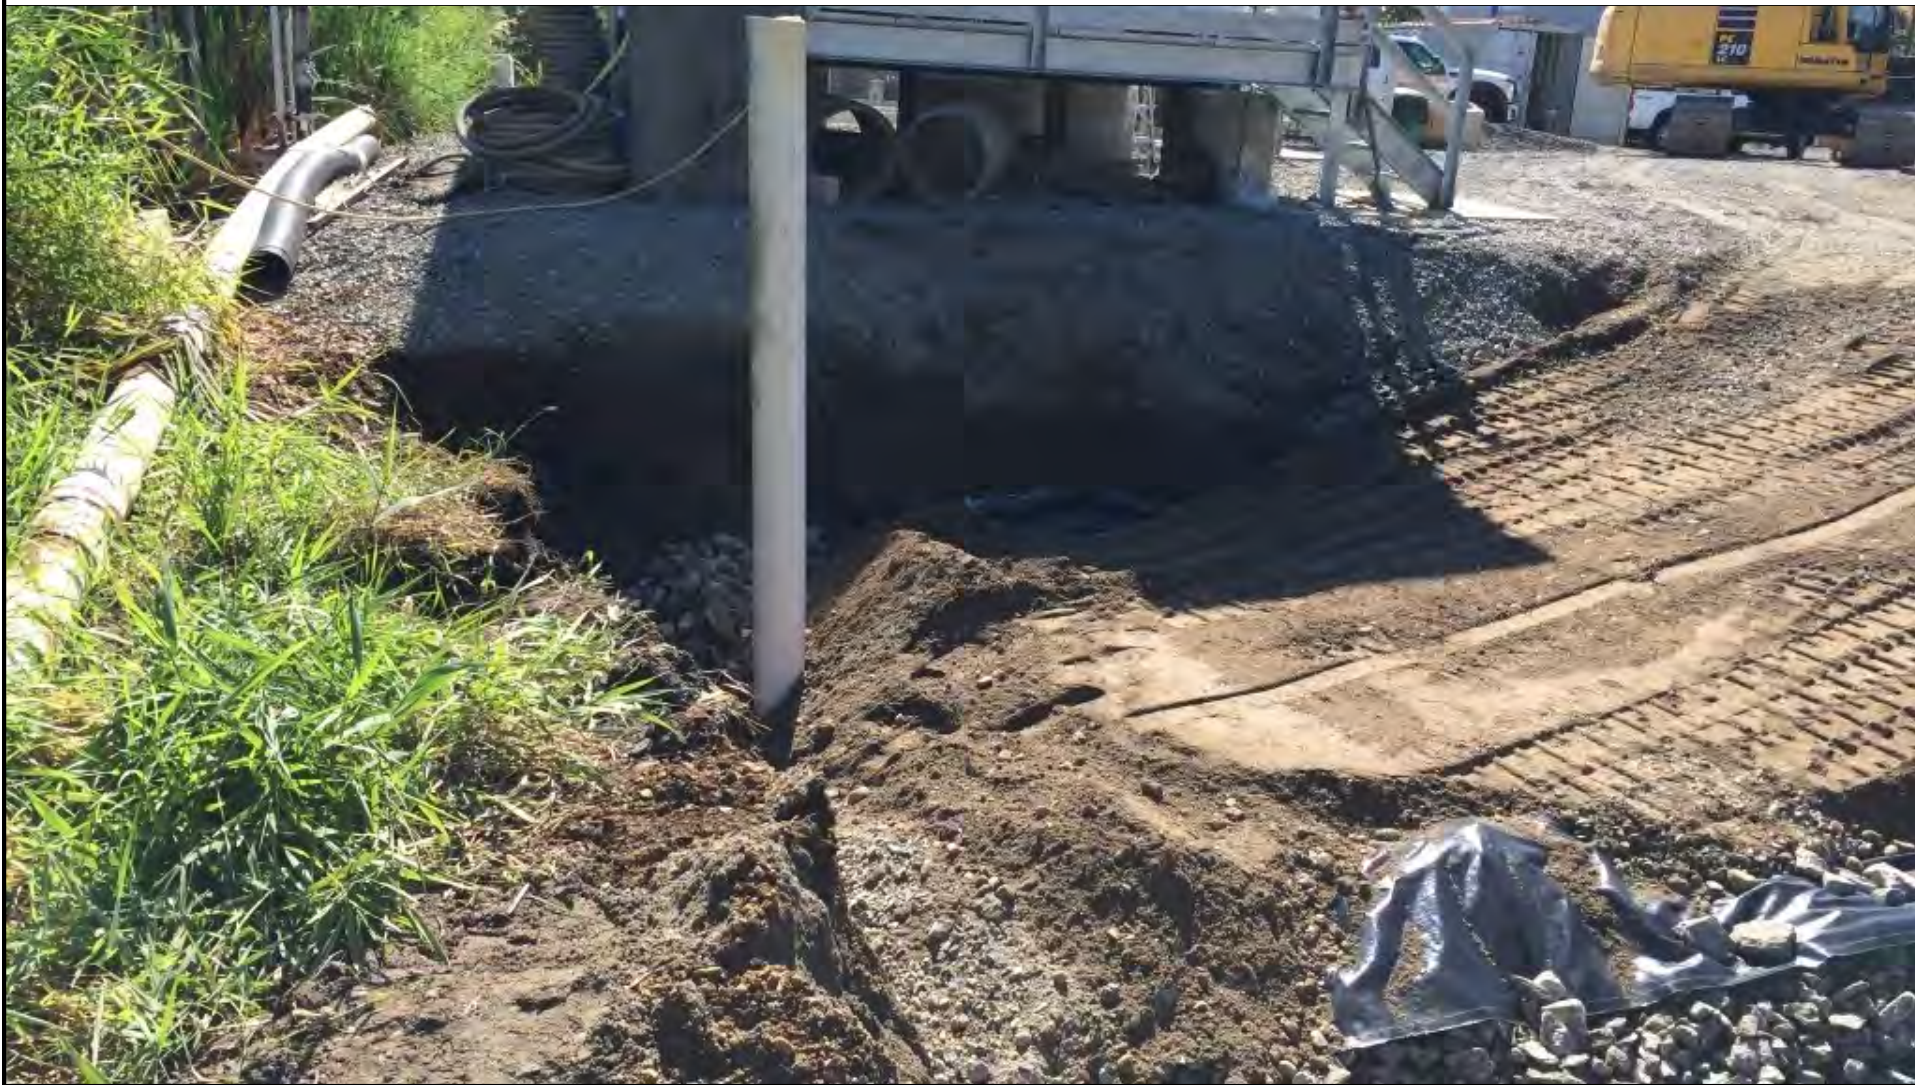
**Photo 10—East Side of Excavation, Backfilled
8/17/15**

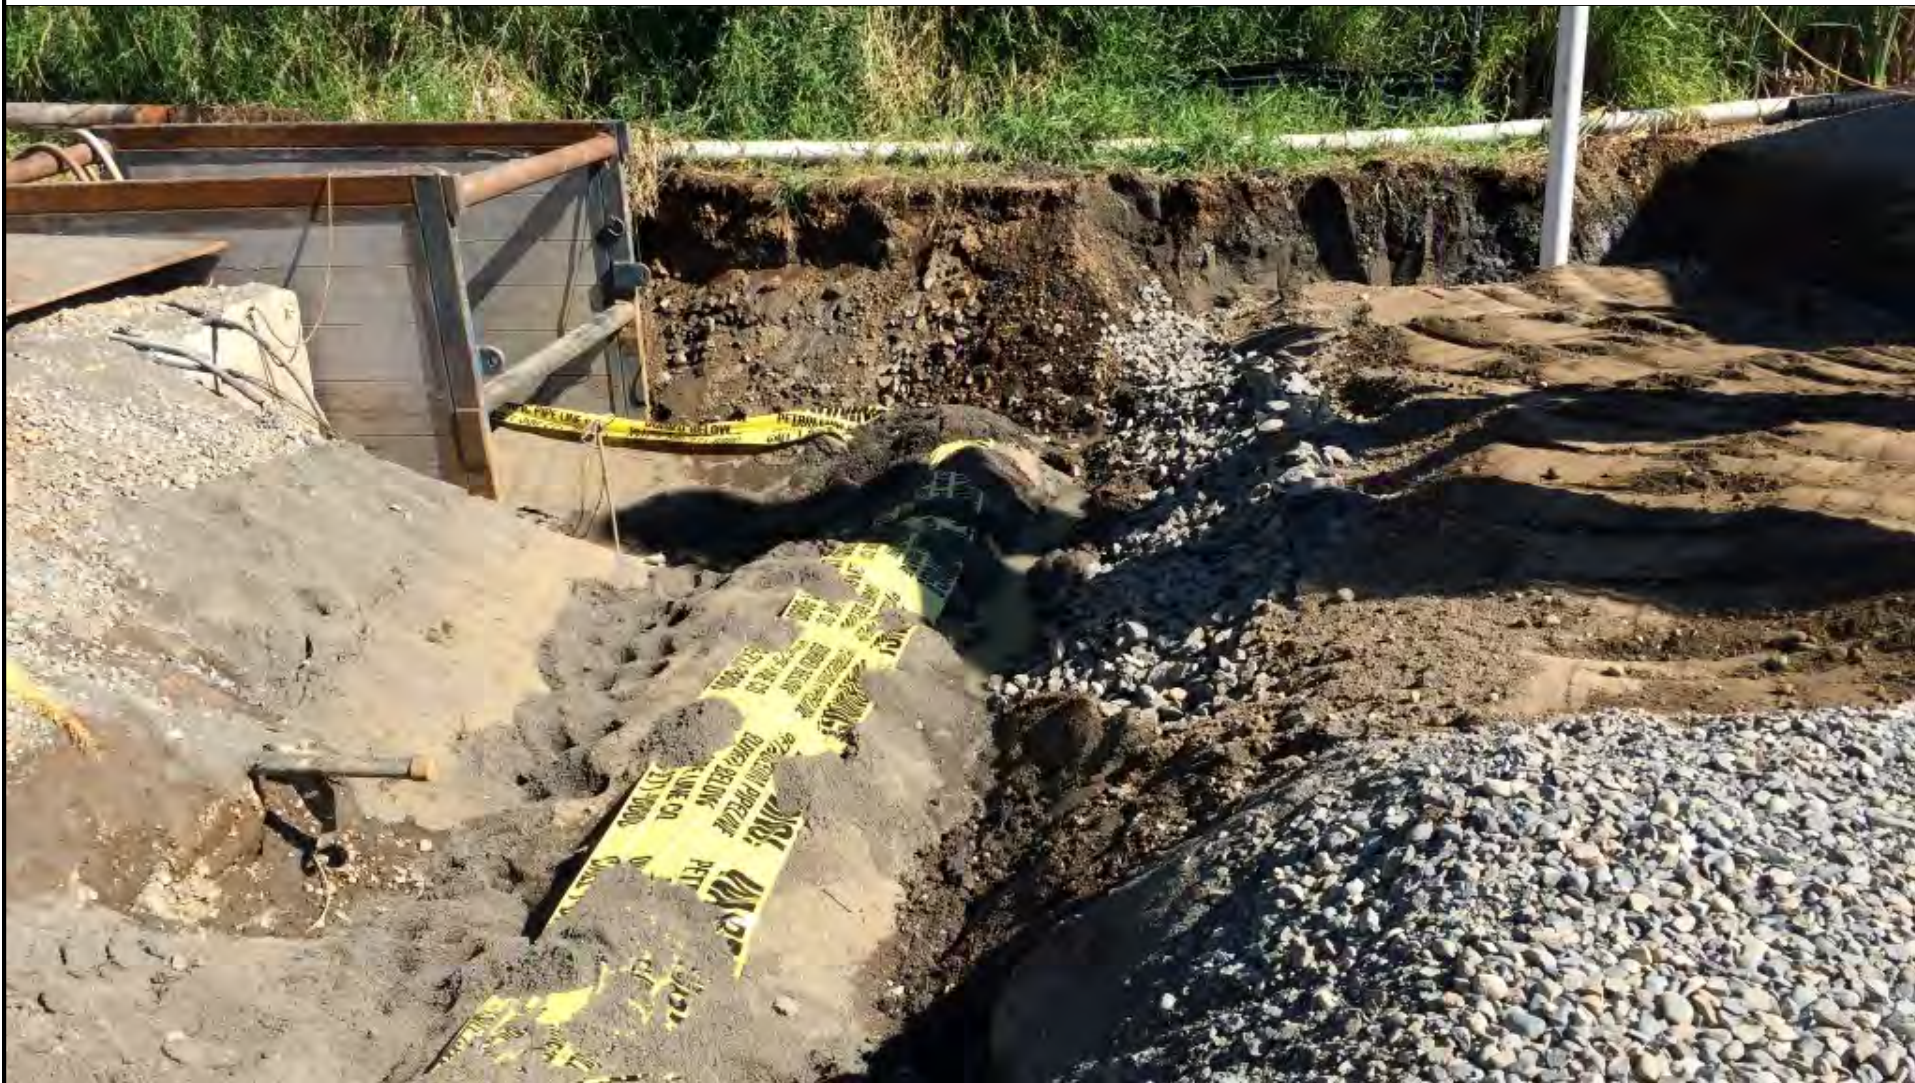
**Photo 11—Excavation During Backfilling
8/17/15**

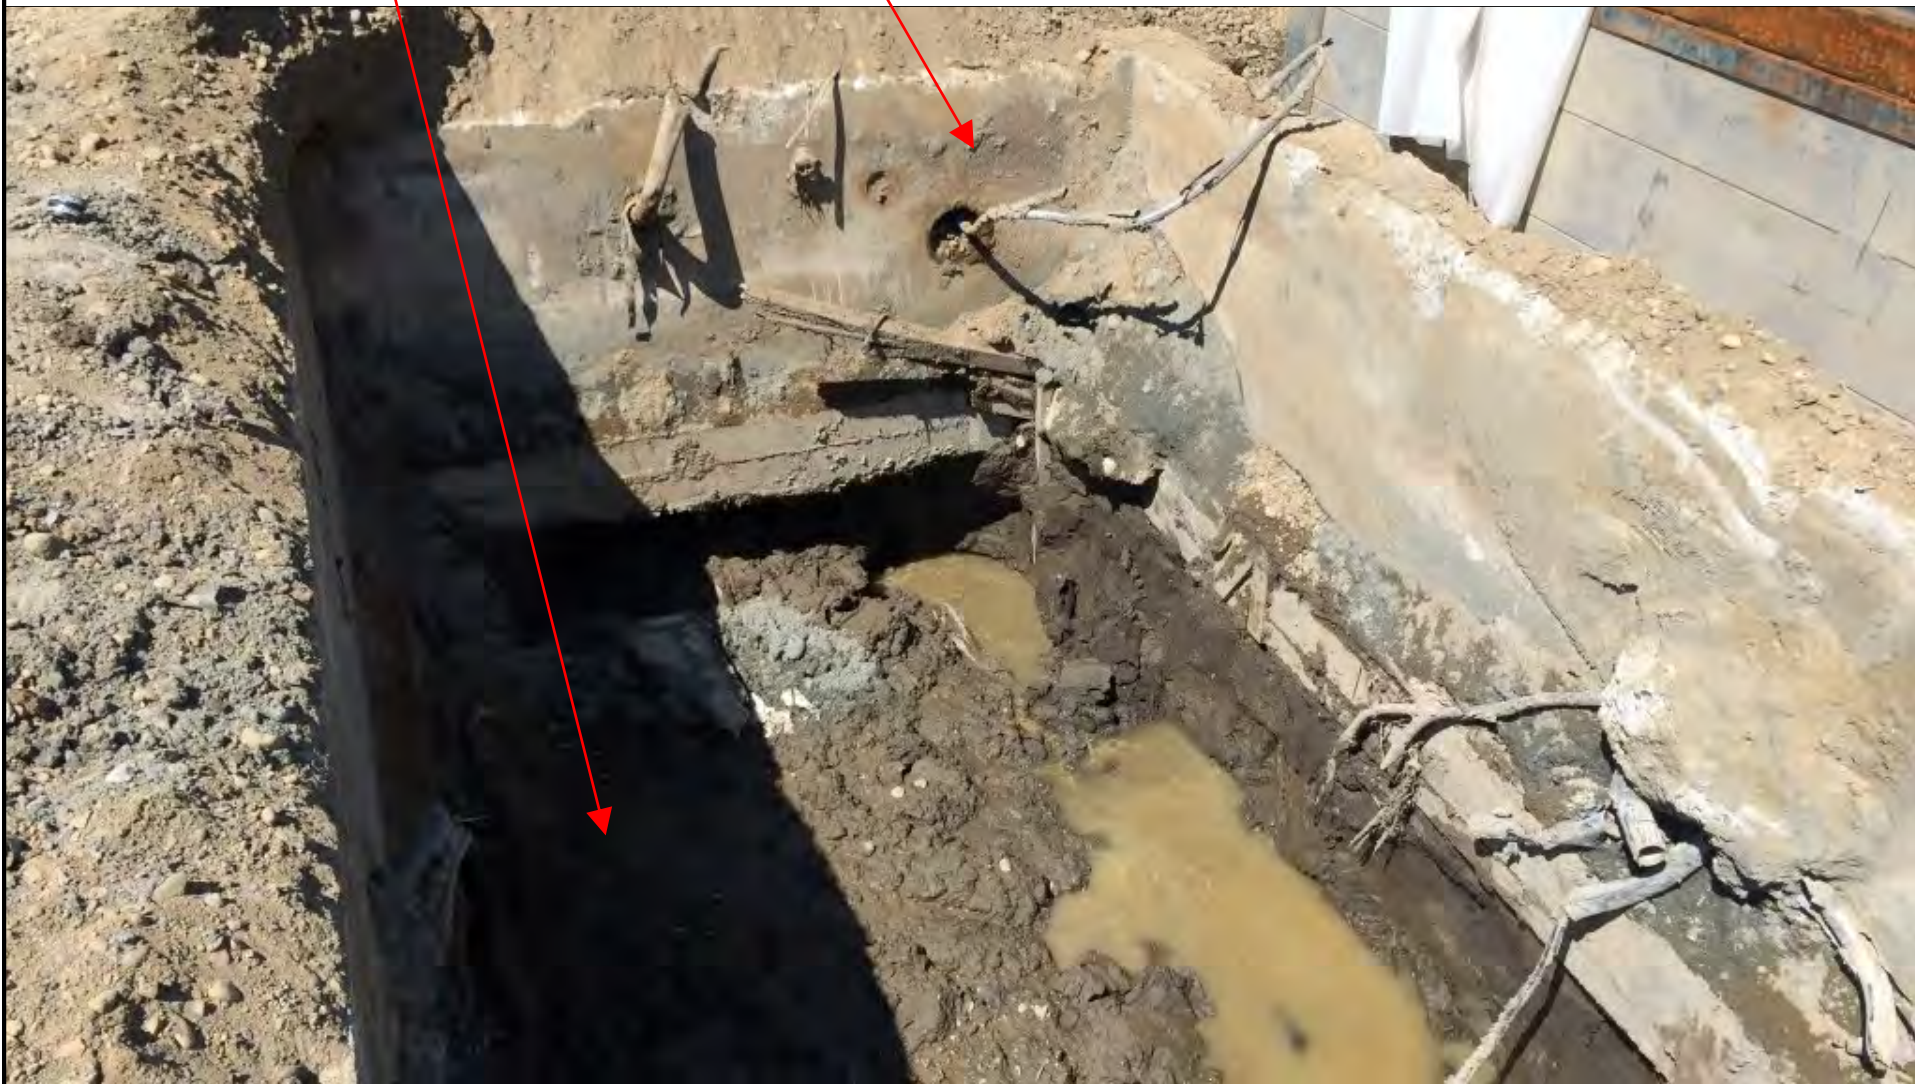
Sample 12

Former Control Building Foundation

**Photo 12—Sample 12
8/19/15**
