SITE DISCOVERY AND INDEPENDENT REMEDIAL ACTION REPORT

*Olympic Pipeline Company
Tacoma Junction
2660 Frank Albert Road East
Fife, Washington*

October 12, 2015

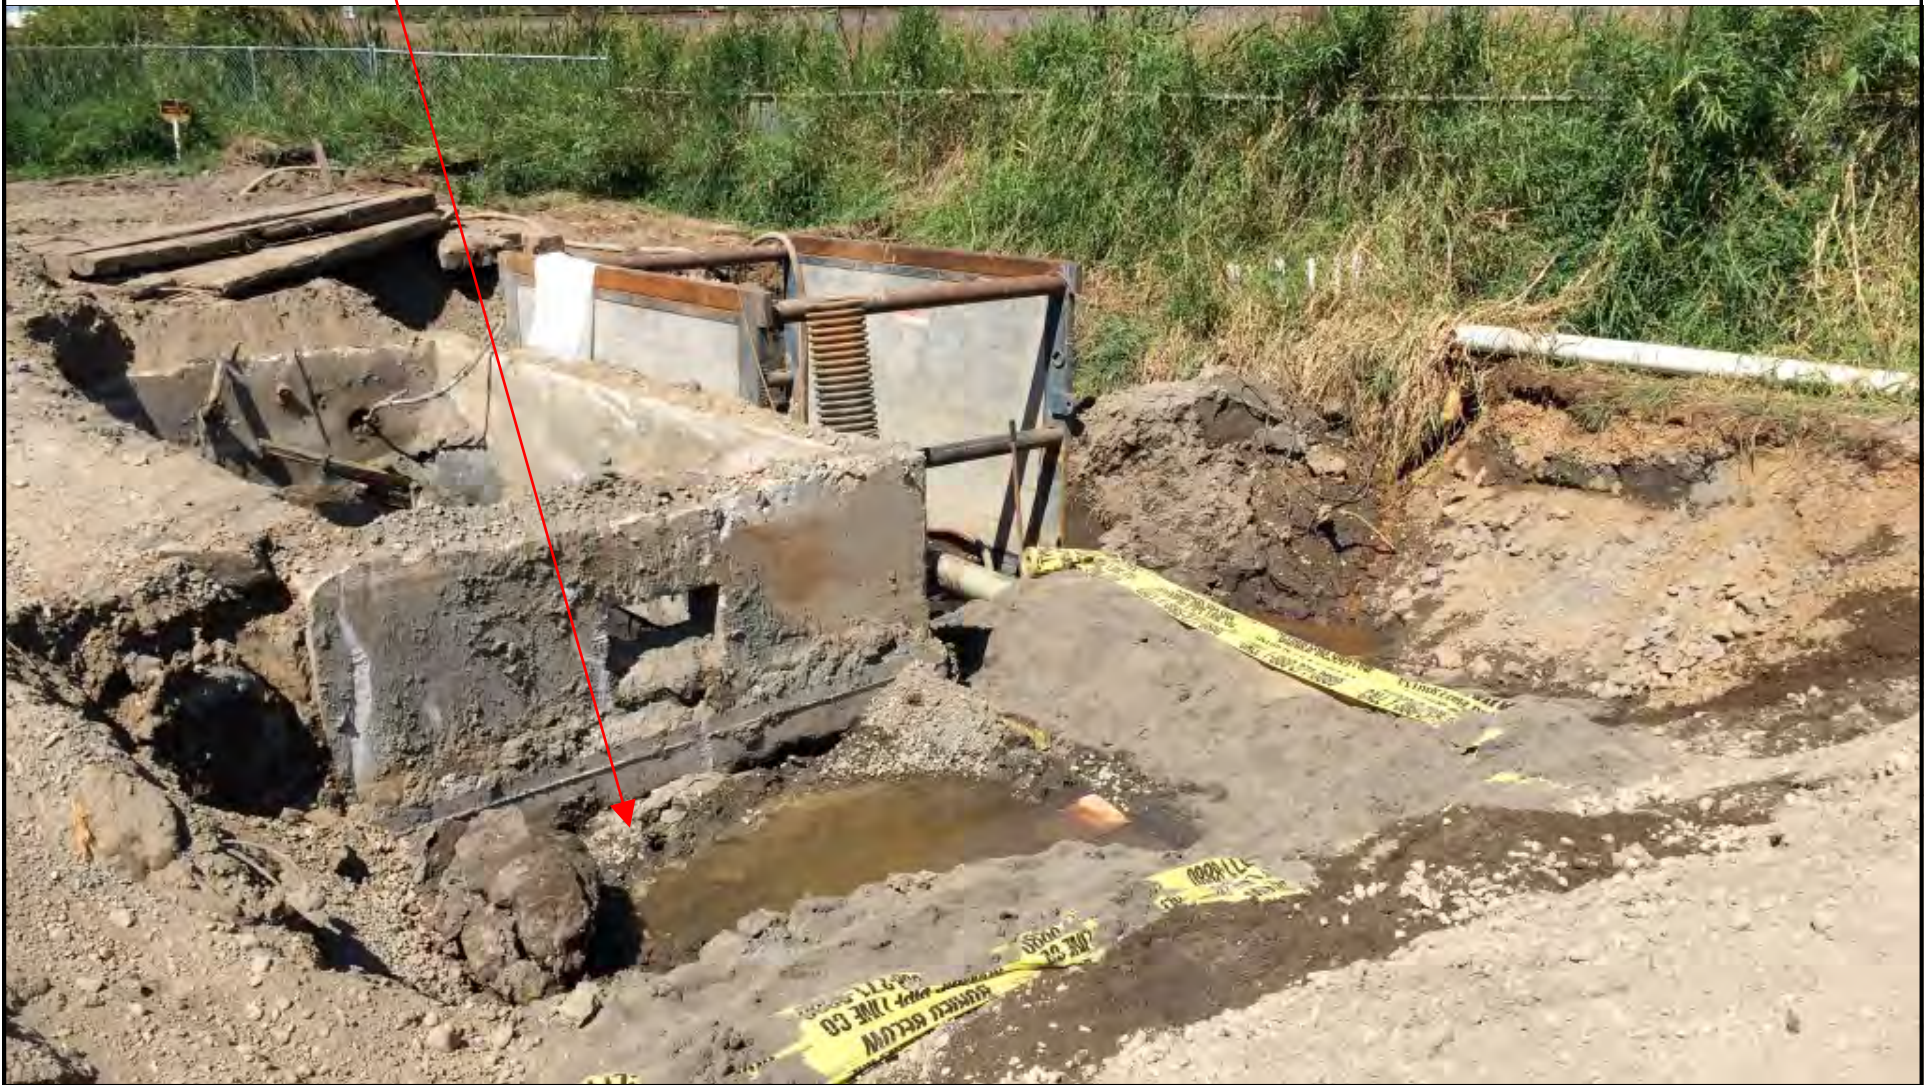
Sample 11.2

Photo 13—Sample 11.2
8/19/15
Olympic Pipe Line Company
Tacoma Junction
2660 Frank Albert Road East
Fife, WA
