Re: Interim Action Work Plan and Response to Ecology Comments
Claremont Village Shopping Center
4821 and 4925 Evergreen Way
Everett, Washington
VCP Number NW2961

*Interim Action Work Plan
Claremont Village Shopping Center
Everett, Washington*

Prepared for:
Phillips Edison & Company

August 2, 2017
PECO_2016-22

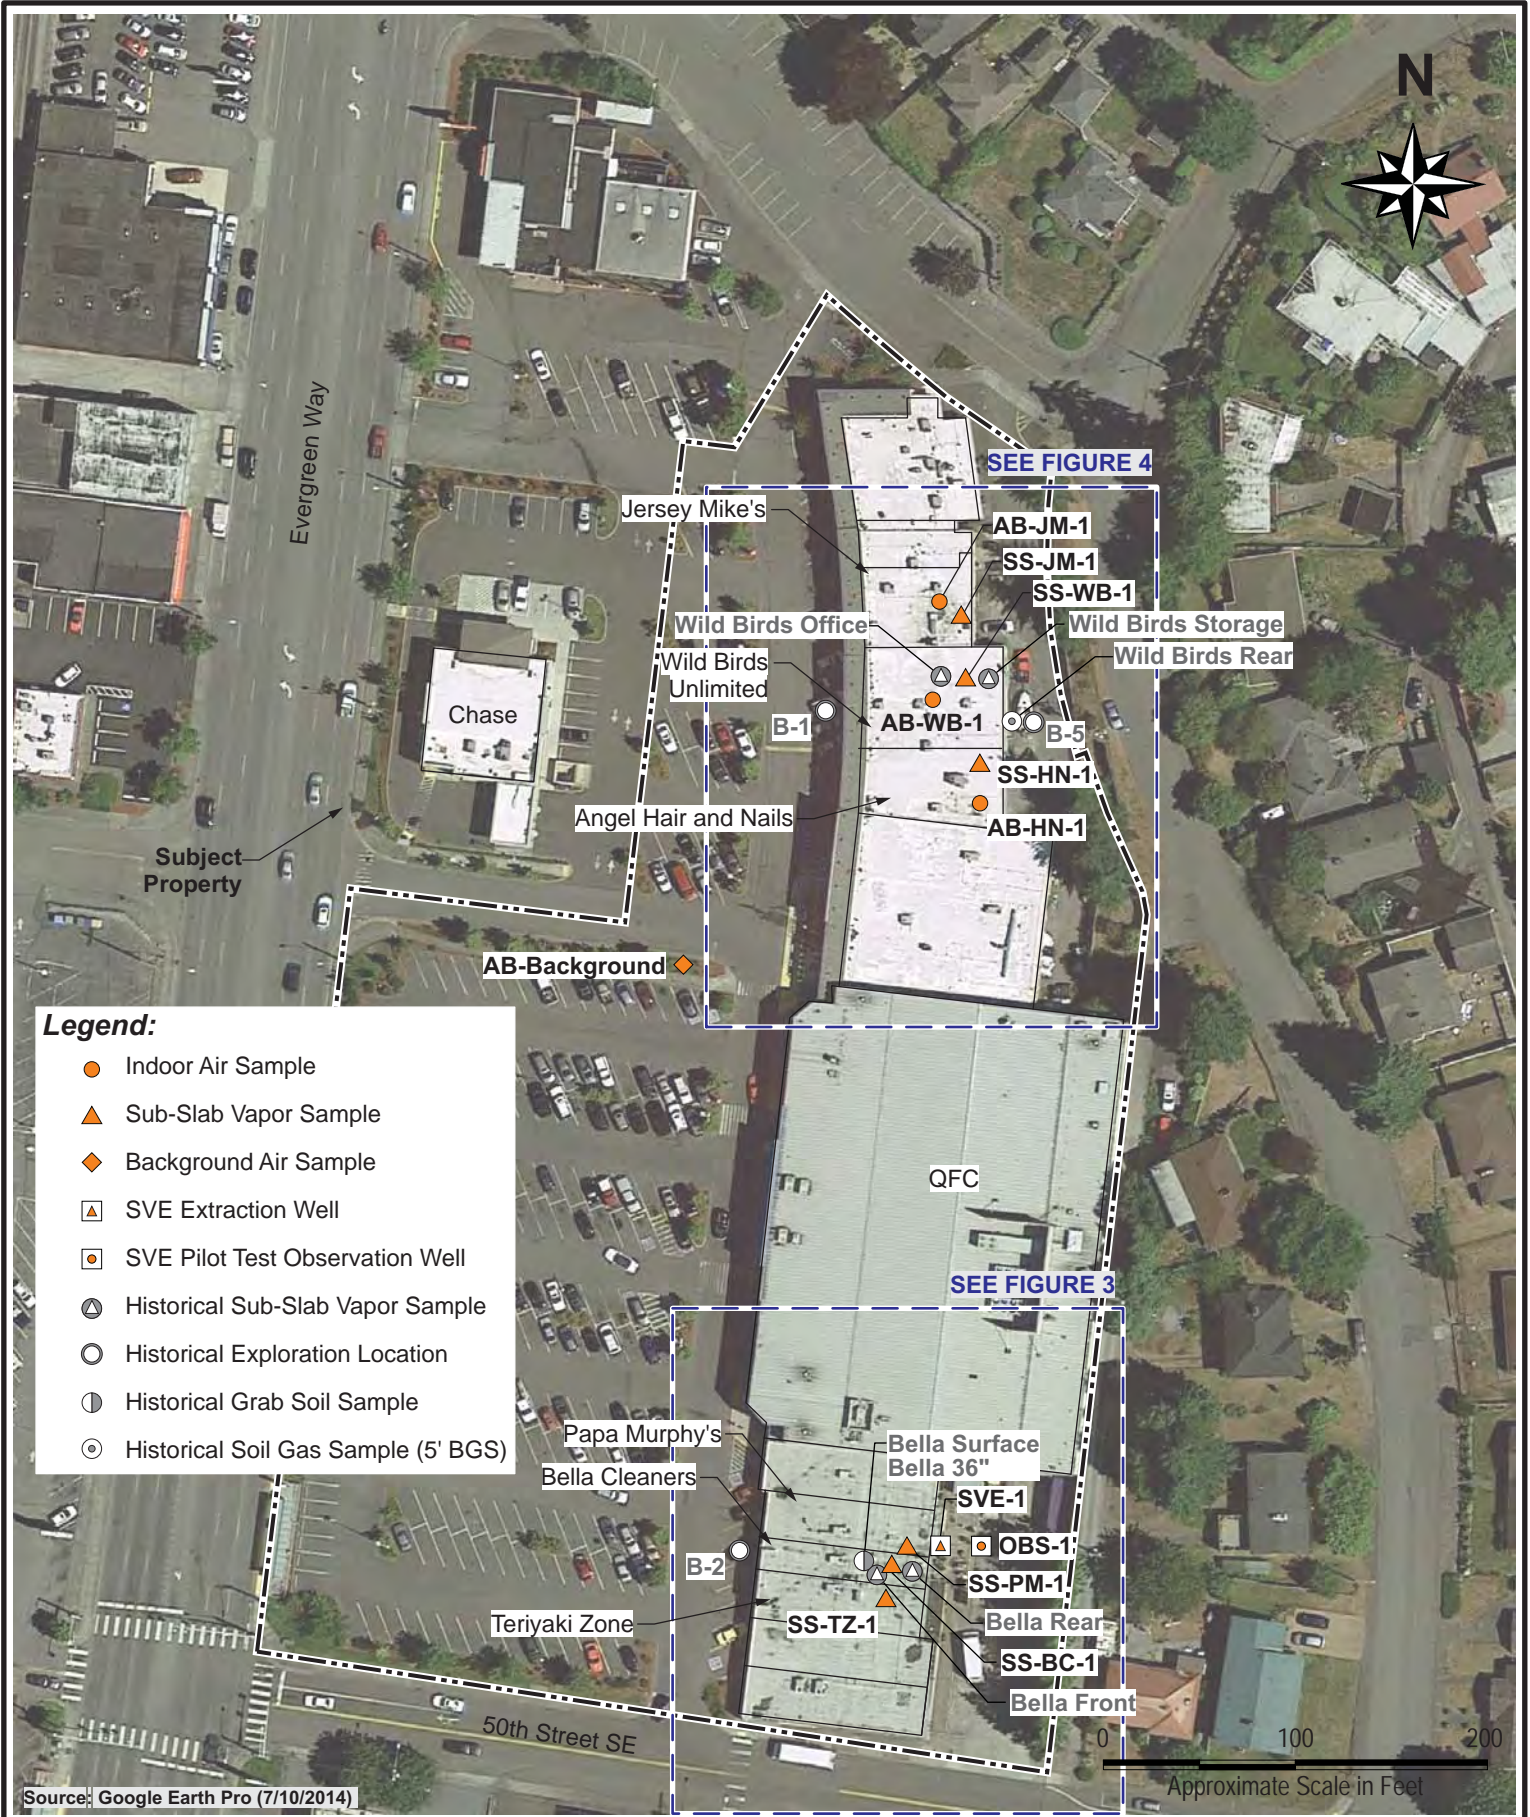
Figure 2:

**Site Plan and
Historical Explorations**

- **Response:** Previous grab groundwater sampling at the Site, including to the east (GW-1, collected at the location of OBS-1 on Figure 2) and west (B-2) of Bella Cleaners, and to the west of Wild Birds Unlimited (B-1) has not shown the presence of dry cleaning related chemicals in groundwater. PCE was detected in one groundwater sample, collected east of the Wild Birds Unlimited facility, but at a concentration significantly below the relevant MTCA screening level for unrestricted use. While we understand Ecology's interest in understanding groundwater flow, the lack of significant detections in previous sampling suggests that groundwater has not been impacted. Therefore, we propose moving forward with addressing soil concerns by implementing SVE as an interim action without conducting additional groundwater

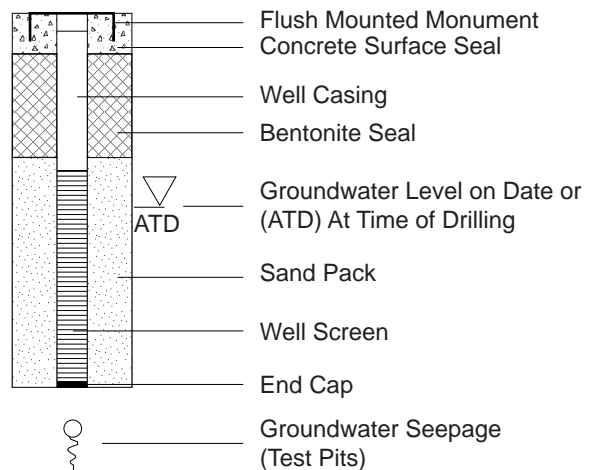
Groundwater Observations and Monitoring Well Construction

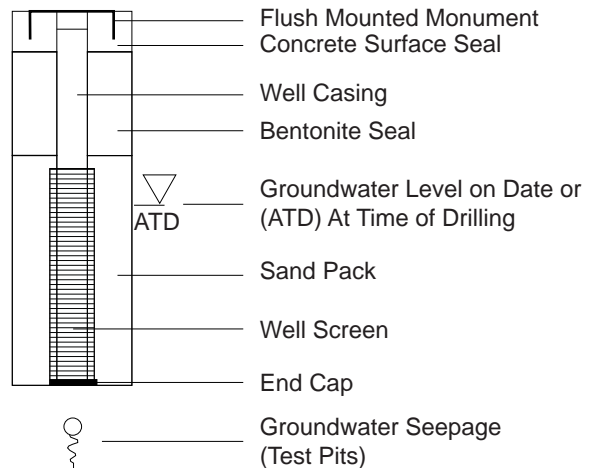
Groundwater Observations and Monitoring Well Construction
