SITE CLOSURE REPORT ADDENDUM

FORMER CLEANING CENTER OF REDMOND 15796 REDMOND WAY REDMOND, WASHINGTON

**Submitted by:
Farallon Consulting, L.L.C.
975 5th Avenue Northwest
Issaquah, Washington 98027**

April 26, 2017

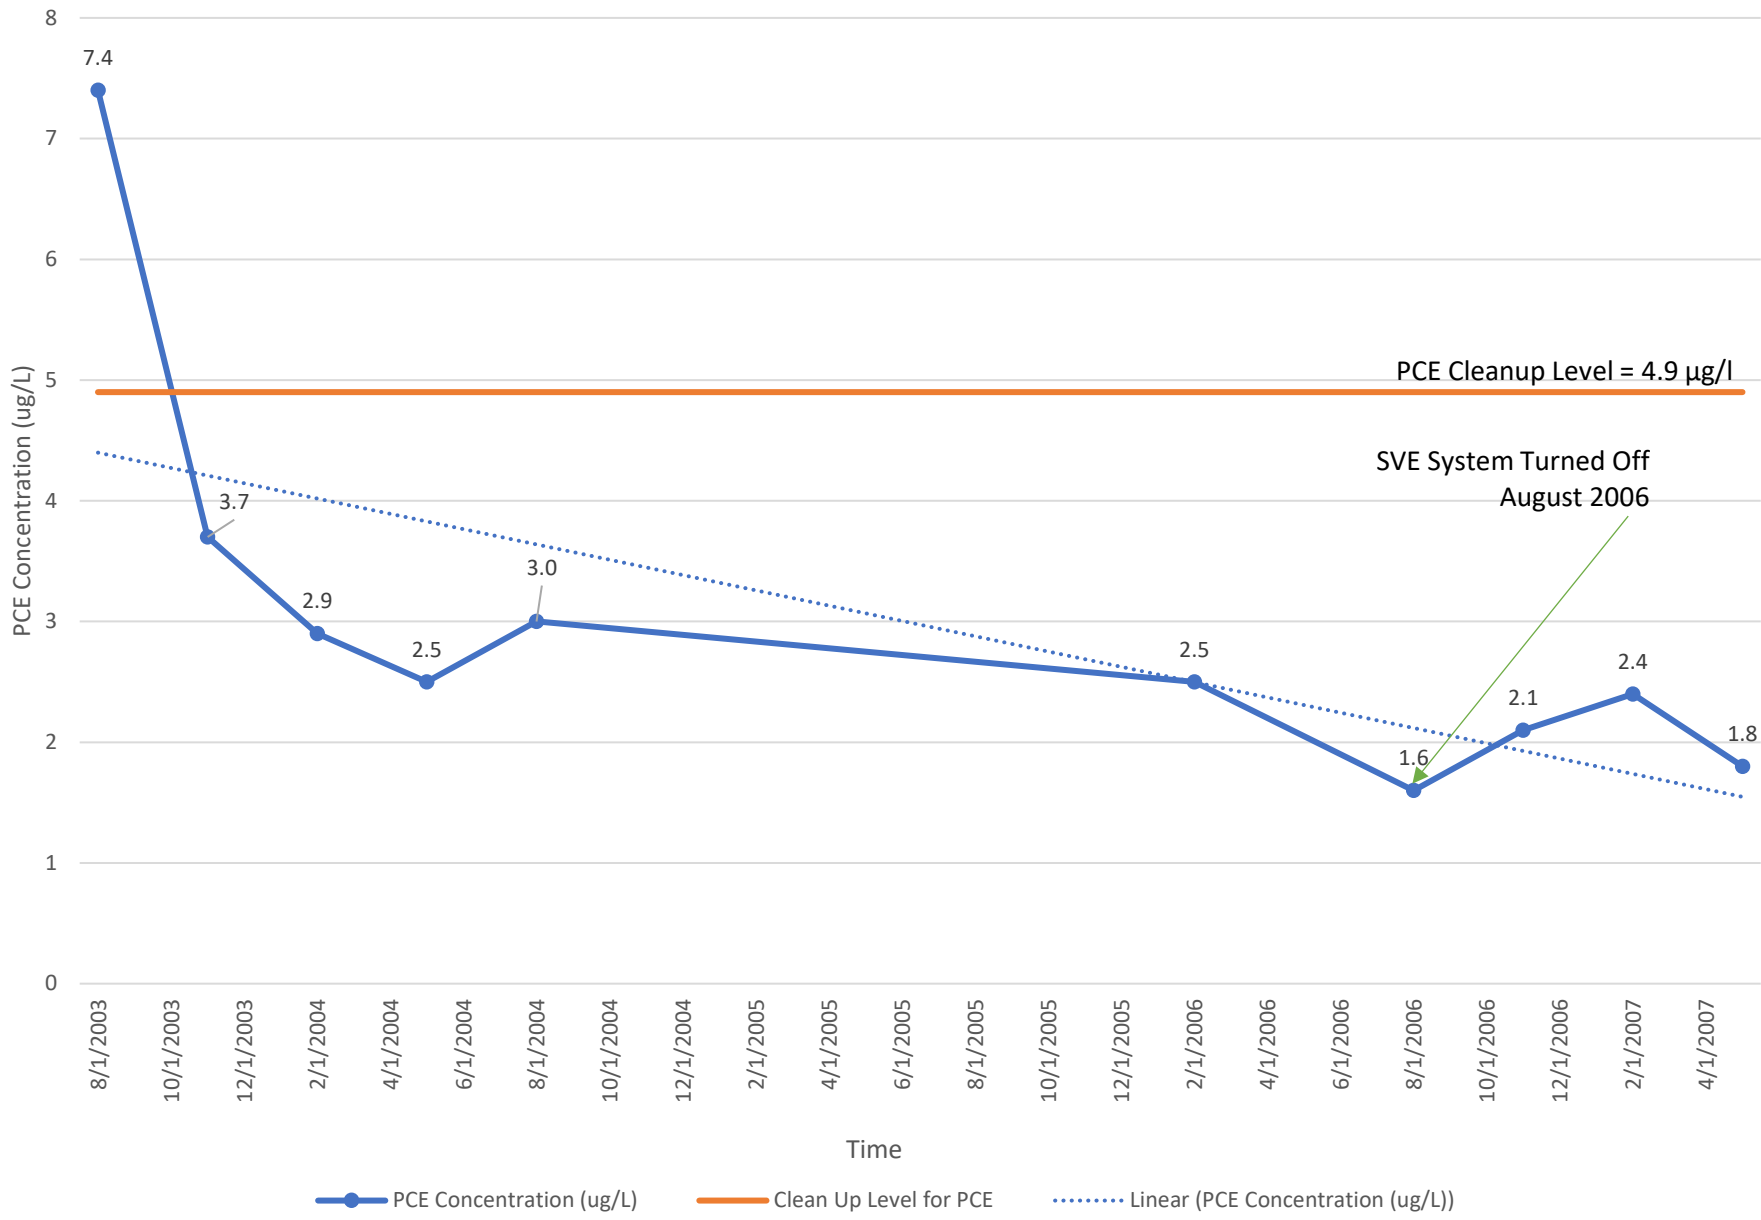
PCE Concentration vs. Time at Former Monitoring Well MW-9
