July 11, 2017

Re: June 2017 Groundwater Sampling Report – Twenty-Third Round
Estes West Express Trucking Facility
2102 West Valley Highway North
Auburn, Washington
VCP No. NW 2532

EPI Project No. 61901.1

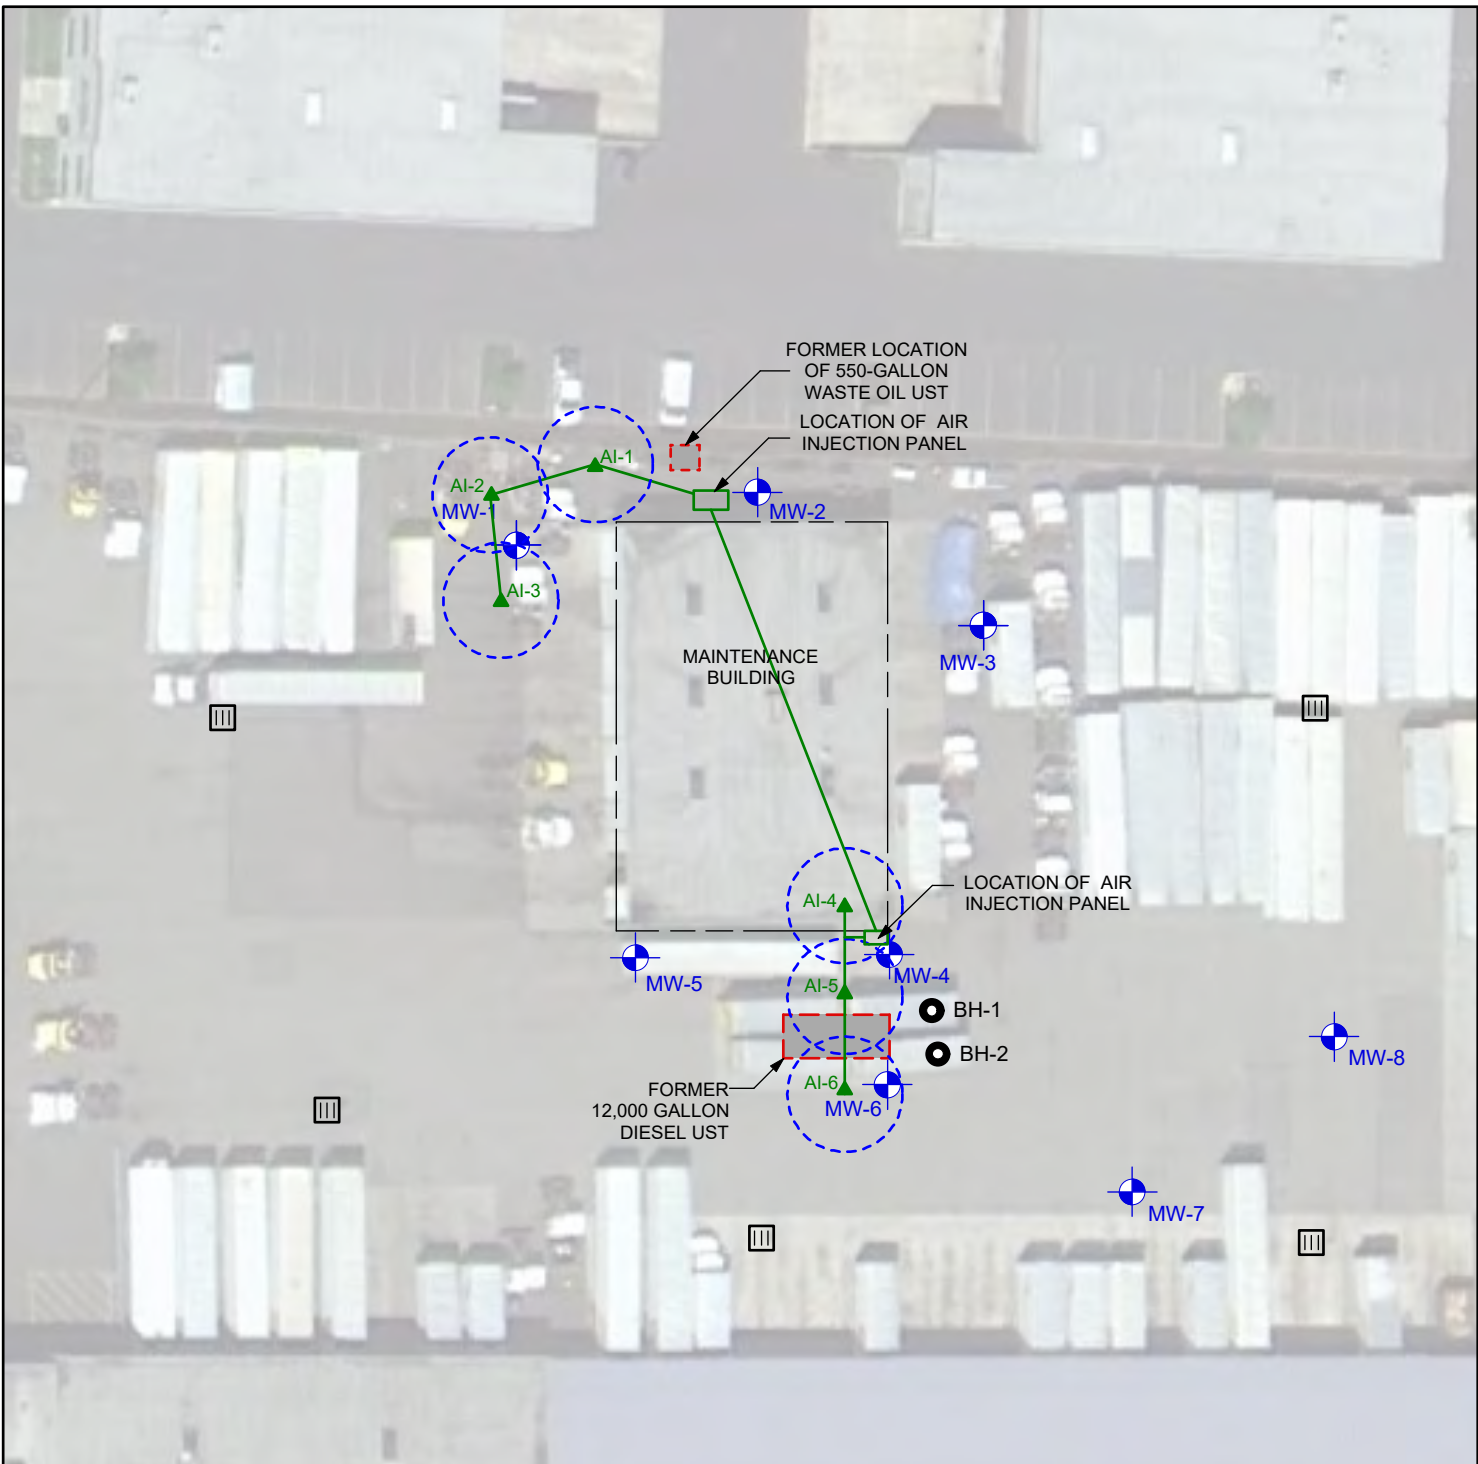
FIGURE 2			
AIR INJECTION REMEDIATION SYSTEM LAYOUT			
PREPARED BY

In May 2014 EPI installed three shallow air injection wells at locations upgradient of MW-1 as shown in Figure 2. The purpose of the air injection wells and compressor system is to add dissolved oxygen (DO) to the groundwater. The increased DO concentrations in groundwater due to system operation stimulates population growth and increases the activity of aerobic bacteria and provides the oxygen necessary for those bacteria to metabolize dissolved petroleum hydrocarbons in groundwater.

Each of the shallow air injection wells is equipped with a 1-ft. length Kerfoot Technologies C-Sparger® screen set in a sand filter pack and fully submerged in groundwater at approximately 14 to 15-ft bgs. Pressurized air pumped through the C-Sparger® screens forces air, containing oxygen, into groundwater as microbubbles, greatly increasing the surface area of the bubbles for more efficient oxygenation of the groundwater. The remaining well annulus was sealed using hydrated bentonite chips and the surface was completed in 8-inch diameter flush completion steel monuments set in concrete.

An appropriately sized rotary vane air compressor was installed in the fenced area at the north end of the truck maintenance building to provide air to the shallow air injection wells. The shallow air injection wells are connected to the compressor using 1-inch diameter PVC piping installed below the ground surface through the side of each of the well monuments. PVC air supply lines were installed in trenches that were appropriately backfilled and patched with asphalt at the surface to match the surrounding pavement grade.

Soil and groundwater at the Site were impacted by petroleum hydrocarbon releases from a 550-gallon waste oil underground storage tank (UST) located near the northwest corner of the existing truck maintenance building. The UST and approximately 350 cubic yards of petroleum-contaminated soil (PCS) were removed and four monitoring wells, designated MW-1, MW-2, MW-3, and MW-4, were installed in December 1998. The locations of the former UST and monitoring wells relative to the truck maintenance building are shown on Figure 2.

downgradient of the former 12,000-gallon diesel UST and existing well MW-6. Well MW-8 was installed northeast of MW-7, also downgradient of the former 12,000-gallon diesel UST and existing well MW-6. The purpose of the POC monitoring wells is to monitor groundwater conditions downgradient of the former 12,000-gallon diesel UST, which is a source area for diesel impacts to groundwater at the Site. Figure 2 shows the locations of borings and monitoring wells relative to Site features.
