**PHASE 1 ENVIRONMENTAL SITE ASSESSMENT
Commercial Structure and Residence
1222 Northeast 65th Street
Seattle, Washington**

April 4, 1997

JN 97090A

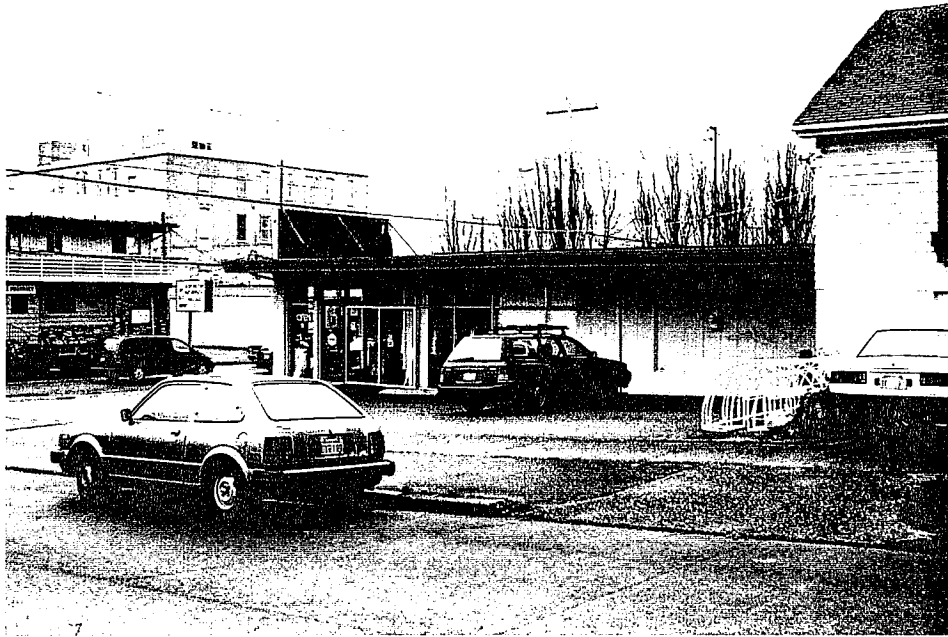
The commercial building is of concrete block construction with a flat, built-up roof and a concrete foundation. The interior of the building has carpet and concrete flooring, concrete block walls and plasterboard ceilings. We observed fluorescent lighting throughout the building. Both structures are heated by natural gas.

VIEW OF DRY CLEANERS,
FACING TOWARD THE SOUTHWEST
