INITIAL INVESTIGATION FIELD REPORT

<u>Site Name (Name over door):</u> Lowe's Semi Diesel Spill	<u>Site Address (including City, State and Zip):</u> 3300 169th PI NE Arlington, WA 98223	<u>Phone</u> <u>Email</u>
<u>Site Contact, Title, Business:</u> KEVIN BREENE, MANAGER LOWE'S COMPANIES OF 61	<u>Site Contact Address (including City, State and Zip):</u> 3300 169th PI NE Arlington, WA 98223	<u>Phone</u> (360) 653-7405 <u>Email</u>
<u>Site Owner, Title, Business:</u> Bobbi Tenborg, Environmental Compliance Supervisor	<u>Site Owner Address (including City, State and Zip):</u> 1000 Lowes Blvd Mooresville, NC 28117	<u>Phone</u> (704) 758-2955 <u>Email</u> Bobbi.L.Tenborg@lowes.com
<u>Site Owner Contact, Title, Business:</u> Larry Pierce, INFOTRAC	<u>Site Owner Contact Address (including City, State and Zip):</u> PO Box 1000 Mooresville, NC 28115	<u>Phone</u> (800) 535-5053 <u>Email</u>
<u>Previous Site Owner(s):</u>	<u>Additional Info (for any Site Information Item):</u> Budd Padilla, Secondary Contact for Lowe's

Semi at Lowe's conducting a delivery hit an object in the parking area and damaged the saddle tank. Spill of 50 gals potential to soil.

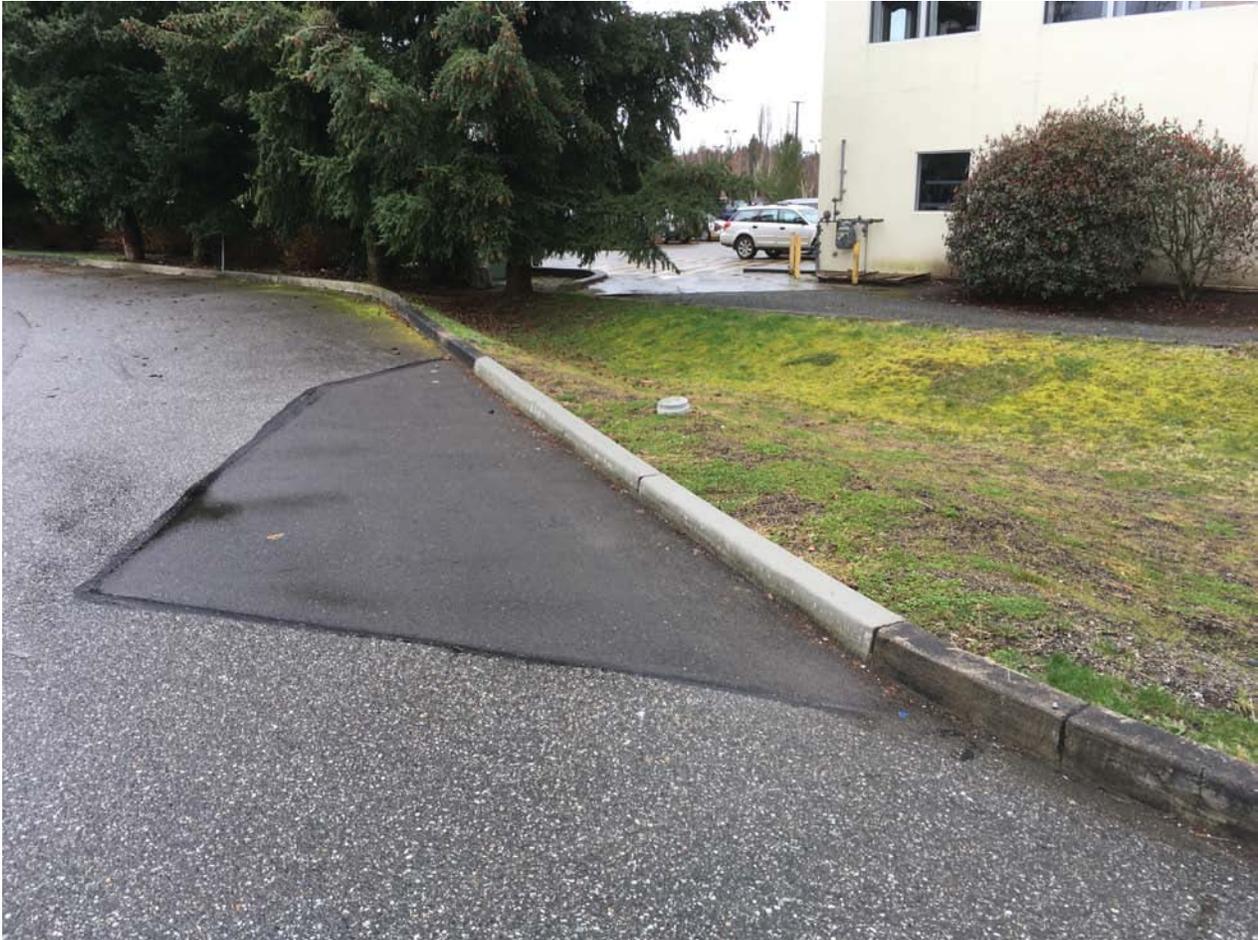
PHOTO NO:	1	ADDRESS:	3300 169TH PL NE ARLINGTON, WA 98223
DATE:	3/20/2017		
TIME:	1PM		
CAMERA:	IPHONE	TAKEN BY:	MY
COMPLAINT #:		WITNESS:	N/A
DESCRIPTION/COMMENTS:			
New pavement and curb noted where spill occurred. Neighboring hotel in background.

The spill site has been remediated and confirmation cleanup samples were provided by the consultant. Site inspection found no evidence that contamination still exist. Therefore, we recommend that No Further Action be taken at this site, because of a successful independent cleanup.

3/20/2017 SHD site visit, no evidence that contamination.

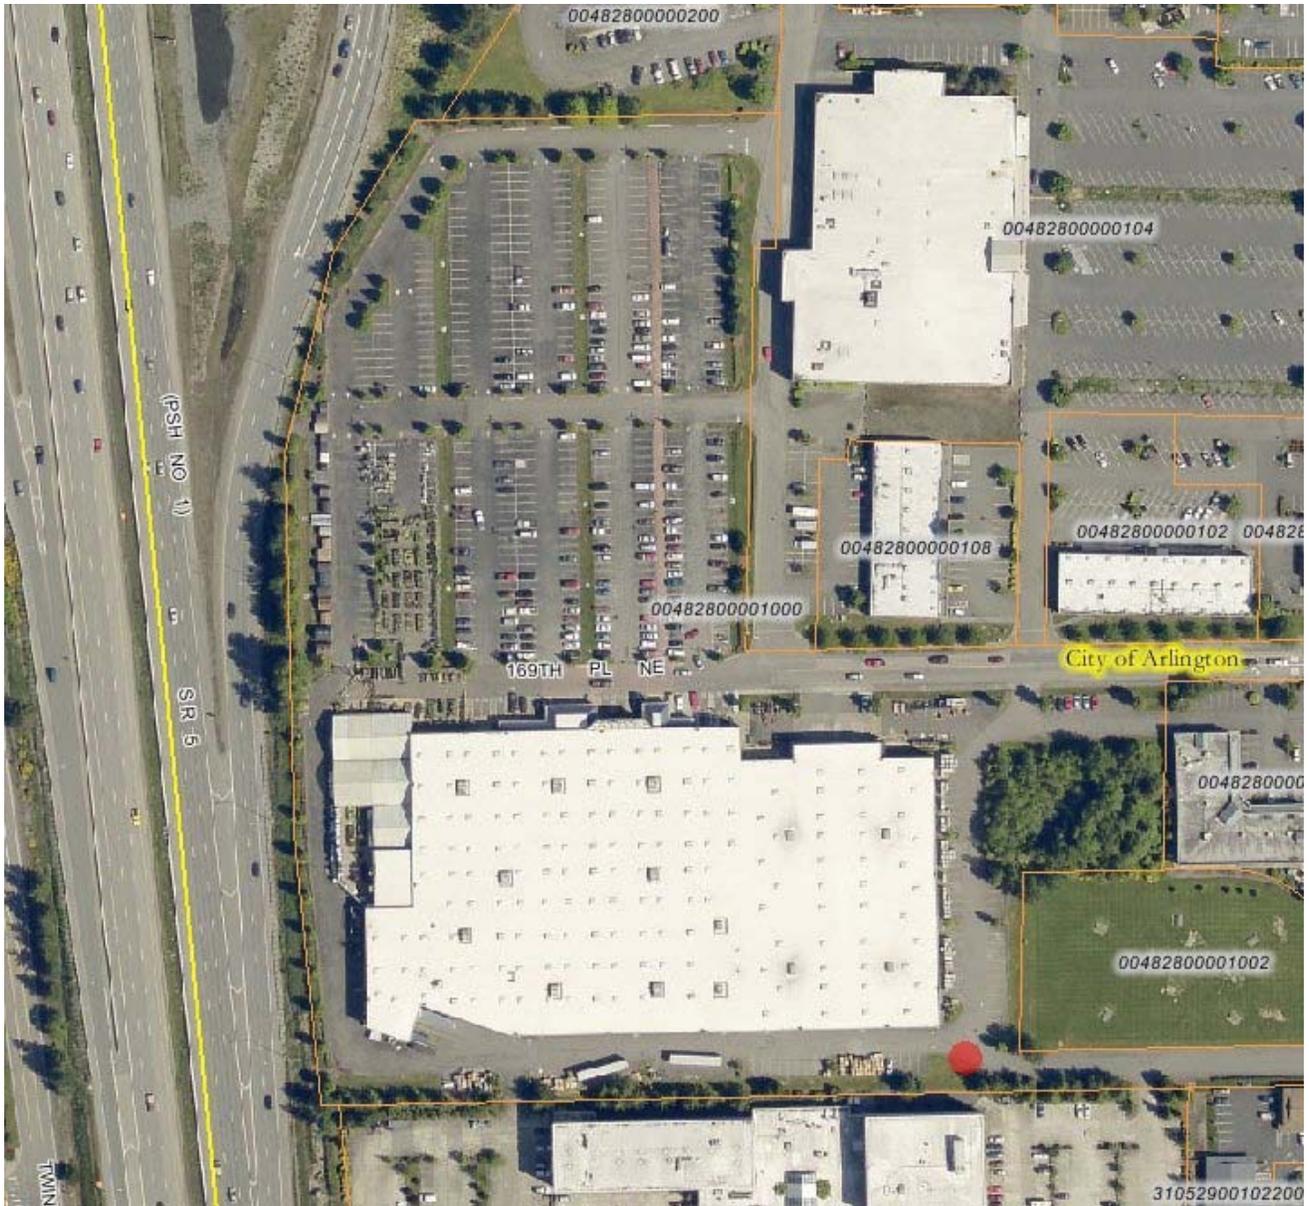
PHOTO NO:	2	ADDRESS:	3300 169TH PL NE ARLINGTON, WA 98223
DATE:	2012		
TIME:	NA		
CAMERA:	NA	TAKEN BY:	Sno Co
COMPLAINT #:		WITNESS:	N/A
DESCRIPTION/COMMENTS:			
Lowes property line, red dot is where spill occurred.
