Re: Report of Activities for Diesel Spill
27230 SR 9
Arlington, W A 98223
NRC Job # 100966

Response Activities

Diesel Spill from Semi Wreck SR 9, Arlington, WA NRC Job # 100966

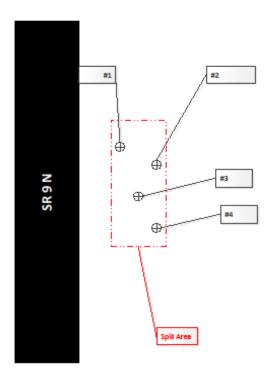
Sampling Map
Great West Casualty
Prepared by NRC Environmental Services
January 22, 2016

On December 31, 2015, in order to identify the areas of petroleum-impacted soil before remediation began, a total of four (4) discreet soil samples were initially obtained from the site.

On January 7, 2016, in order to confirm that remediation activities had removed all petroleum-impacted soil, a total of one (1) discreet soil sample was initially obtained from the excavation.

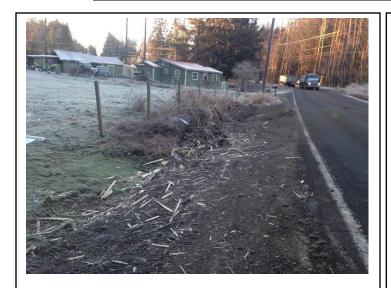
Photo 1: Site upon arrival.

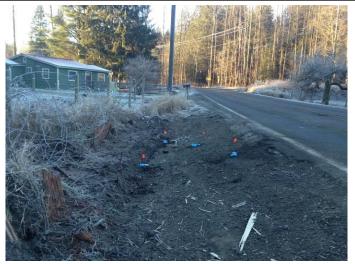
Photo 2: Initial sample locations.

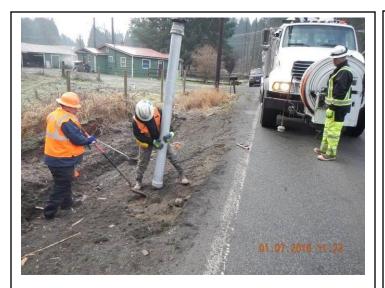
Photo 3: NRC personnel removing impacts.

On January 7, 2016, NRC personnel returned to the site and utilizing a vactor truck removed 2.34 tons of impacted material along the shoulder of SR 9. NRC personnel then collected one (1) soil sample to ensure that all of the impacts had been removed. NRC then utilized a mini excavator to backfill the excavated area and returned it to its original state.

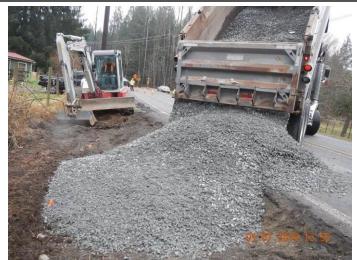
Photo 4: NRC personnel placing backfill material.

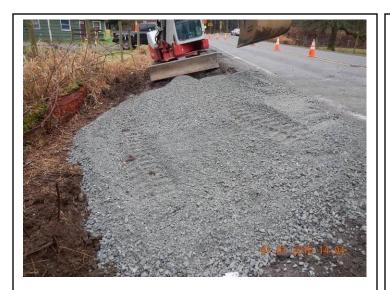
Photo 5: NRC personnel placing backfill material.

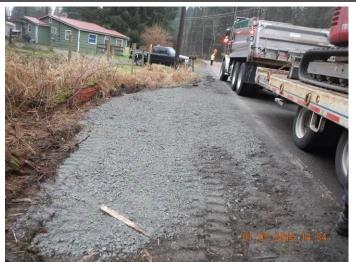
Photo 6: Site upon completion.

NRC does not recommend any further actions at this site due to the confirmation samples being below the Washington State Department of Ecology MTCA regulations and that the site has been restored in accordance with Washington State Department of Transportation specifications.
