August 1, 2016
Project No. KV150055B

Subject: **Site Assessment Report**
The Heron (Accurate Auto Body)
7662 159th Place Northeast
Redmond, Washington

REMEDIAL EXCAVATION PLAN

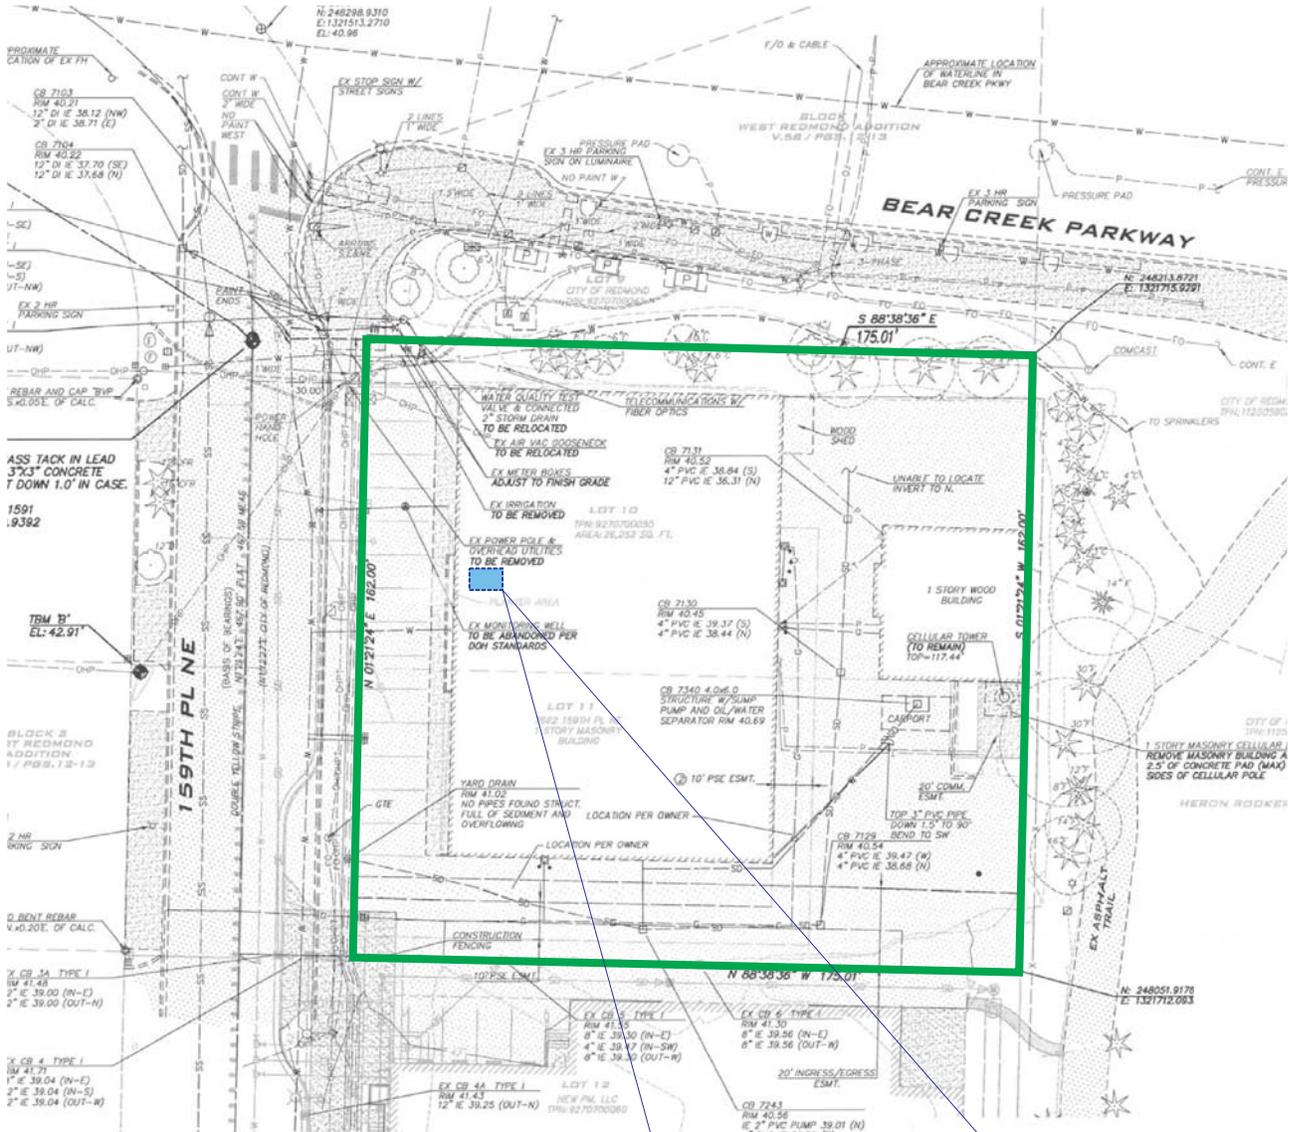
PROJ NO.	KV150055B	DATE:	7/16	FIGURE:	2
----------	-----------	-------	------	---------	---

After removal of the tank, excavation began to remove soils affected by the heating oil. Soils were loaded directly into dump trucks and transported to CEMEX in Everett for disposal. The material removed was a Recent alluvium material, consisting of brown gravelly medium to coarse sand. All material removed had a petroleum odor and dark staining, but none of the material was grey and characteristic of weathered petroleum. A total of 73.55 tons of soil was transported and disposed of at the CEMEX facility. This tonnage is estimated at a volume of approximately 52 cubic yards of soil. After completion of excavation, the sidewalls and base of the excavation were sampled. The tank removal pit was completed into the side of an excavation cut and no sidewall was present to the east. The eastern sidewall sample was collected at the same elevation as the base sample, but 5 feet east of the former tank location. All other sidewall samples were collected at mid-depth of the excavation. The results of the soil sample analyses are presented in Table 1 and the approximate locations of the samples are shown on Figure 2. All samples were non-detect for diesel- and heavy oil-range petroleum hydrocarbons by NWTPH-Dx and therefore below the Model Toxics Control Act (MTCA) Method A cleanup levels. It should also be noted that no ground water was present in the location of the tank or the excavation area.

Soil samples were placed directly into laboratory-prepared sample containers using stainless steel spoons and labeled with the site name, date, time, exploration number, sample number, and sampling personnel. Sample containers were placed in a chilled cooler immediately after sampling, and subsequently transported to the analytical laboratory by AESI under standard chain-of-custody protocols. The analytical laboratory used for analysis was Friedman & Bruya, Inc. located at 3012 16th Avenue West in Seattle, Washington. Laboratory reports are presented in Appendix A.

**ENLARGED UST
EXCAVATION AREA**
NO SCALE
