SITE HAZARD ASSESSMENT Worksheet 1 Summary Score Sheet

Cleanup Site ID: 12004

American Linen Supply Co. Dexter Ave.

Site scored/ranked for the Hazardous Sites List Publication: February 2018

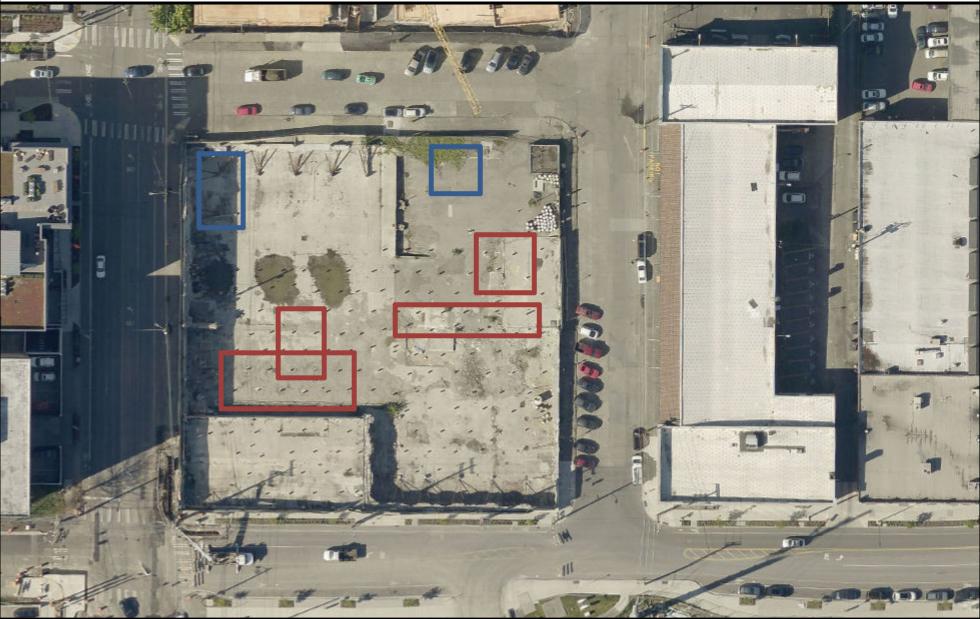
Historical Structures at American Linen

station structures Red indicates historical dry cleaning structures

Blue indicates historical service
