ESC17-E034
Page No. 1

Subject: Summary of Issues Requiring Resolution: January 13, 2017
L & E Auto Sales
Naval Avenue & 2101 Burwell Place
Bremerton, Washington
VCP No.: NW2785

BURWELL PLACE
2017 SITE CHARACTERIZATION
Bremerton, Washington

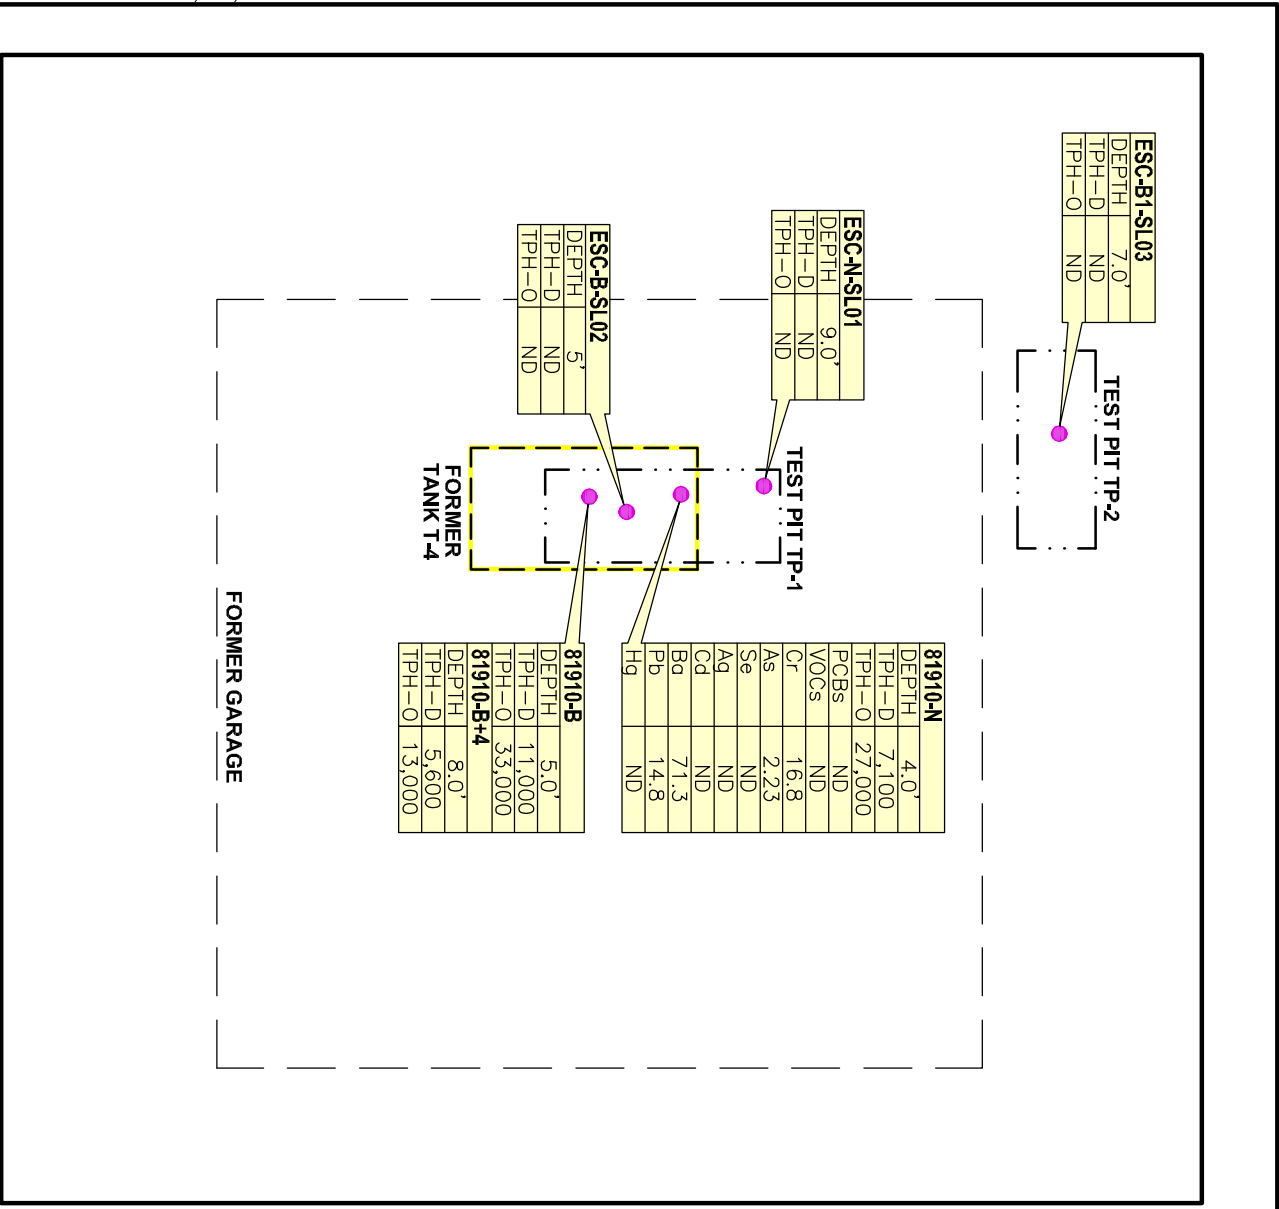
WASTE OIL TANK
SCALE: 1" = 5'

The source of contamination (waste oil tank and the hydraulic lift) has been removed along with the petroleum-impacted soils. No stained soils were observed in the EnviroSound test pit excavated in the former waste oil tank location. Diesel and lube oil were not detected in soil samples collected by EnviroSound at 5 and 9 feet bgs below the areas of concern.

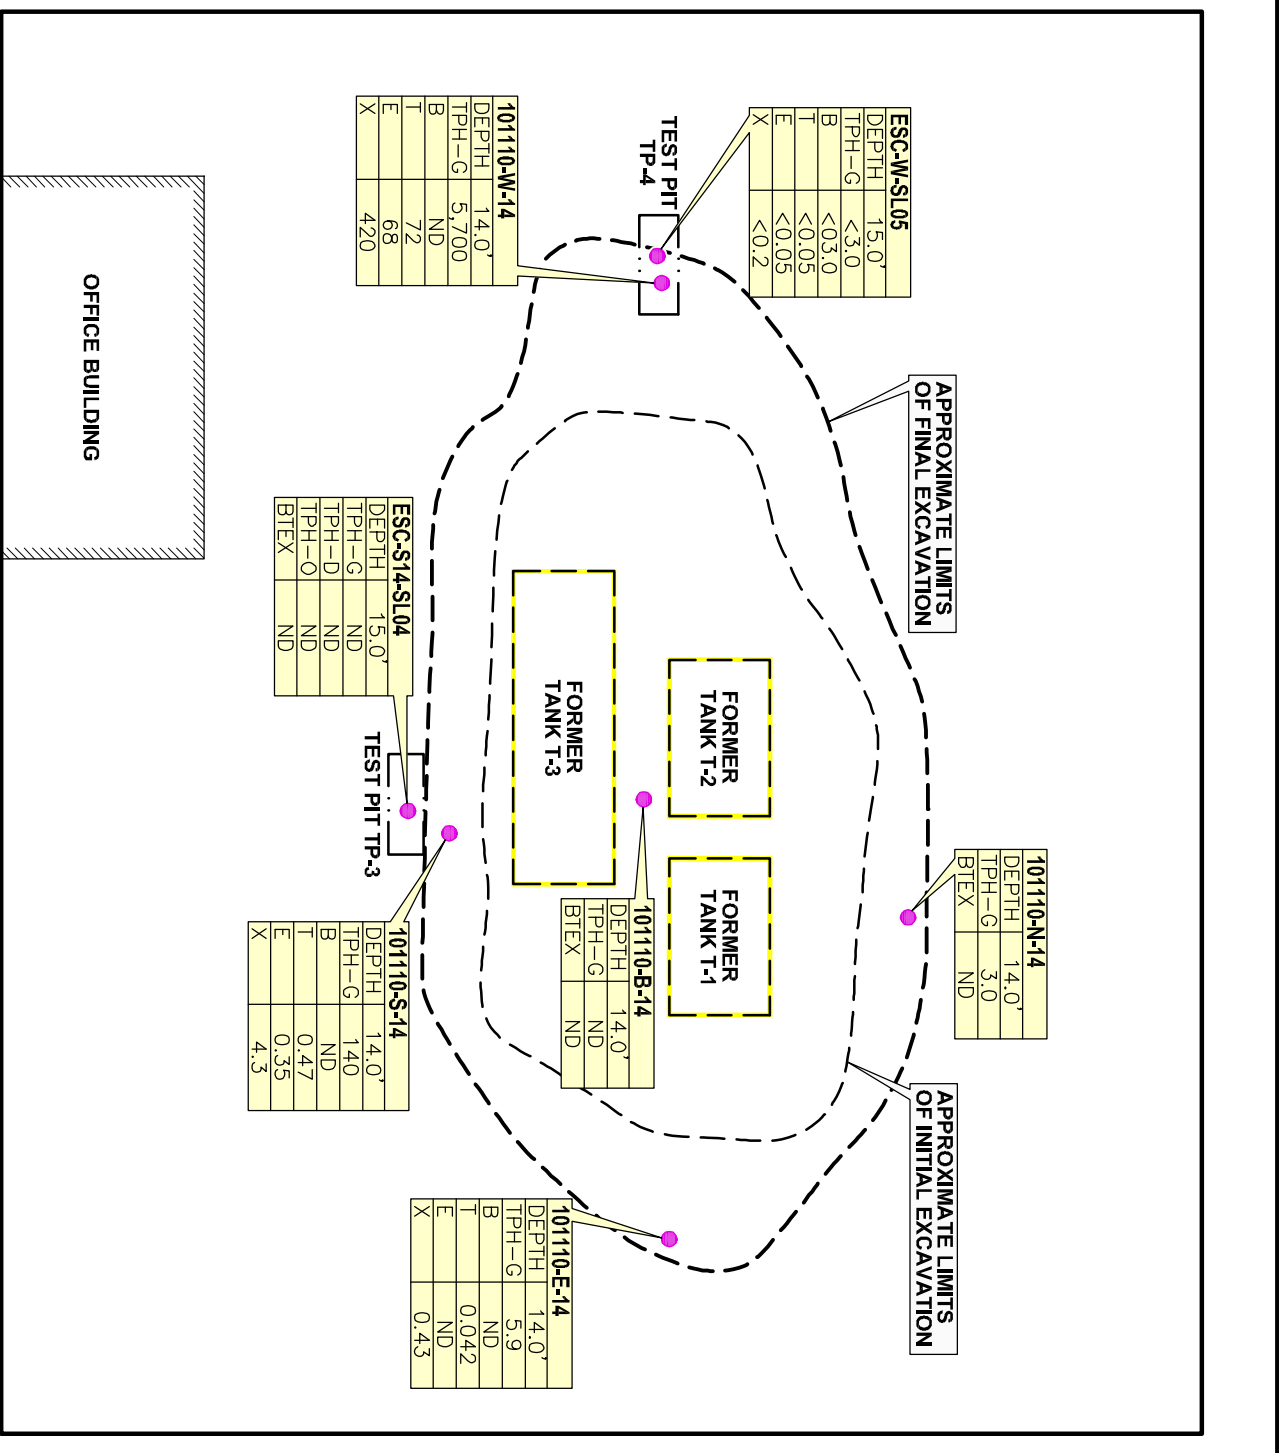
GASOLINE UNDERGROUND STORAGE TANKS - T1, T2, AND T3
SCALE: 1" = 10'

The source of contamination (three gasoline USTs) has been removed, as has 75.95 tons of impacted soil. EnviroSound collected samples below samples previously collected by DLH to determine the vertical extent of contamination with corresponding sample results shown on Table 1. Samples collected from borings placed around the USTs during the Phase II ESA by DLH had no detectable concentrations of NWTPH-Dx at depths ranging from 15 to 20 feet and no petroleum-impacted soils were observed in test pits logged by EnviroSound adjacent to the UST excavation.

FUEL TANK EXCAVATION, SAMPLING, AND RESULTS

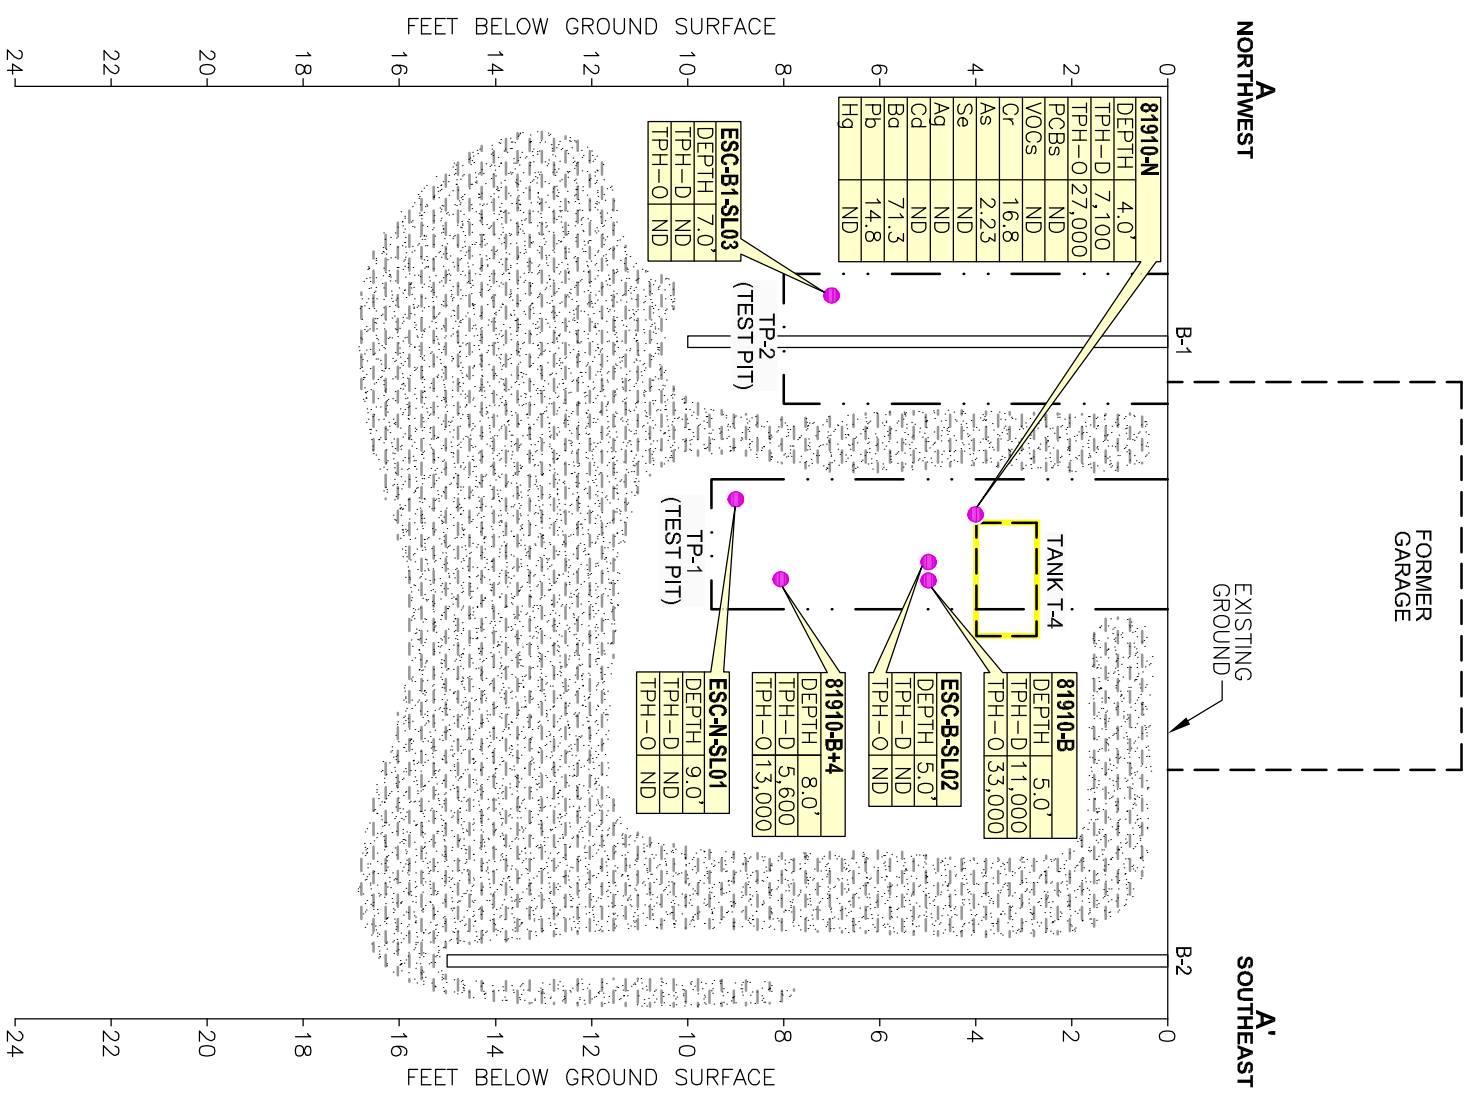
CROSS SECTION A-A'
BURWELL PLACE
2017 SITE CHARACTERIZATION
Bremerton, Washington

HORIZONTAL SCALE: 1"=10'
VERTICAL SCALE: 1"=4'
EXAGGERATION 2.5X

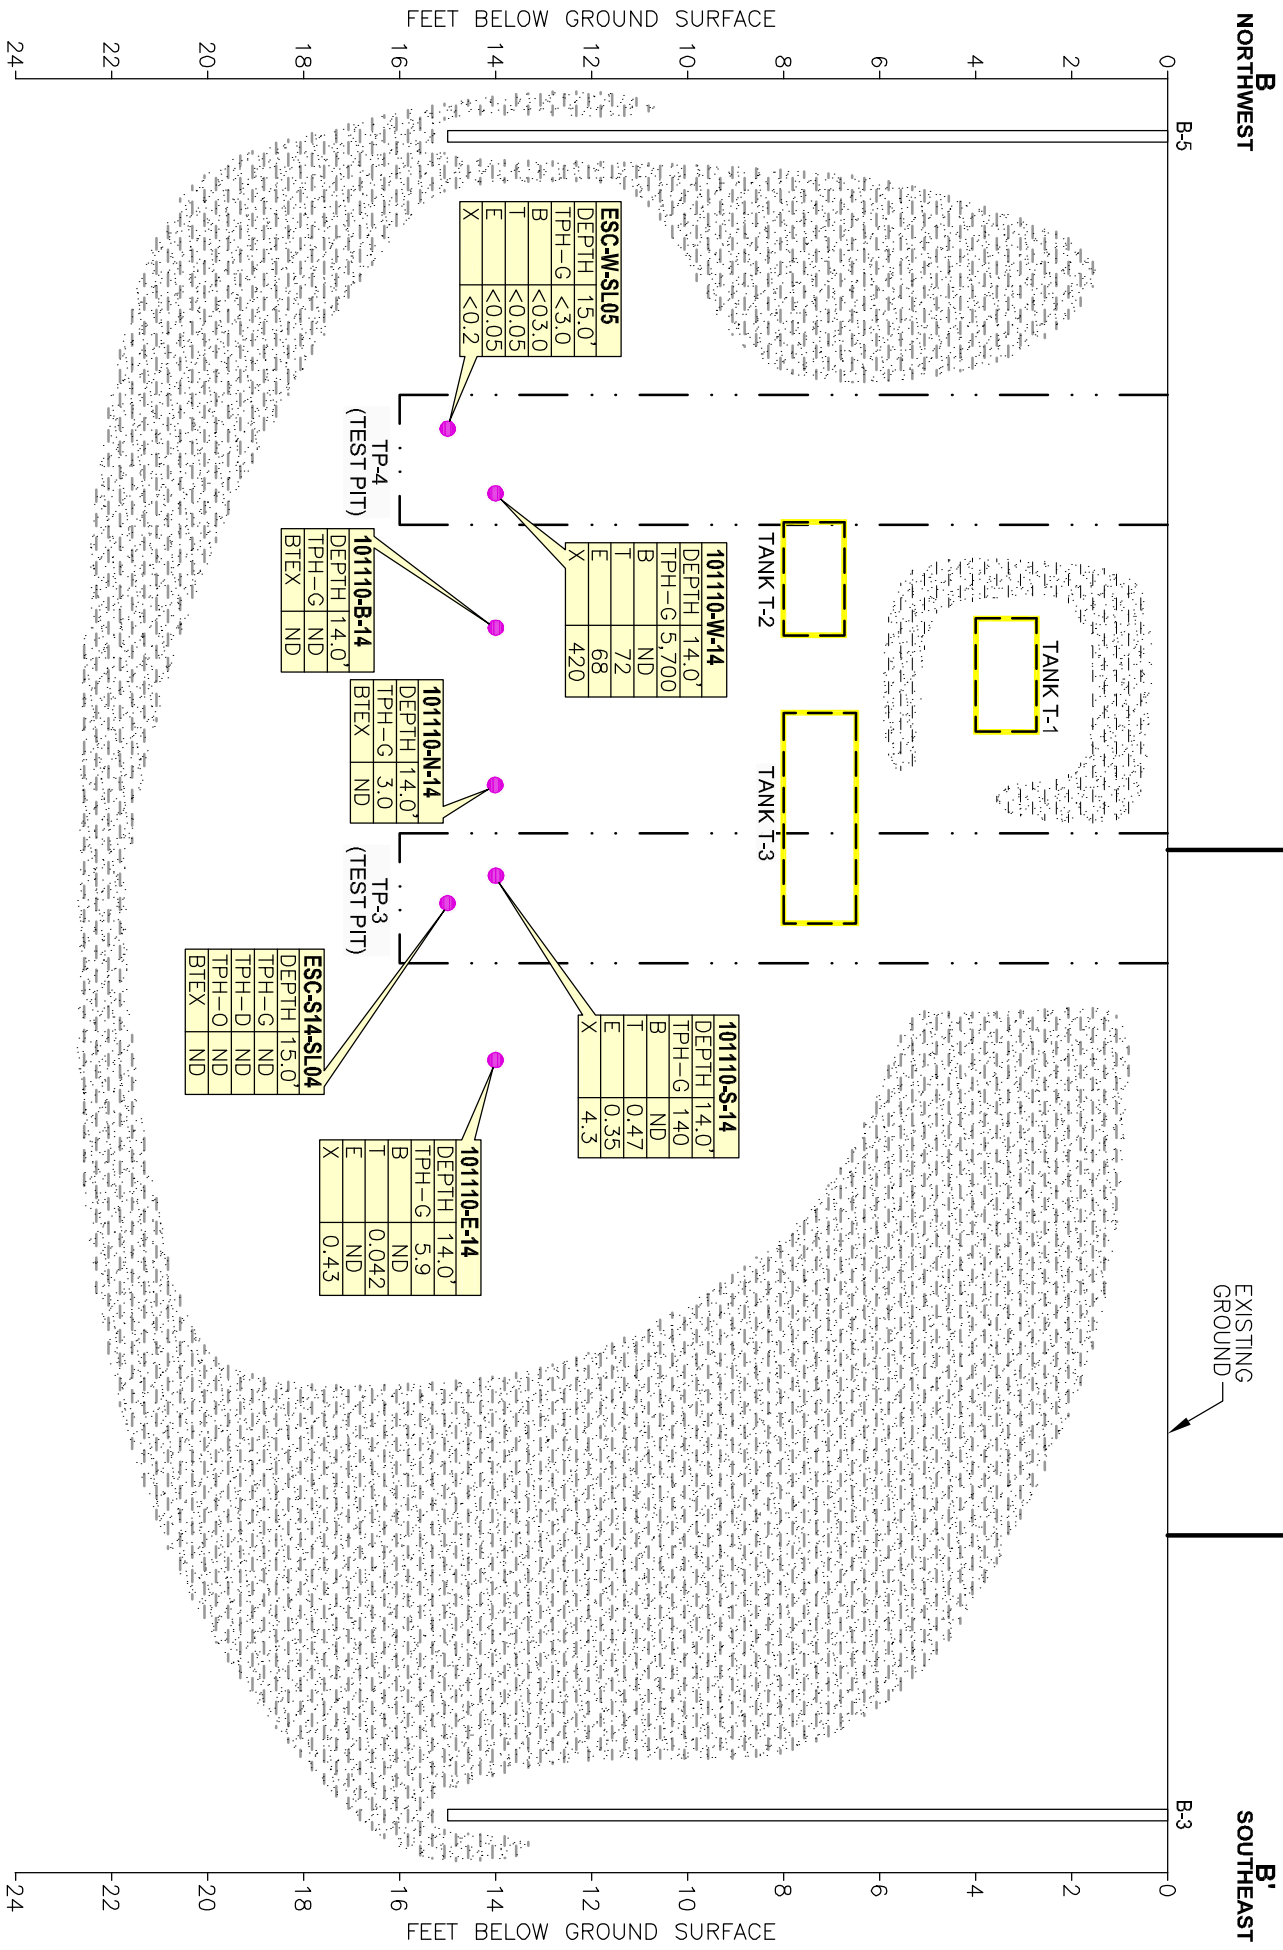
CROSS SECTION B-B'

TAN SILTY SAND WITH CLAY TRACES

HORIZONTAL SCALE: 1"=10'
 VERTICAL SCALE: 1"=4'
 EXAGGERATION 2.5X
