**REMEDIAL INVESTIGATION  
AND PROPOSED CLEANUP ACTION PLAN**  
with  
**PHASE III SUBSURFACE INVESTIGATION RESULTS**

*Performed at:*  
**Lynnwood Auto Body**  
19320 Highway 99  
Lynnwood, Washington 98036  
**VCP NW 2555**

**SITE REMEDIATION  
and  
CLOSURE REPORT**

**LYNNWOOD AUTO BODY SHOP  
19230 Highway 99  
Lynnwood, Washington 98036**

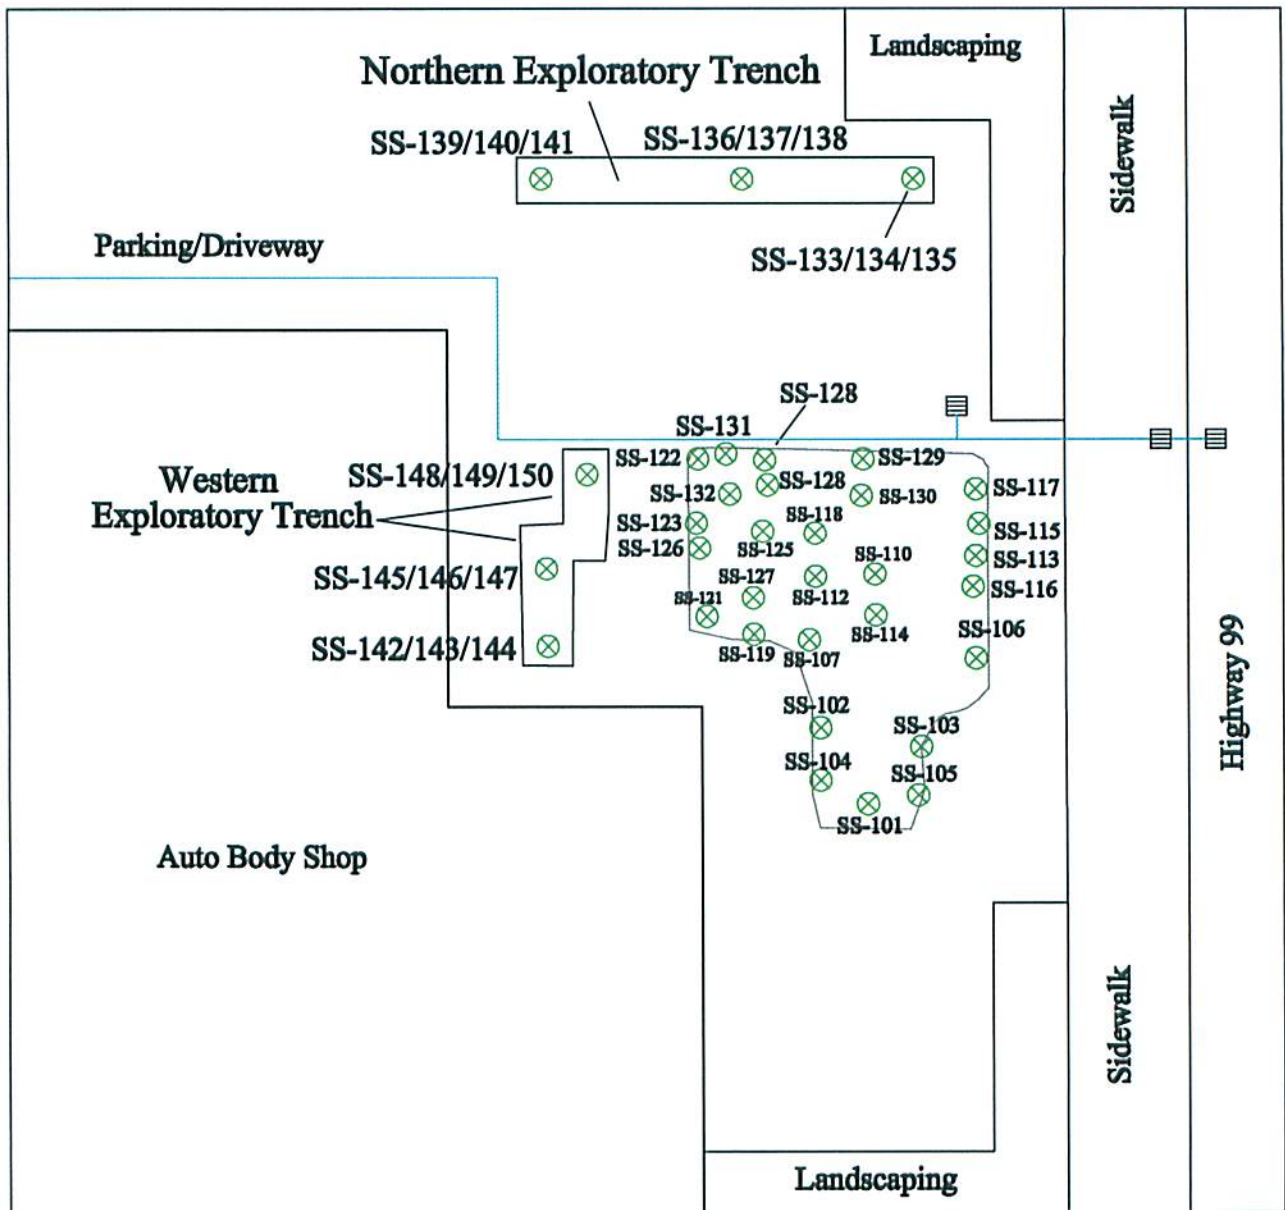
Soil Sample or SS-108, SS-108 and SS-111 were collected above SS-129 and SS-130.

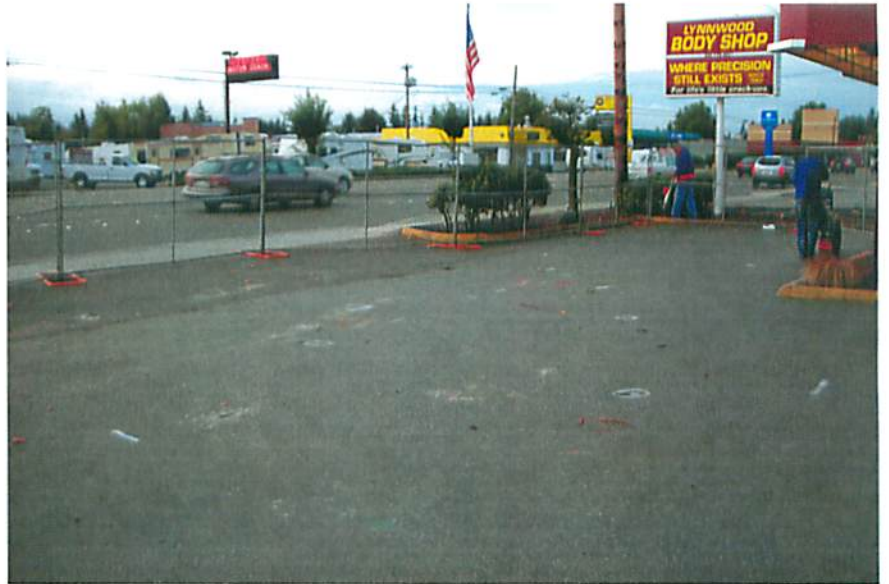
Remediation area

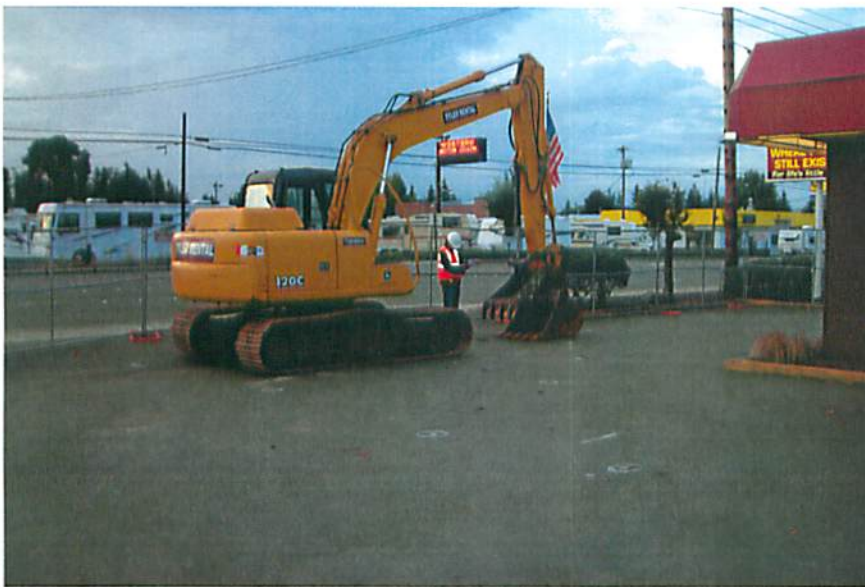
Start of Remediation  
(Fuel dispenser island)

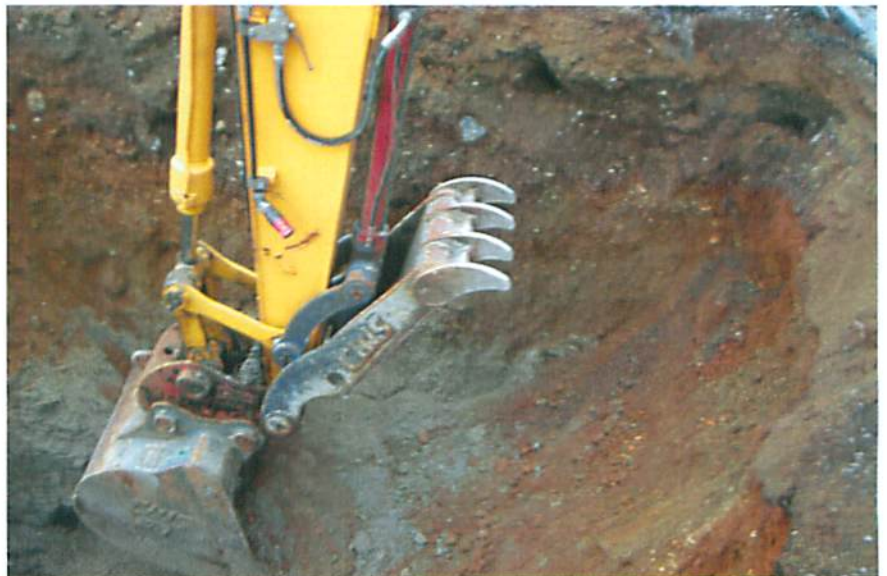
Excavation at fuel dispenser  
island

Completion of fuel dispenser  
island remediation

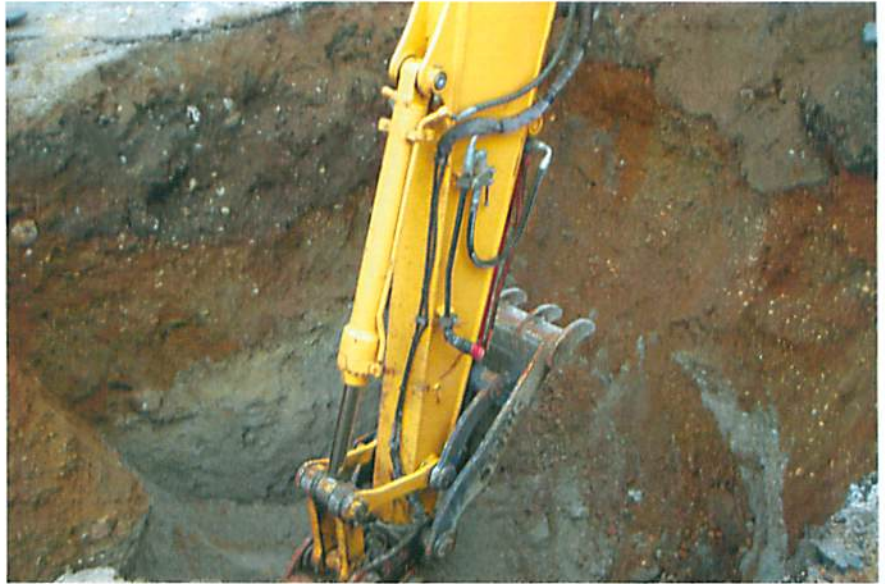
Excavation along eastern  
Property boundary

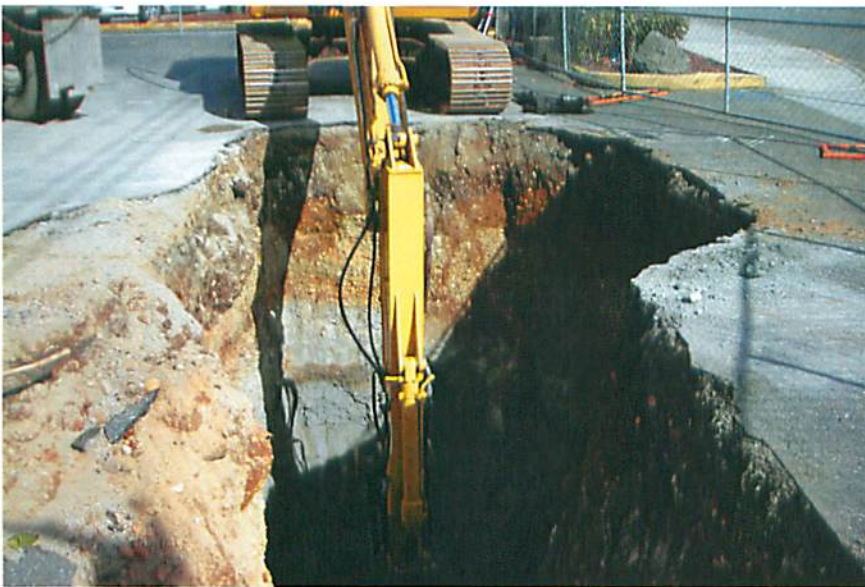
Depth of Excavation  
at 20 feet bgs

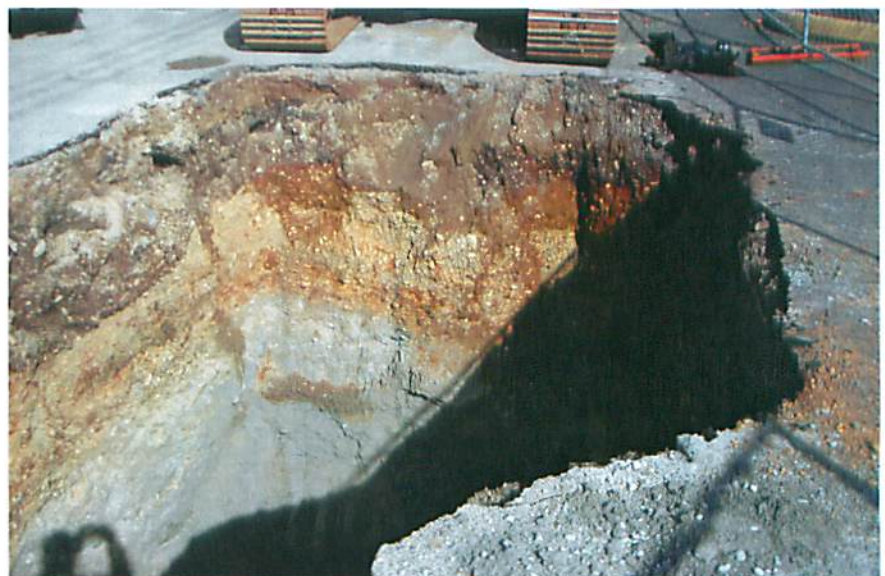
Former tank pit excavation

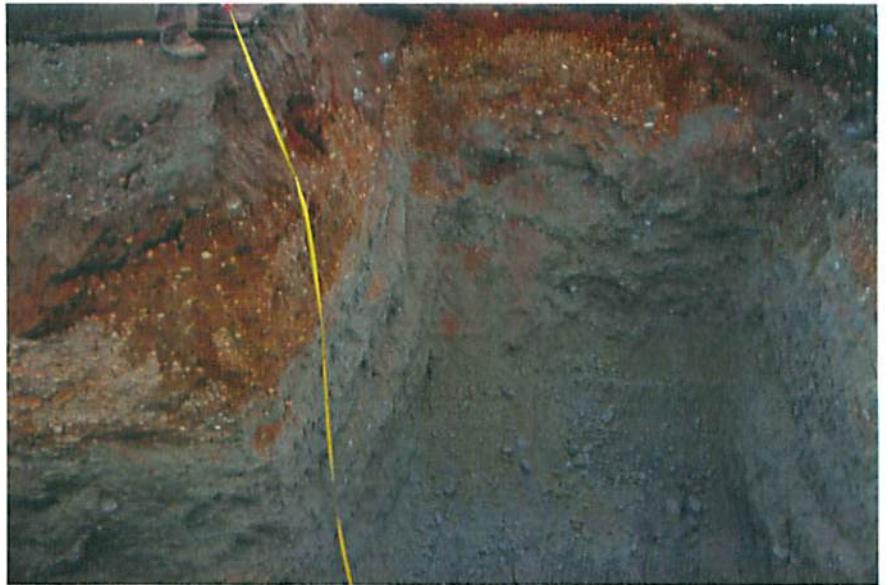
Bottom of tank pit excavation  
at 20 feet bgs

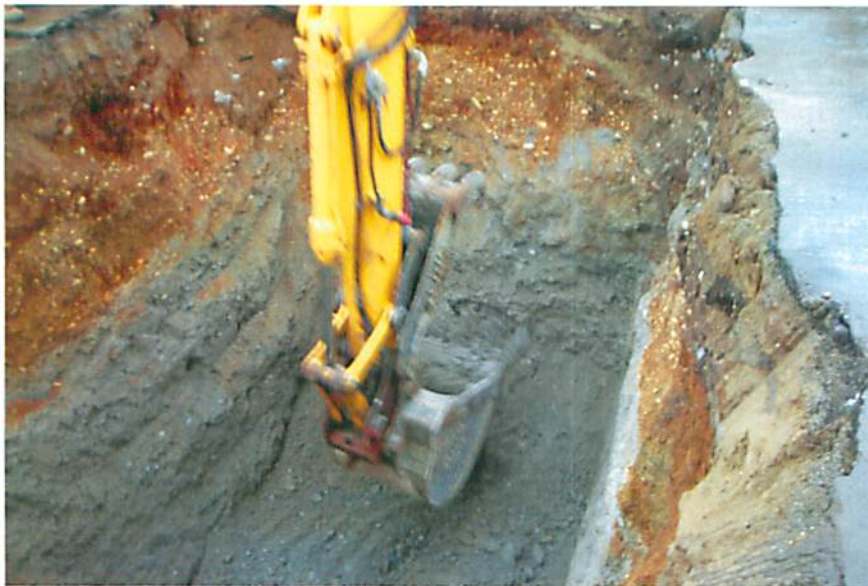
Northwest corner of tank pit  
excavation

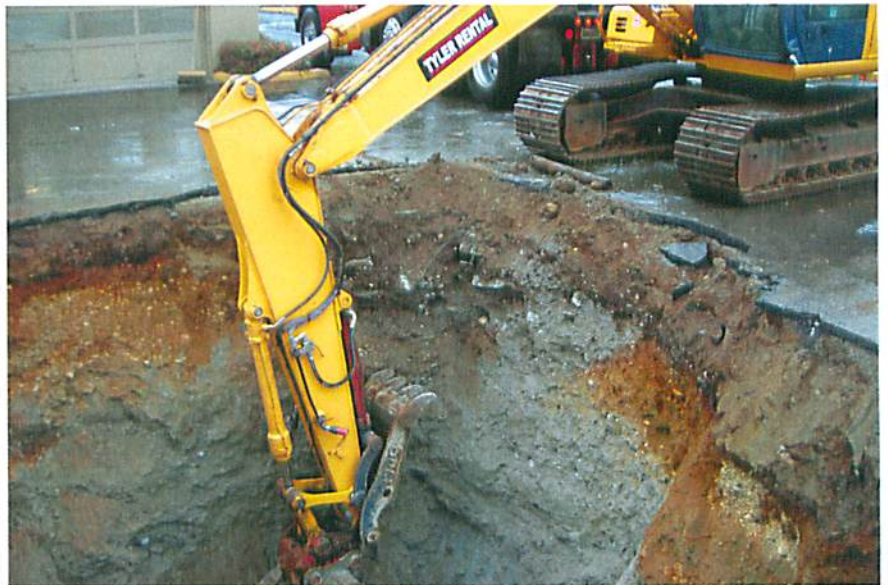
Tank pit excavation  
north side

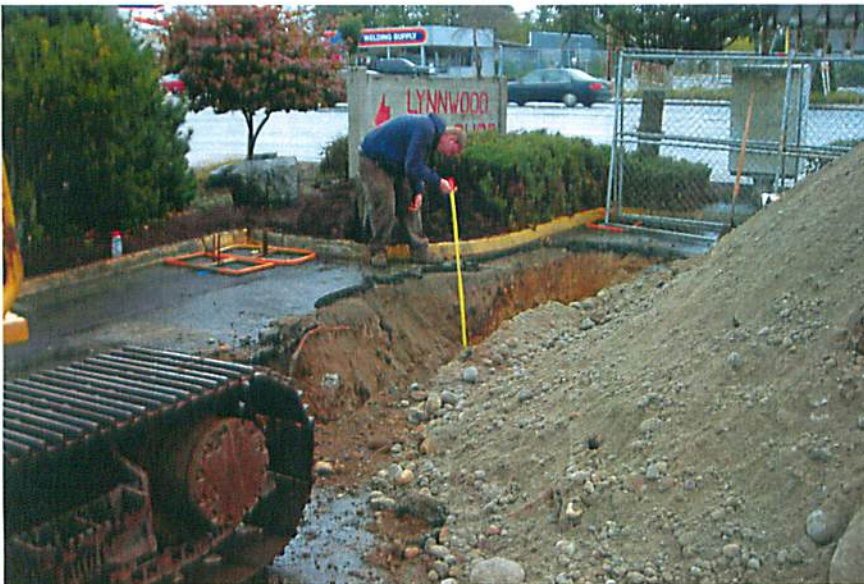
Northern exploratory trench

An Exploratory Trench along the northern Property boundary confirmed that petroleum impact did not extend off Site to the north. An Exploratory Trench west of the area of the excavation encountered elevated levels of petroleum at approximately fourteen feet below ground surface encountered elevated levels of gasoline and diesel range organics at approximately fourteen feet below ground surface.

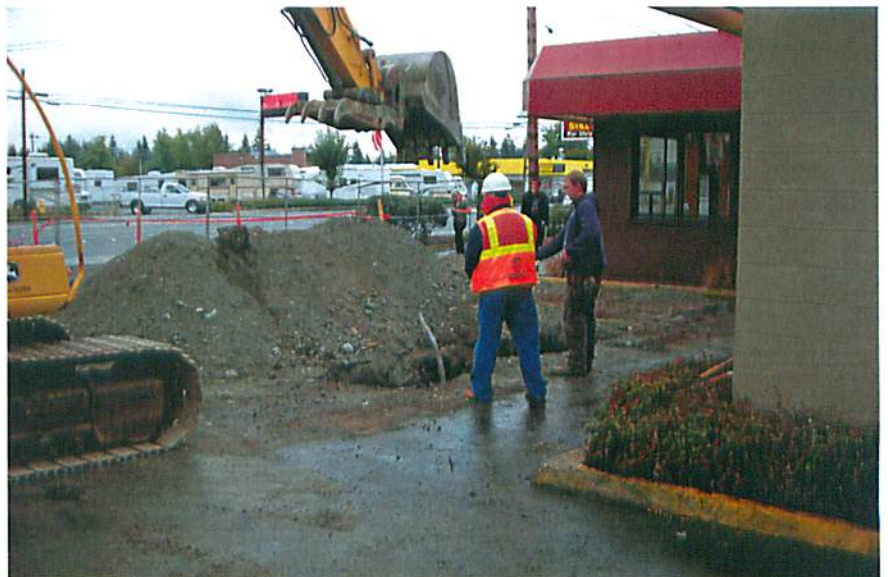
Western exploratory trench

The laboratory results indicated that no petroleum hydrocarbon impact was present until a depth of fourteen feet below ground

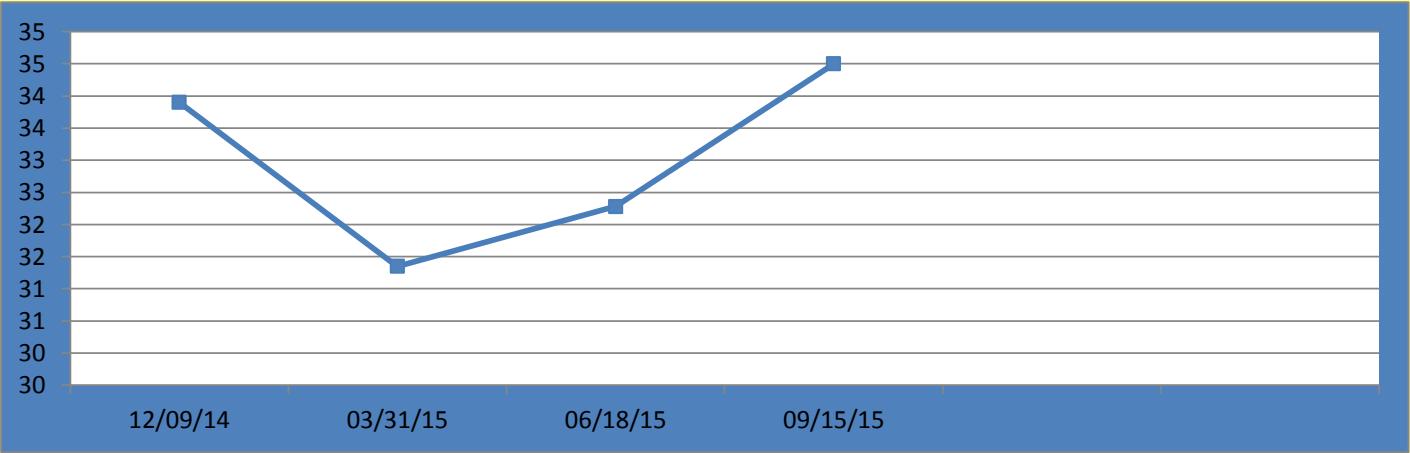
Hydrograph

MW-1
