PROJECT COMPLETION REPORT
ALCOA/EVERGREEN VANCOUVER SITE

Washington State Department of Ecology

Alcoa, Inc.

Anchor QEA, LLC

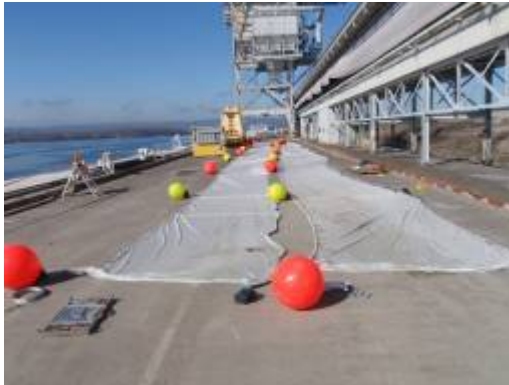
Photograph 1: Mesh panel for fish diversion prior to installation

The Corps' extension specified that several supplemental BMPs were to be in place during in-water work conducted between March 1 and March 18, 2009. The supplemental BMPs consisted of the installation of a mesh fish diversion panel to isolate the work area by "guiding" juvenile fish moving downstream around the work area (shown on Photographs 1 and 2) and the presence of an on-site monitor to ensure that fish were not being entrapped in the mesh panel. Alcoa complied with the special requirements during project activities and finished all in-water work on March 18, 2009. Appendix E presents daily logs documenting the performance of additional activities during the work window extension and the observations made during the fish diversion panel monitoring.

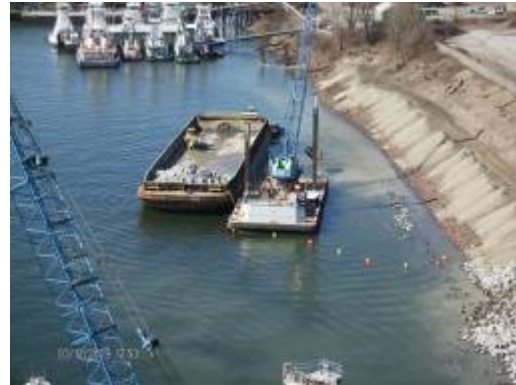
Photograph 2: Installed mesh panel for fish diversion

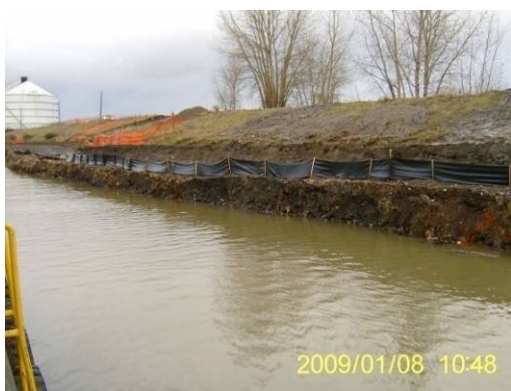
Photograph 3: Erosion fencing

On December 5, 2008, prior to upland excavation and grading activities, TtEC installed silt fencing meeting the requirements presented in Section VII.D of the Project Specifications (Appendix A) at the downhill limits of the excavation, uphill of the water surface elevation (Photograph 3). A containment boom was placed in a horseshoe pattern downstream of the in-water activities (Photograph 4). The boom was deployed December 1, 2008. TtEC maintained these BMPs for erosion control during upland activities and retained an erosion control specialist on site.

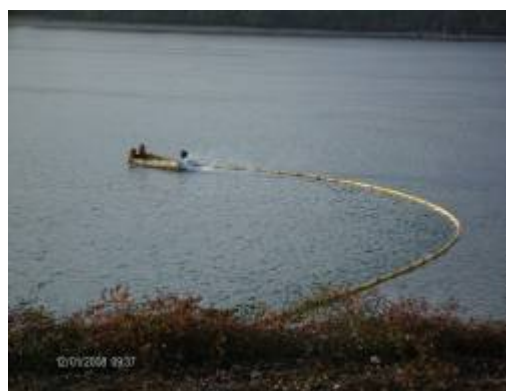
Photograph 4: Debris boom installation

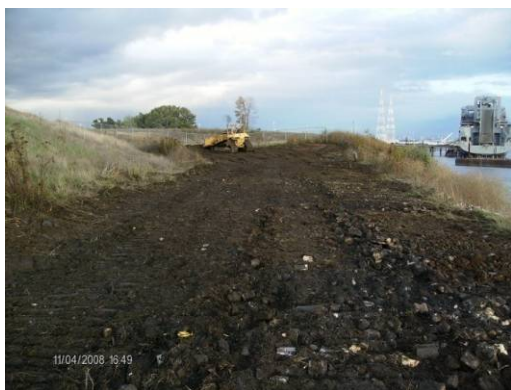
Photograph 5: Grading of the lower levee road

Pumping action was observed on the lower levee road on December 9, 2008. The roads were regraded and stabilized to correct this problem. Subsequently, the roads were regraded on a daily basis through project completion. Snow removal was required to clear the roads on December 22 and 23, 2008, after winter storms. The roads around the North and North 2 landfills were reinforced with brick and crushed concrete material during January 2009.

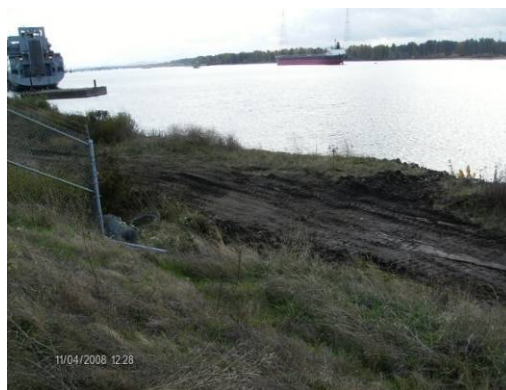
Photograph 6: Removed fencing along the lower levee road

Clearing and grubbing of the existing roads and site of the temporary roads (shown in Photograph 5) began on November 4, 2008. Also on this day, a fence was removed at station number 18 + 80, along the site of the lower levee road (shown in Photograph 6). After

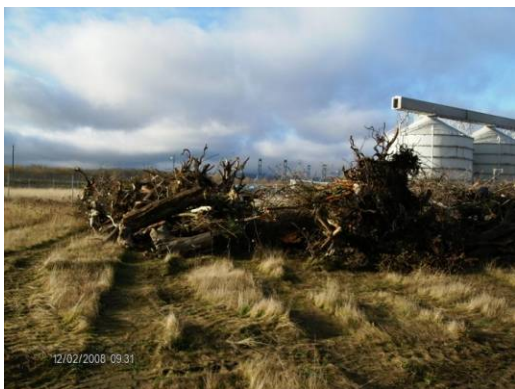
Photograph 7: Grubbed material

Vegetated areas of the shoreline and upland areas were cleared and grubbed prior to excavation and/or grading activities. TtEC cleared and grubbed vegetation areas in DU1A, DU2B, DU2C, DU3C, DU3E, DU4D, and DU5 prior to dredging to expose the underlying soil and/or salvageable debris. The North and North 2 landfill areas were cleared and grubbed in preparation of material placement activities, as were the road areas to facilitate access and road improvement and construction activities. Mechanical methods were used for these activities. The waste material generated by these activities was transported off-site for disposal at the Wasco County Landfill. Road and landfill areas were cleared and grubbed during early November 2008. Shoreline areas were cleared and grubbed during December 2008.

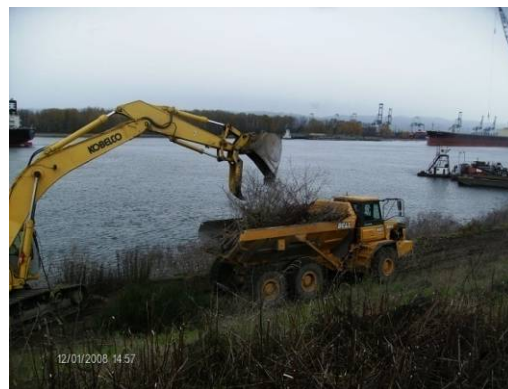
Photograph 8: Clearing and grubbing the shoreline area

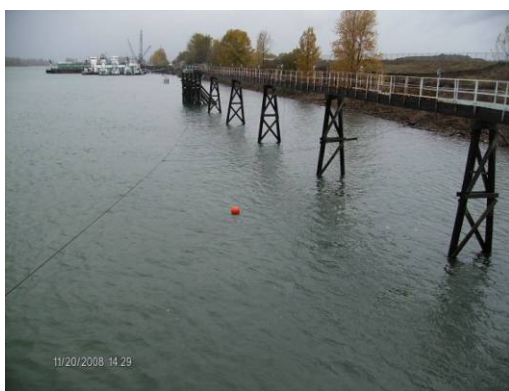
Photograph 11: Buoy marking outfall

On November 19, 2008, the outfalls to the east and west of the Alcoa dock were located by the diving subcontractor Northwest Underwater Construction, LLC's (NWUC's) divers, and buoys placed to mark the end. GPS coordinates were taken and loaded into the on-board computers, which allowed dredging around the structures without damage. A lost or stolen buoy was replaced on December 1, 2008 by NWUC.

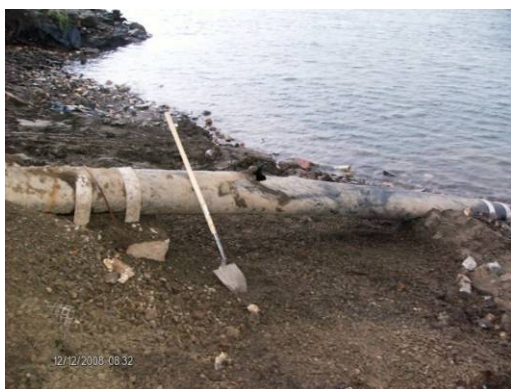
Photograph 12: Damaged outfall

A 12-inch HDPE PUD outfall was damaged on December 4, 2008, during shoreline excavation work. The PUD was notified and PUD contacted Ecology (because the outfall is permitted discharge). The outfall was repaired on December 12, 2008. PUD representative Ben Maier was on site to oversee the repair and to verify that it met with their expectations.

PUD shut down the discharge on the outfall at 2AM to allow it to drain because the pipe needed to be free of water in order to complete the work. However, it was discovered at approximately 8AM that there was still residual flow in the pipe. Dry ice was obtained and placed down the vent/clean out pipe on the shoreline to form an ice dam. Additional dry ice was placed directly into the pipe where it was cut. This successfully blocked the water flow. Once water flow was stopped, the damaged section was removed and a new section welded in place.

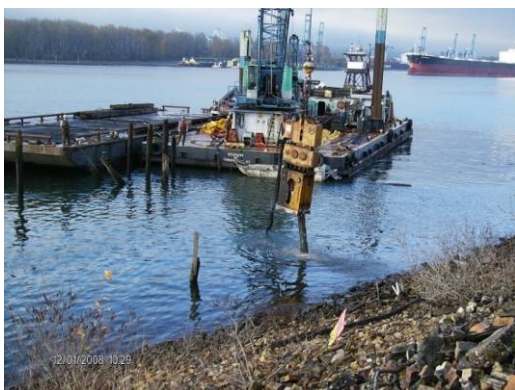
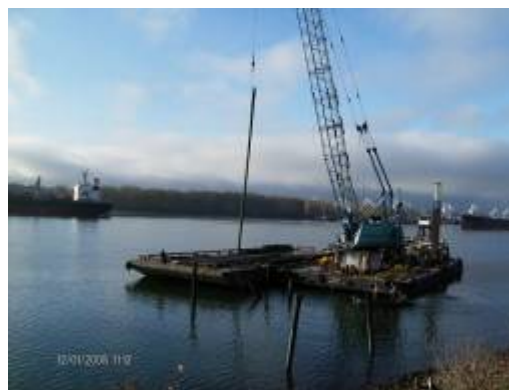
Photograph 16: Pile loosening using vibration **Photograph 17: Pile removal**

Hickey removed 27 creosote-treated piles as part of the project on December 1, 2009. Vibratory methods were used to initiate vertical pile movement and a crane was used to complete pile removal. Two of the piles were removed from under the Alcoa dock western catwalk to facilitate site access. These piles were replaced with new untreated piles upon completion of project activities. The remaining 25 piles were removed from the pile removal area shown on Project Drawing G-3 (in Appendix A). Removal activities in this area are depicted on Photographs 16 and 17. The piles were brought to shore by barge and transported off site by truck for final deposition at the Wasco County Landfill, located in The

An attempt was made to remove each pile in its entirety. However, Hickey reported that two of the piles in the pile removal area broke off at the mudline during removal. The broken piles were removed during subsequent dredging activity within the area. No other difficulties or broken/cut piles were reported.

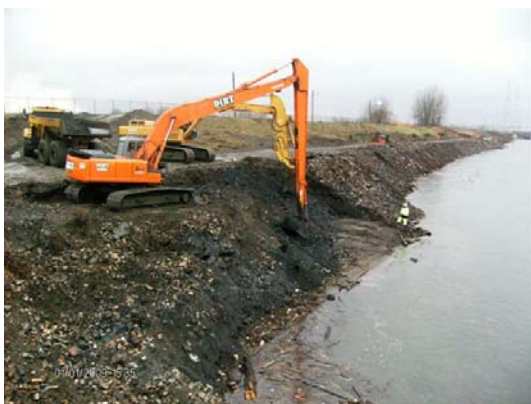
Photograph 18: Shoreline debris removal

A variety of debris was encountered on the shoreline. This material consisted of metal, brick, carbon products, cardboard, paper, and miscellaneous other non-hazardous materials. Photographs 18 and 19 are of debris removal along the shoreline. This waste stream was removed from the shoreline within the project limits, from December 2, 2008 to February 11, 2009, and was stockpiled in the staging area. Approximately 3,396 tons of debris was disposed of off-site.

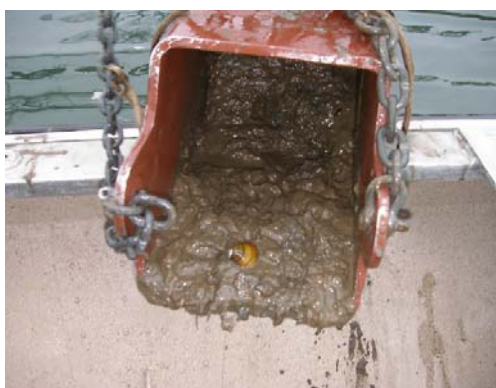
Photograph 20: Asian Clam harvested during site reconnaissance

The location of on-site Asian clam beds was identified during the site reconnaissance activities conducted in early 2008. Photographs 20 and 21 depict samples of clams collected as part of the reconnaissance activities. This area, designated "clam removal area" is shown on Project Drawing G-3 (included in Appendix A). Hickey removed a minimum of 1 foot depth (approximately 1,760 cy) of sediment across the clam removal area. A downstream debris boom was in place during these dredging activities. Additional pollution control materials, including absorbent booms and absorbent pads, were available on site in the event that sheens were produced during the removal activities. The dredged sediment and clams were transported off site by barge to an offloading facility in The Dalles, Oregon, where the material was dewatered and transported by truck for final deposition at the Wasco County Landfill.

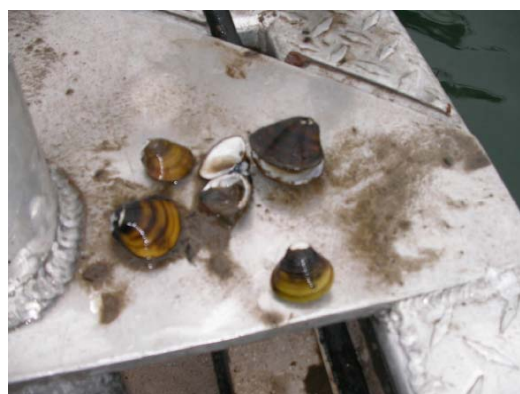
Photograph 21: Live Asian clams and remnant shells collected during site reconnaissance

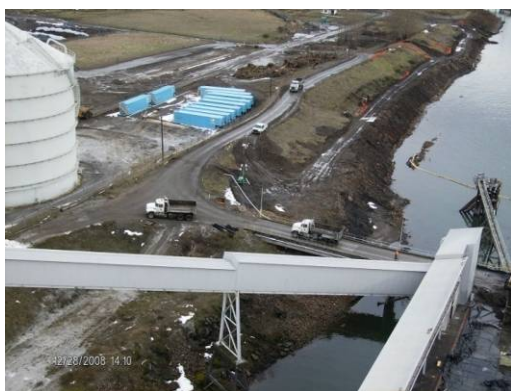
Photograph 22: Transport of dredged material to the North Landfills

Approximately 44,150 cy of material was placed in the North Landfills from the sediment and shoreline remediation work. The material was turned using excavators after placement as necessary to reduce the material moisture content. The material was worked in this way until it behaved more like soil than liquid, after which it was track-compacted and graded. This represents a modification in methods, as the Project Specifications indicate that the material should be placed in 12-inch lifts and track compacted. This was not possible due to the nature of the material and weather conditions during construction activities.

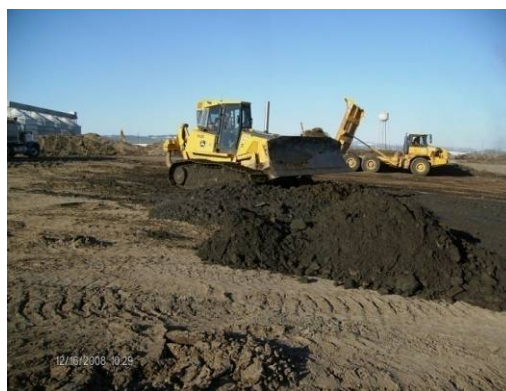
Photograph 23: Spreading of material in the North Landfills

A Modified Standard Proctor density test (ASTM D698) was conducted on material placed in each landfill, and in-place densities and moisture content testing (following ASTM D2922 and D3017, respectively) were conducted to verify compaction. The geotechnical testing subcontractor Columbia West Engineering, Inc. (Columbia) conducted in-place densities and moisture content testing and collected samples for laboratory density tests on April 20, 2009. Due to the above-described modification in placement method, geotechnical testing was not conducted on each lift (as specified in the Contract Documents). Rather, the material was tested after completion of the material working activities and compaction. Columbia dug a test pit within the footprint of each landfill and measured in-place density and moisture content (ASTM D2922 and D3017) at various depth intervals. In addition, Columbia collected a representative sample from each test pit and laboratory-tested the sample for

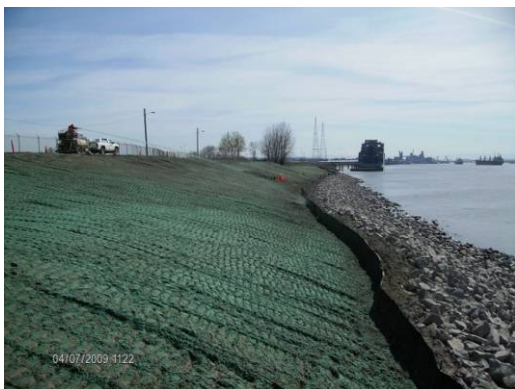
Photograph 24: Hydroseeded shoreline

The hydroseeding subcontractor, Charlton Landscape, applied a mixture of grass seed, fertilizer, and Flexterra® flexible growth medium meeting the material specification in Section VII.K of the Project Specifications (contained in Appendix A) and the March 31, 2009 Design Bulletin that provided supplemental hydroseeding information for shoreline areas (Hydroseeding Design Bulletin). The material was applied in two applications per the Hydroseeding Design Bulletin; the first applications consisted of the seed, fertilizer, and Flexterra® mix, and the second application consisted of Flexterra® only. Charlton Landscape hydroseeded the east and west riverbanks on April 7, 2009 and April 8, 2009, respectively.

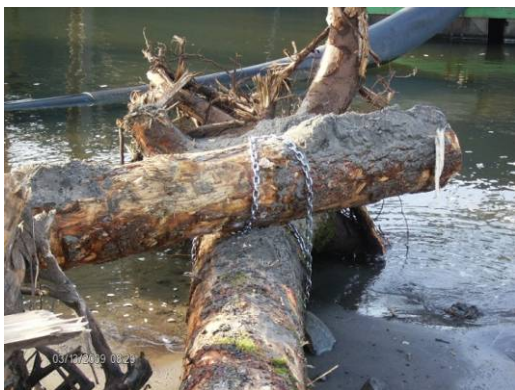
Photograph 26: LWD pile

Photographs depicting habitat improvement activity implementation and documenting the planting locations are presented in Photographs 26, 27, and 28.

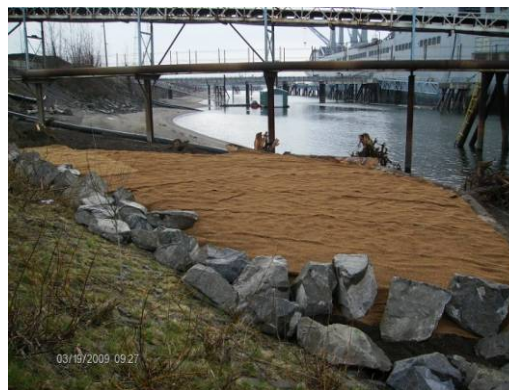
Photograph 27: Riparian planting area prior to planting

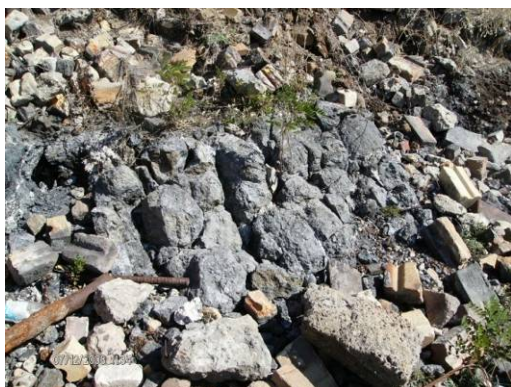
Photograph 31: Visually contaminated surface debris

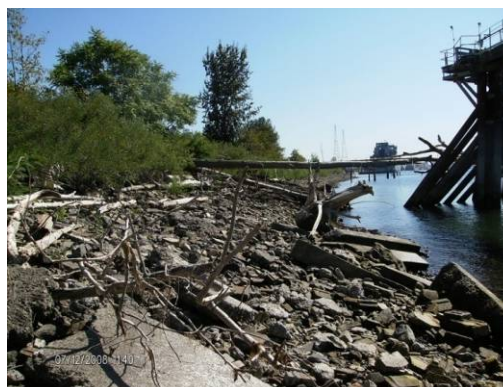
Photograph 32: Concrete and woody debris

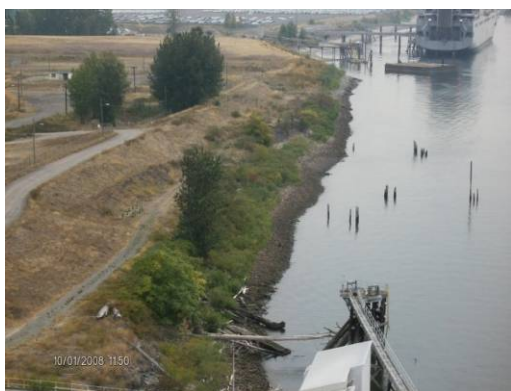
Photograph 33: Dredge areas and piles, taken facing east

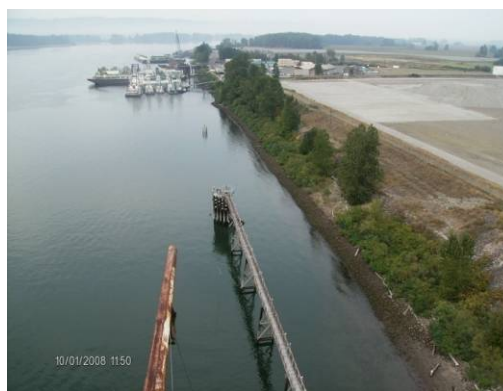
Photograph 34: Dredge areas, taken facing west

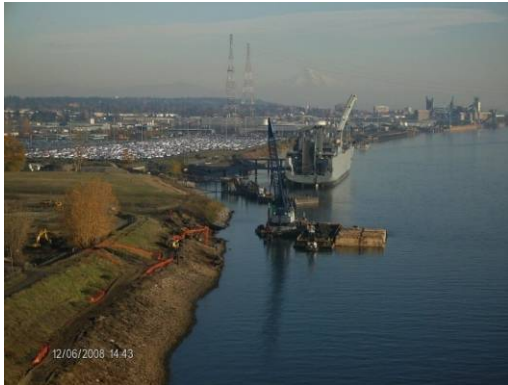
Photograph 35: Shoreline excavation and dredging, taken facing east

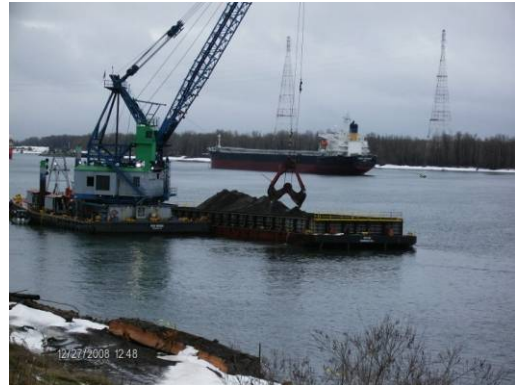
Photograph 36: Dredging, taken facing southeast

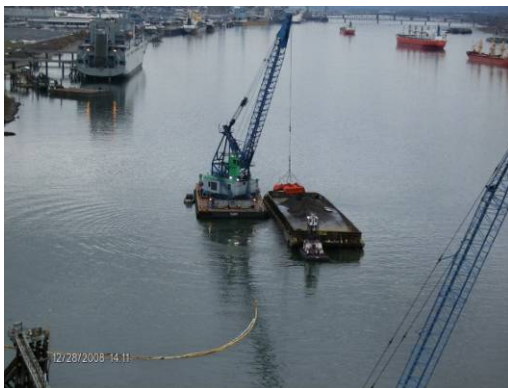
Photograph 37: Dredging with debris boom, taken facing east

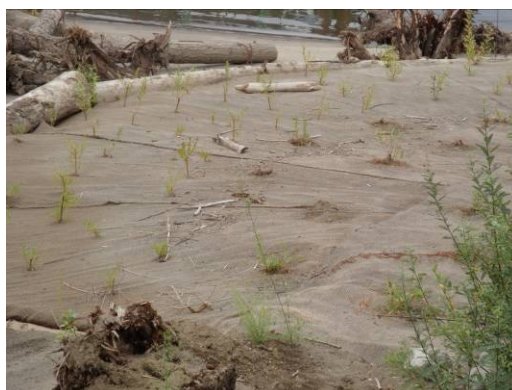
Photograph 46: Habitat Improvement area

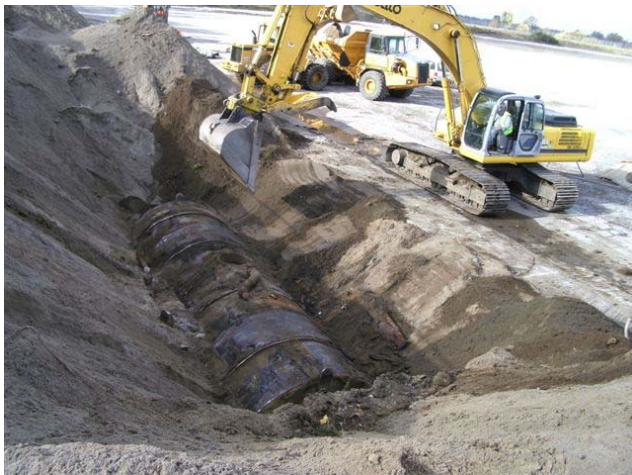
Photograph 47: Soil removal from UST #3

The removal of the USTs occurred on December 16, 2008. The sand was pulled away from the edges of the USTs and they were removed from with excavators. Photographs 47 and 48 show UST # 3 removal. The USTs were loaded into off-road trucks and moved to the scrap steel staging area. The steel was sized and shipped off-site for recycling.

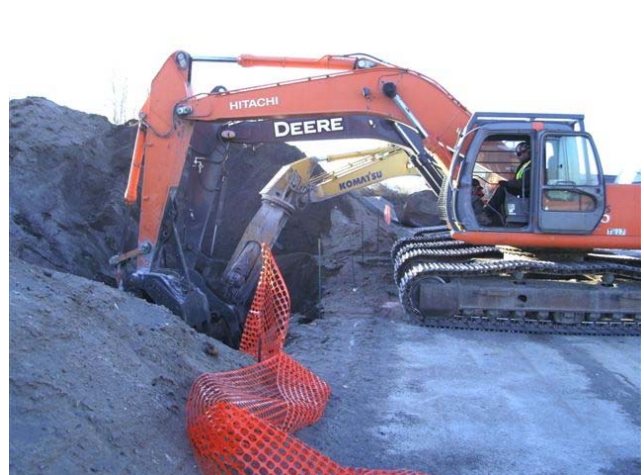
Photograph 48: Removal of UST #3

On December 23, 2008, the UST excavations were backfilled and compacted with the overburden stockpiled in the area and clean sand from the internal dikes. The slope at the dike was returned to a grade similar to the dike, which was undisturbed.

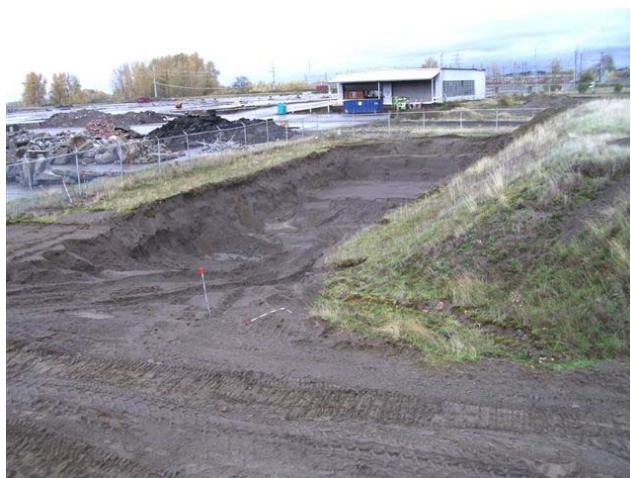
Photograph 49: Removal at SSO 001, 002, and 003

The removal of the PCB-impacted soils began on November 3, 2008. Excavation continued in all areas until the PCB cleanup goal was met in the remaining soils in the excavation. Photograph 49 shows the final excavation of areas SSO 001, 002, and 003. Photograph 50 shows the final excavation of areas SSO 004, 006, and 008. The final excavation event occurred on November 18, 2008, and was followed by compaction and backfilling. Along the northern edge of the excavation, carbon plant materials were encountered. PCBs were not present above the cleanup levels in this location. An additional remedial activity occurred to address these materials and is discussed in Section 8.

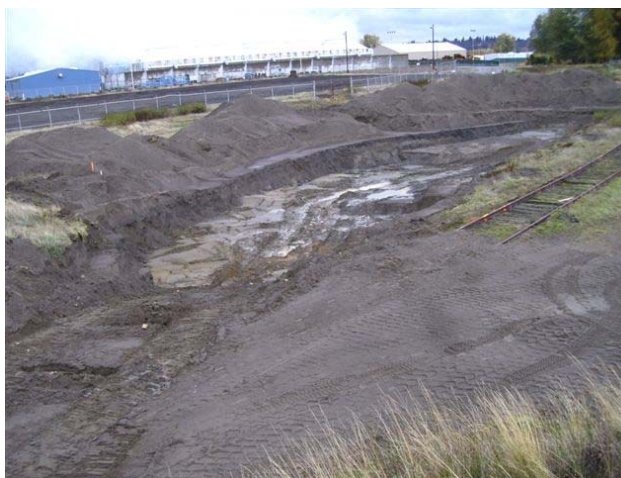
Photograph 50: Removal at SSO 004, 006, and 008

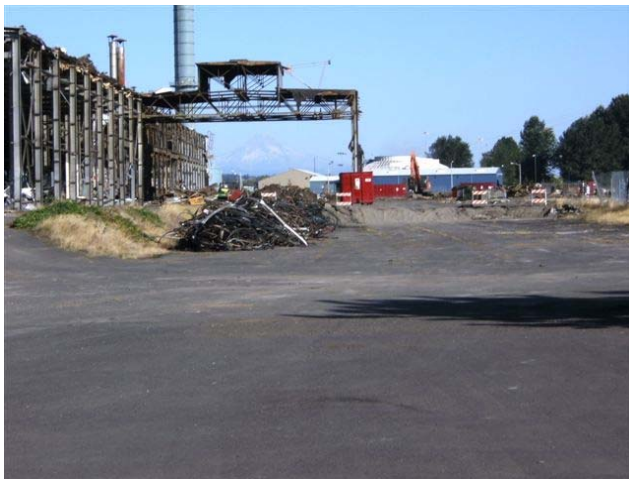
Photograph 51: Demolition of Building 410

Prior to structure demolition, liquids, asbestos, refrigerants, light bulbs, fluorescent light ballasts, and any other materials that may be hazardous or require management separately from building structure materials, were removed from the building. These materials were segregated and prepared for shipment off-site, either for recycling or disposal. Global Pacific Environmental LLC managed the removal of the asbestos-containing materials at the Site. Floor mastic was used in ACPC and this material contained PCBs. The mastic was removed from the concrete and managed as PCB bulk product waste. After building demolition, the building materials were segregated and prepared for off-site shipment or disposal. The majority of the Vanexco and Rod Mill buildings were disposed of off-site in a TSCA Subtitle C landfill because the interior of the building was impacted by historical PCBs releases. Photographs 51 and 52 show the demolition of the last section of Building 410.

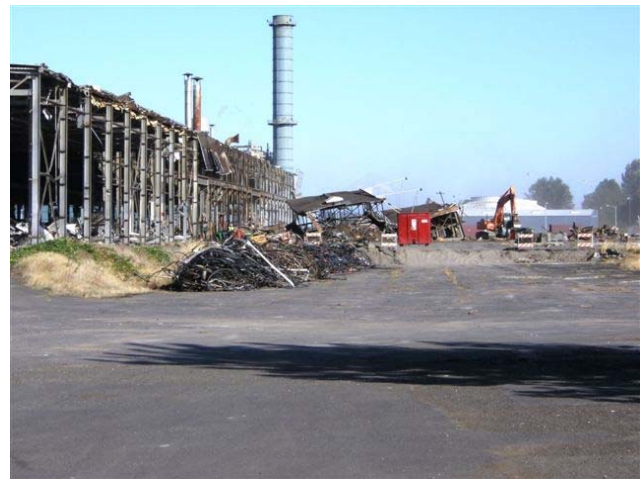
Photograph 52: Demolition of Building 410

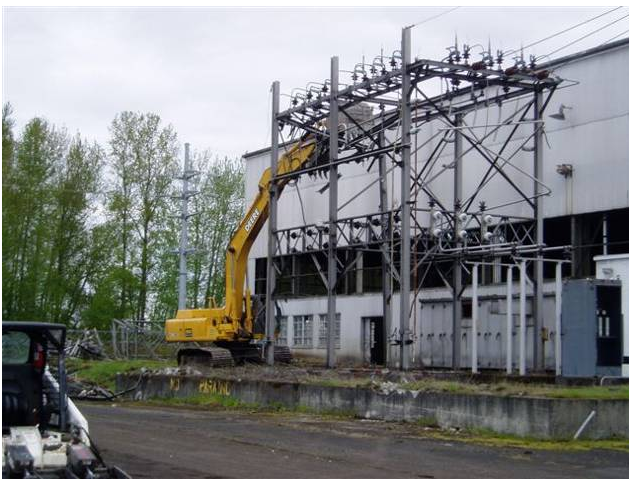
Photograph 53: Demolition of electrical station near Vanexco

Every effort was made to protect the soil on the west and north sides of Vanexco during the demolition project. Photographs 53 and 54 show demolition activities for the Vanexco buildings. To verify that the soil was not inadvertently contaminated, the soil on the west

(north of the substation) and north of Vanexco was sampled and analyzed for PCBs by both Alcoa and TtEC. The data indicated that PCBs were not present above 1 mg/kg and may be reviewed in Appendix I. At the completion of the demolition at Vanexco, the top of the soil and any debris was removed from around Vanexco. The same ten soil sample locations were resampled at various depths. The sample locations and extent of excavation are on Figure 11. All the samples were analyzed for PCBs. Nine samples were analyzed for PAHs. All of the sample results met Site cleanup levels for PCBs and PAHs. The data are presented in Table 11.

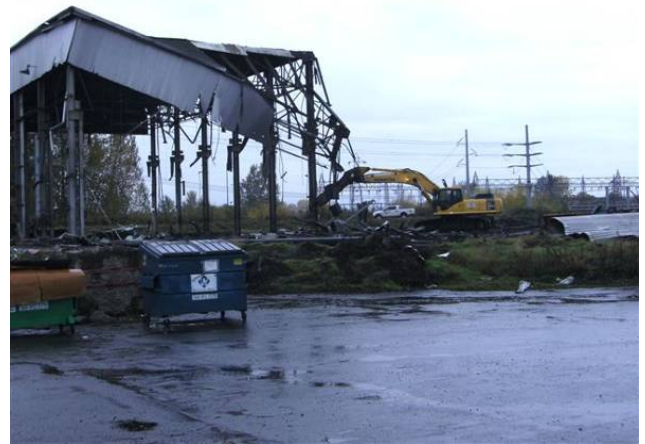
Photograph 54: Demolition of Building 401 (Vanexco building) onto concrete floor slab

The floor slabs in all the buildings were cleaned of demolition debris and the debris was segregated with the appropriate waste streams. Care was taken with the Vanexco and Rod Mill floor slabs, which was the cap that was left in place over the impacted soil under these buildings. Any penetrations of the cap were filled with concrete prior to the completion of the project to ensure the cap's integrity.

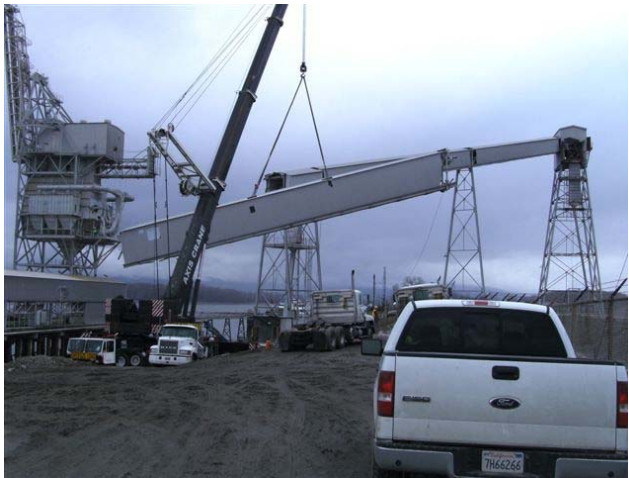
Photograph 55: Crane removing section of ore conveyor

A crane was used to gently remove the ore conveyor that spanned from the dock in the Columbia River to the shore, as shown in Photograph 55. All work to demolish these sections of conveyor housing was completed in the area of the ore silos. Water was used to wet sections of conveyor housing prior to demolition activities to minimize dust emission during the project. Photograph 56 shows the removal of silo foundations.

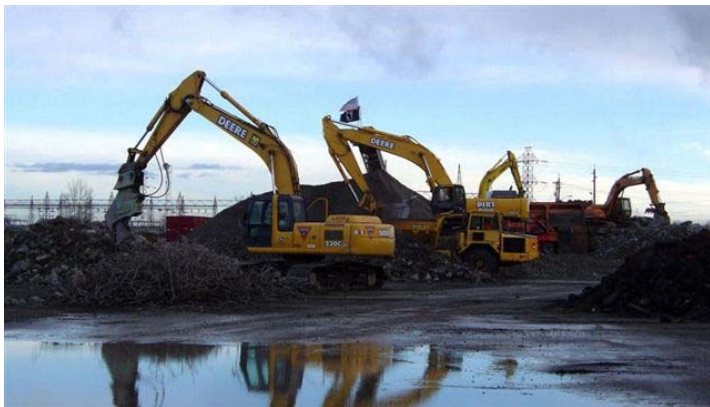
Photograph 57: Crushed concrete piles and relocation activities

reuse goal of 1 mg/kg PCBs. Sample results for all the crushed concrete testing are found in Table 12. Crushed concrete piles with sample results greater than or equal to 1 mg/kg and less than 10 mg/kg for PCBs were placed in the North Landfill, as dry material to mix with the sediment. Crushed concrete piles with sample results less than 1 mg/kg PCBs were released for unrestricted Site use. The crushed concrete piles near the crusher were relocated, as show in Photograph 57. This crushed concrete was placed in two stockpiles and left for use by the future property owner.

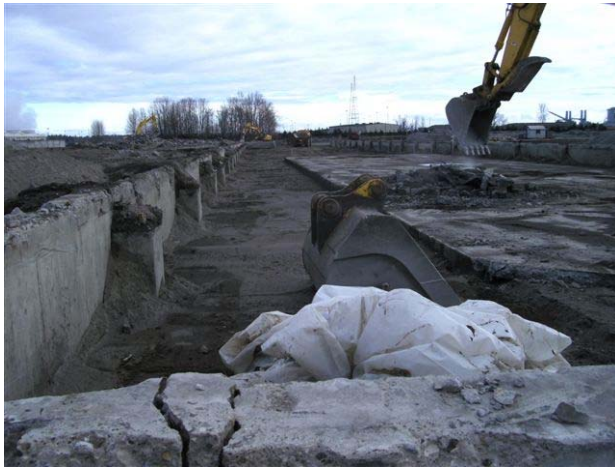
Photograph 58: Excavation under Building 427 to concrete pad

Under Building 427, a significant remedial effort occurred. Three areas of fill sand under Building 427 were impacted by PCBs, in concentrations greater than or equal to 50 mg/kg and less than 50 mg/kg. In one location just west of the middle of Building 427, a lens of black carbon material was identified. PAH concentrations were well below Site cleanup levels in the characterization samples. Further sampling efforts delineated the PCB contamination in situ in the fill sand. Dependant upon the in situ characterization, the fill sand was either placed in the TSCA Subtitle C landfill stockpile, the Subtitle D landfill stockpile, or North Landfill. The extent of the excavation and the sampling locations are on Figure 12. Photographs 58 and 59 show the excavation area under Building 427. The in situ characterization data are in Appendix I and the confirmation sampling data is in Table 13. All final confirmation sample results were less than 1 mg/kg PCBs, which met Site cleanup levels for PCBs.

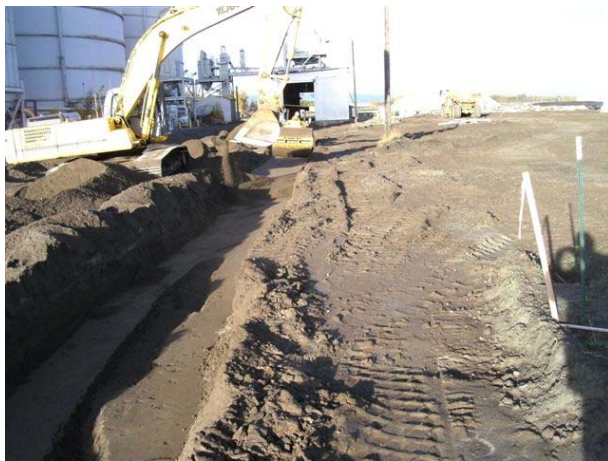
Photograph 60: Storm sewer line removal

Storm sewer sections that were found to contain PCB-bearing, oily grease residues were removed. Several sections that were originally to be left in place were removed. These sections were placed in the TSCA Subtitle C sewer pipe stockpile and disposed of off-site.

Excavations from the removal of storm sewer lines were backfilled and compacted. Photograph 60 shows the excavation of the storm sewer line near the ore silos and Photograph 61 shows the backfill and compaction at an ACPC storm sewer line.

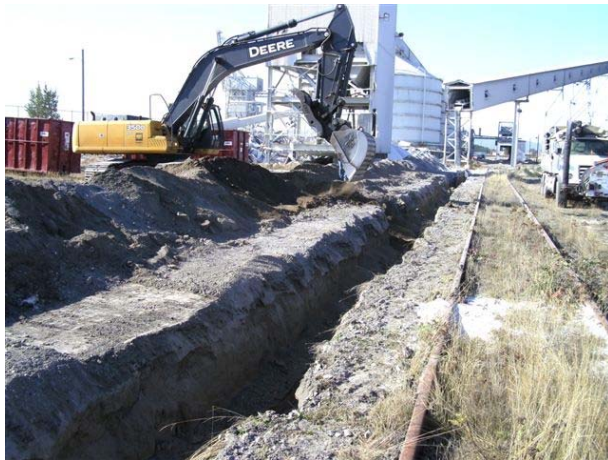
Photograph 62: ASTPT excavation along rail line

locations. Photograph 62 shows the pipeline excavation. This impacted soil was removed and stockpiled for off-site disposal. At two locations, oil had leaked from the pipeline, creating larger excavations. The location of the pipeline and the extent of these two excavations are shown on Figure 13, as well as confirmation sample locations along the pipeline and in the excavations. Both of the large excavations were 8 to 15 feet bgs. Photograph 63 shows the southern excavation. The excavation at the north end of the pipeline extended onto Evergreen property. Characterization sample data is in Appendix I. All confirmation sample results met Site goals for TPH and are presented in Table 22. The excavated areas were compacted and backfilled with clean sand from the internal dikes.

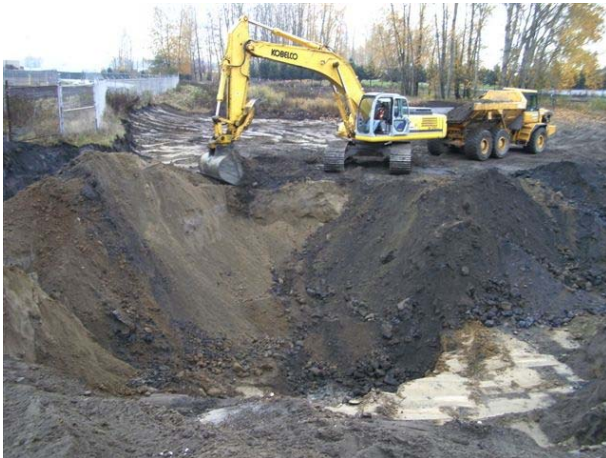
Photograph 64: Excavation of carbon materials

The carbon soil identified during the excavation of the soluble oil area was removed and stockpiled with the Subtitle D soils for off-site disposal. The area extended to the north of the soluble oil area and required the fence to the east parking lot to be removed to complete the excavation. The western area of the excavation (105 feet by 75 feet) was 1 foot bgs. The eastern area of the excavation (120 feet by 90 feet) was an average of 12 feet bgs, with the deepest area 18 feet bgs. The extent of the excavation and the location of the confirmation samples are shown on Figure 10 and highlighted in the photographs below. The confirmation sample results all met site cleanup levels for PAHs and are in Table 26.
