Final Remedial Investigation Report

**North Colfax Petroleum
Contamination Site**

North Main Street and
East Tyler Street
Colfax, Washington

Final Remedial Investigation Report
North Colfax Petroleum Contamination Site
North Main Street and East Tyler Street
Colfax, Washington 99111

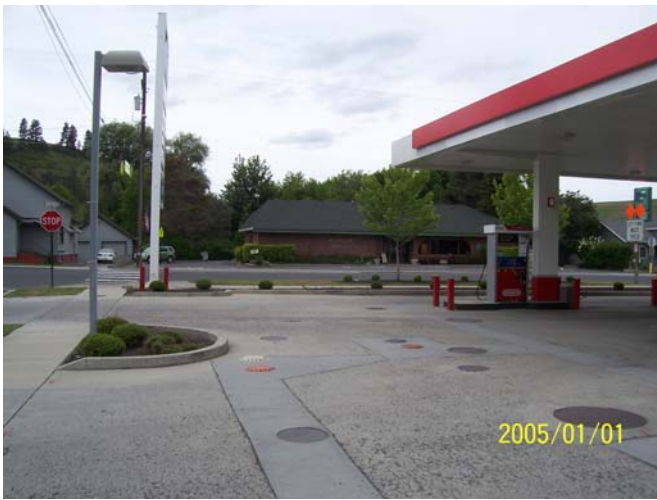
Photograph 1. View looking west across the southern portion of the Time Oil property toward the Sterling Savings Bank across North Main Street.

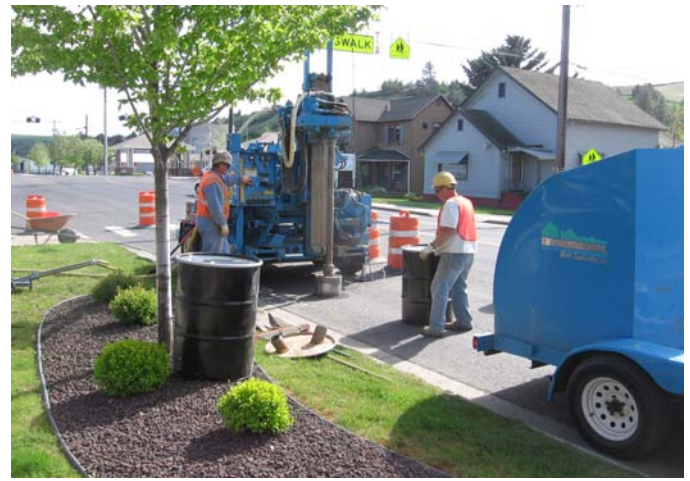
Photograph 2. View looking southwest toward boring B26, completed as monitoring well MW26, located in the right-of-way along the east side of North Main Street adjacent to the Time Oil property.

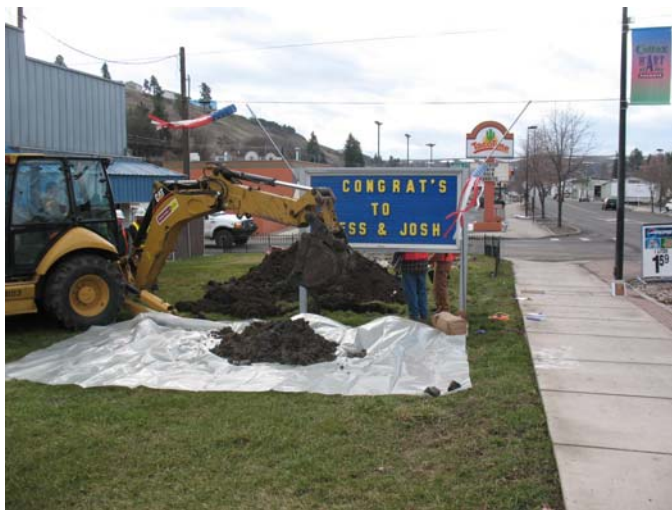
Photograph 10. View of the installation of MW32 looking northeast toward the Colfax Grange Supply Company building along East Harrison Street.

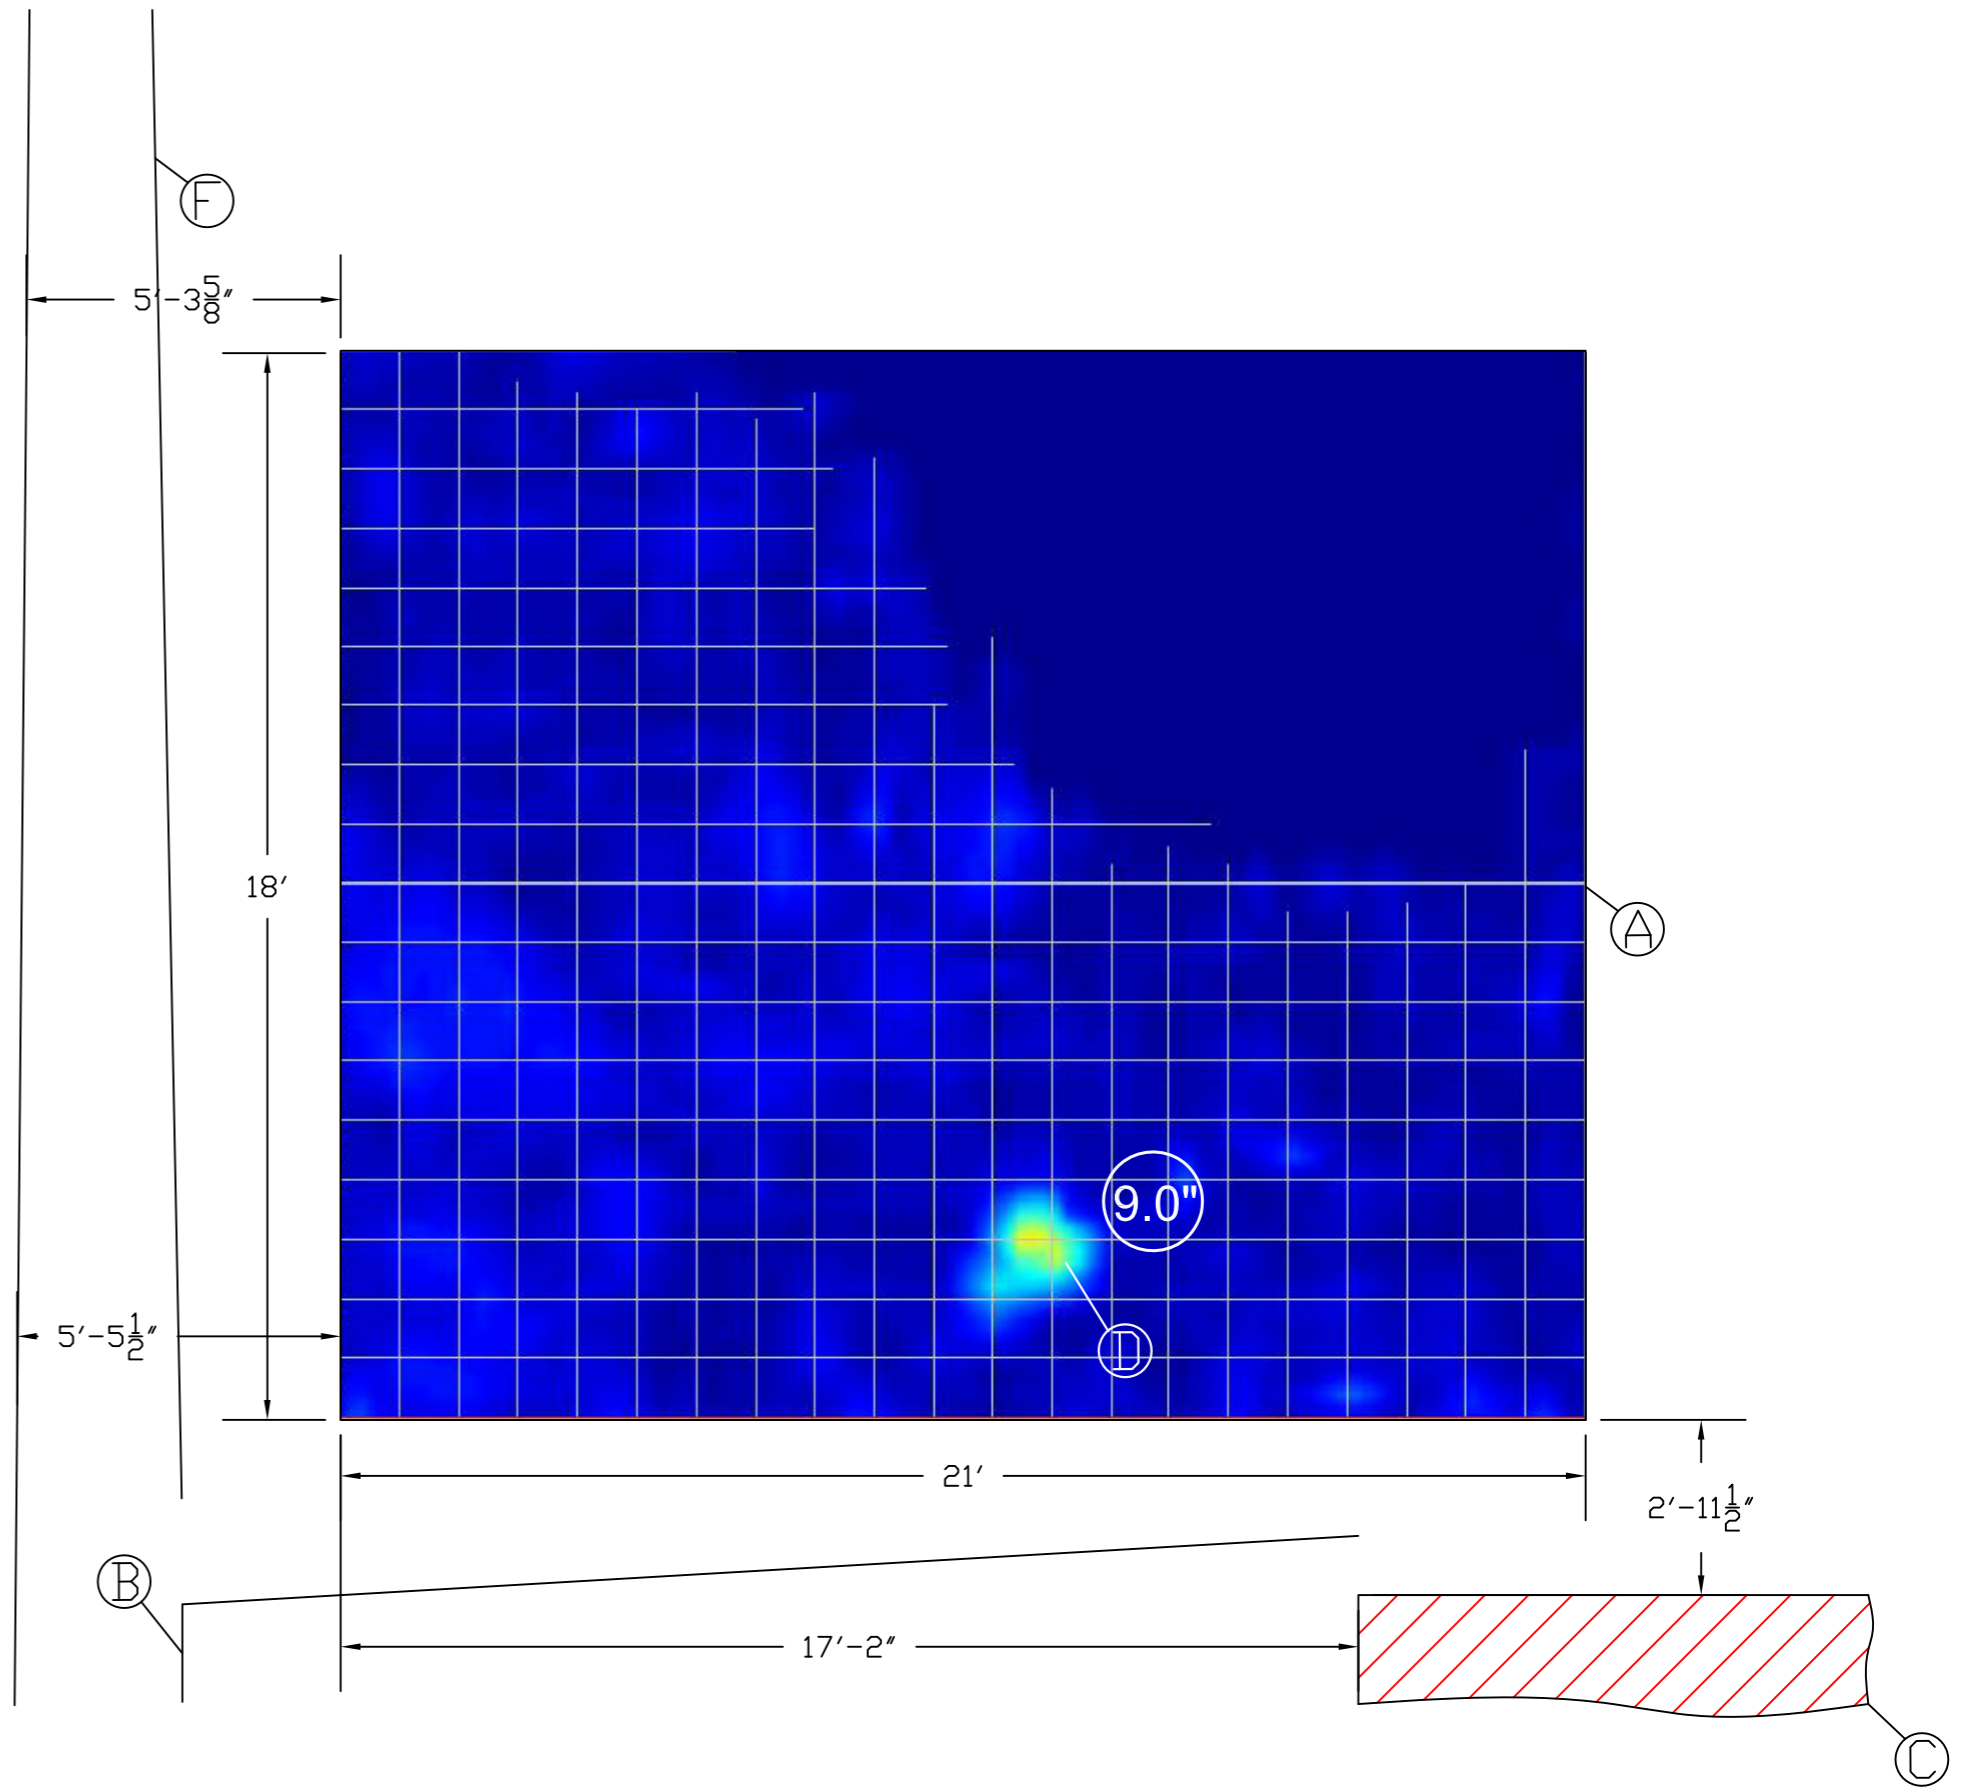
Item	Description
A	Composite Image of Scan Area.
B	Chain Link enclosure Fence.
C	Building.
D	Unknown object at 9.0 Inches deep. Possibly metal.
E	Photo of Scan area with corners marked by painted stakes.
F	Black decorative fence.

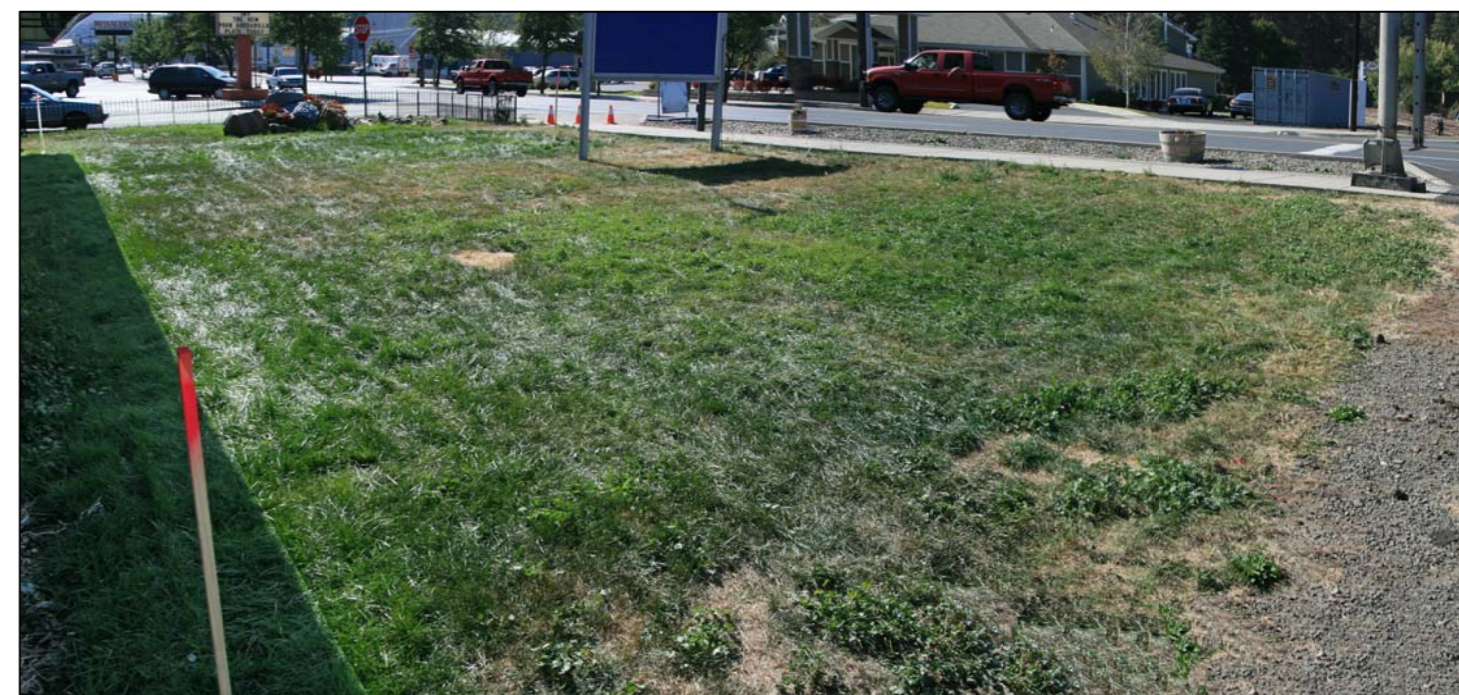
Drawing Number: D-2008-1038-01

Item	Description
A	Composite Image of Scan Area.
B	Photo of Scan area with corners marked by painted stakes.
C	Unknown linear object at 1.2 ft. depth to 1.9 ft. depth.
D	Metal cover imbedded in sidewalk.
E	Light Post.
F	Hatched area is Sidewalk
G	Rail Road Crossing Sign.

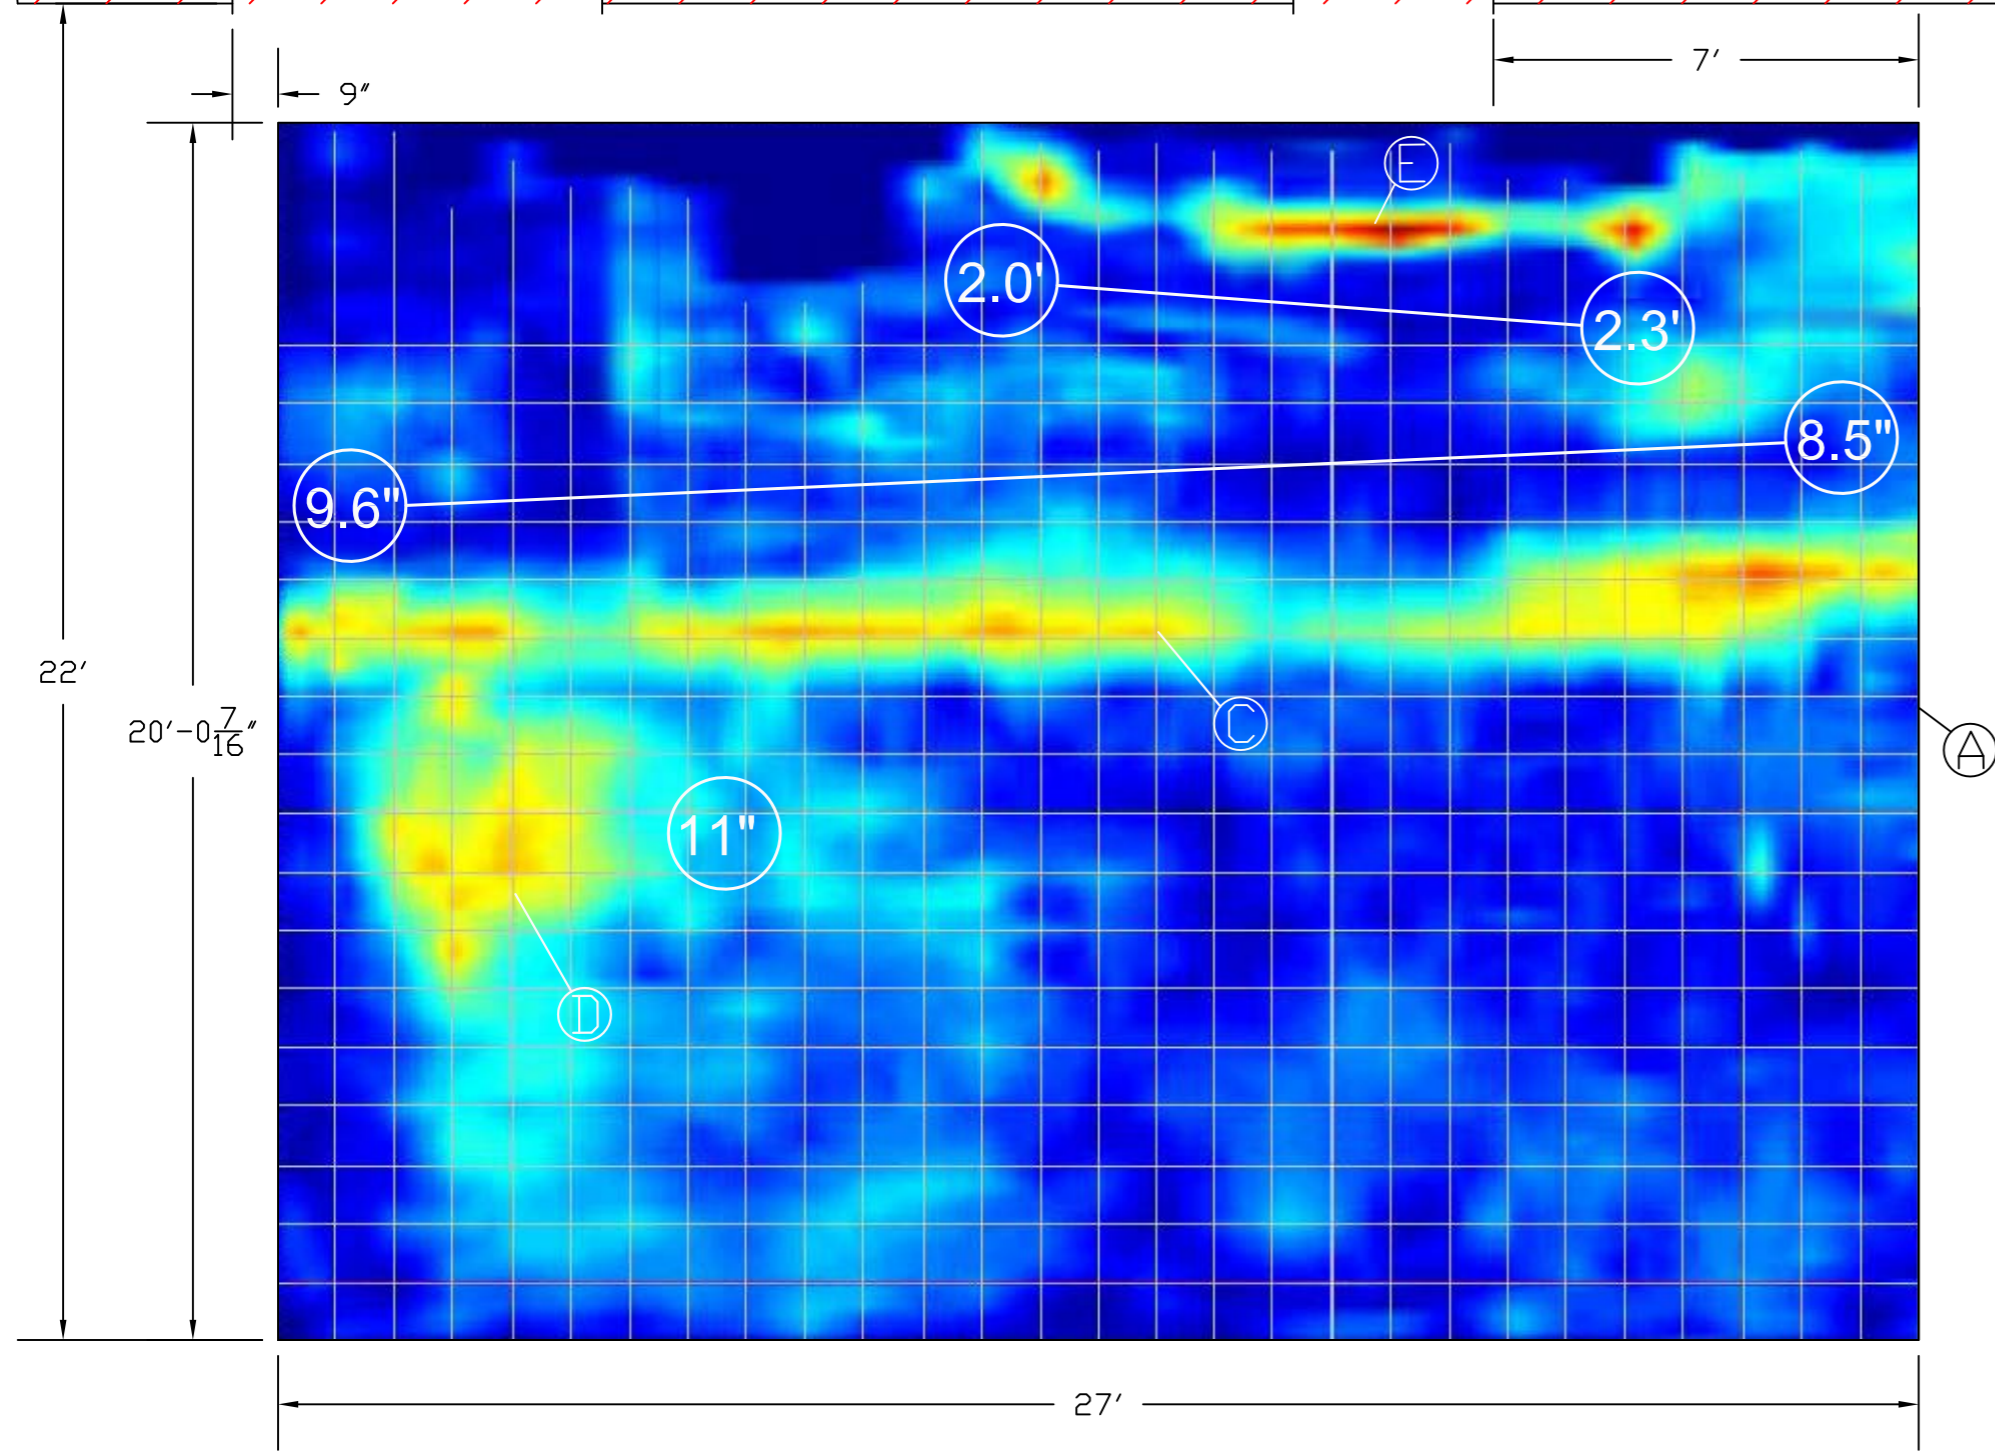
Drawing Number: D-2008-1038-02

Item	Description
A	Composite Image of Scan Area.
B	Photo of Scan area with corners marked by paint on surface
C	Unknown linear object at 9.6 inch depth to 8.5 inch depth.
D	Unknown Possible object at 11" depth.
E	Unknown linear object at 2.0 ft. depth to 2.3 ft. depth.

Notes: Grid Spacing is on 1' interval. All elevations relative to surface.
 Surface was dry gravel and concrete.
 Items C & D: Non circular profile, possibly rectangular in shape.
Scale: .026 = 1
Drawing Number: D-2008-1038-03
